Experimental Study of Various Techniques to Protect Ice-Rich Cut Slopes

Lin Li, M.S., Research Assistant
Department of Civil and Environmental Engineering
University of Alaska Fairbanks

August 2014

Number: 4000(113)B

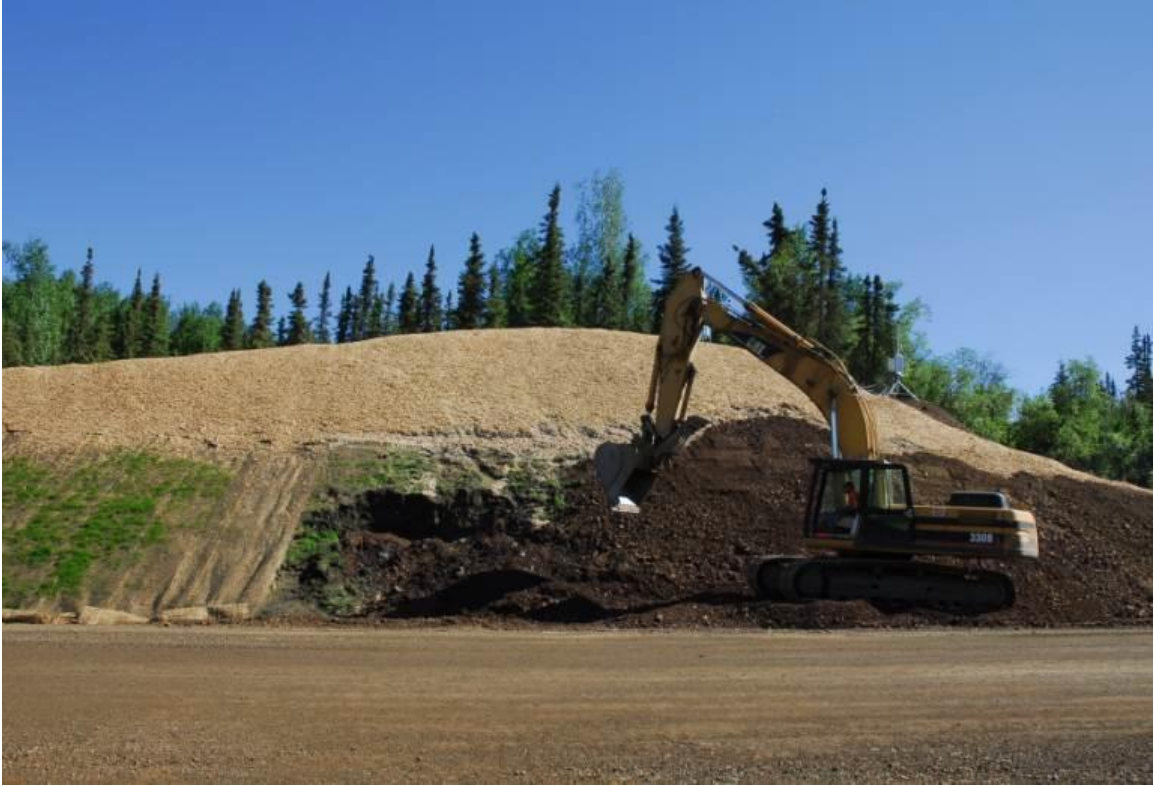
According to the recommendations listed above, on June 17, 2013, Tecco-mesh and the coconut erosion control blankets at Section C were removed (shown in Figure 6.5). The great loss of volume in cut slope soil at Section C can be seen in Figure 6.6, especially where massive ice is exposed. Crushed rock was hauled to the test site, and an excavator was used to cover Section C with crushed rock (see Figure 6.7). The hollow rebar anchors were left intact during these repairs to serve as survey and photogrammetric reference points. Figure 6.8 shows the cut slope after completion of repairs on June 17, 2013.

Figure 6.7 Covering Section C with crushed rock

- Extend the rock blanket material (control section material) across that section. During this process, leave as many of the Tecco-mesh anchors in place as possible. It was thought that thaw-related problems would initially continue given the very high ice content of some of the cut slope material, and that the rock blanket would conform to the slope surface as the slope receded. The rock blanket would provide some degree of insulation and serve as a filter to keep silt from running into the ditch. Initial failure of the project's standard design thickness of blanket material, due to loss of massive ice volume, would require placement of additional blanket material.

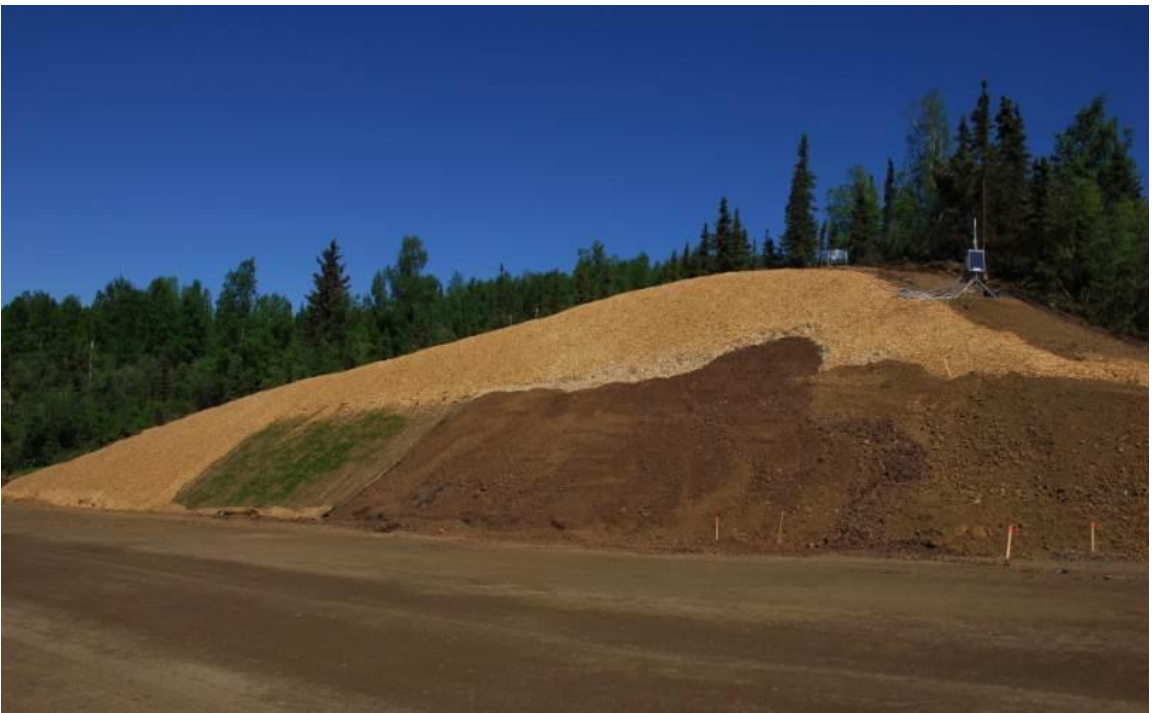
Figure 6.8 Cut slope after construction on Section C

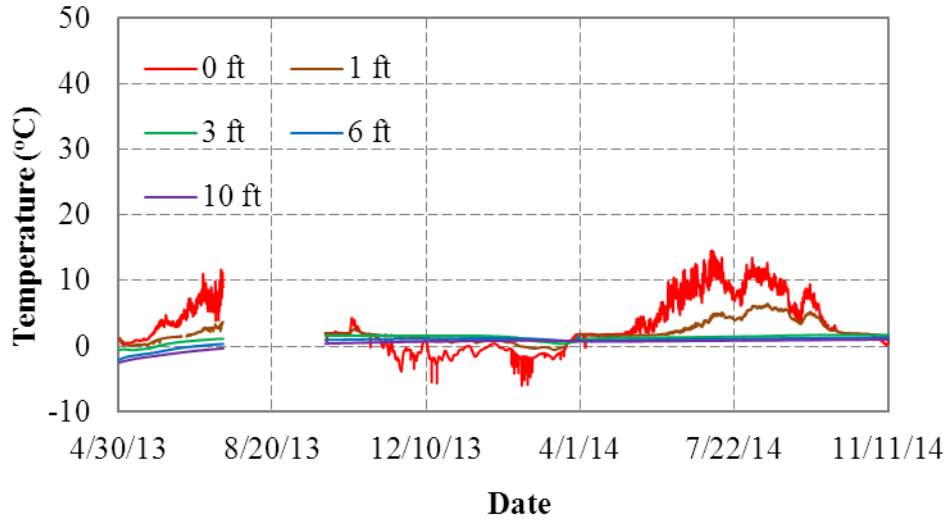
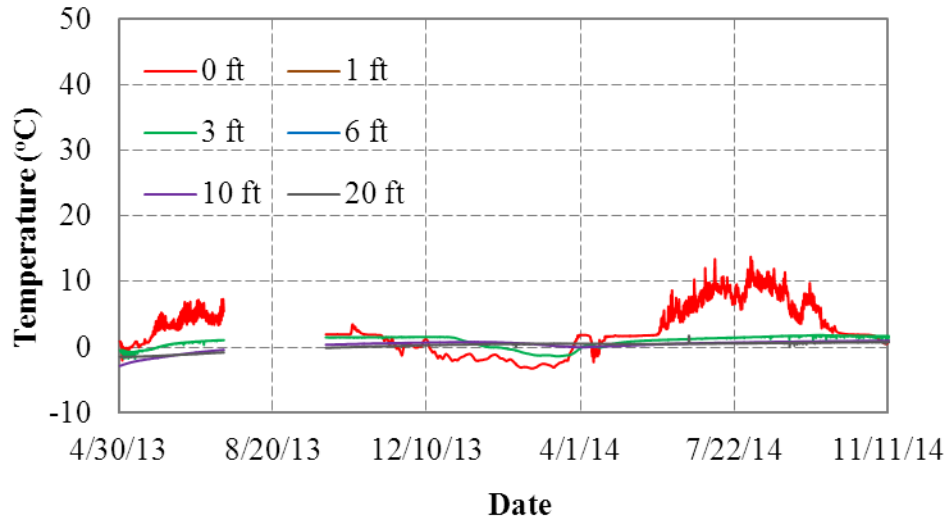
Figure 7.10 Temperature variations in Section A

Figure 7.10 shows the temperature changes at the bottom, middle, and top of the Section A slope (wood chips) at different depths (0, 1, 3, 6, 10, and 20 ft). Temperature variations at different depths are presented in different colors. As indicated in Chapter 3, the maximum sensor depth, perpendicular to the slope face, is 10 ft for the sensor strings at the top and bottom of the slope face for all four sections. The maximum depth for the sensor string at the middle of the slope for

all sections is 20 ft. At the middle of Section A, no temperature data were obtained from sensors at depths of 1 and 6 ft due to malfunctioning.

Figure 7.10 indicates that temperatures increased at all depths within Section A during the time period between April 30 and July 15, 2013 and decreased during the time period between November and December 2013. Then, in March, soil temperature at 0 ft started to rise up with fluctuations till the end of June and then continuously decreased. However, the soil temperature at depths below 0 ft continuously decreased from January to April and then rose up till August and then decreased. Close to the slope face, temperature variations were controlled by daily air temperature variations, even though one ft of wood chips covered the slope surface. Soil temperatures at deeper locations were lower and varied less with time in the summer when compared with the soil temperatures at lower depths. However, in winter, soil temperatures at deeper locations were higher and slightly varied with time. Temperatures at various depths, according to the sensor string at the upper part of the slope, were slightly higher than temperatures measured by the strings further down the slope. This difference is because the wood chips were not evenly distributed on this section. The lower part of the slope (Figure 7.10a) was covered with more wood chips than that at the top (Figure 7.10c), and the wood chips worked as insulation, which protected the slope from air temperature changes. At the start of the monitoring period (the first week after construction), temperatures close to the ground surface decreased slightly because the new cut slope surface was exposed to low ambient air

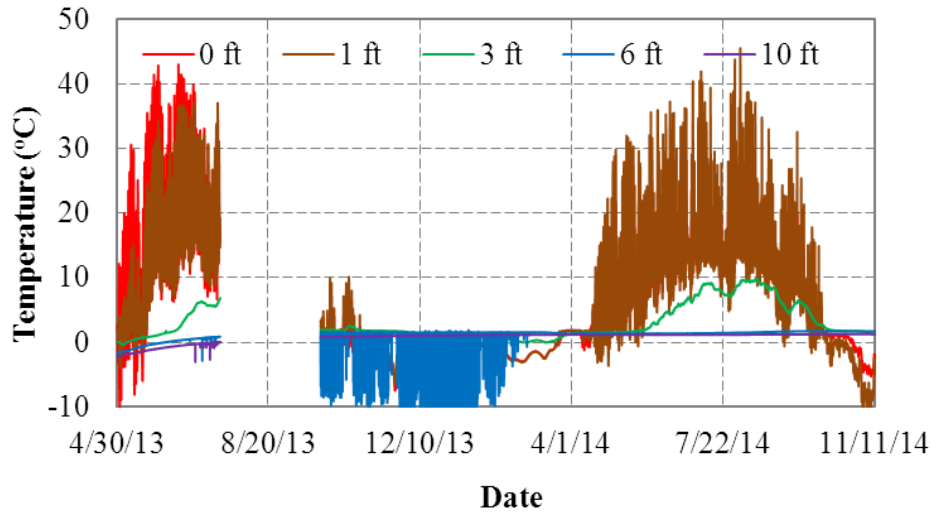
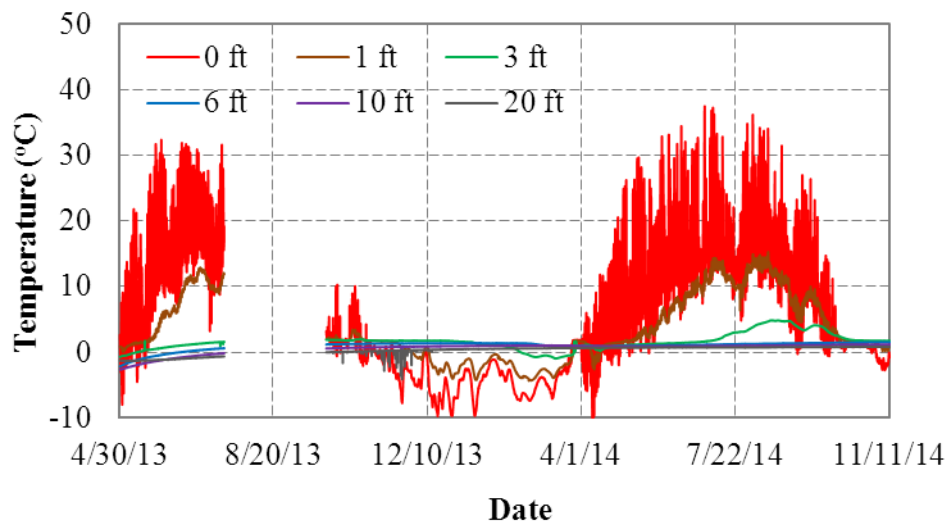
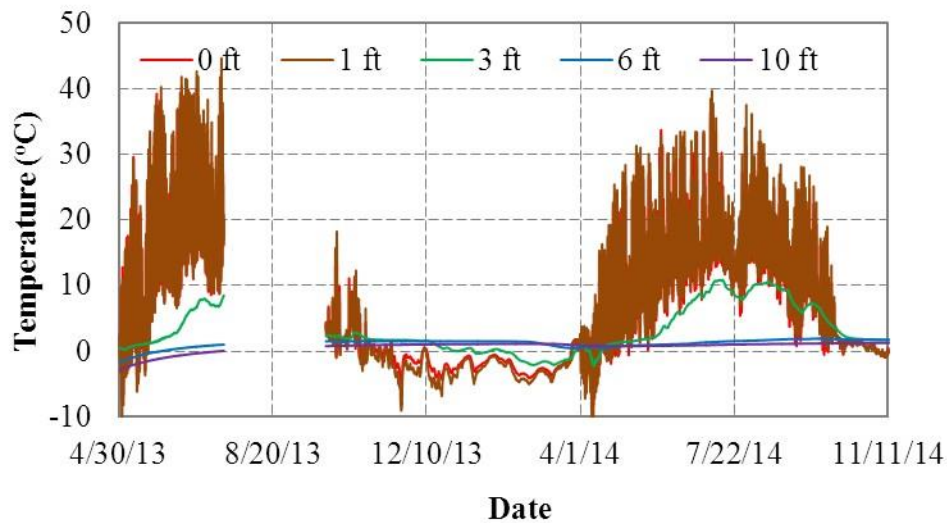
Figure 7.11 Temperature variations in Section B

Figure 7.11 shows temperature changes at the bottom, middle, and top of Section B (coconut blanket) at different depths (0, 1, 3, 6, 10, and 20 ft). For Section A, temperature variations at different depths are presented in different colors.

Similar to the temperature variation in Section A, due to the air temperature increase during the time period between April 30 and July 15, 2013, soil temperatures increased throughout the monitoring period at different depths and decreased during the time period between November and December 2013, as seen in Figure 7.11. Then, in March, soil temperature at 0 ft started to rise up with fluctuations till the end of June. The soil temperature at depths below 0 ft continuously decreased from January to April and then rose up till the end of June. At the slope surface, the temperature changes closely followed air temperature variation. Also, the temperature variations for the bottom, middle, and top of the section were consistent with one another due to the thickness uniformity of the coconut blanket, except for the temperatures at the middle with depths of 1 and 3 ft. At 1 ft below the slope surface in this section, especially for the temperatures at the top and bottom of this slope, the soil temperature changes closely followed the daily air temperature variation. Compared with the layer of wood chips, the coconut blanket (as expected) offered essentially no insulative benefit. Three ft below the slope surface of this section, soil temperature changes smoothly followed the long-term increase in air temperature—in a damped response compared with the soil at 1 ft depth.

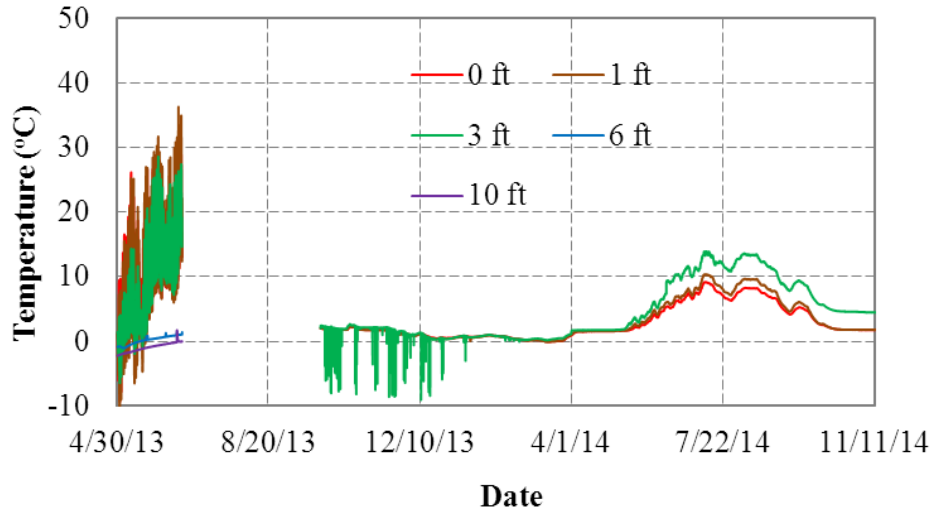
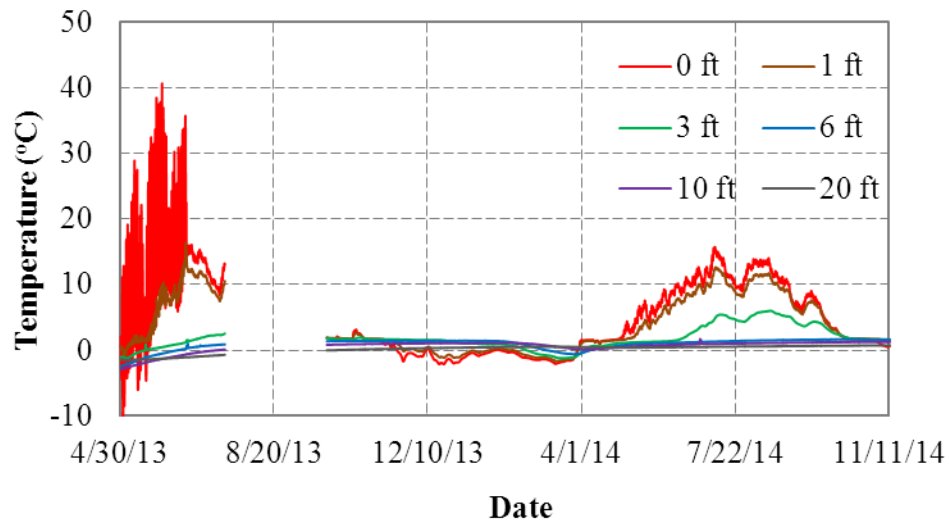
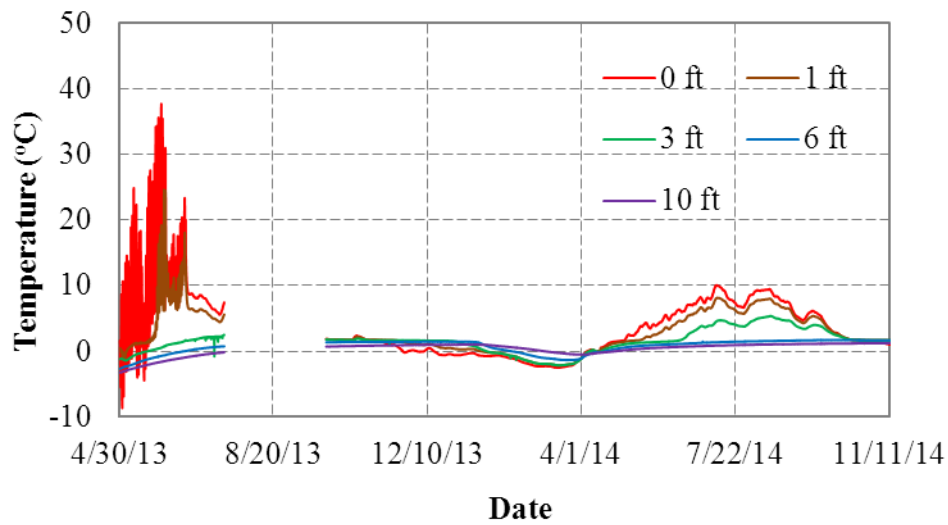
Figure 7.12 Temperature variations in Section C

Figure 7.12 shows temperature changes at the bottom, middle, and top of Section C (Tecco-mesh and coconut blanket) at different depths (0, 1, 3, 6, 10, and 20 ft). Temperature variations at different depths are presented in different colors. Due to thaw-related slope failures in this

section, the Tecco-mesh and coconut blanket were removed and replaced by crushed rock on June 17, 2013. The layer of crushed rock was of variable thickness due to the uneven surface of the damaged slope. The thickness of the rock blanket ranged from about 1 to 3 ft. Temperature sensors located at depths of 6 and 10 ft at the bottom of Section C stopped working after the June 17, 2013 repair work.

Before the major repair work on June 17, 2013, temperature variations within Section C were generally similar to those of Sections A and B, as seen in Figure 7.12. At the slope surface and 1 ft below, temperatures followed the daily air temperature variation. Compared with the wood chip section (Section A), the coconut blanket together with the Tecco-mesh offered essentially no insulative benefit, as expected. After the replacement of the Tecco-mesh and coconut blanket with a rock blanket, temperature sensors at the original slope surface and originally 1 ft below indicated that a period of cooling occurred. No such period of cooling was seen in Sections A or B. Soil temperatures variations between October, 2013 and August 2014, which was after the repair work on June 17, 2013, were also similar to that in Sections A and B.

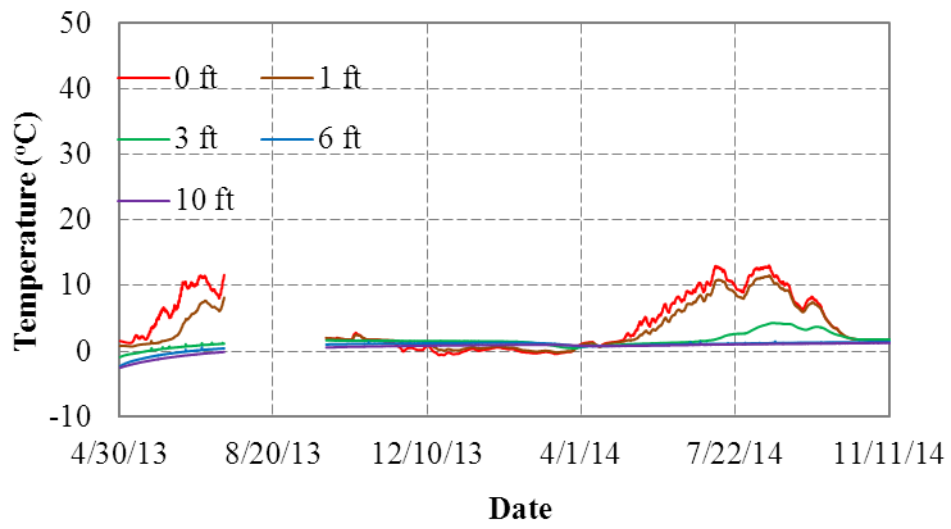
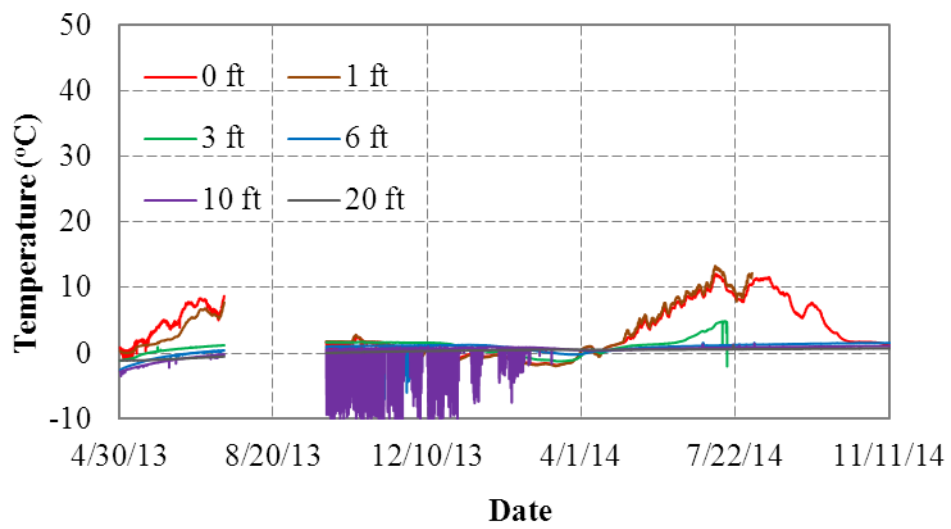
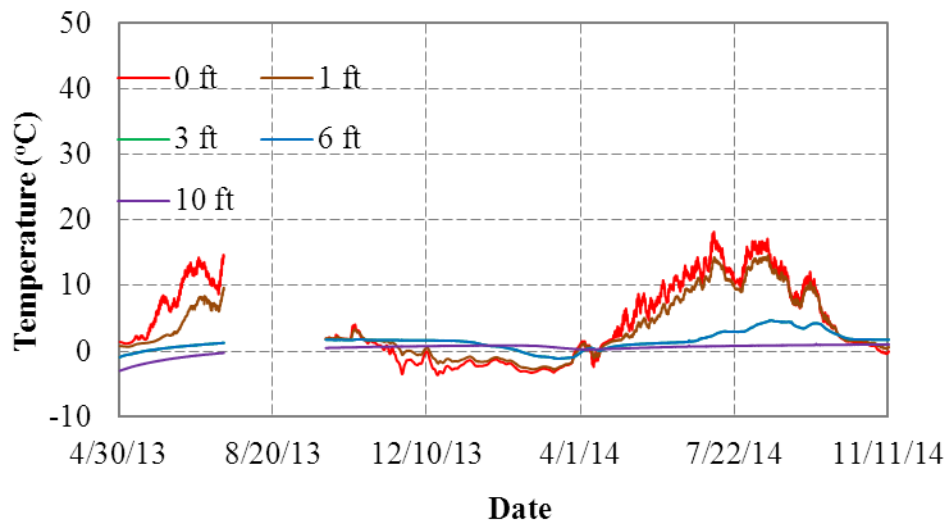
Figure 7.13 Temperature variations in Section D

Figure 7.13 shows the temperature changes at the bottom, middle, and top of Section D (crushed rock) at different depths (0, 1, 3, 6, 10, and 20 ft). At the top of Section D, no temperature data were obtained from the sensor at a depth of 3 ft due to malfunctioning. Due to erosion in Section D, associated with repairs and placement of crushed rock in Section C, more crushed rock was placed in Section D.

As shown in Figure 7.13, soil temperature variations follow the same pattern as for Sections A through C except that the soil temperature response is damped by the overlying rock blanket. Due to the presence of the covered 1 ft of crushed rock, soil temperatures at 0 and 6 ft were higher and lower than that in Sections B and C in summer and winter, respectively.

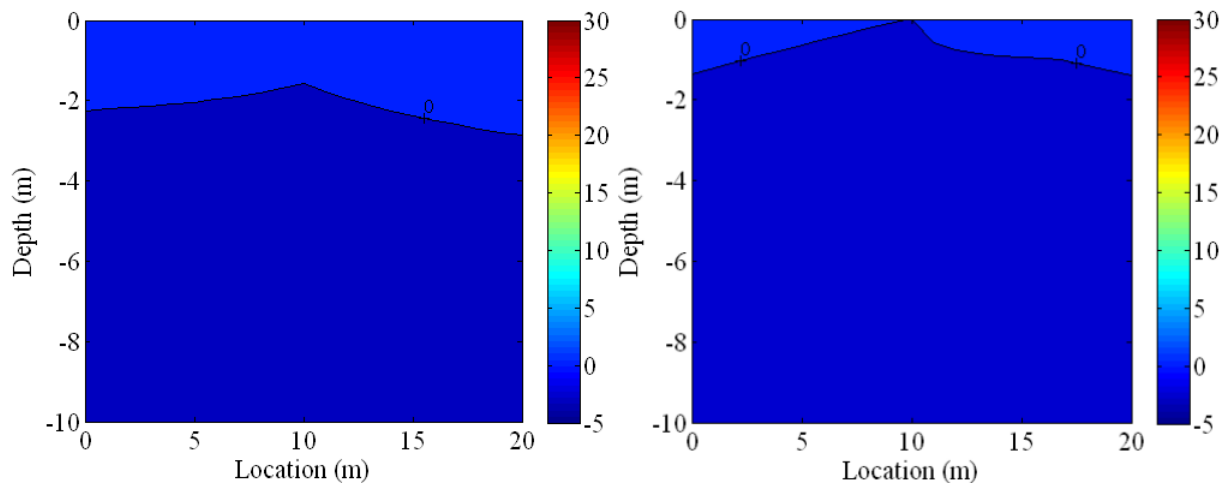
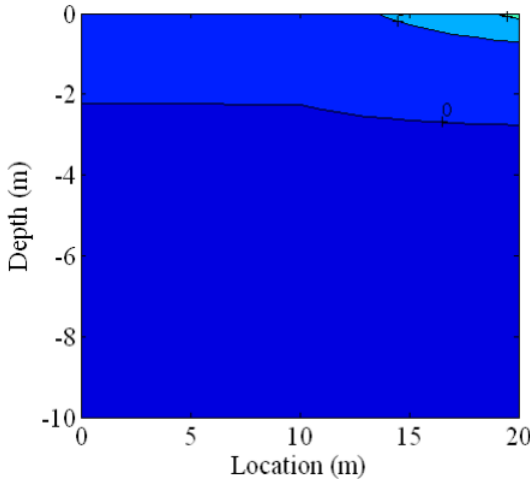
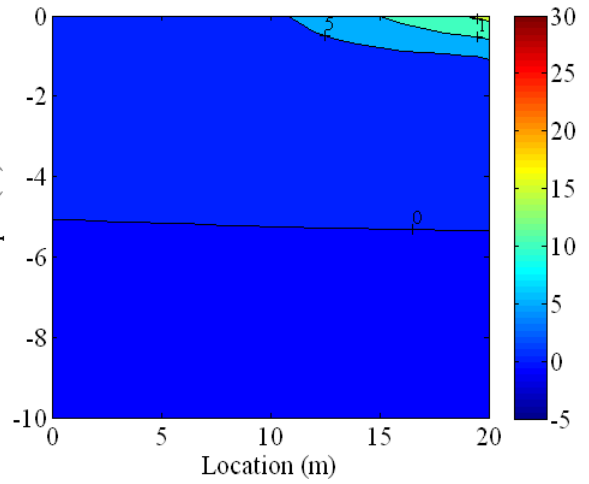
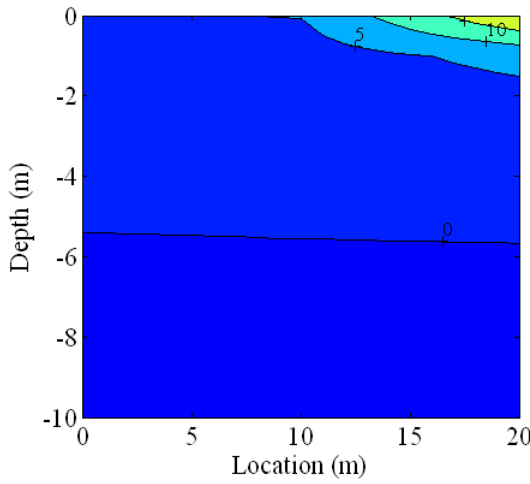
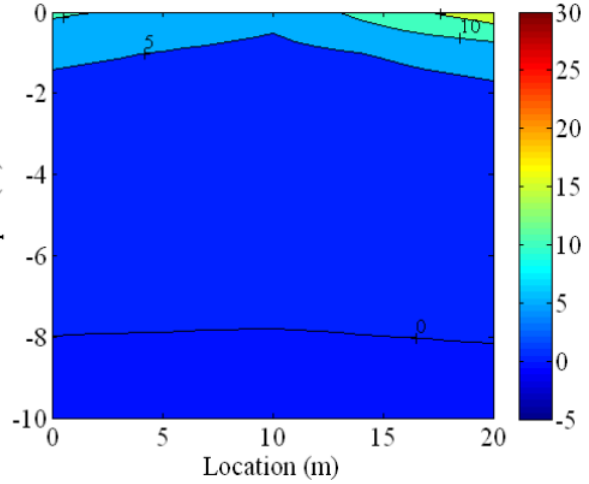
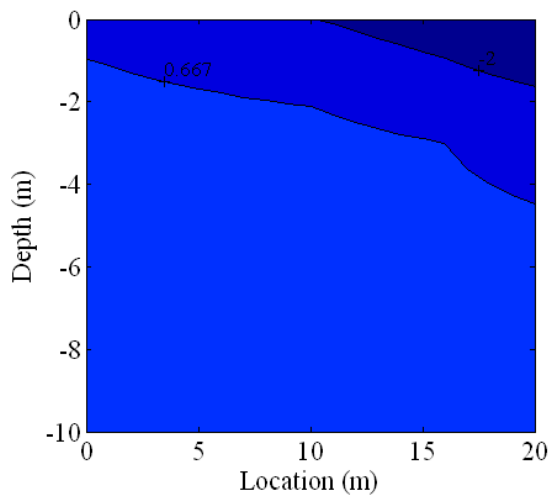
Figure 7.14 Temperature contours at different times in Section A

Besides the temperature variations with time at individual slope locations, temperature contours at different times in degrees Celsius for four sections are presented in Figures 7.14 to 7.17. Each plot provides soil temperature contours for a specific date, interpreted from the temperature sensor data recorded on that date. Each plot provides a “map” of isothermal contours of soil temperatures at various depths from the bottom of the slope (left side of plot) to the top of the slope (right side of plot) for the indicated date. For Section A shown in Figure 7.14, the isotherms were approximately parallel to the slope surface right after construction on April 30, 2013. Also, the temperature gradient was almost evenly distributed with depth. However, after construction, the temperature varied dramatically within 1 to 2 ft below the slope surface. The maximum temperature variation occurred at the top of the section, possibly because, as was discussed previously, the wood chip thickness was greater at the bottom than at the top of the slope. The highest and lowest temperatures were both identified to be at the top of the section in summer and winter, respectively. In Section B, as shown in Figure 7.15, the temperature varied

dramatically within 3 to 4 ft of the slope surface. A comparison of Figures 7.14 and 7.15 strikingly illustrates that the single-layer coconut blanket provided essentially no thermal protection for the frozen cut slope soils compared with 1 ft of wood chips. The isothermal lines more or less parallel the slope face at the different times plotted. In Section C, as shown in Figure 7.16, isothermal lines were at an angle to the slope surface, which is different from the other sections. The bottom of the slope within Section C, the Tecco-mesh section, was warming much faster than at the top of the slope for reasons that are yet unknown. Unfortunately, due to construction of the Section C slope protection replacement on June 17, 2013, the temperature sensors at the bottom of the slope stopped working. After that date, temperature information for defining a 3-point isotherm was not available; hence, Figure 7.16e and 7.16f only present half of the isotherm lines. Soil temperatures for Section D are presented in Figure 7.17. Until late May, 2013, the bottom of the slope experienced more rapid warming than the upper portions of the slope. This accentuated warming at the bottom of the slope was similar to what occurred at Section C, but not as severe. Penetration of the thaw front within this section appears to have been somewhat slowed by the additional rock placed in Section D during the Section C repairs.

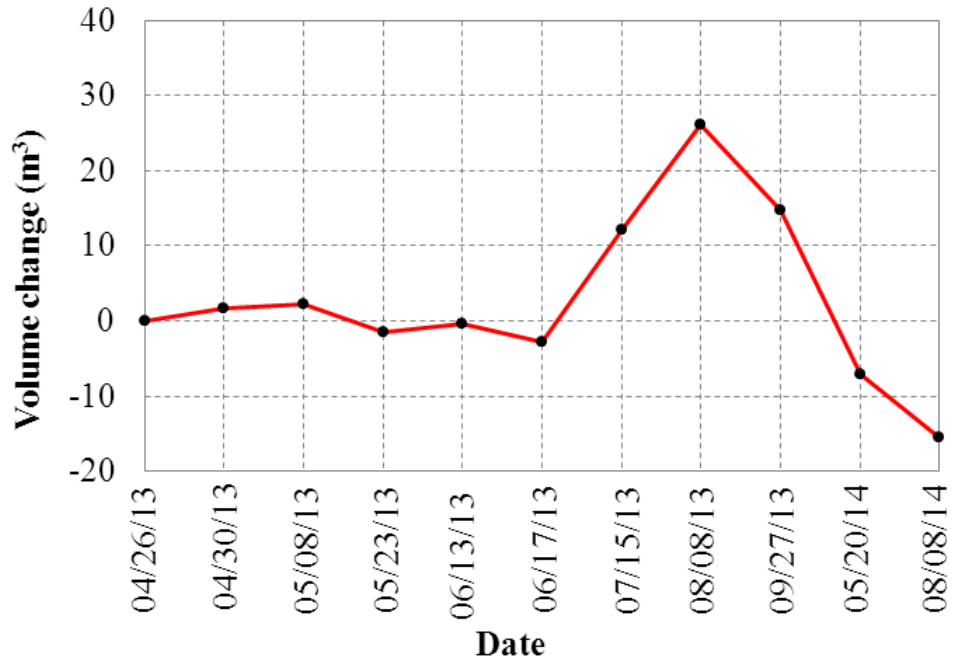
Figure 7.28 Surface volume change on Section B

Similar to Section A, no erosion on Section B (the coconut blanket section) was observed, which is consistent with the photogrammetric erosion measurement results shown in Figure 7.28. Before June 17, 2013, the volume change on the surface of Section B was not significant. Figure 7.29 presents a picture of this section on June 17, 2013, prior to the rapid growth of grass on the slope surface. After June 17, 2013, significant grass growth on this section was observed. Figures 7.30 and 7.31 are photos of this section captured on July 15 and August 8, respectively. Figure 7.31 is a photo showing the surface of Section B on September 27, 2013. This fall-time photo shows that the grass has wilted. This wilting process was detected as surface volume loss during the fall season, as shown in Figure 7.32. For two volume change measurement results in 2014 as shown in Figure 7.28, volume of Section B continuously decreased significantly which is similar to Section A. Part of the reason for this may be attributed to the melting of ground ice in the slope. The other two reasons is the grass grow in 2014, as shown in Figure 7.33, was not as good as that in 2013.

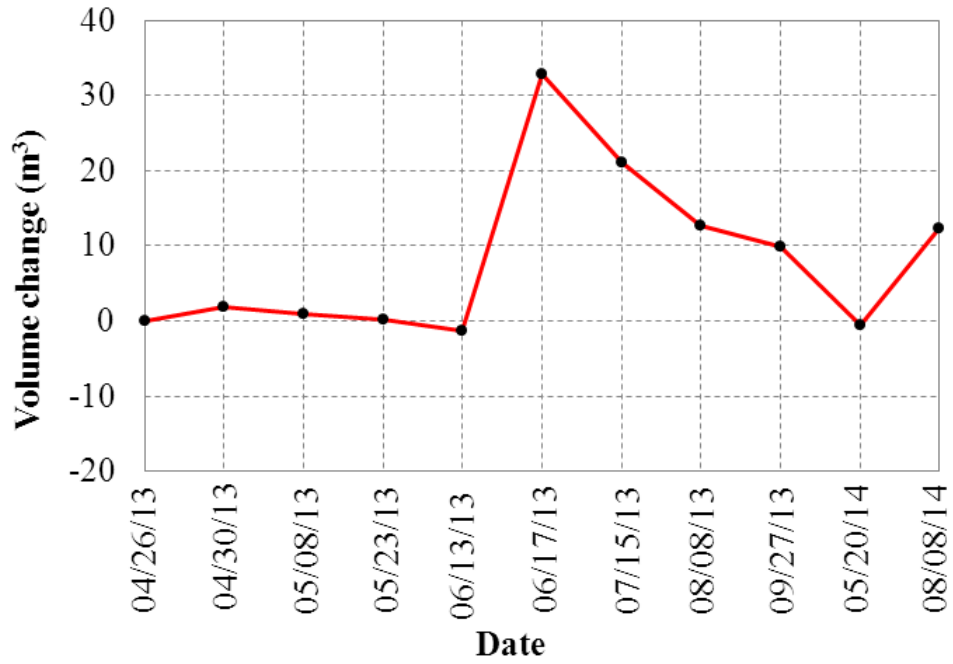
Figure 7.34 Surface volume change on Section C

As discussed previously, massive ground ice was found in Sections C and D. Erosion within these two sections was much greater than the erosion observed in Sections A and B. Figure 7.34 provides a very misleading record of total surface volume changes for Section C (Tecco-mesh and coconut blanket), because the photogrammetric process was only able to discern changes at the surface of the Tecco-mesh instead of at the underlying soil surface.

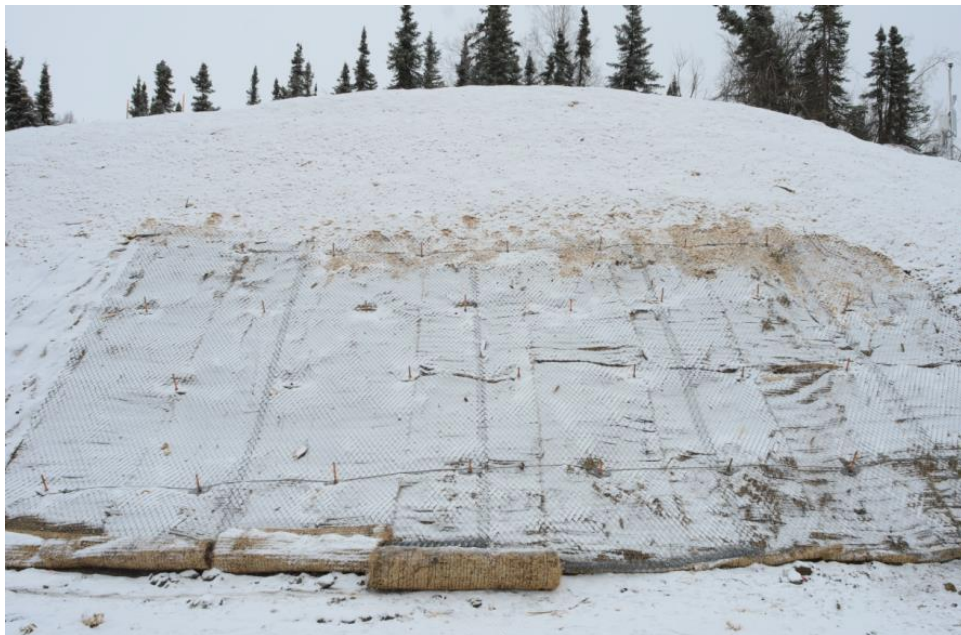
Figure 7.35 Section C on April 30, 2013

At the beginning of the photogrammetric record, April 26, measurements indicated a small surface volume increase due to the snow cover shown in Figure 7.35. During the period between about April 30 and June 13, 2013, a rather large volume of icy soil (and massive ice) materials, originally located beneath the Tecco-mesh slope cover, were lost to runoff and thaw-consolidation. Photogrammetric measurements, as indicated in Figure 7.34, keyed on the surface of the Tecco-mesh, and therefore provided no indication of the volume loss that was occurring under the Tecco-mesh. Figure 7.36 shows obvious signs of the actual condition of the cut slope face under the Tecco-mesh by June 13, 2013. Obviously, the deterioration process of the cut slope face under the Tecco-mesh was not detected by the photogrammetric process!

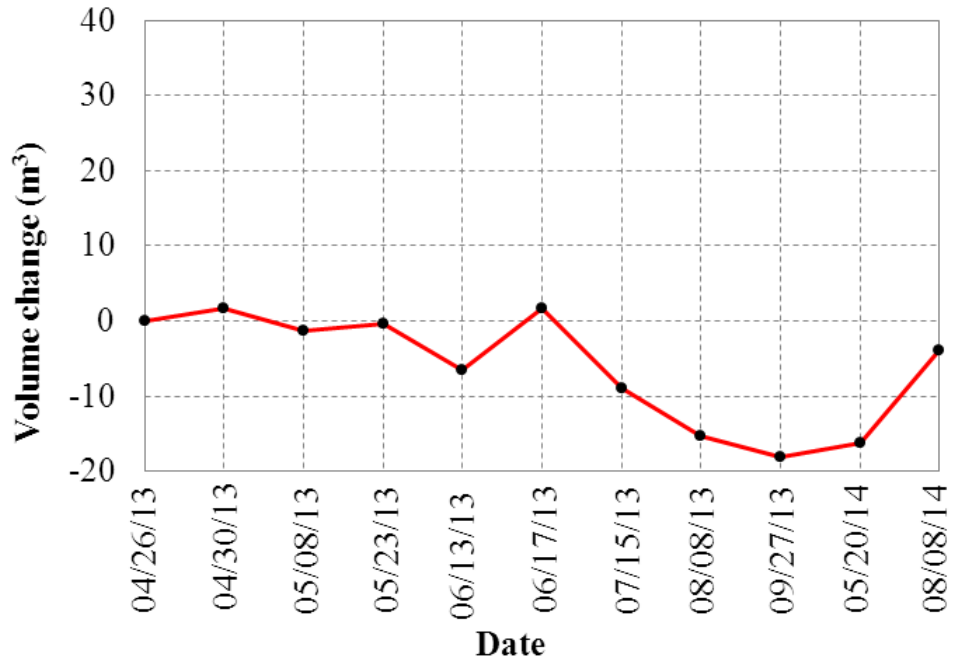
Figure 7.41 Surface volume change on Section D

Section D (originally constructed with a crushed rock blanket) serves as the control section for the Experimental Feature. Figure 7.41 indicates that a more or less continual loss of slope surface volume occurred through September 27, 2013. The initial small volume increase at the surface of Section D was because of the late April snowfall shown in the photo in Figure 7.42. Loss of surface volume (through erosion and/or thaw-consolidation) continued through June 13. Figure 7.43 shows the condition of the slope face on June 13, 2013. Then, on June 17, 2013, a volume of rock material was added to the surface of Section D during Section C repairs (see photo in Figure 7.44). The immediate surface volume increase due to this addition of material in Section D is plotted in Figure 7.41. After placement of additional crushed rock on June 17, 2012, the loss of surface volume continued through the end of this report's monitoring period, on September 27. The condition of the slope at that time is shown by the Figure 7.45 photo. Figure 7.41 indicates that the surface volume loss rate for Section D had not attenuated much prior to September 27, 2013. As shown in Figure 7.41, in 2014, surface volume of Section D increased. On May 20, 2014, no grass was shown at this section. However, grass grown was identified at Section D as show in Figure 7.42 on August 8, 2014.
