Use of H2Ri Wicking Fabric to Prevent Frost Boils in the Dalton Highway Beaver Slide Area, Alaska Final Report

Xiong Zhang, Ph.D., P.E.

December 2012

INE/AUTC 12.23

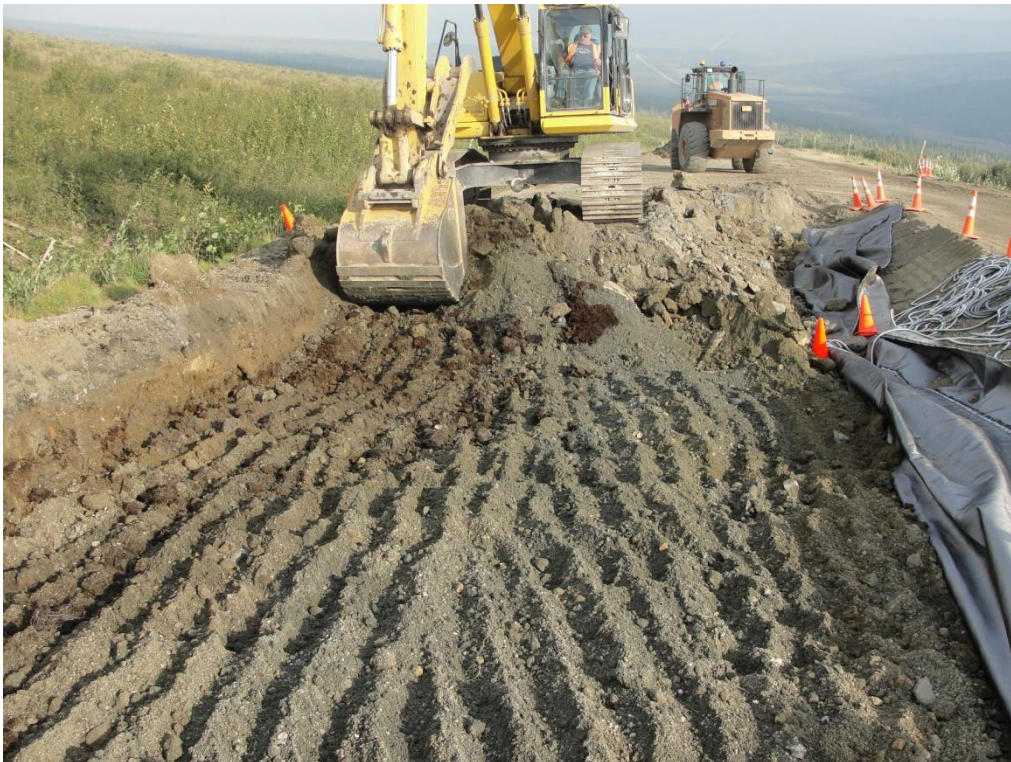
Figure 32. Excavation of the lane on the west side of the road

Construction on August 4, 2010, started with digging out the west lane of the road to a depth of approximately 3.5 ft, as shown in Figure 32. The first 3 ft of soil was still light yellow to brown sand with gravel. At 3 ft below the west edge of the original road, degraded vegetation was found similar to that found in the excavation pit at the center of the road. The same degraded dark-brown material was also found at the bottom of the west side of the excavation when grading the excavation pit (see Figure 33). To avoid the possible introduction of water from the ditch to the road section, the west road shoulder was not excavated (Figure 32).

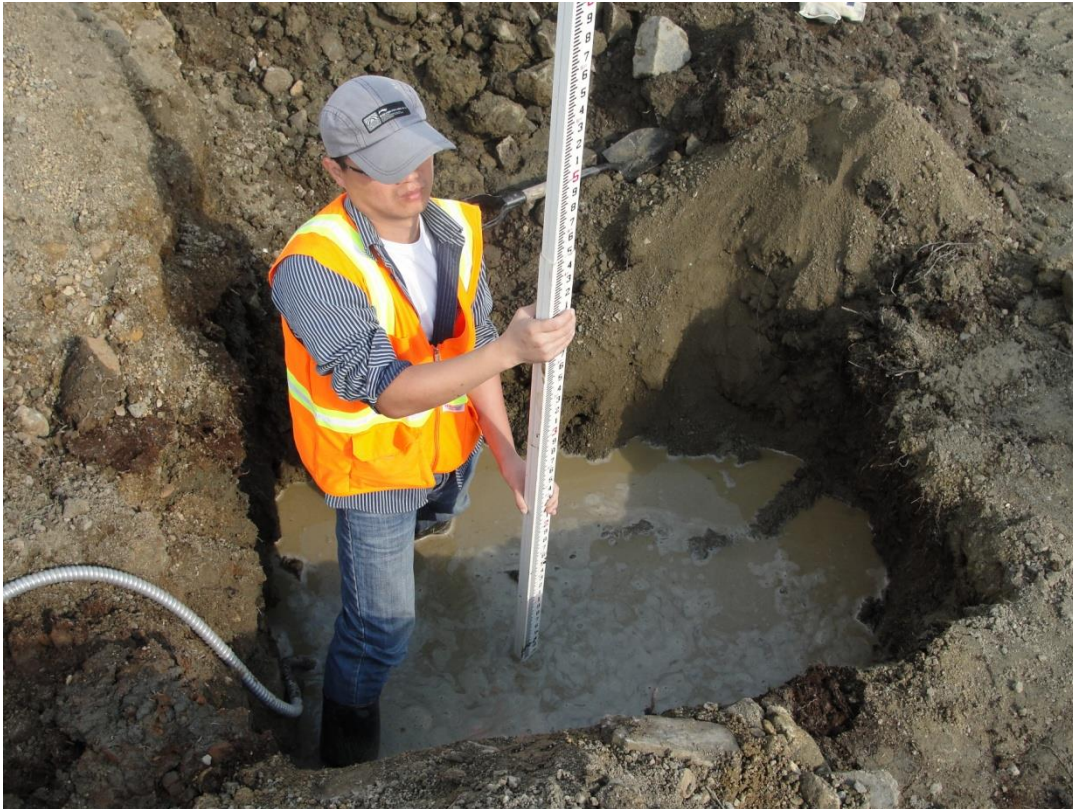
Figure 34. Installation of sensor 20

After the bottom of the excavation was graded, a pit was excavated at about 18 ft from the center of the road to install sensor 20, as shown in Figure 34 (please also refer to Figure 19). The pit was about 1.5 feet by 1.5 feet, with a depth 3 feet. During this process, groundwater was encountered at a depth of 2.5 feet (total about 6 feet below the original road surface). The soil was crushed rock with sand and silt and had high permeability. After the soils were excavated, water quickly migrated to the pit and in less than 1 hour, the bottom of the excavation pit was filled with water. As a result, sensor 20 was installed under the water, and then the pit was backfilled with soils excavated from the pit.

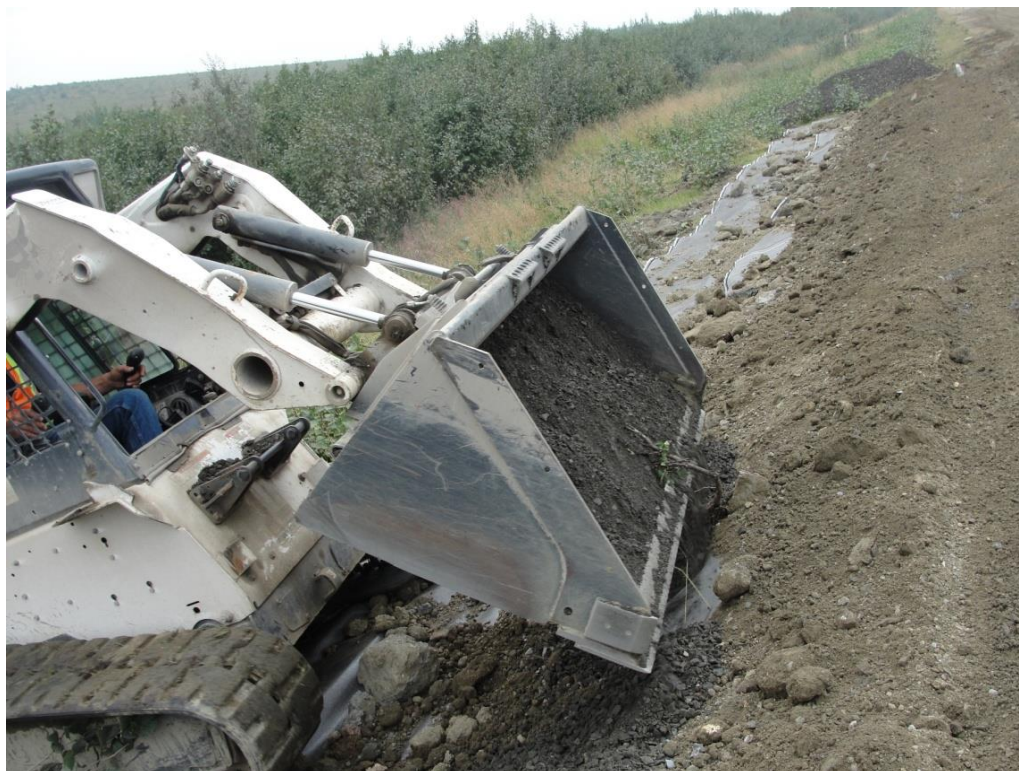
Figure 43. Covering the wicking fabric with crushed rocks

To prevent possible degradation of the wicking fabric due to sunlight exposure, crushed rocks were brought to cover the wicking fabric on the east shoulder (see Figure 43). Figure 44 shows the coverage of the wicking fabric after completion.

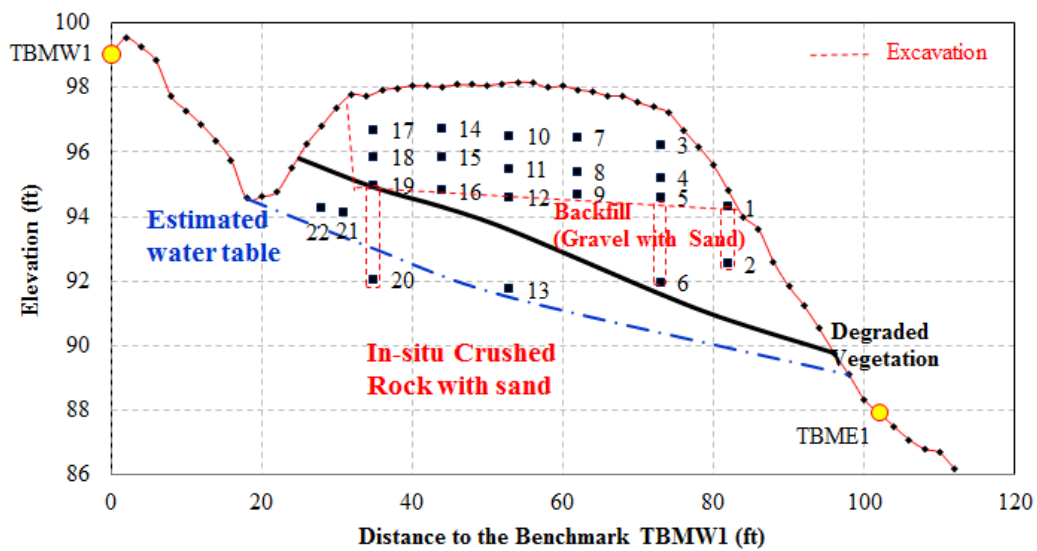
Figure 50. Soil stratigraphy at the test section

Construction of the test section required excavation of the whole road at the site, and the excavation provided information for the geotechnical site investigation. Figure 50 shows the soil stratigraphy for the test section based on observations made during the construction process. It was found that the road section was built directly on the original tundra of the hill using degraded granite, which can be classified as silt with gravel according to USCS classifications. The original tundra was about 3 feet below the surface at the west edge of the road, 4.5 feet below the centerline of the road section. It was about 9 feet lower than the road surface when it extended to tree line at the west shoulder of the road. The buried vegetation had degraded to a dark yellow layer 1 to 2 in, thick. Below the degraded vegetation was in situ crushed rocks with sand.

ditch to bury the sensor cables, we found that water seeped out of the soil surface once the tundra was removed. Additionally, water was found during the construction process in the existing ditch along the east side of the road. Figure 52 shows water in the ditch after the data collection box was installed on August 5, 2010. On the west side of the road, water was found along the tree line sporadically, as shown in Figure 53. Groundwater was also found when installing sensor 20 (see Figure 34). Figure 50 shows the approximate groundwater table based on the above observations.

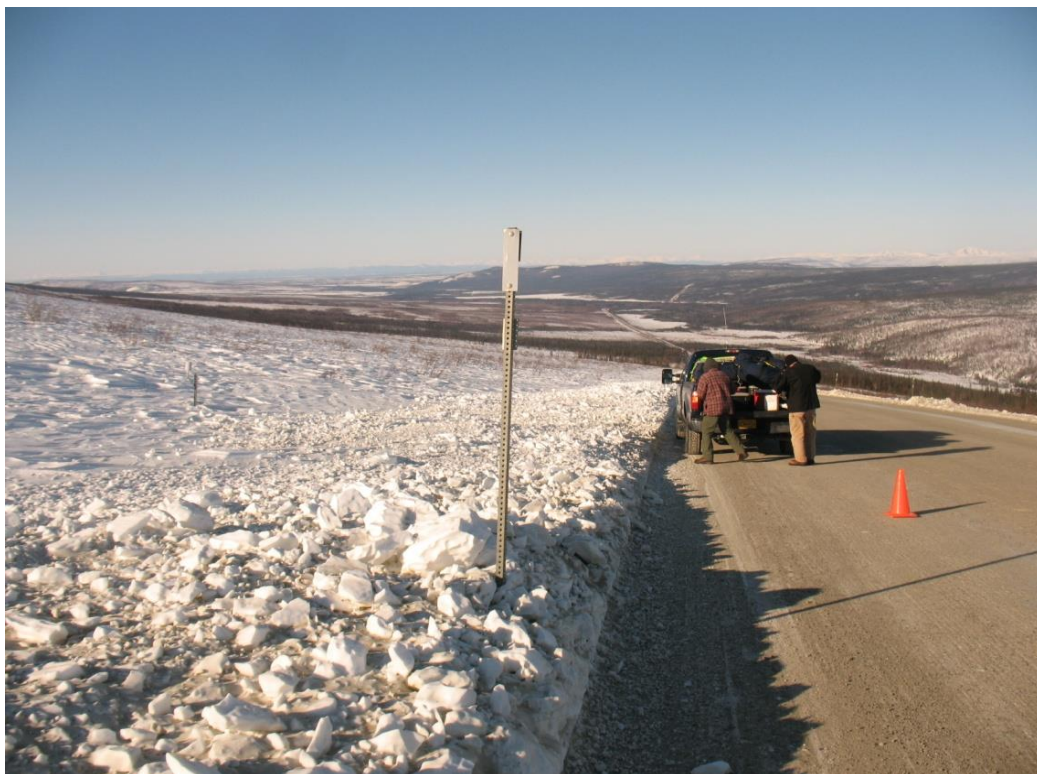
Figure 54. Site conditions on March 12, 2011, before installation of the solar panel

The first site visit to the test section was on October 16, 2010. The preliminary test results indicated that all sensors were functioning well. However, the voltage of the battery

for the datalogger decreased from 12.5 volts to 12.2 volts in two months. Although the CR1000 would have run correctly until the battery voltage reached about 10 volts, there was concern about whether the battery could survive the harsh winter in Alaska. It was decided that it might be better to add a solar panel as a backup source of power for the datalogger. A second trip was made to the test site on March 12, 2011, to download the data and install the solar panel. Figure 54 shows the test site conditions on March 12, 2011, before installation of the solar panel. The data collection box was completely covered by snow. Figure 55 shows the data collection box after installation of the solar panel. Another visit was made on March 30, 2012, and the site conditions that day are shown in Figure 56. The solar panel was exposed to the air. Figure 57 shows the changes in battery voltage over the past two years. The data indicated that battery voltage was high enough to maintain the functionality of the datalogger.

Figure 67 shows the temperature changes for sensors 1, 2, and 22 at the shoulders of the road section. The figure indicates that during the summer months, soil temperatures follow changes in air temperature. During the winter months, the temperature changes were small and not closely related to air temperature changes, mainly due to the insulation effect of thick snow at the shoulder (see Figure 54).

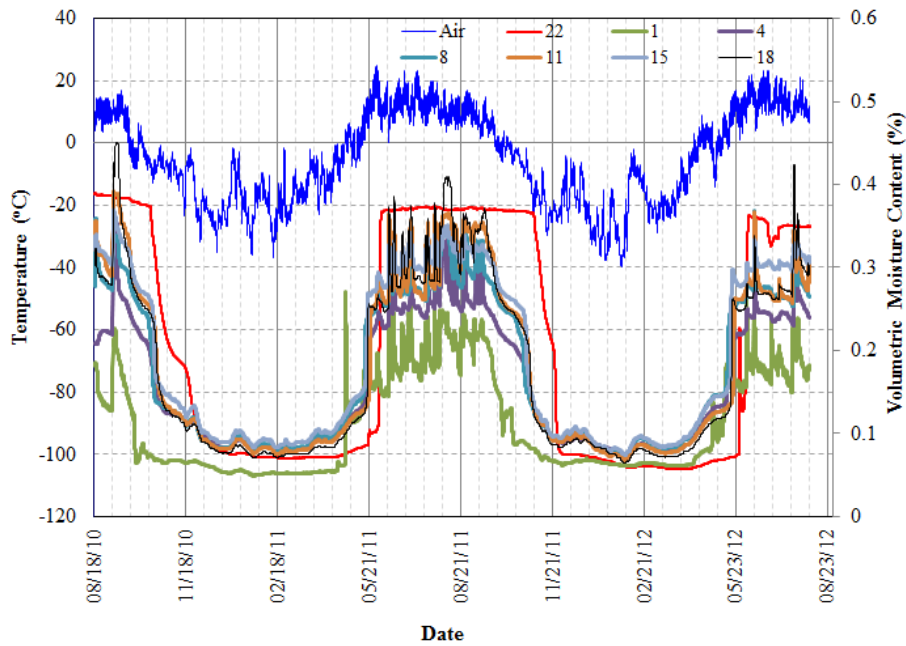
Figure 70. Volumetric water content changes at 2.5 feet below the road surface

Figure 70 shows the air temperature and volumetric water content changes for sensors 1, 4, 8, 11, 15, and 18 at about 2.5 feet below the road surface. Similar to Figure 69, when the soils were frozen, the moisture content for soils at most sensor locations (all but sensor 1) had limited changes, with a pattern similar to the air temperature changes. When the soils were unfrozen, dramatic changes in moisture content occurred. Moisture content at the sensor locations shown in Figure 70 was higher than moisture content at the corresponding locations and 1.5 feet below the soil surface, as shown in Figure 69. Under most situations, the soils closer to the west side (ditch) had higher moisture content. Of all soils, only the soil at sensor location 18 occasionally exceeded the saturation moisture content of sensor 22. Note that sensor 18 was at the edge of the road section and might not be compacted very well. The moisture content of moist soils under most situations was much less than saturation moisture content. The increases in moisture content, if there were any, were usually rapid. The high moisture content status normally did not last long. Instead, the moisture content normally dropped quickly, indicating that the drainage of water was quick in the test section.

Again, sensor 1 was at the shoulder of the road section and was less than 1 ft below the ground soil surface. The moisture content at sensor 1 was much lower than at any other sensor shown in Figure 70, mainly due to the better drainage at that location.

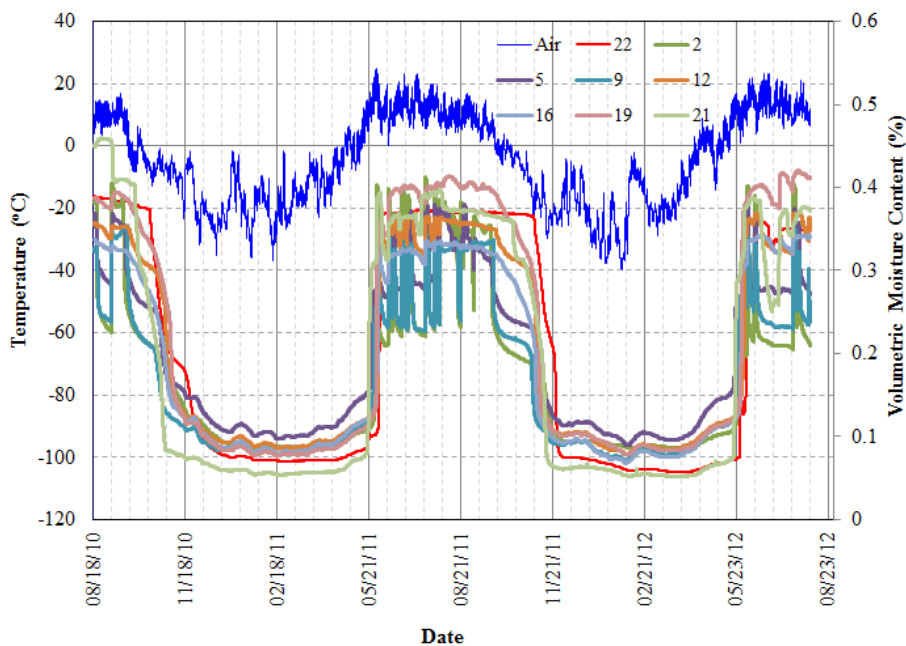
Figure 71. Volumetric water content changes at 3.5 feet below the road surface

Figure 71 shows the air temperature and volumetric water content changes for sensors 2, 5, 9, 12, 16, 19, and 21 at about 3.5 feet below the road surface. Compared with Figure 70, the soils in Figure 71 had higher moisture content, and the higher moisture content was maintained for a longer time. The soils at the edges of the road section had higher moisture content than those in the center of the road section.

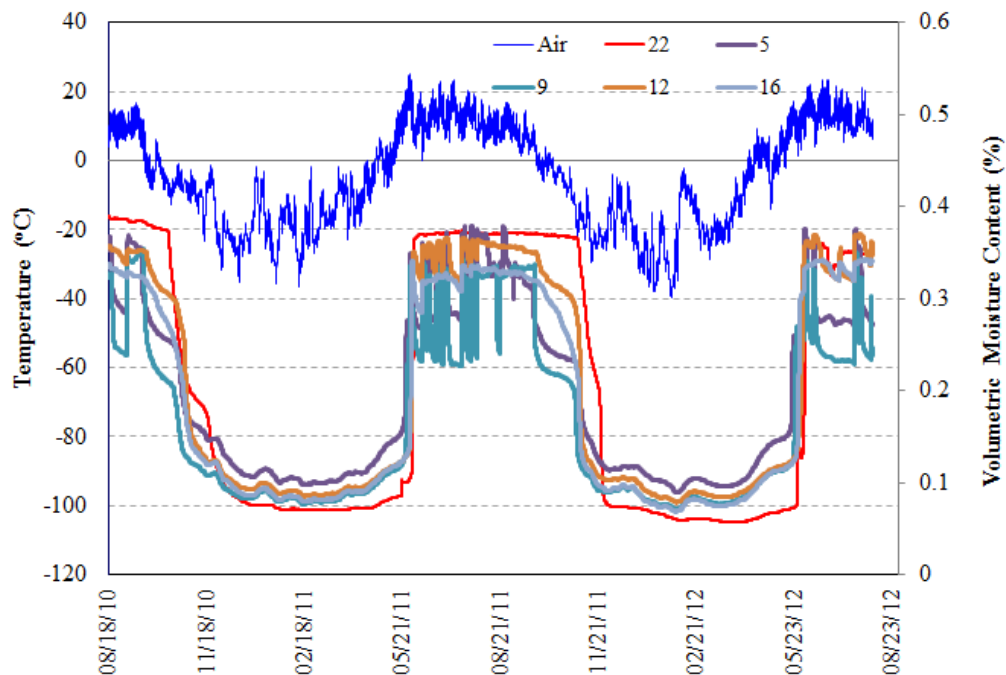
Figure 72. Volumetric water content changes at 3.5 feet below the road surface

Figure 72 shows the air temperature and volumetric water content changes for sensors 5, 9, 12, and 16 only. Comparing Figure 71 with Figure 72, it can be seen that during the summer months the locations with higher moisture content were soils at the edge of the road section such as sensor locations 2, 19, and 21. Note that sensor locations 19 and 21 were close to the ditch and had elevations only slightly higher than the bottom of the ditch. During the winter months, the variations of unfrozen moisture content in all soils were small and smooth. Similar to previous discussions, the unfrozen moisture content of all soils shown in Figure 71 decreased dramatically when the soils were freezing, and increased significantly when they were thawing.

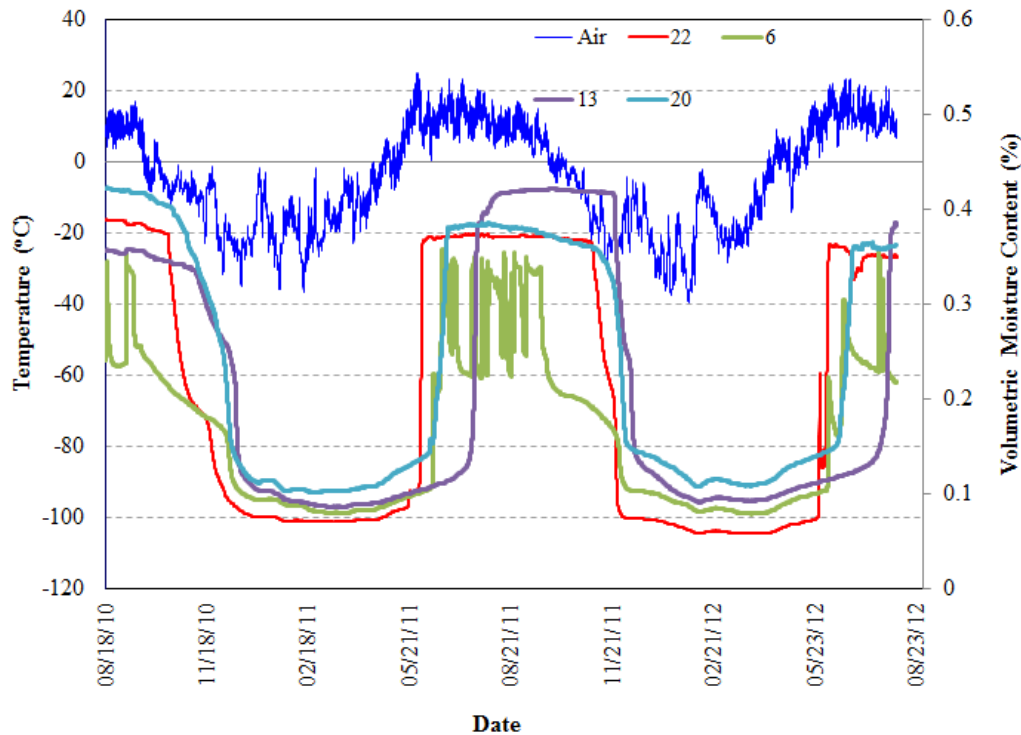
Figure 73. Volumetric water content changes at 6 feet below the road surface

Figure 73 shows the air temperature and volumetric water content changes for sensors 6, 13, and 20 at about 6 feet below the road surface. Soils at sensor 6 had lower moisture content than those at sensor locations 3 and 20, mainly due to better drainage at the location of sensor 6. As described in Chapter 3, sensor 20 was installed under water. Figure 73 indicates that the moisture content of soils at sensor 20 was higher than that of the soils at sensor 22 in August 2010. The soil moisture content kept decreasing until it became completely frozen in December 2010. The average unfrozen water content during winter 2010–2011 was about 10%, which is 2% higher than soils at sensor 22. Soils at sensor 20 thawed in June 2011; the moisture content was close to the soils at sensor 22 and decreased slightly with time. The average unfrozen water content for soils at sensor 20 during winter 2011–2012 was similar to that of the previous winter at the same location. When the soils thawed in June 2012, the moisture content of the soils was close to that of the soils at sensor 22 and remained constant. From these observations, it seems that soils at sensor location 20 were not fully compacted during the construction process and became more compacted with time due to the freeze-thaw cycle.

Variations of moisture content for soils at sensor location 13 had a trend opposite of that for soils at sensor location 20. Soils at sensor 13 had moisture content lower than soils at sensor 22 in August 2010. Moisture content continued decreasing until the soil was completely frozen in December 2010. The average unfrozen water content during winter 2010–2011 was similar to soils at sensor location 22. Soils at sensor 13 thawed in July 2011, and the moisture content was 41.9%, which is 5% higher than soils at sensor 22 during the same period. The average unfrozen water content for soils at sensor 13 during winter 2011–2012 was similar to that of the previous winter at the same location. From these observations, it seems that soils at sensor location 13 experienced some frost heave, causing the soil to become loose. The variations in moisture content for soils at sensor location 13 during August and September 2012 were unknown due to the lack of available data at the time of writing this report.

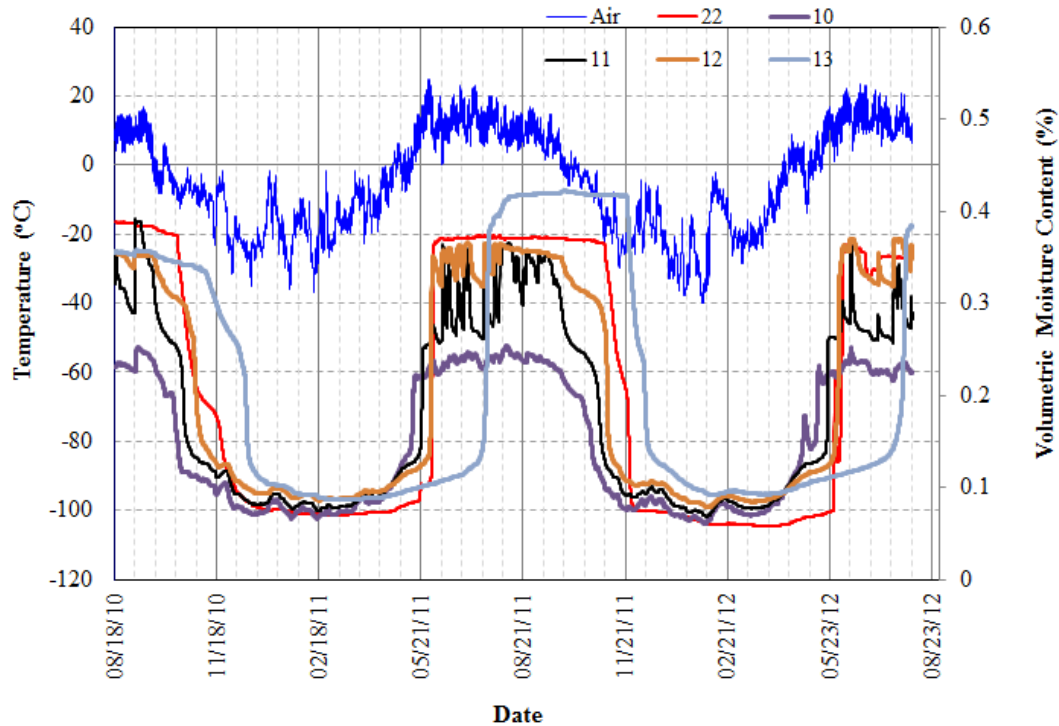
Figure 74. Volumetric water content at the center of the road with different depths

Figure 74 shows the moisture content changes for sensors 10 through 13 at the center of the road section but at different depths. It can be seen that with an increase in depth, moisture content at thawed conditions increased. However, moisture content for soils 3.5 feet below the road surface was lower than saturation most of the time.

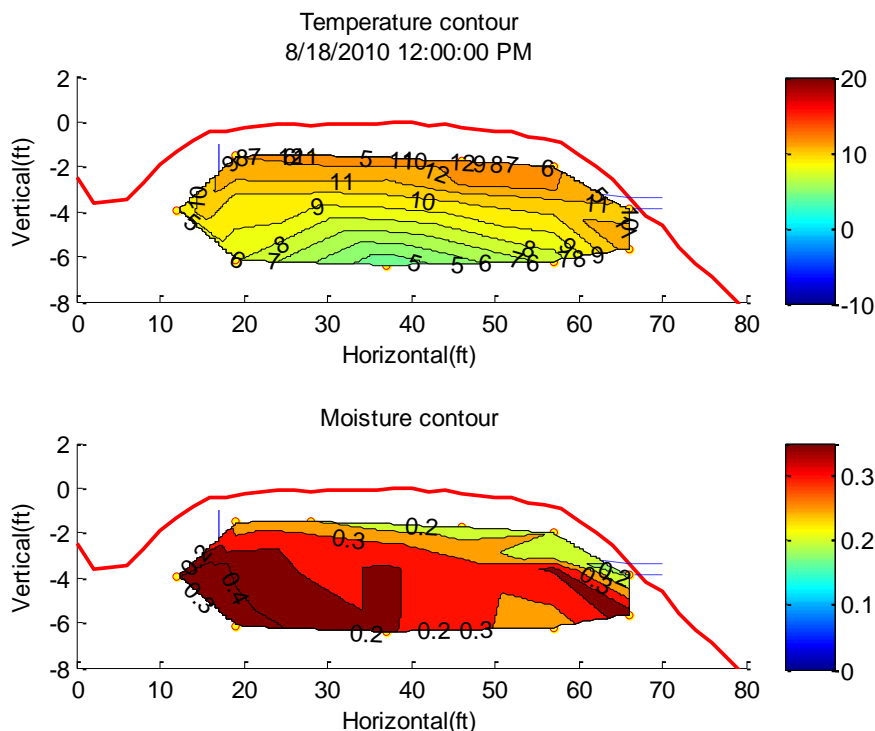
Figure 75. Temperature and moisture content contours at noon on August 18, 2010

As shown in Figure 75, on August 18, 2010, two weeks after the test section was constructed, the soils at 6 feet below the road surface were completely unfrozen. The soil temperatures decreased with increase in depth, varying from 40°C to 12°C. The isothermal lines were approximately parallel to the configuration of the road section. The moisture content contour was not related to the temperature contour, but depended on groundwater flow. At sensor locations 19 to 22 close to the ditch, the soils were saturated. Soils at sensor locations 12 and 13 were also saturated, while the soils at sensor locations 14 through 16 were unsaturated. The saturated soil protrusion coincided with the excavation pit for sensor installation at the center of the road, which implies that compaction at the excavation pit was not good and resulted in a channel with relatively high permeability. At the east shoulder of the road from sensors 5 to 2, a narrow zone of soils had high moisture content. It was close to the exit of the H2Ri wicking fabric.

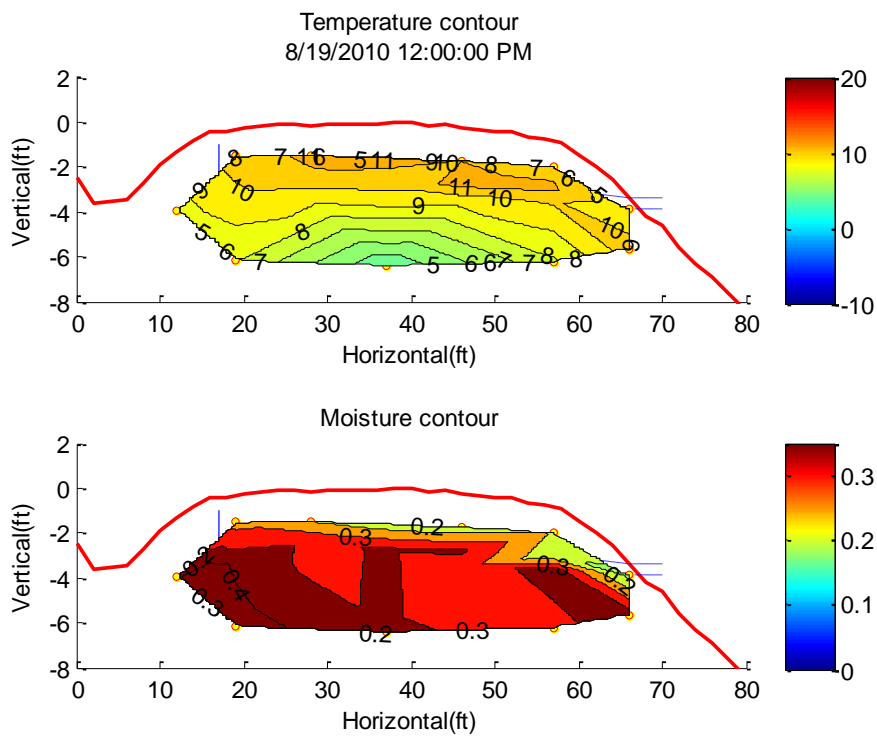
Figure 77. Temperature and moisture content contours at noon on August 19, 2010

As shown in Figure 76, the relative humidity on August 19, 2010, from 3:00 a.m. to 9:00 a.m. was 100%, indicating that a rainfall event occurred. This event was consistent with changes in the moisture content contour at noon on August 19, 2010, as shown in Figure 77. Compared with the previous day, there was a clear increase in the moisture content in the test section, especially along the H2Ri at 3 feet below the road surface. At the east shoulder of the road from sensors 5 to 2, moisture content increased for soils close to the exit of the H2Ri wicking fabric. This was a clear indication that the H2Ri provided a good channel for water transport.

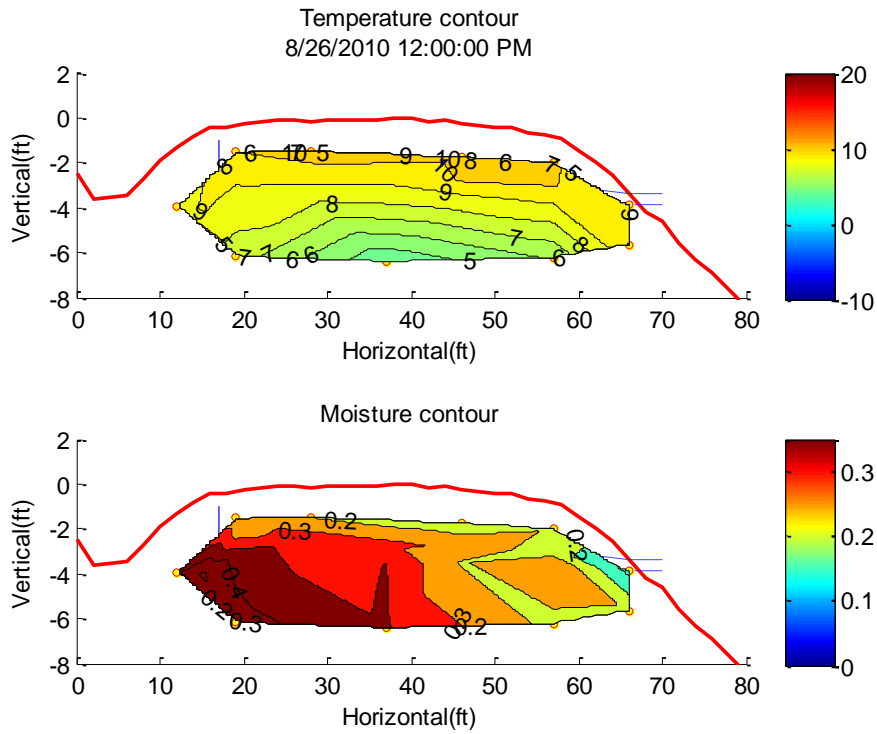
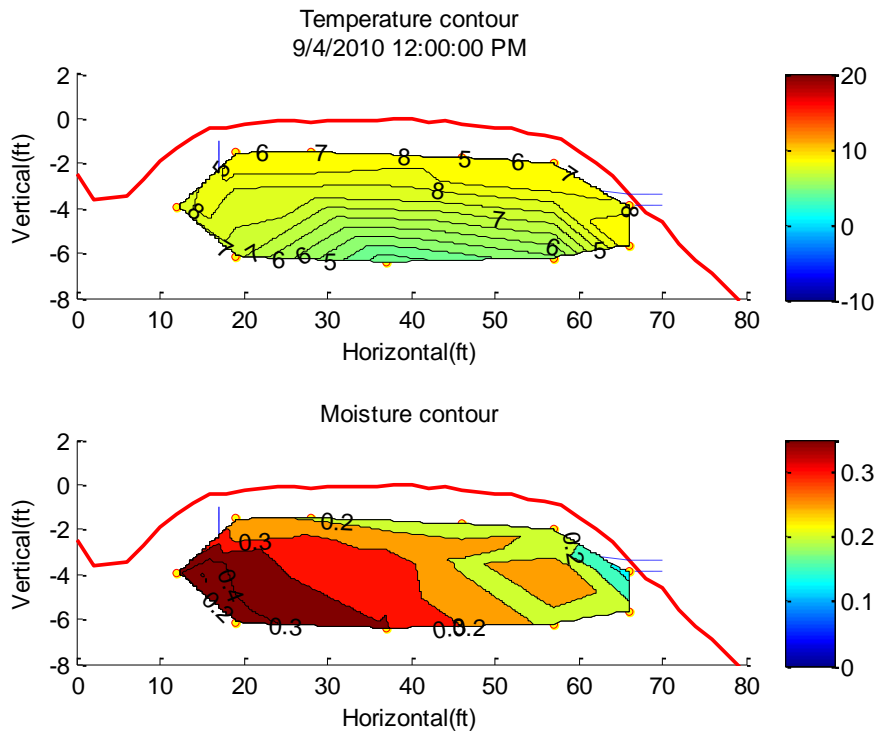
The relative humidity data indicate that no rainfall occurred during the following two weeks. Compared with Figure 75 and Figure 77, the moisture content in the test section clearly decreased, as shown in Figure 78 and Figure 79, especially in the east lane of the road. The soils at the exit of the H2Ri wicking fabric were the driest. A decrease in moisture content in the west lane of the road was clear, although it was not as dramatic a decrease as in the east lane. The high moisture content protrusion at the center of the road, which was reduced significantly until August 26, 2010 (Figure 78), nearly disappeared on September 4, 2010 (Figure 79). The soils remained saturated at sensor locations 20 to 22, close to the ditch.

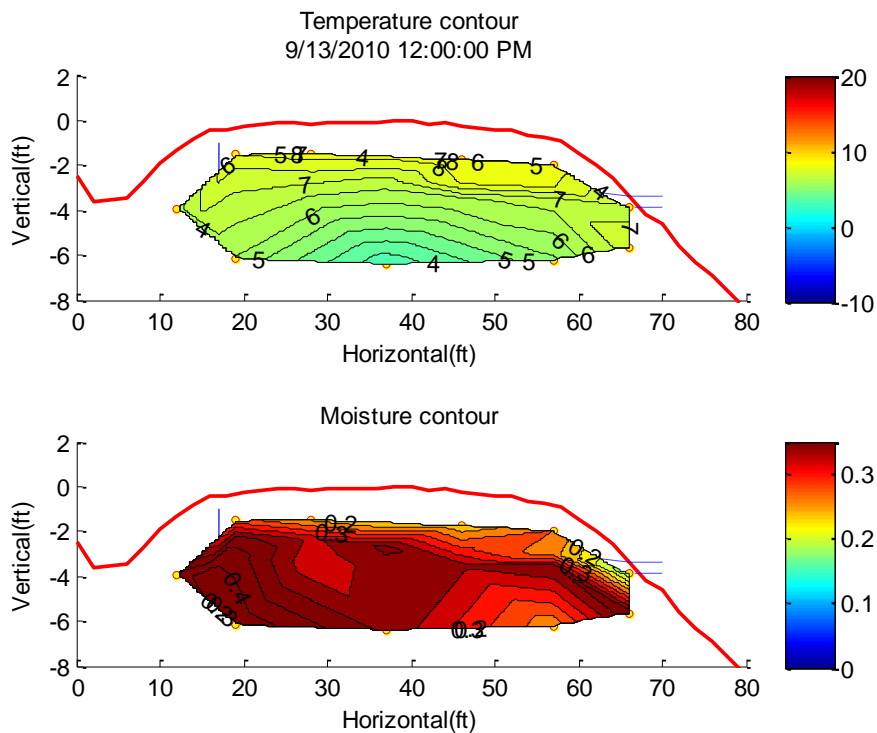
Figure 84. Temperature and moisture content contours at noon on September 13, 2010

Figure 84 shows an unexpected increase in moisture content in the road section on September 13, 2010, compared with the moisture content contour in Figure 83 and relative humidity in Figure 80. The water supply seemed to be related to groundwater at deeper depth (water seemed to flow along sensors 20→13→12→9→5→1). Once again, the water was flowing along the H2Ri wicking fabric. The soils near the exit of the H2Ri were dry, while the soils below the H2Ri were wet.

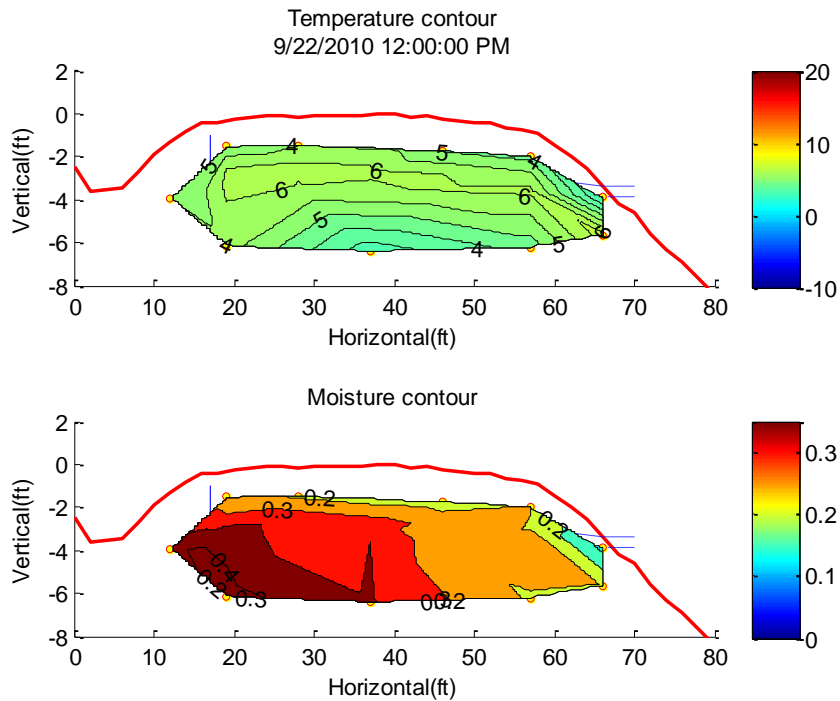
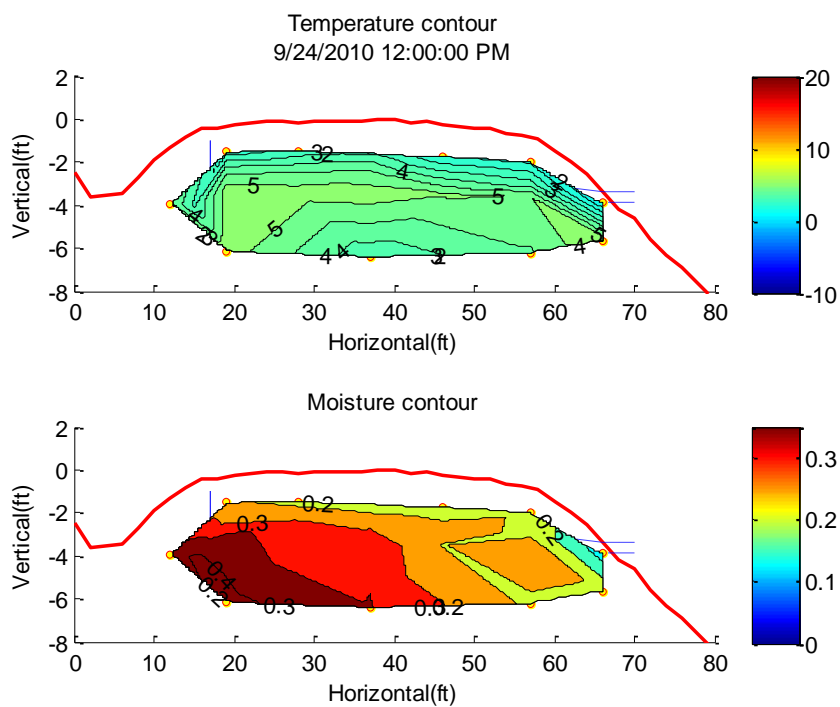
From September 13 to 22, 2010, the relative humidity at the test site was lower than 90%, indicating that most likely no rainfall occurred during this period. The moisture content in the road section kept decreasing, as demonstrated in Figure 85 by the moisture content

contour on September 22, 2010. As shown previously, the air temperature at the test site dropped to below 0°C on September 23, 2010. Freezing reduced free water in the soil and, subsequently, in the groundwater supply. As a result, the moisture content in the road section was further decreased, as shown in Figure 86 by the moisture content contour on September 24, 2010.

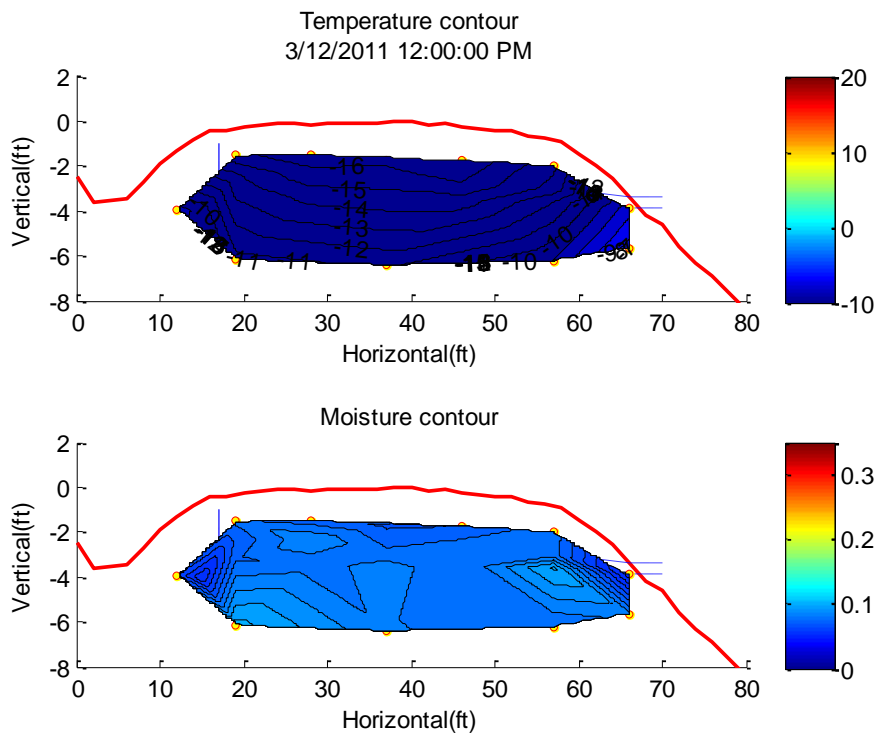
Figure 91. Temperature and moisture content contours at noon on March 12, 2011

Figure 91 shows the temperature and moisture content contours for the road section on March 12, 2011, when the whole road section was completely frozen during the field trip (Figure 54). The moisture content was not above 10% anywhere.

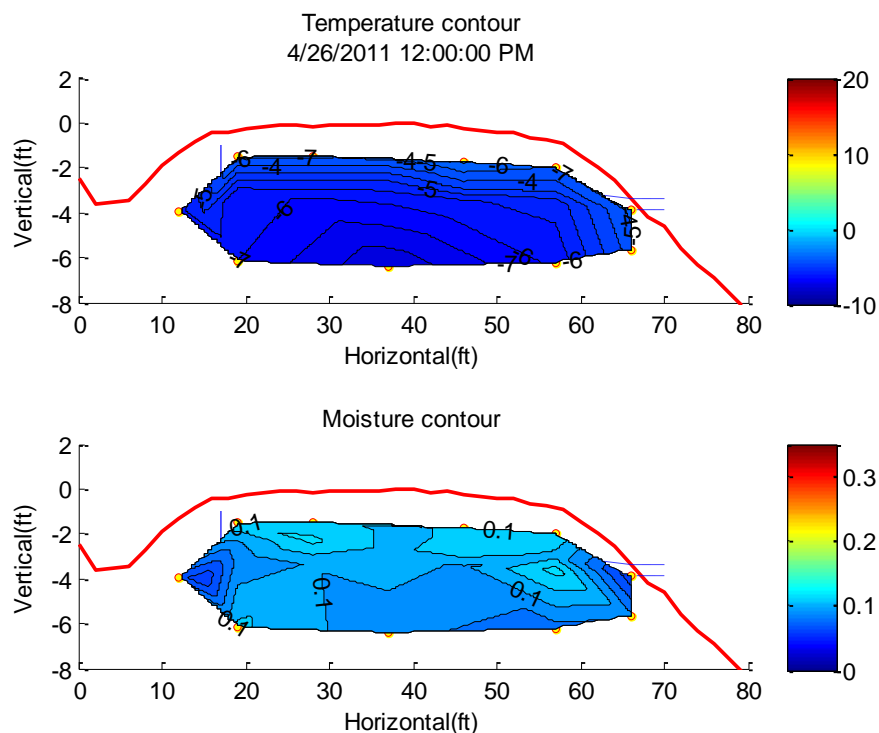
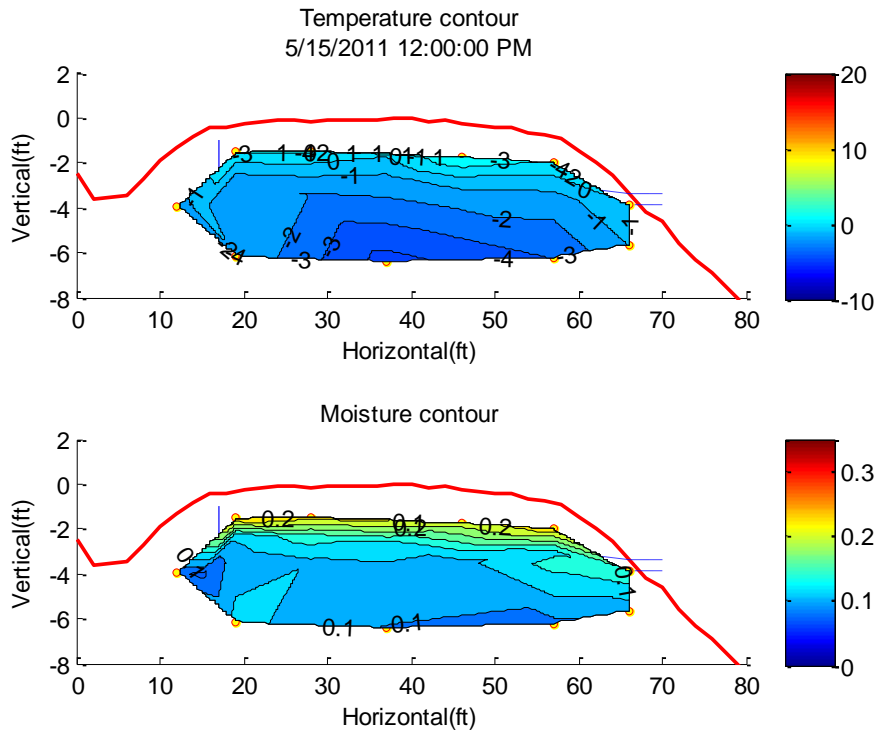
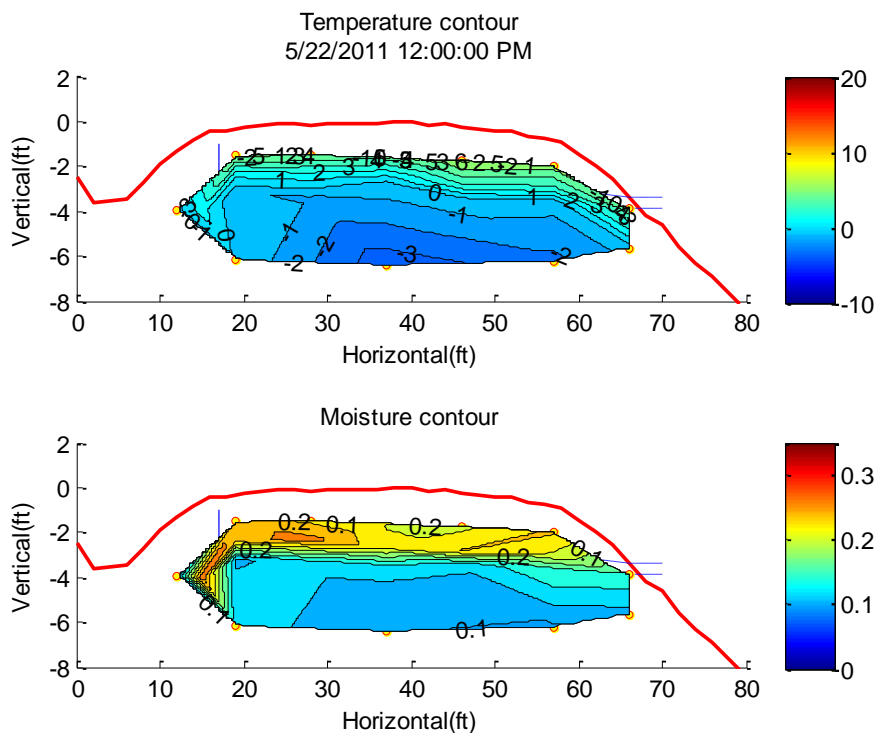
When the air temperature rose to above zero on April 26, 2011, the whole road test section remained frozen, and the unfrozen moisture content was very low, as shown in Figure 92. Figure 93 and Figure 94 show the temperature and moisture content contours of the road section on May 15 and May 22, 2011, when the thawing depths were 1.5 feet and 2.5 feet below the road surface. Appendix I shows that during this period, although the moisture content in the range of 1.5–2.5 feet below the road surface increased, the soils did not reach saturation anywhere. Soils at sensor 22 near the ditch remained frozen. Note that in previous years, frost boils/soft spots were apparent at this time. We concluded, therefore, that in previous years frost boils/soft spots in early spring each year at the Beaver Slide were not likely caused by groundwater; they were more likely caused by thawing of in situ water in the soils. Since an excess amount of water is needed to form frost boils/soft spots, it must come from thawing of ice lenses caused by frost heave. Figure 93 and Figure 94 as well as the figures in Appendix I for the period of April 26 to May 22, 2011, indicate that the soil moisture content in the road section remained low, which implies that there was no frost heave 2.5 feet below the road surface. In other words, the H2Ri wicking fabric successfully eliminated frost heave and subsequent thaw weakening in early spring 2011.

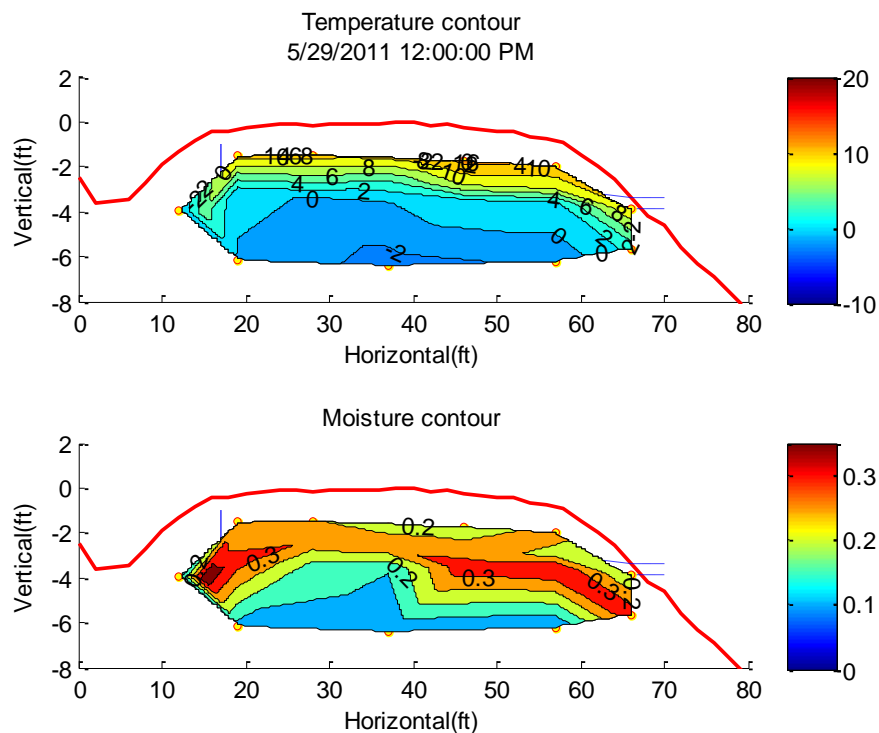
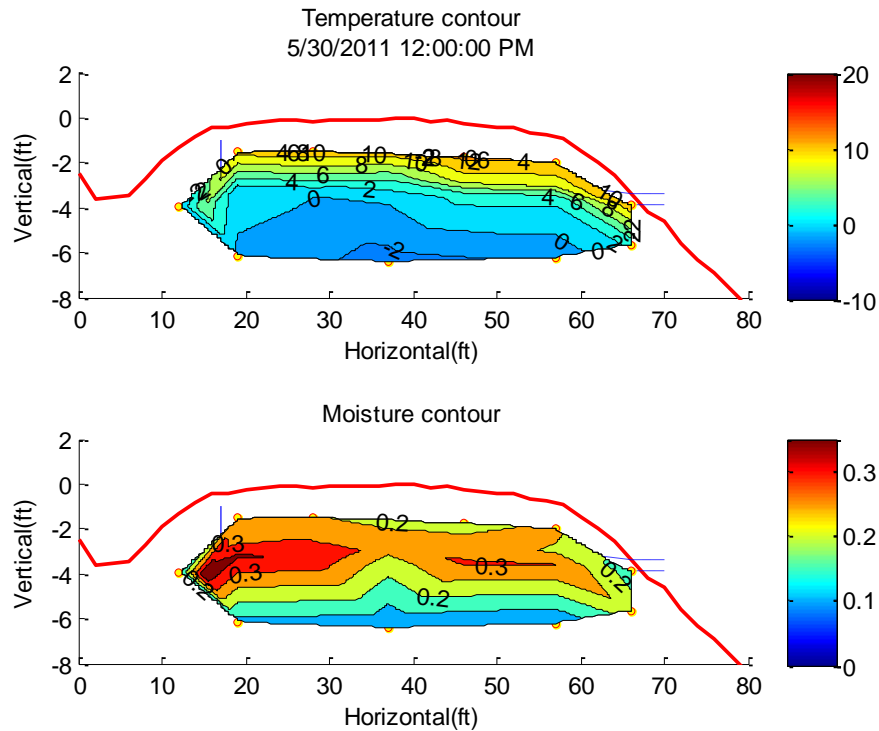
Figure 95 shows the temperature and moisture content contours of the road section on May 29, 2011. The east lane of the road section had higher soil temperatures and thawed to a

depth of 6 feet below the road surface, while the west lane of the road thawed to a depth of 4.5 ft. In Figure 95, it can be seen that soils at sensor locations 2, 5, 8, 9, 19, 21, and 22 were nearly saturated. There was a frozen soil protrusion at sensor locations 20, 16, 11, 12, and 13, seen more clearly in Figure 96, which shows the temperature and moisture content contours of the road section on May 30, 2011. The frozen soil protrusion reduced at the center of the road where sensors 12 and 13 were located. On both sides of the frozen soil protrusion, soils were near saturation at the depth of 4 feet below the road surface. Compared with Figure 95, the soils at the east lane of the road were much drier, as shown in Figure 96. The soils at 6 feet below the road surface remained frozen.

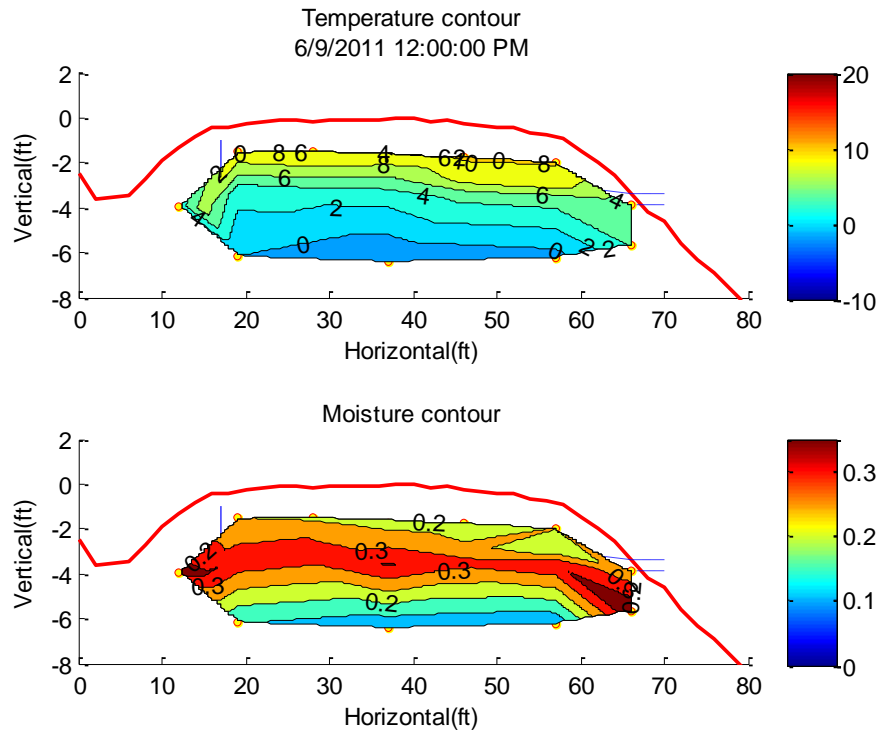
Figure 97. Temperature and moisture content contours at noon on June 10, 2011

From April 17 to June 8, 2011, there was no clear indication of any rainfall event. The groundwater was mainly from thawing of frozen soils from the hill. On the morning of June 9, 2011, a rainfall event occurred. As a result, the water content of the road section increased. As shown in Figure 97, there was a high water content channel at 3 to 5 feet below the road surface where the two layers of H2Ri wicking fabric were installed. The soils 5 feet below the road surface remained frozen, and was considered an impermeable layer. The soils above 3.0 feet below the road surface had moisture content of less than 30%.

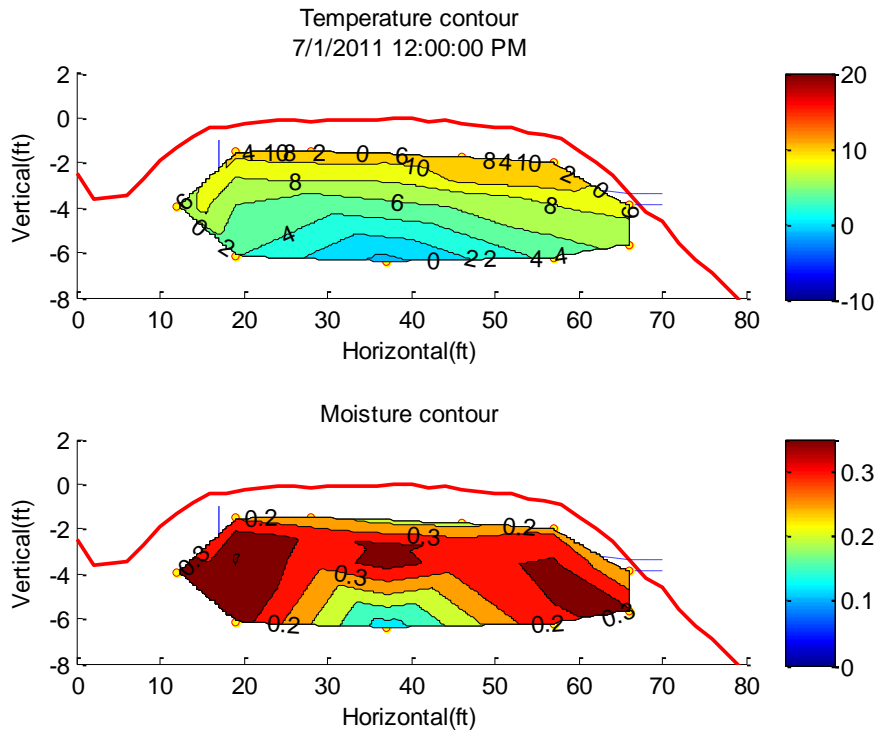
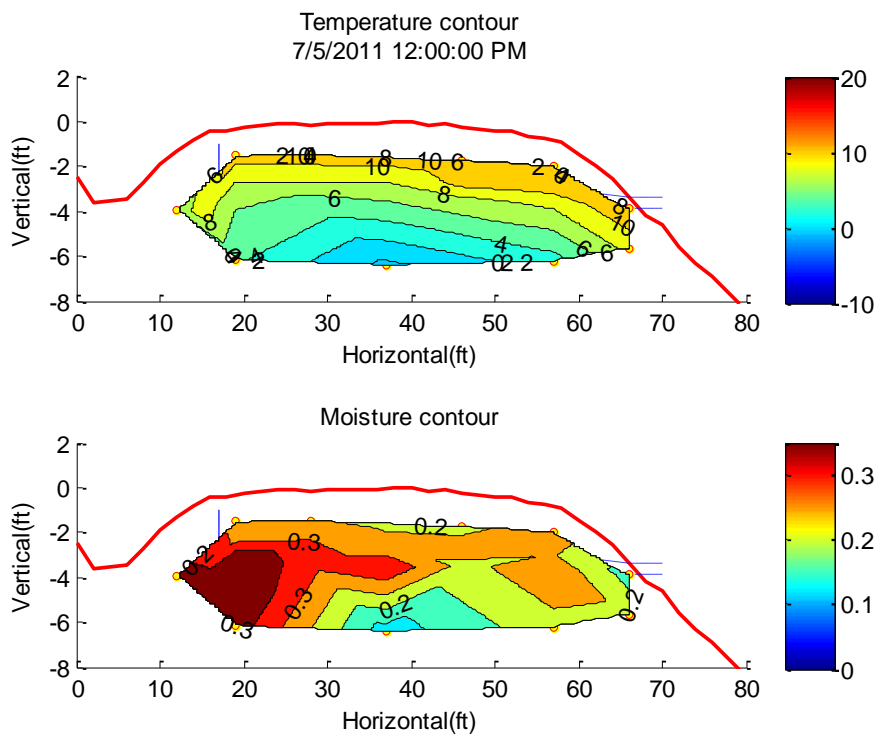
Figure 98 shows the temperature and moisture content contours at noon on July 1, 2011, after a possible rainfall event in the morning of the same day. There were three saturated soil zones in the moisture content contour: one near the ditch, one at the center, and one at the east lane. Below the saturated soil zone at the center was a frozen soil core with low (unfrozen) water content, which seems to imply that non-uniform thawing of the soils caused ponding of water at the center of the road. With the installed wicking fabric, the road section dried out in a few days. Figure 99 shows the temperature and moisture content contours at noon on July 5, 2011. Comparing Figure 98 and Figure 99, it can be seen that the wicking fabric works as a siphon to drain the ponded water caused by non-uniform thawing. This is consistent with the results from the laboratory tests as discussed in Chapter 2.

Under situations where it is not convenient or it is impossible to install H2Ri wicking fabric with a slope, having the exposed exit portion of H2Ri lower than the road section is important. Figure 98 and Figure 99 indicate that the H2Ri wicking fabric can siphon water out if there is water ponding.
