Use of H2Ri Wicking Fabric to Prevent Frost Boils in the Dalton Highway Beaver Slide Area, Alaska Final Report

Xiong Zhang, Ph.D., P.E.

December 2012

INE/AUTC 12.23

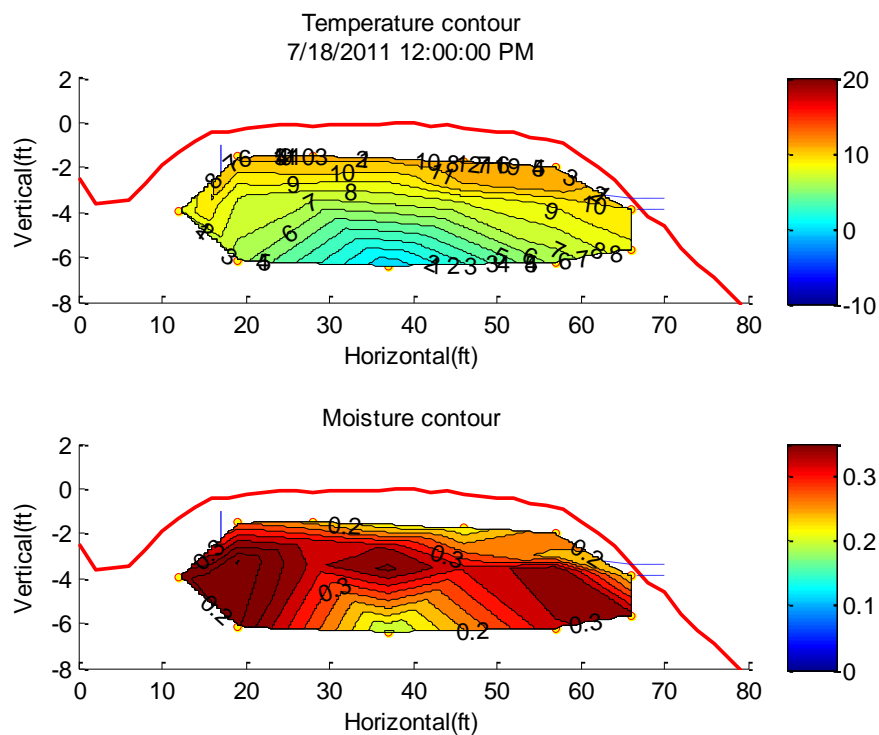
Figure 100. Temperature and moisture content contours at noon on July 18, 2011

Figure 100 shows the temperature and moisture content contours at noon on July 18, 2011, after a possible rainfall event in the morning of the same day. There were three

saturated soil zones at the same locations as those in Figure 98, which confirmed the conclusion that the wicking fabric works as a siphon to drain the ponded water caused by non-uniform thawing. Comparing Figure 98 and Figure 100, it can be seen that the frozen soil core had been reduced significantly.

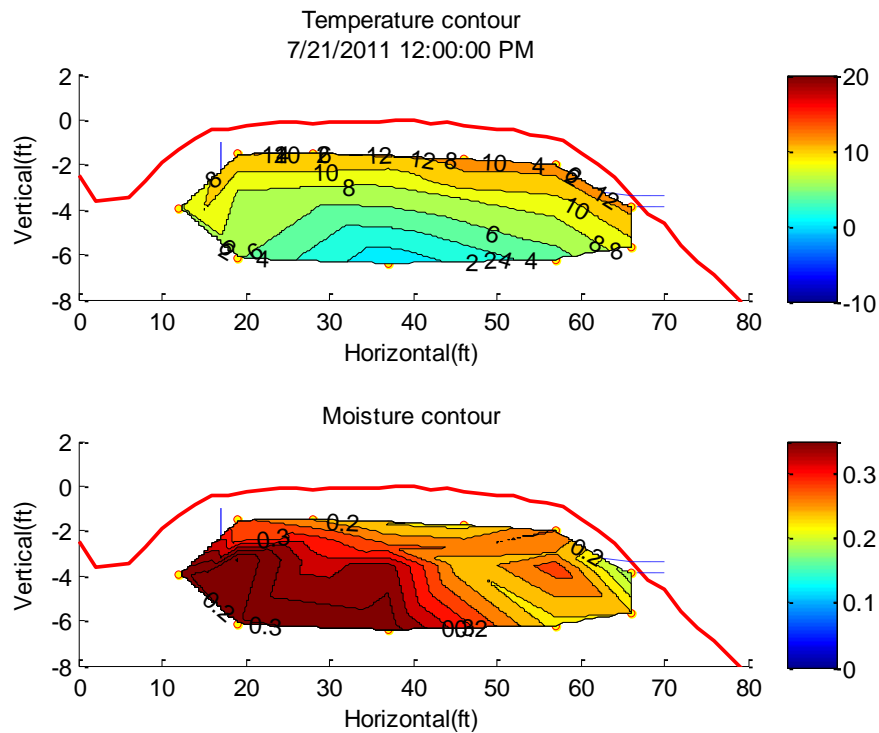
Figure 101. Temperature and moisture content contours at noon on July 21, 2011

Figure 101 shows the temperature and moisture content contours at noon on July 21, 2011, when the road section was completely thawed. The soils at 6 feet below the center of the road became saturated. The moisture content contour was similar but not identical to the ones in Figure 75, Figure 77, and Figure 85 for the previous year. The difference might imply that the freeze-thaw cycle changed the soil structure in the road section. Specifically, it seemed that the soils at the west lane of the road between sensor locations 13 and 22 had been loosened and had higher moisture content compared with the previous year. The soils at the east lane of the road were significantly drier than soils at the west lane.

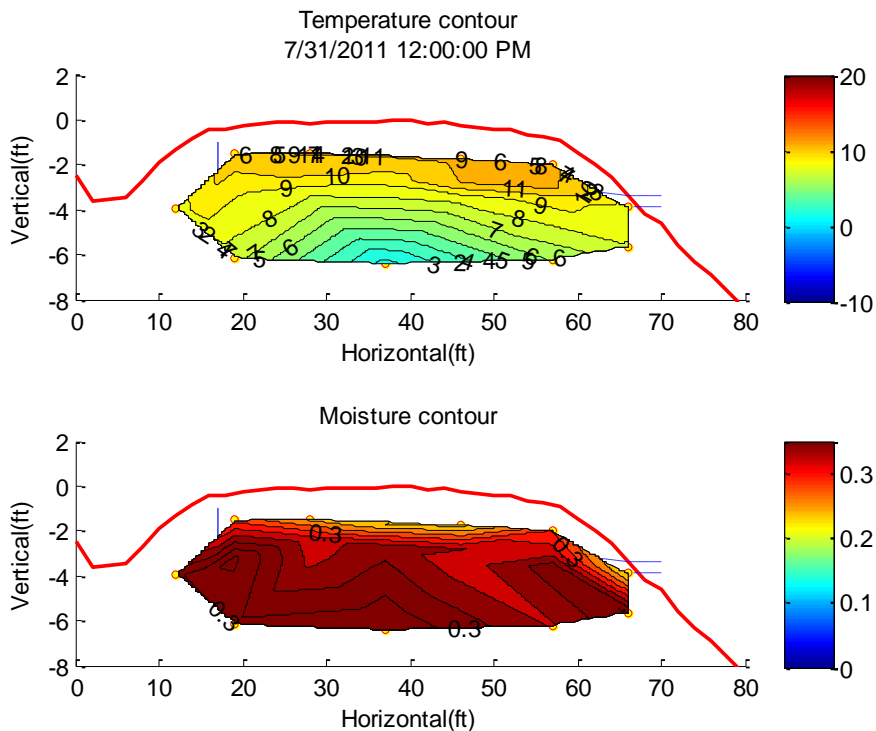
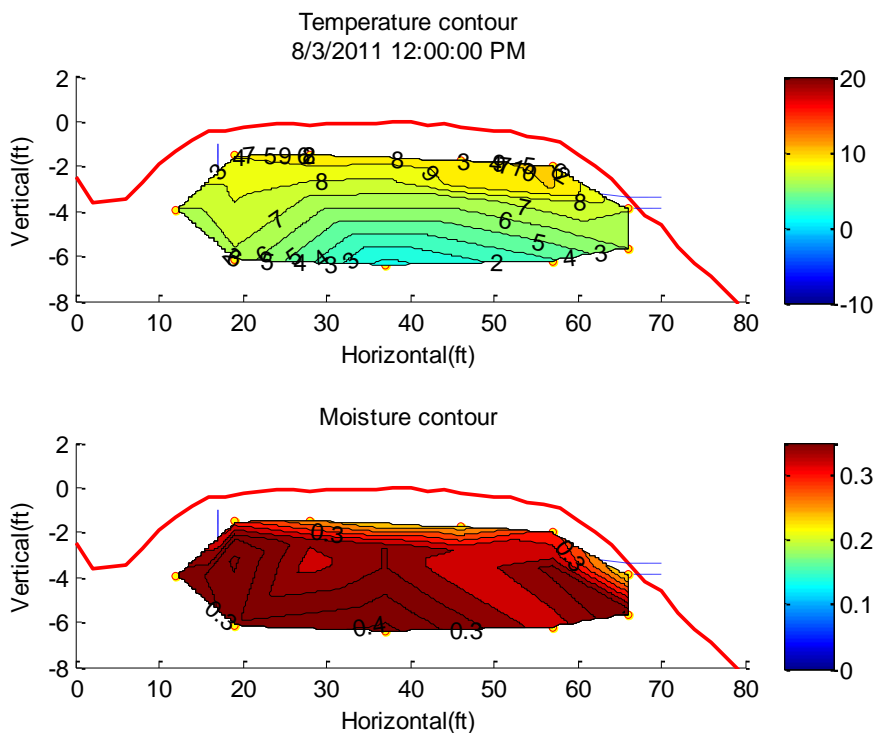
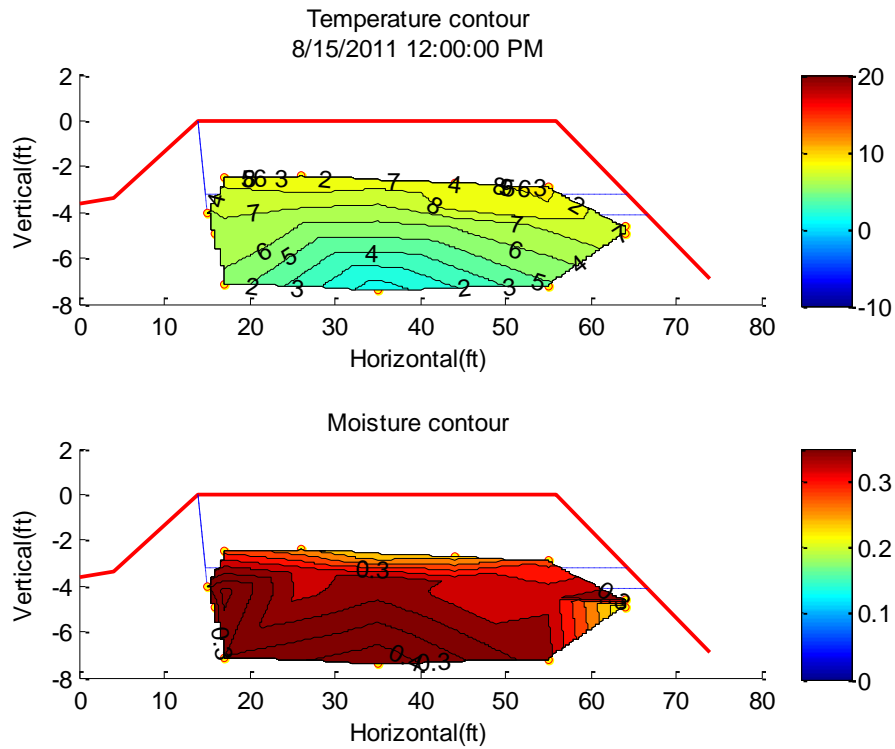
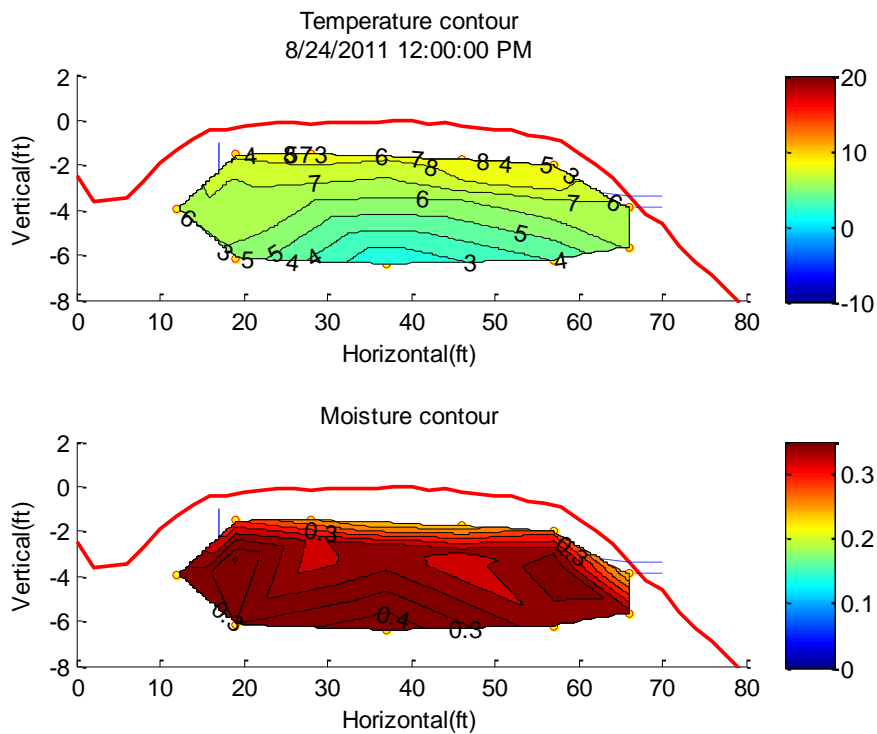
Several rainfall events as well as the continuous thawing of frozen soils on the hill kept the road section relatively wet in August and early September 2011. Figure 102, Figure 103, Figure 104, and Figure 105 show the temperature and moisture content contours at noon on July 31, August 3, August 15, and August 24, 2011, respectively, after a rainfall event on each day. The first 3 feet of soils below the surface, however, was always unsaturated with lower water content. In addition, after a rainfall event, the road section on the east lane dried out in a few days along the horizontal direction where the wicking fabric was installed. All the moisture content contours clearly show that water moved along the wicking fabric out of the road structure.

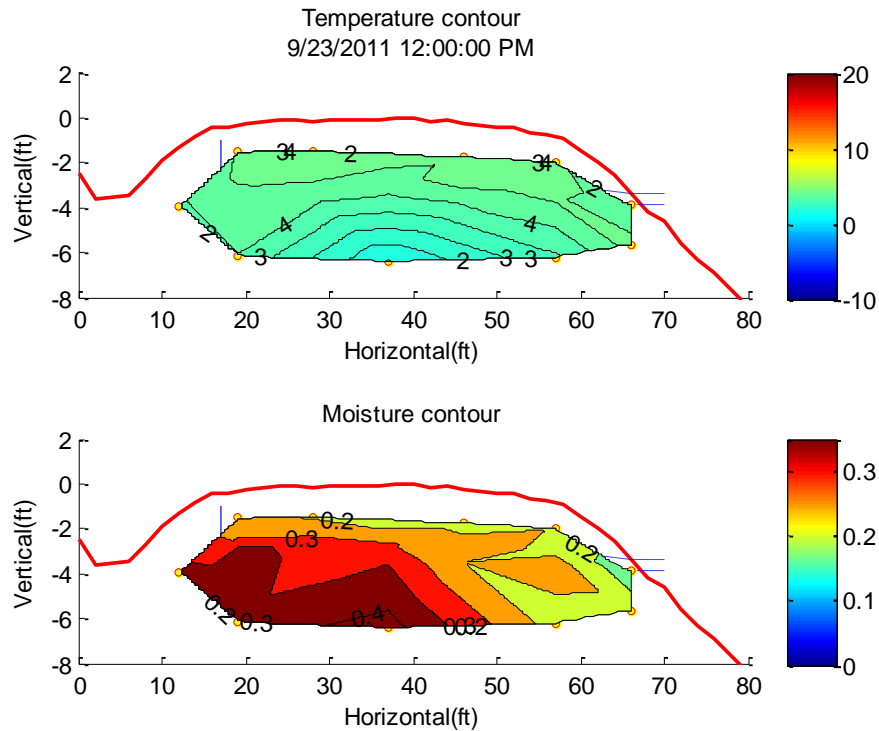
Figure 106. Temperature and moisture content contours at noon on September 23, 2011

In 2011, the air temperature dropped to zero on September 23. The corresponding temperature and water content contours are shown in Figure 106. Before the soil froze, water

had drained out, and the moisture content in most of the road section was low, especially in the first 3.5 feet below the road surface, where the soil moisture content was generally less than 20%, corresponding to a degree of saturation less than 50%. Because the soils were relatively dry, frost heave was not expected to occur in the first 3.5 feet of soils.
