# Monitoring and Analysis of Frozen Debris Lobes, Phase I

December 2012

INE/ AUTC 12.25

FHWA-AK-RD-12-17

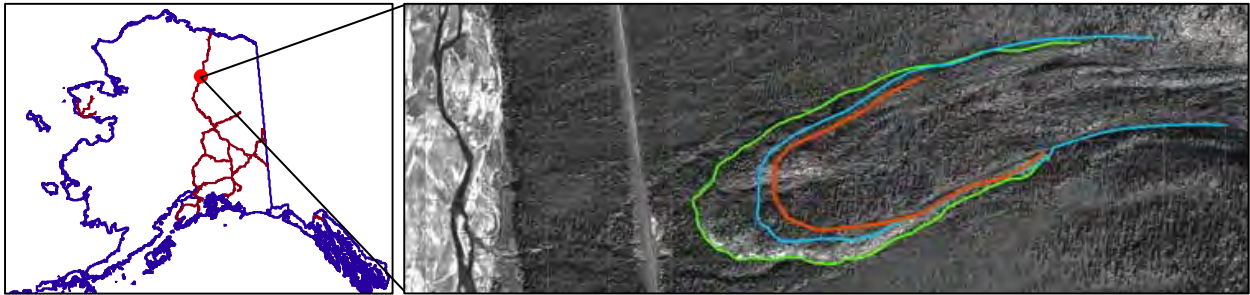
Figure 1. Location of the study area within Alaska. The inset illustrates the termini position of FDL-A from 1955 (red line), 1979 (blue line), and 2008 (green line) from high-resolution aerial and satellite-based remotely sensed imagery. Two drainage channels in front of the lobe are not part of the moving body. (Inset modified from Daanen et al. 2012).

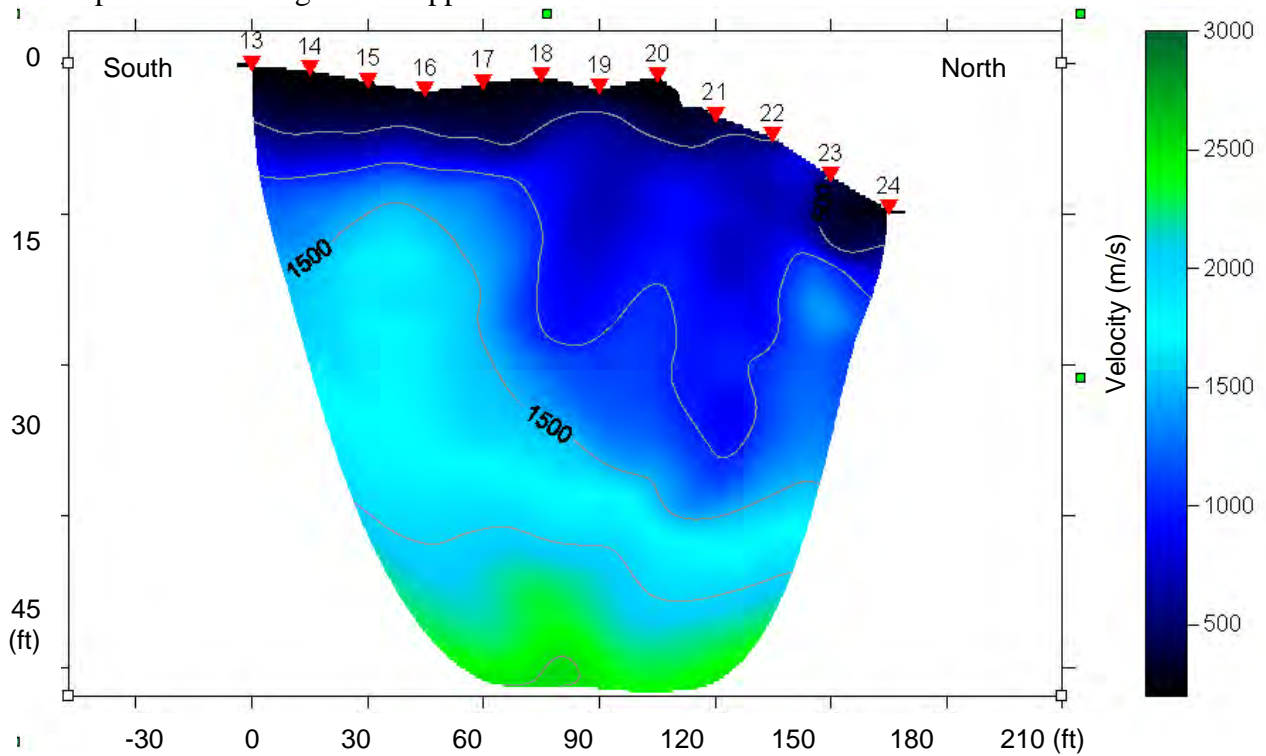
Figure 7. Seismic survey results for L2. Elevation and distance provided are relative to Shot 13 along this line. Velocity is provided in m/s from the seismic program.

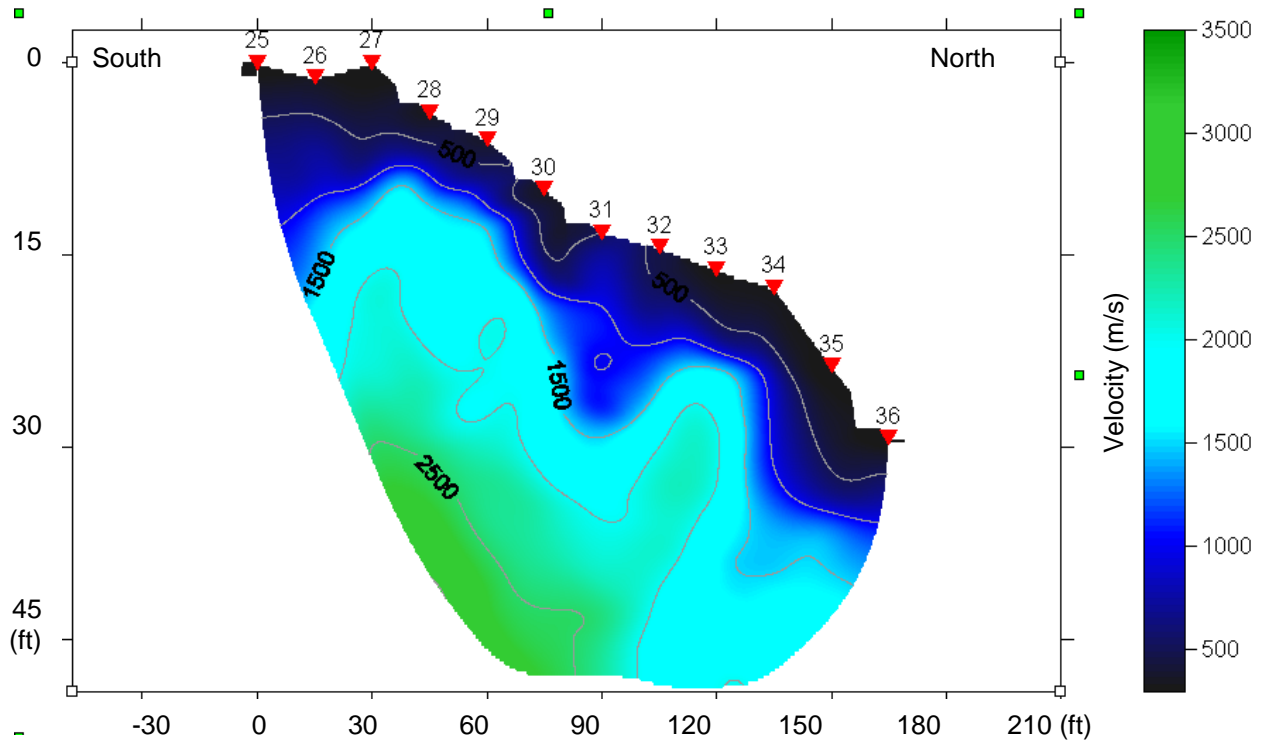
Figure 8. Seismic survey results for L3. Elevation and distance provided are relative to Shot 25 along this line. Velocity is provided in m/s from the seismic program.

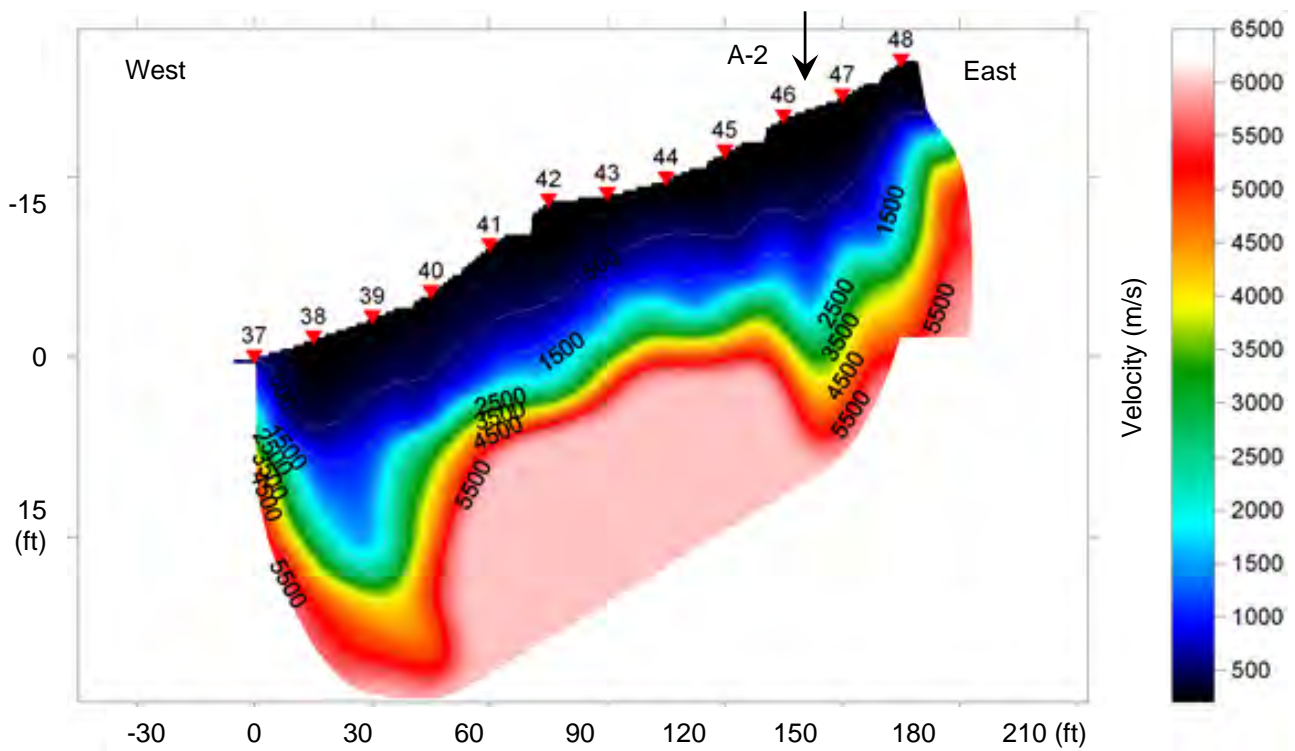
Figure 9. Seismic survey results for L4. Elevation and distance provided are relative to Shot 37 along this line. Velocity is provided in m/s from the seismic program. Arrow and identifier correspond to that figure in Appendix A.

As mentioned above, the seismic velocity is far from uniform with depth. Instead, there are several areas where lower velocities are present dipping down into the subsurface. These low velocity areas seem to correlate with the location of cracks observed at the surface; photographs of examples of cracks documented along the seismic lines are included in Appendix A. As these cracks may function as conduits for liquid water, it follows that the water thaws the adjacent debris, which results in deep zones of lower seismic velocity.

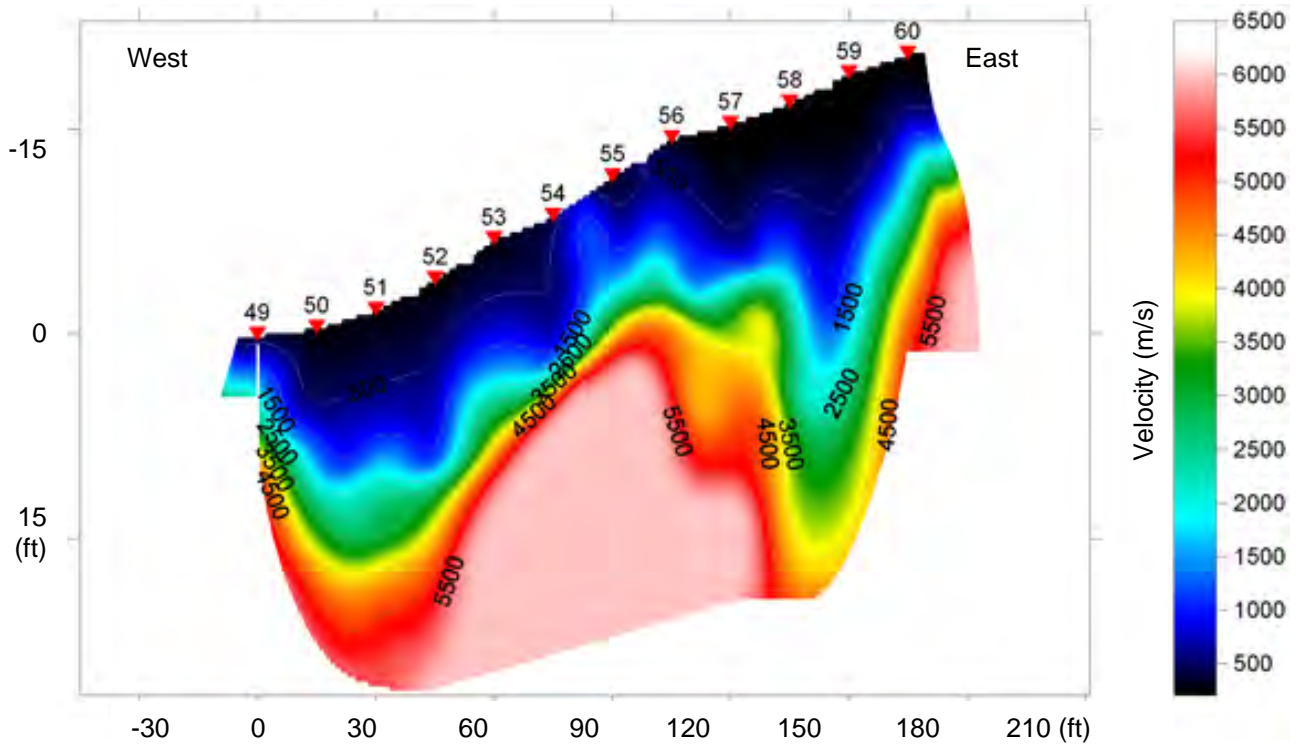
Figure 10. Seismic survey results for L5. Elevation and distance provided are relative to Shot 49 along this line. Velocity is provided in m/s from the seismic program.

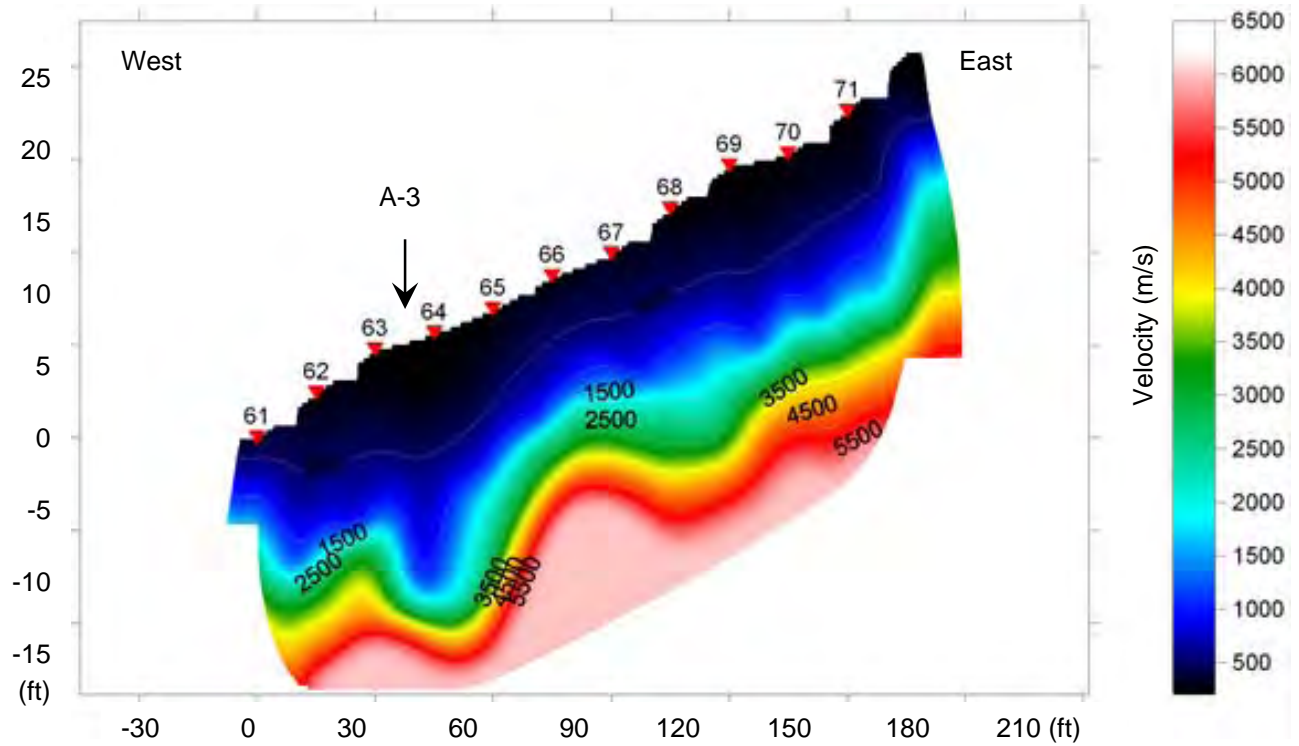
Figure 11. Seismic survey results for L6. Elevation and distance provided are relative to Shot 61 along this line. Velocity is provided in m/s from the seismic program. Arrow and identifier correspond to that figure in Appendix A.

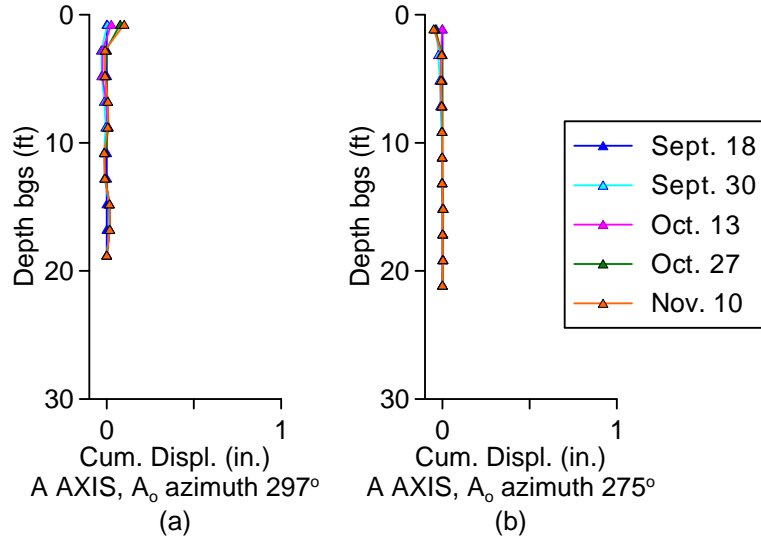
Measurements of TH12-9000 and TH12-9002 indicate that there is no appreciable slope movement between FDL-A and the highway or to the south of the lobe where drilled (see Figure 21). Figure 22 contains plots of cumulative displacement from the M-IPI device installed in TH12-9004, and the manual inclinometer readings of TH12-9005. We corrected the data for TH12-9004 using vector summation (Cornforth 2005) to determine the direction and magnitude of maximum movement. We also corrected for the cumulative change in depth of the sensors, as horizontal movement along the shear zone pulled the M-IPI device further down into the casing. These adjusted readings (shown in Figure 22a) indicate movement within a well-developed shear zone between 66 ft and 74 ft bgs. When drilling this interval, the drilling fluid changed from gray to a dark brown at 70 ft and 76 ft bgs, indicating zones rich in organic material. Wood pieces were flushed up in the drilling fluid/cuttings from 74 to 84 ft bgs. We collected some of these wood pieces, which were well-preserved within the frozen debris. We sent one of the larger pieces of wood to Beta Analytic Inc. for  $^{14}\text{C}$  dating. The calibrated results indicate that the wood was 1,330 years old. Based on its location below the current shear zone and above the bedrock surface, this wood is the remnant of a tree that either was growing on the slope and was covered by the debris lobe, or was buried and incorporated within the debris lobe and carried some distance downslope.

Figure 21. Cumulative displacement measurements for (a) TH12-9000 and (b) TH12-9002.

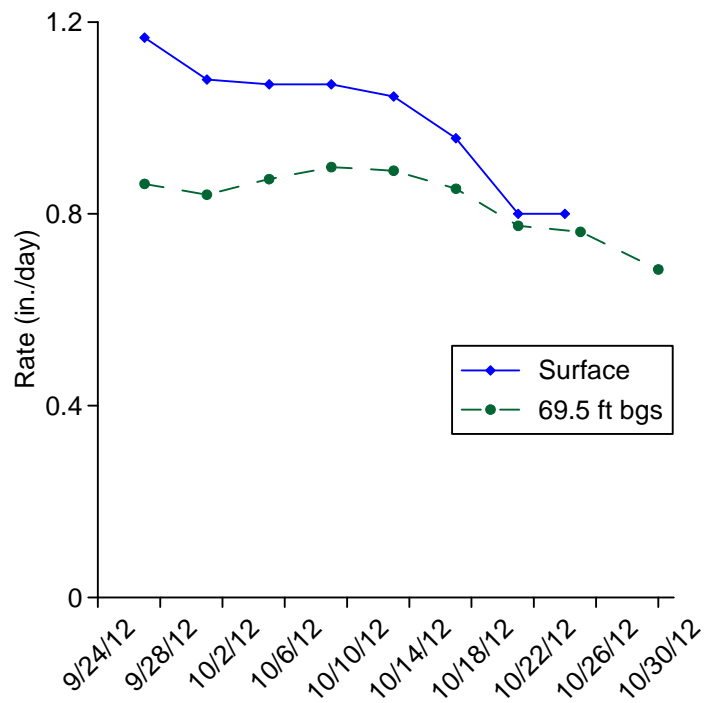
Figure 23 illustrates changes in the rate of movement measured at two different depths within TH12-9004. These rates were calculated from the surface sensor and the sensor originally at 69.5 ft bgs, which experienced the most displacement before the M-IPI device completely sheared. We continued to calculate the rate at this depth until the readings became unreliable on October 30. Calculations of the surface rate of movement were possible until the device indicated retrogressive motion on October 24. The combined movement of shear and slow to moderate flow is apparent as the movement rate at the surface was higher than the rate at 69.5 ft bgs throughout the measurement period. The data in Figure 23 also indicate that FDL-A was slowing down during this time. Movement at the shear zone was more consistent, averaging just over 0.8 in. per day. Movement at the surface was highest in late September, at approximately 1.2 in. per day; by the end of the measurement period, it slowed to nearly the same rate as the shear zone. This indicates that the internal flow was stopping over the measurement period, perhaps due to the dropping temperature within the surficial portion of the lobe.

Figure 23. Changes in the movement rate of FDL-A measured within TH12-9004. Rates are plotted for M-IPI sensors at the surface and at 69.5 ft bgs.

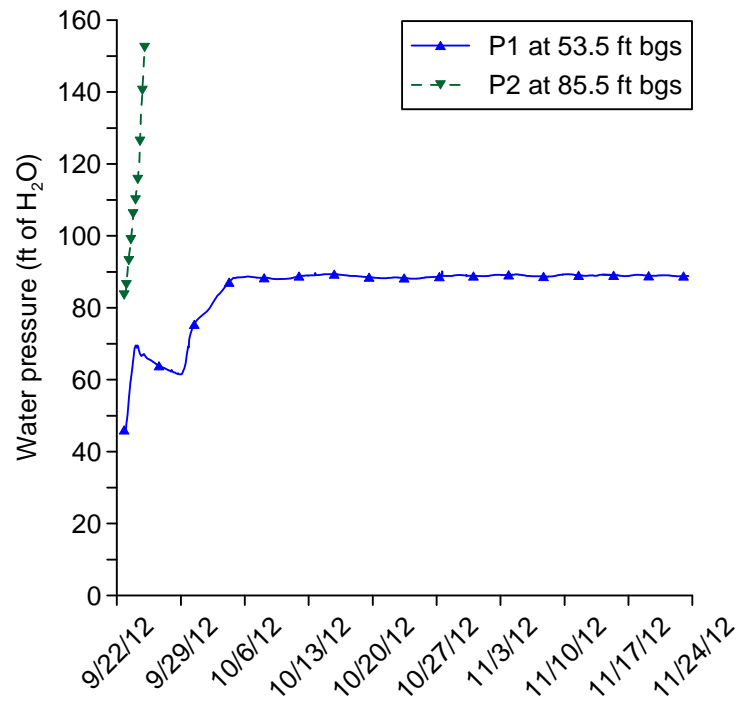
Figure 25 contains the water pressure readings for the two piezometers installed in TH12-9004. Both piezometers demonstrated a steep rise in pressure immediately after installation. The rise in P2 continued for 56 hours, at which point the piezometer began reporting erroneous values. The rise in P1 continued for 28 hours, gradually dropped, then rose again to record a nearly constant pressure of 88.5 ft of water. We suspect that the initial rise in pressure in both P1 and P2 was due to a combination of equilibrating to the *in situ* water pressures and the swelling of the cement-bentonite grout. Each piezometer is rated to an operating pressure of 117 ft of water (350 kPa) with an over-range of two times the full scale. Despite the large over-range, it appears that the high pressure of 155 ft of water was sufficient to damage the lower piezometer, P2. Beginning in early October 2012, the upper piezometer at 53.5 ft bgs consistently read water pressure indicating a potentiometric surface 35 ft above the ground surface. Initially, we suspected that this was due to an incorrect laboratory calibration; however, subsequent trips made to the site indicated that this reading may be accurate.

Figure 25. Water pressure measurements from TH12-9004. The vibrating wire piezometer at 85.5 ft bgs failed on September 25, 2012.

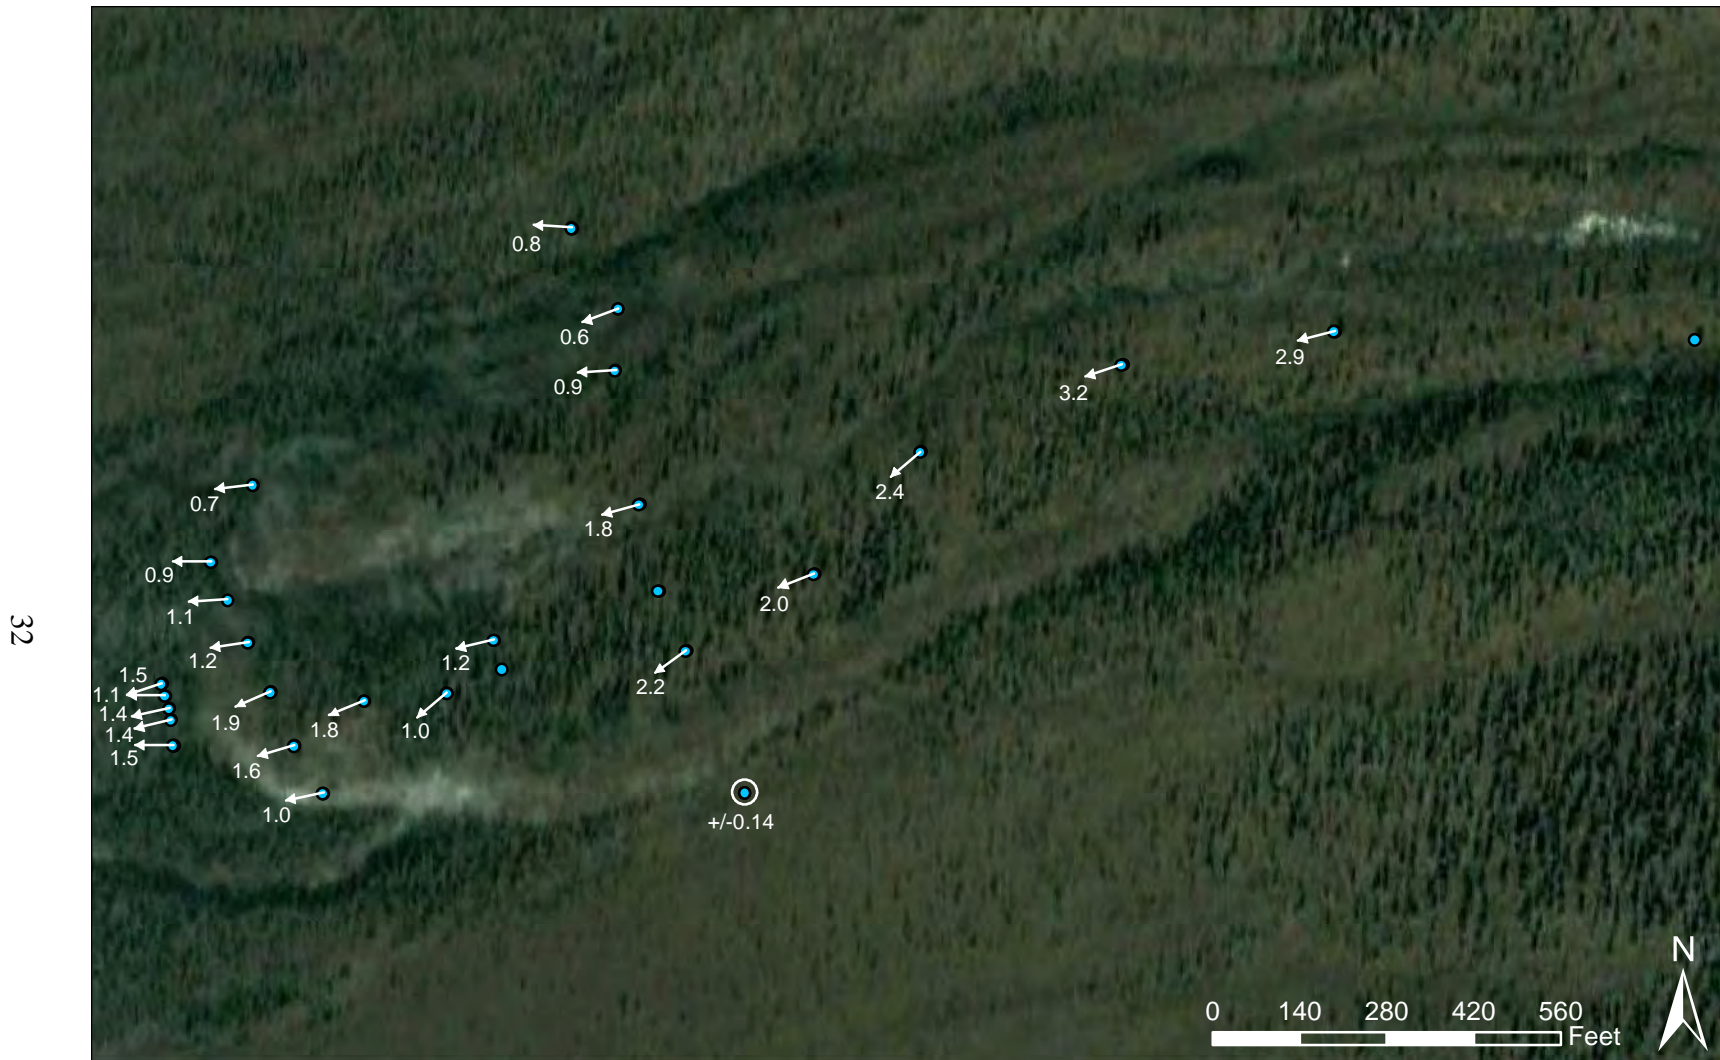
The results of our surface movement measurements are presented in Figure 28. Total movement measured from October 27 to November 23 for each point is provided in ft in the figure (points that could not be measured on either of those days are shown, but no measurements are provided). Based on the measurements made of the slotted casing in TH12-9002, we assume that the southernmost measurement point off of the lobe is not moving. In Figure 28, this point is indicated with a circle, and the text “+/-0.14”. As there is apparent movement of 0.14 ft between the measurement dates, we use this value as the minimum error of the other measurements. Additionally, in some low topographic areas and areas with thick vegetation, readings necessitated holding the DGPS at a greater height. This was especially true on November 23, when cold temperatures caused low battery power in the base station unit. This contributes to additional error. For example, the northernmost point off of the lobe most likely is not moving; however our measurements indicate 0.8 ft of movement. Considering these issues, we are treating the data presented in Figure 28 as preliminary; additional measurements must be made to reduce the error.

Despite its preliminary nature, the amount of movement indicated in Figure 28 is sufficient to make initial observations of the overall movement of FDL-A. These initial readings indicate between 1.0 and 1.9 ft of movement at the toe, increasing in magnitude upslope to a maximum of 3.2 ft of movement in 28 days. These values equate to rates of 0.4 to 0.8 in. per day at the toe and 1.4 in. per day upslope. The arrows indicate that while movement is in the downslope direction to the west, there is some variation in the direction of overall movement for this set of measurements. Again, since this is preliminary data, we will need to make additional measurements before we can verify or dismiss these variations in movement direction.

Figure 28. Summary of surface movement measurements. All points were measured using a differential global positioning system (DGPS). The length of all arrows is the same; they indicate direction of movement only, not velocity. Total movement for each point is provided in feet near the head of each arrow. The circle around the southernmost point indicates the use of this point for error calculations, which we estimate at  $\pm 0.14$  ft.
