**Observations from the EEFIT-TDMRC Mission to Sulawesi, Indonesia to Investigate the 28th September 2018 Central Sulawesi Earthquake**

Lagesse, Richard; Rossetto, Tiziana; Raby, Alison; Brennan, Andrew; Robertson, David; Adhikari, Rohit Kumar

*Published in:*  
SECED 2019 Proceedings

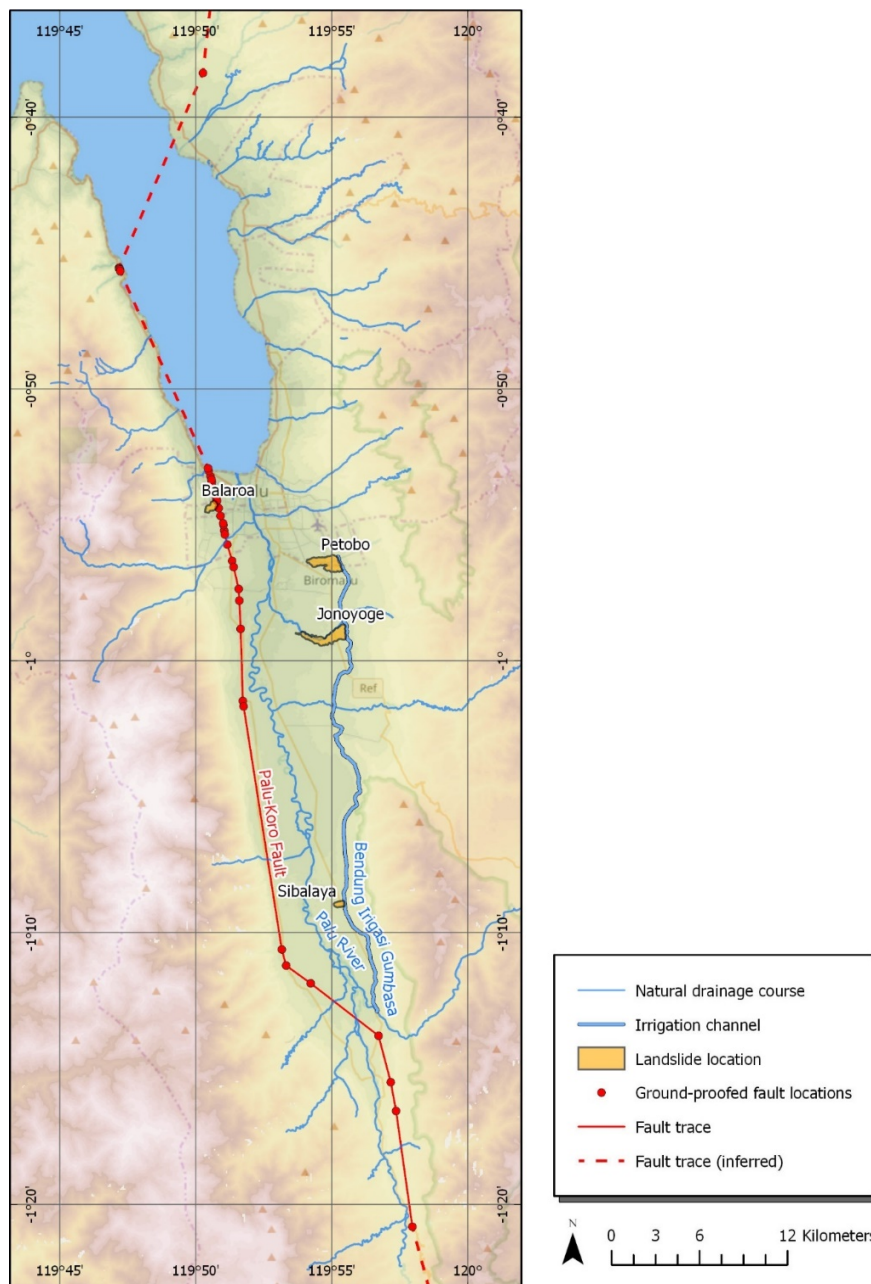
Part of the mission was focussed on ground-proofing the fault rupture (Figure 1) and surface rupture of the fault was observed in the field with evidence of displacement identified at the Palu city bay-front area and at the far southern end of the Palu valley. Other instances of surface fault rupture were identified on the western side of the Gulf of Palu at Tasiburi as well as on the eastern side of the bay near Dalaka. However, the interconnectivity of these ruptures with the surface rupture in the Palu valley area is inferred, particularly the undersea component.

Figure 1. Overview of Palu valley showing the Palu-Koro Fault, major landslides, Bendung Irigasi Gumbasa irrigation channel and the major natural drainage courses.

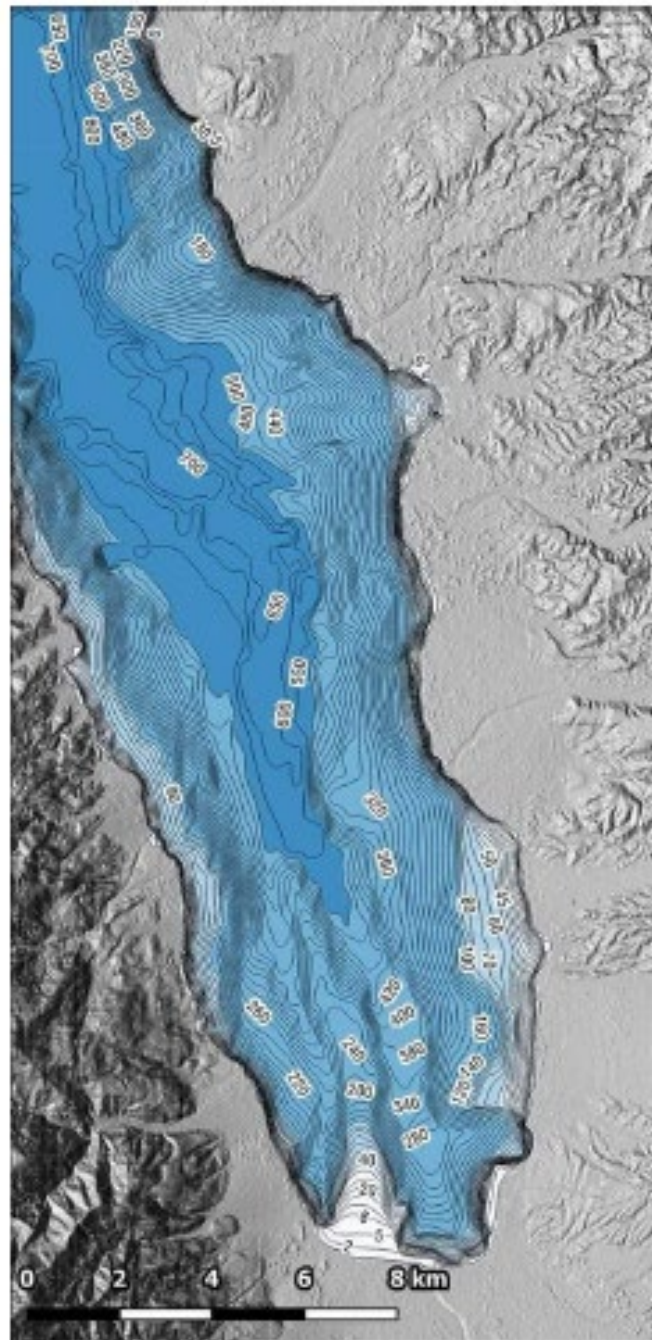
As mentioned above, the 28<sup>th</sup> September 2018 earthquake had a predominantly strike-slip mechanism. The relative movements of the plates in this type of earthquake are largely horizontal, and hence would not typically cause a tsunami, though due to the steep bathymetry of the bay (Figure 7) it is not inconceivable that horizontal movement could displace water (STEER, 2019). Measurements from outside of the bay suggest that a tsunami originating from a location close to the epicentre would not have had time to reach the bay before the first waves were observed (Muhari *et al.*, 2018). There are a variety of causal mechanisms now suggested, amongst which are landslides triggered by the earthquake. This seems plausible given the number of observed sub-aerial landslides that occurred and some slides on the west of the bay that were seen to cause tsunamis (STEER, 2019). However, to date the location of a single submarine landslide of the size required to cause a tsunami of the size recorded has not been identified.

Figure 7. Badan Informasi Geospasial Contour map of Palu Bay before the earthquake, Retrieved from <https://cloud.big.go.id>. Accessed 30 Oct 2018.
