# Evaluation of the Overheight Detection System Effectiveness at Eklutna Bridge

## Final Report

INE/AUTC 13.12

FHWA-AK-RD-13-01

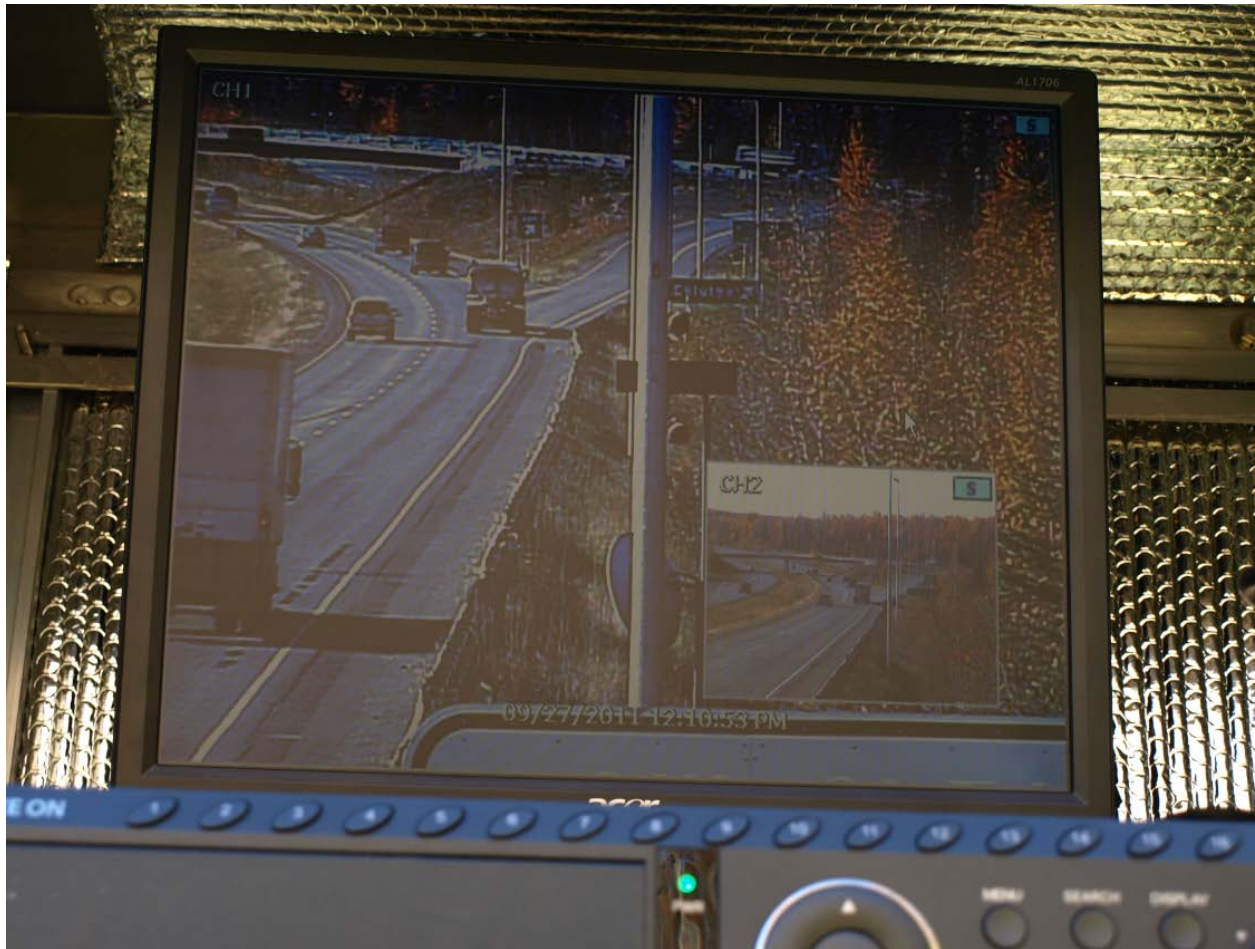
**Figure 8 Video images captured by camera #1 (CH1) with a separate view of camera #2 (CH2)**

Camera #1, mounted on the pole with the detector (see Figure 7), is to provide streaming video of the Blank Out Sign (blankout sign) that directs overheight vehicles to exit the highway in advance of the overpass. This camera also captures the violating vehicles in both lanes as they approach the blankout sign/flashers. Figure 9 shows the video image captured by camera and displayed on the monitor housed in the system cabinet.

Figure 9 also shows the DVR unit (i.e., underneath the monitor) that is connected to the cameras and the iSINC controller. The DVR is currently set up to record for 15 seconds whenever the blankout sign/flashers are turned on by the controller. The DVR has the capacity to advance and retain frames prior to the trigger. This feature allows the saved video clips to demonstrate that the blankout

sign/flashers were actually turned on for a specific vehicle and were not false alarms. The video clip will show the actual activation as the truck approaches the sign.

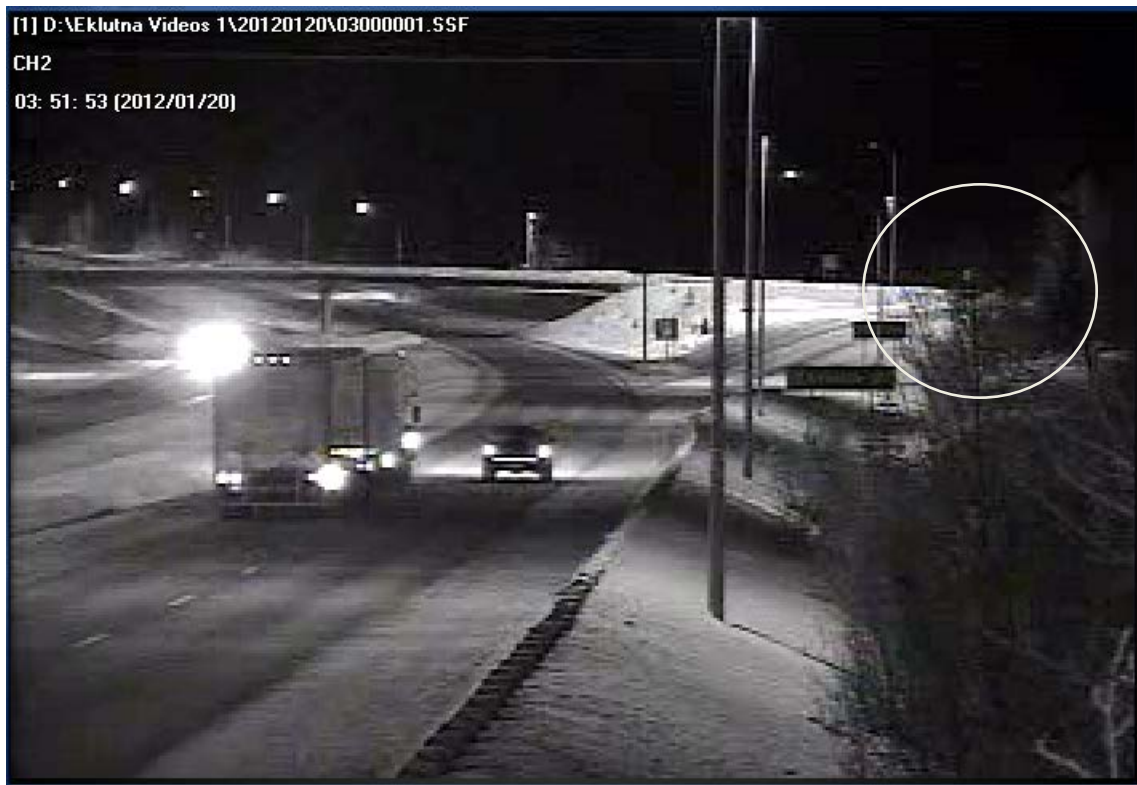
**Figure 11 The VMS before flashing (located in center of the circle area)**

The VMS sign is located at a spot near the visible limit of the images recorded by Camera#2. The activation of the VMS sign can be verified through the video images captured by Camera#2 in winter nights. Figure 12 and Figure 13 show the VMS sign before and after. When compared with Figure 12, it can be seen that VMS was illuminated in the center of the circle in Figure 13.

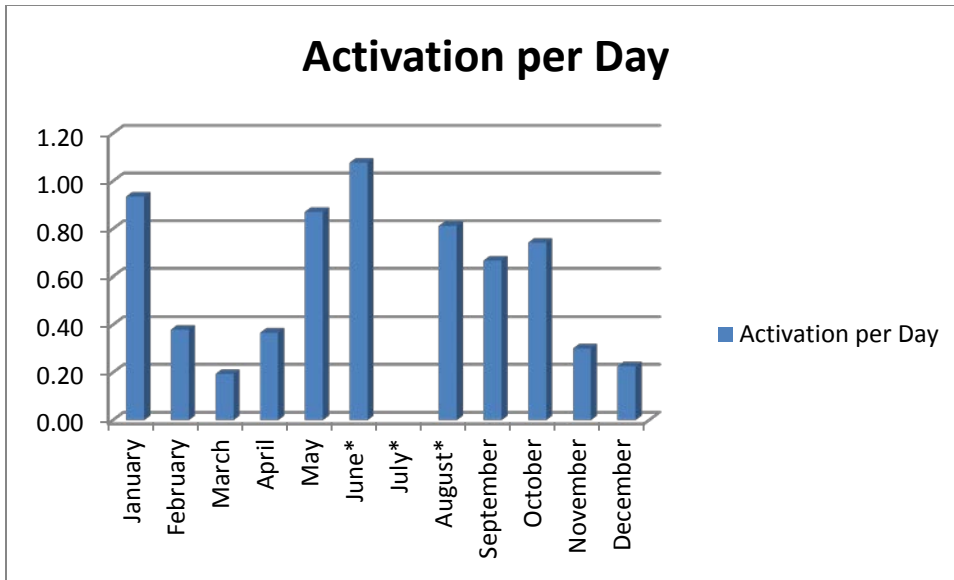
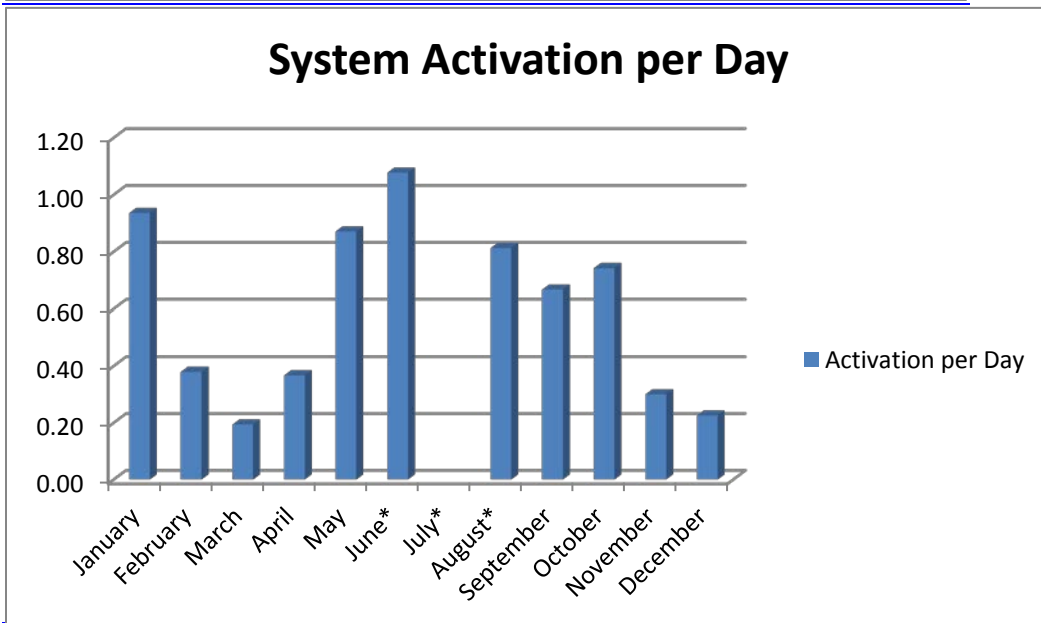
**Figure 13 System Activation Per Day by Month (August 2011 to June 2012)**

Figure 14 is a bar chart created from the Activation per Day variable in Table 3. We can see that system activation per day increases from April to June then decrease from August to September. With the exception of January (i.e., half of the cases are false alarms), activation per day stayed relatively low from November to March of the next year. This peaking pattern from April to September coincides with the summer construction season in Alaska as most of the overheight vehicles carry construction equipments and materials.

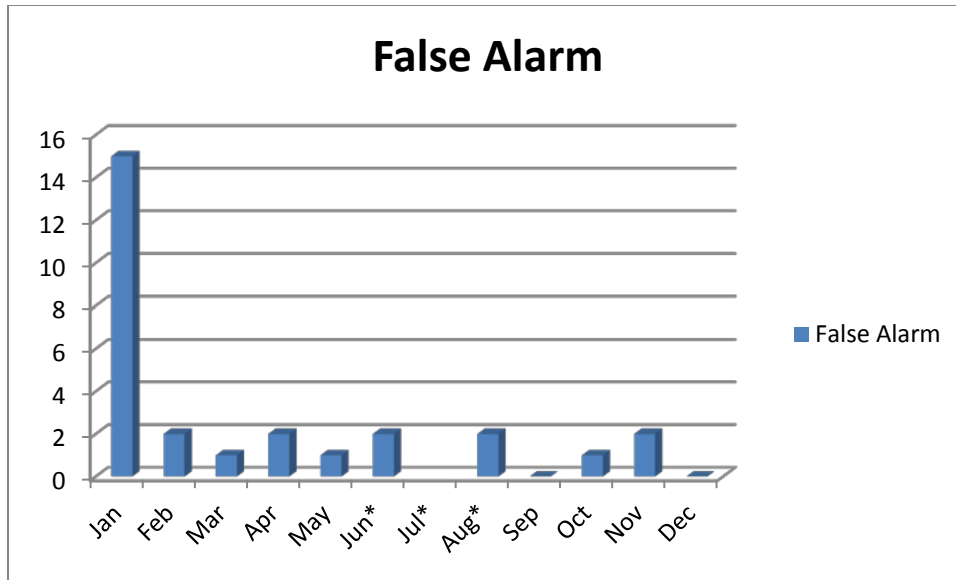
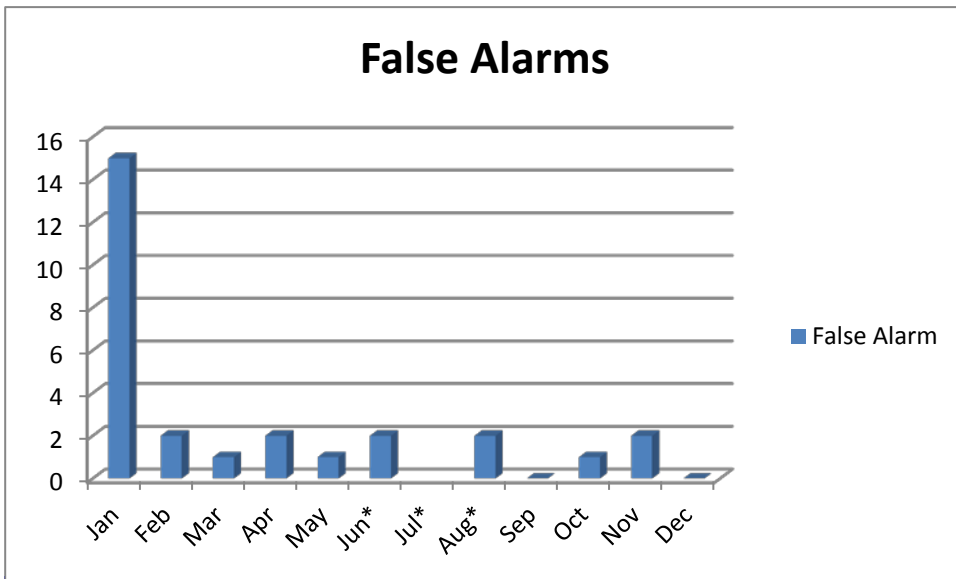
**Figure 14 Number of False Alarms by Month (August 2011 to June 2012)**

The numbers of False Alarms by month (see Figure 15) show that, except for January, there were at most two cases of false alarms per month. In September and December of 2011, there was no false alarm at all. In January, there was an exceptionally higher number of false alarms than occurred in every other month.

After examining the video footages from January of 2012, we found out that in all of the 15 false alarm cases this month the overweight detector beam was not blocked by the cargos of the trucks, but by the freezing fog coming from the exhaust pipes of the trucks. Figure 16 shows the video image of one of these incidents.

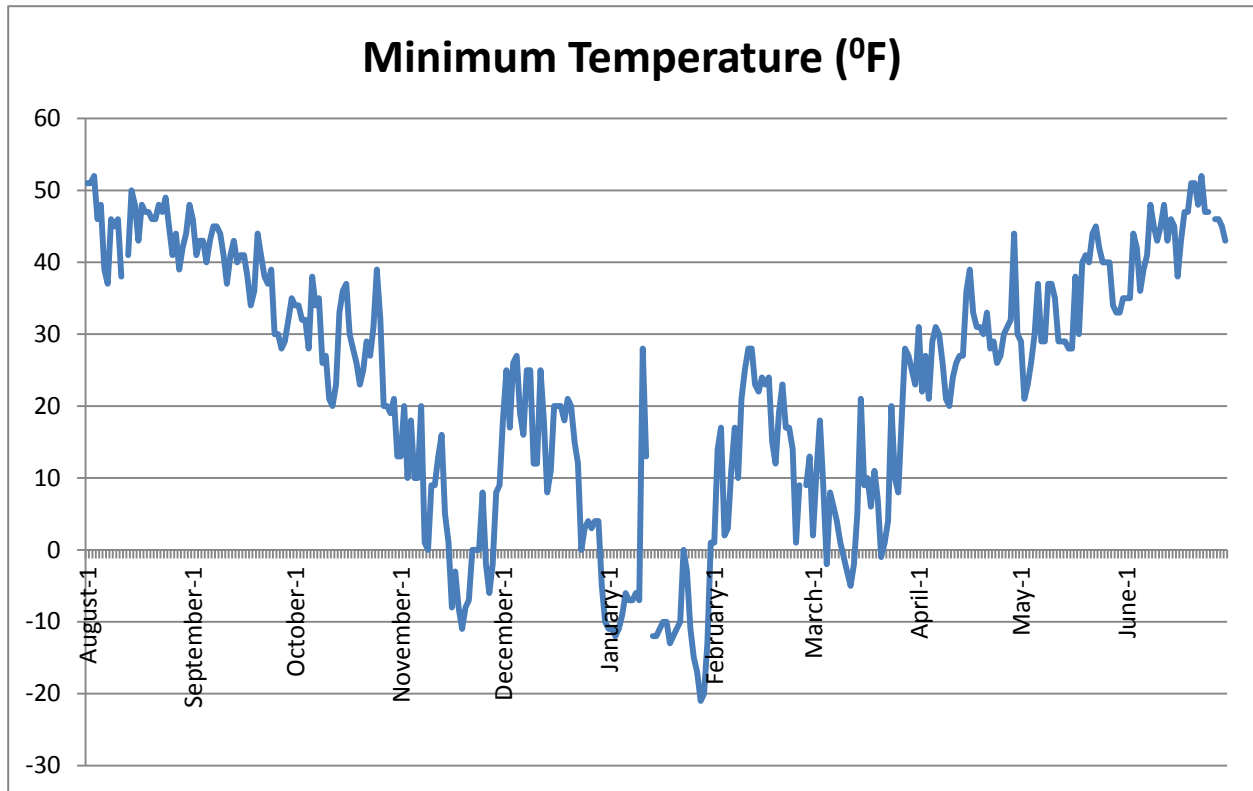
**Figure 16 Daily Minimum Temperatures at the Eklutna Weather Station, August 2011 to June 2012 (Source: NOAA)**

Freezing fog formed from truck exhaust usually occurs when temperature is extremely low. To find out the air temperatures at which these false alarms occurred, we downloaded the daily minimum temperatures at the Eklutna weather station (i.e., located on Eklutna Lake Road at Latitude of 61.4495° and Longitude of -149.323°, which is approximately 1.4 miles from the overcrossing bridge site) from the web site of the National Climatic Data Center of the National Oceanic and Atmospheric Administration (NOAA). Figure 17 shows the minimum temperature curve from August 2011 to June 2012. Note that there is no data available for September 2011 at the Eklutna station. We used data of the same month from the nearby Eagle River station to complete the curve.

The lowest peak in Figure 17 occurred on January 28 of 2012 at the temperature of  $-21^{\circ}$  F. The data of Figure 17 show that the second half of January 2012 (January 14 to January 30) is the coldest period of that winter. We then compared the daily temperature data with our video records. We found that all 15 false alarms in January of 2012 occurred between January 14 and January 28 when the minimum temperatures range between  $-10^{\circ}$  F and  $-21^{\circ}$  F.

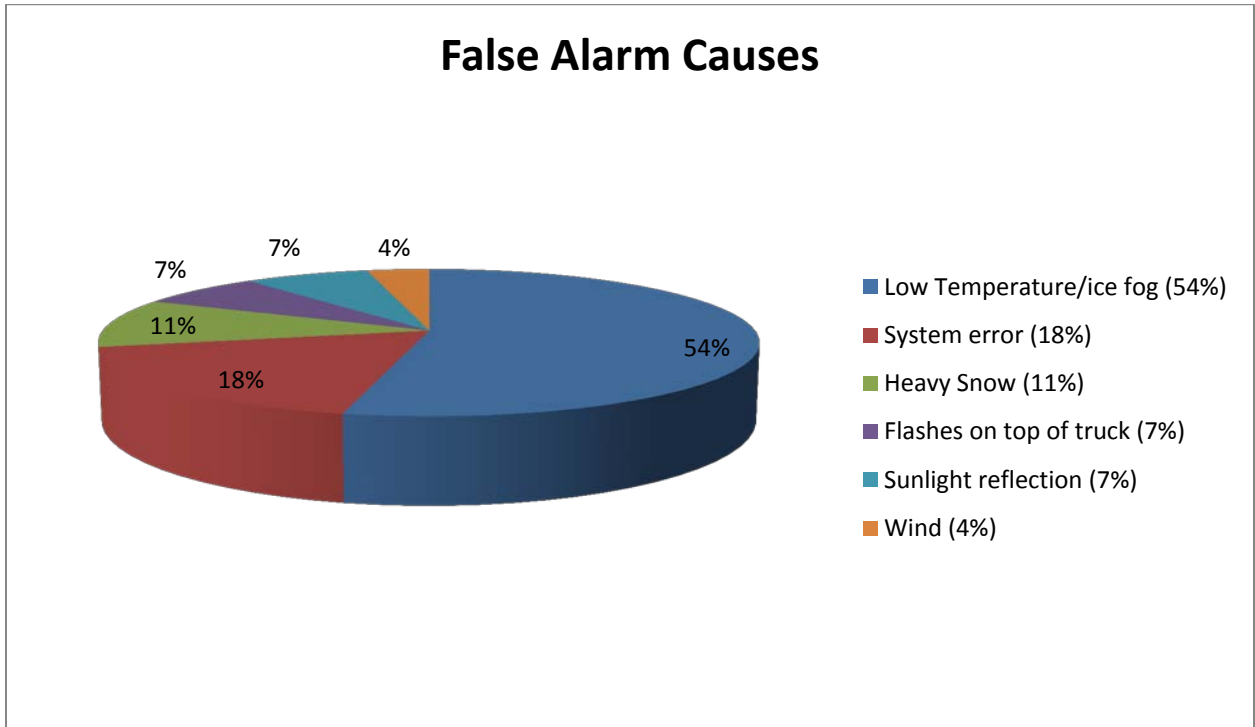
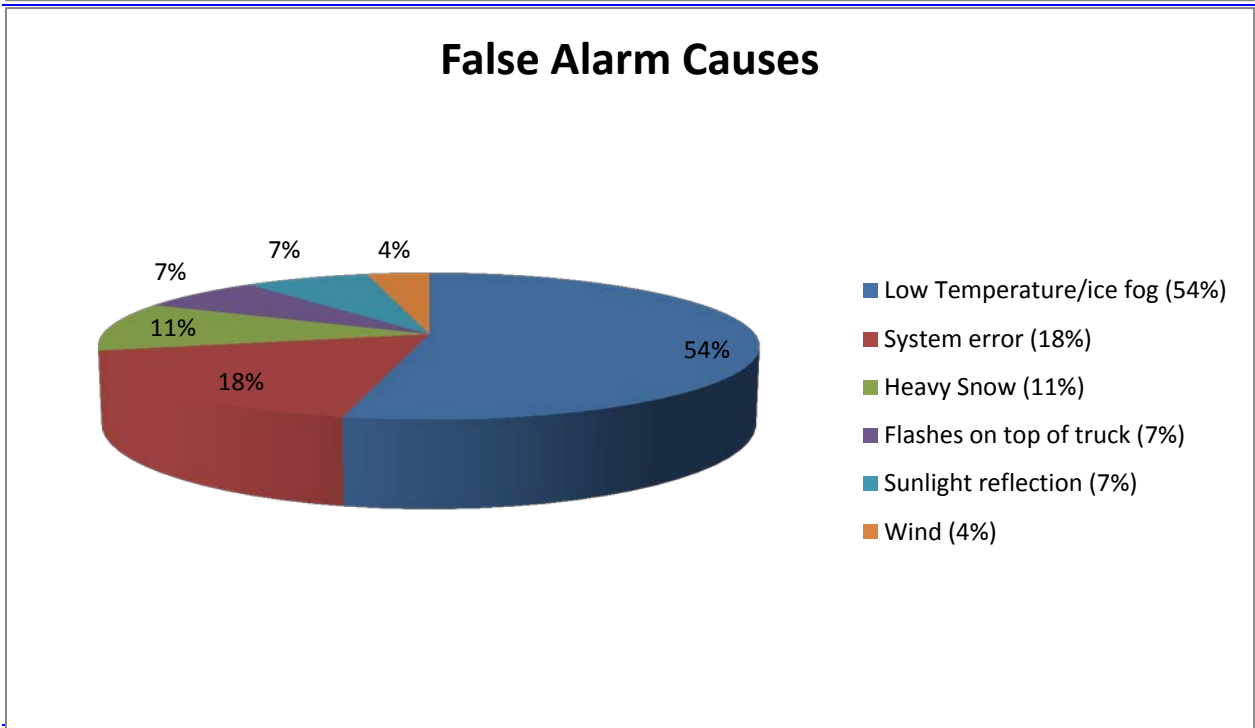
Figure 18 Percent Distribution of All False Alarm Causes

Figure 19 shows the percentage distribution of different false alarm causes. Of the 28 false alarm cases, 54% of them occurred when the minimum temperature of the day was below -10<sup>0</sup> F. When combined with false alarms triggered by heavy snow (11%), winter weather events account for 65% of all false alarms. In all of the cases identified as caused by heavy snow, heavy snow falls with visible snowflakes were identified from the video images. A large aggregation of snowflakes is capable of blocking the

detector beam and triggering the system. Thus, during heavy snow events, the system has a higher chance of being triggered for false alarms. A good example of this is the heavy snow event on the morning of 11/7/2011 (see Figure 20). In less an hour, the system was triggered twice for false alarms by the heavy snow fall.

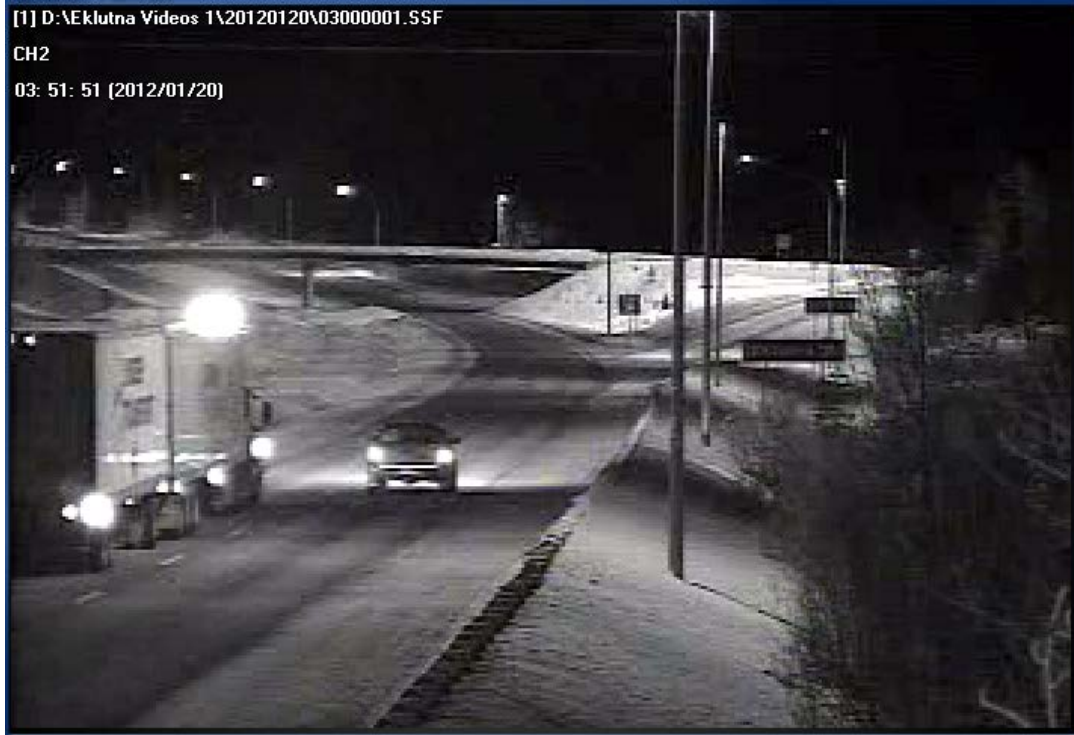
Figure 22 Truck with visible marking on the trailer

We also examined if we can unmistakably identify the triggering overheight vehicle from the images recorded by Camera#2. Specifically, we would like to know if it is possible to read the license plate numbers of the overheight trucks. After reviewing all videos, we concluded that, with the camera resolution and the lighting as they are, the only situation in which a vehicle may be identified is when the sides of the trailers are painted with recognizable signs of the trucking company. Figure 23 demonstrates one of such events. However, Figure 24 shows a more typical event in which identification of the truck in the image is not possible even during daylight hours. If one of the purposes of an overheight detection system is to gather evidence for investigating specific bridge impacts, the resolution of camera#2 would need to be increased, or an additional camera close to the bridge need to be installed. Note that there may not be existing electrical conduits to be used to connect the additional camera. Thus, if an additional camera is to be used, additional cost to put in the conduits may be required.
