Factors Contributing to Heat Affected Zone Damage in Grade 91 Steel Feature Type Cross-weld Tests

John A. Siefert¹, Dr. Jonathan D. Parker² and Rachel C. Thomson³

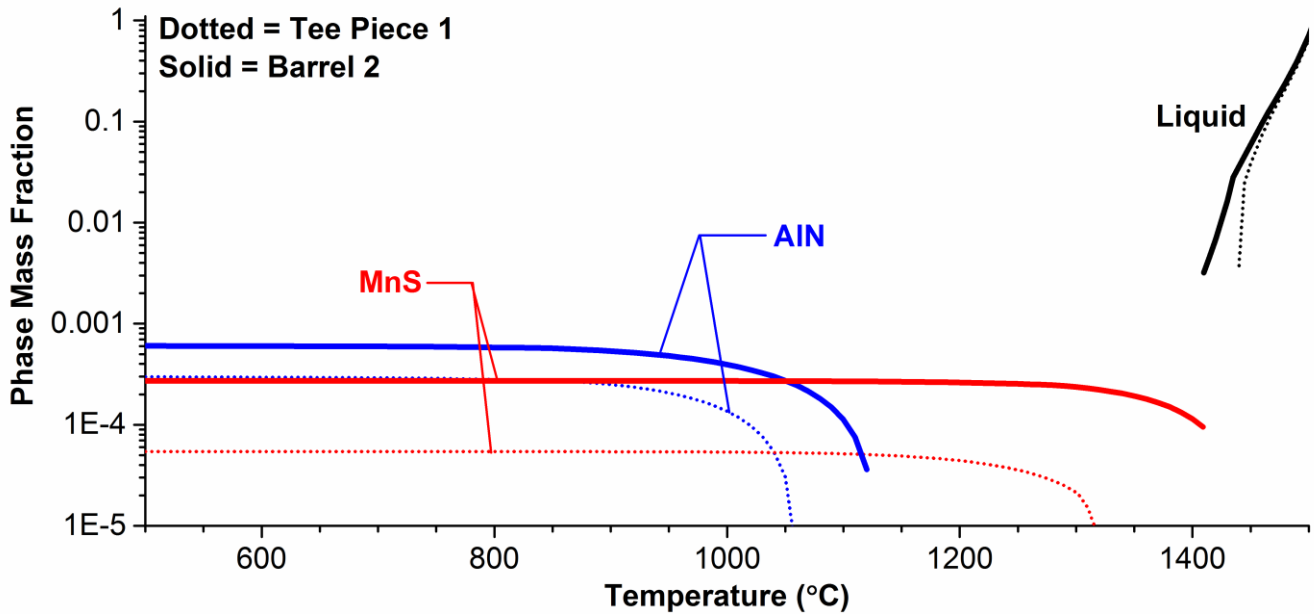
Figure 13: Equilibrium Simulation for Materials B2 and TP1 (Table 3) and for the Liquid, MnS and AlN phases

Analysis of the compositions provided in Table 3 and under equilibrium conditions on-cooling from melting is provided in Figure 13. In this Figure only the primary elements in the specification were considered: Al, C, Cr, Fe, Mn, Mo, N, Nb, Ni, P, S, Si, V using the ThermoCalc database TCFE7 Steels/Fe-Alloys v7.0 and for the liquid, MnS and AlN phases. The influence of composition on the formation of MnS and AlN for the two evaluated heats of material is dramatically different. With regard to the B2 material (identified as 'Barrel 2' in the figure), there is a larger mass fraction of both MnS and AlN as well as increased stability of these phases. The influence of poor composition in B2 is compounded by the overlap of the liquid phase with the formation of MnS, suggesting that the simultaneous evolution of MnS with the liquid would result in the MnS acting as an ideal trap site for low melting point constituents. The melting temperature for elements such as As, Cu, Sb and Sn is well below that of the matrix and the solidification behavior of the material may promote the concentration of these tramp elements to particles which form at solidification such as MnS. As the grain size in the HAZ is typically ~1 to 5 µm and is therefore generally the same

size as MnS, the MnS will intersect newly formed grain boundaries in the HAZ and may result in elemental segregation along grain boundaries. Whether tramp elements reside at MnS or on grain boundaries, the local surface energy at these interfaces will be reduced and result in a reduction in the stress required for nucleation [14]. The presence of a particle in these locations (e.g. inclusions) can cause an enhancement of the stress and intensify strain. Support for this phenomenon is given in Figure 14 where a region above and below the MnS inclusion is apparently recrystallized.
