# **COMPLIANCE TESTING OF IOWA'S SKID-MOUNTED SIGN DEVICE**

## **MIDWEST ROADSIDE SAFETY FACILITY**

MwRSF Research Report No. TRP-03-86-99

July 23, 1999

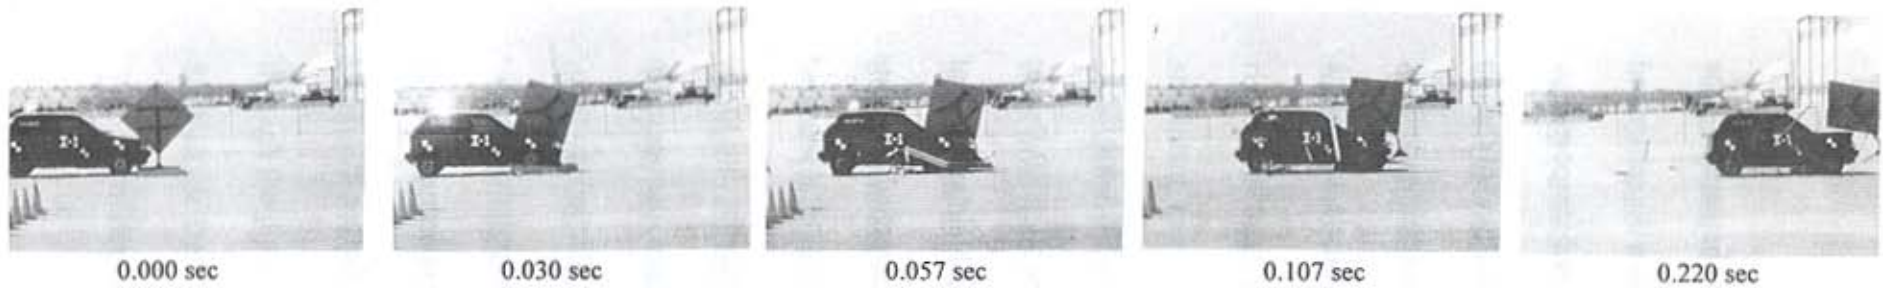
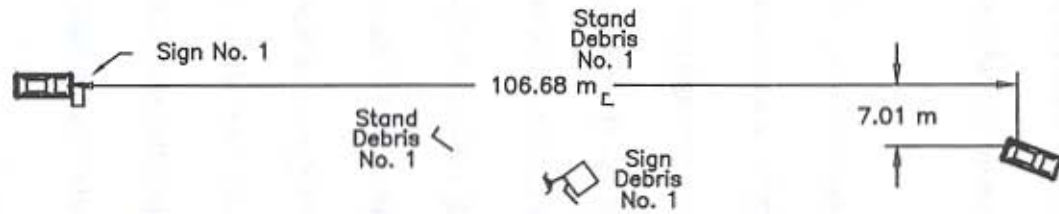
Following test I-1, a safety performance evaluation was conducted, and the work zone traffic control device, System No. 1, was determined to be unacceptable according to the NCHRP Report No. 350 criteria. It was deemed unacceptable due to penetration through the windshield and loss of structure of both glass layers which could result in obstructed driver visibility. Detached elements and debris from System No. 1 slightly penetrated the lower middle of the windshield. Detached elements and debris also showed potential for penetrating the occupant compartment due to the cracked lower-middle region of the windshield. Deformations of, or intrusion into, the occupant compartment did occur. The vehicle’s trajectory did not intrude into adjacent traffic lanes.

Note: The wooden base broke into two large pieces and many smaller pieces with a scatter pattern of 3.81 m left, 3.81 m right, and 24.38 m downstream from the original position of the sign.

After discussion with the sponsor, it was concluded that there were potential minor modifications of the sign support that may prevent intrusion into the occupant compartment. It was decided that a test of the sign at 0 degrees was warranted prior to investigating further effort into modification to address the performance from test no. 1.

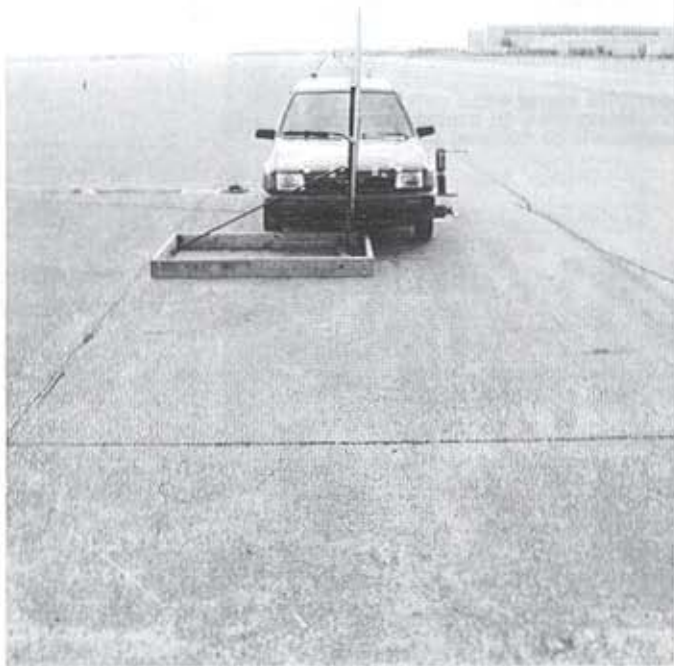
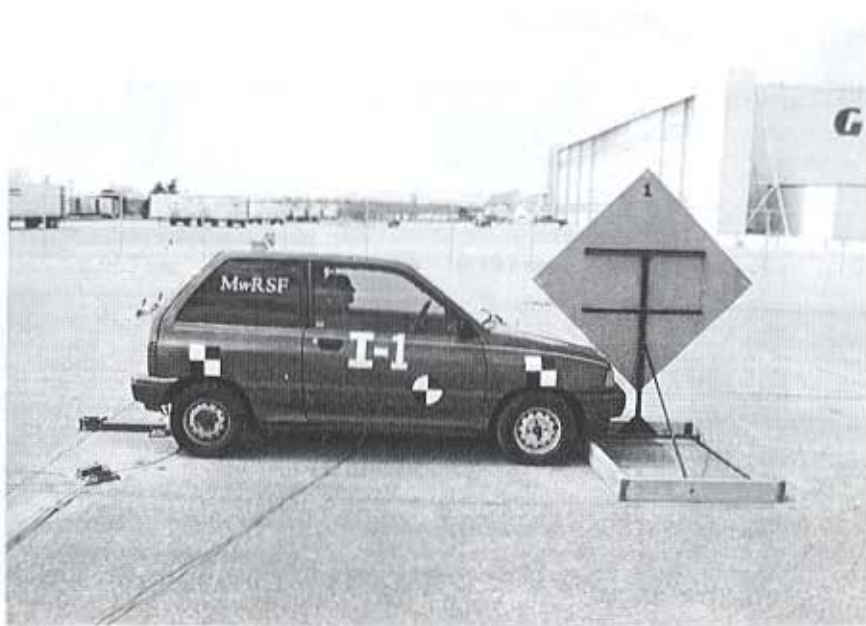
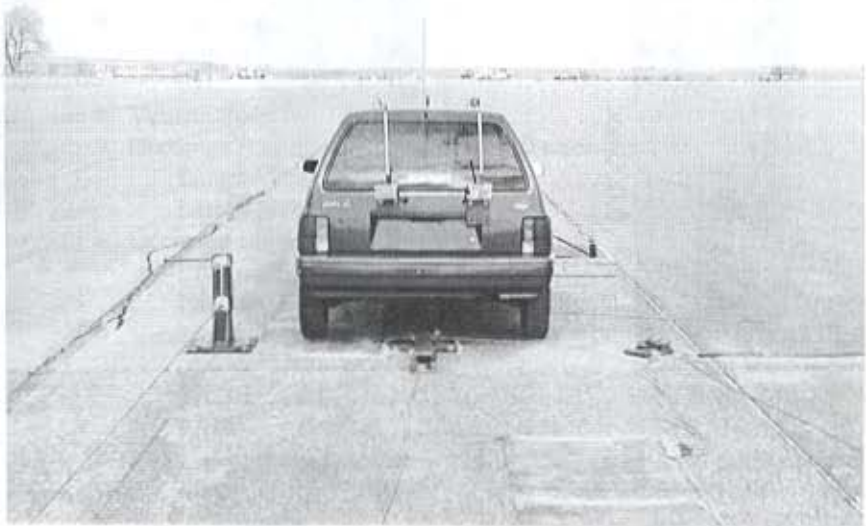
Figure 13. Impact Location, Test I-1

The test vehicle impacted System No. 1 with the centerline of the vehicle aligned with the centerline of the sign support, as shown in Figure 13. At 0.014 sec after impact, the hood was creased down the center and the outside edges buckled upward around the sign panel. At this same time, the vertical support deformed about the vehicle's bumper which caused the top of the sign panel to rotate toward the vehicle. After 0.030 sec, the corner of the sign panel closest to the vehicle impacted the lower-center of the windshield. At 0.032 sec, the vertical support ripped away from the wooden base as the vehicle began to travel over it. After 0.057 sec, the wooden base broke into several pieces. At this same time, the sign panel, with the vertical support still attached, was still in contact with the windshield and hood and continued to travel with the vehicle. At 0.107 sec, the sign panel, which was not in contact with the vehicle, traveled along in front of and at about the same speed as the vehicle. One of the larger pieces of the wooden base was along side the right-front side of the vehicle at 0.110 sec. At 0.179 sec, the sign panel and vertical support began to rotate counter-clockwise (CCW) in front and above the vehicle. At 0.220 sec, the sign panel was above the vehicle's hood and continuing to rotate CCW. At 0.275 sec, the large piece of the wooden base was near the right-side door, while the sign panel continued to rotate CCW.

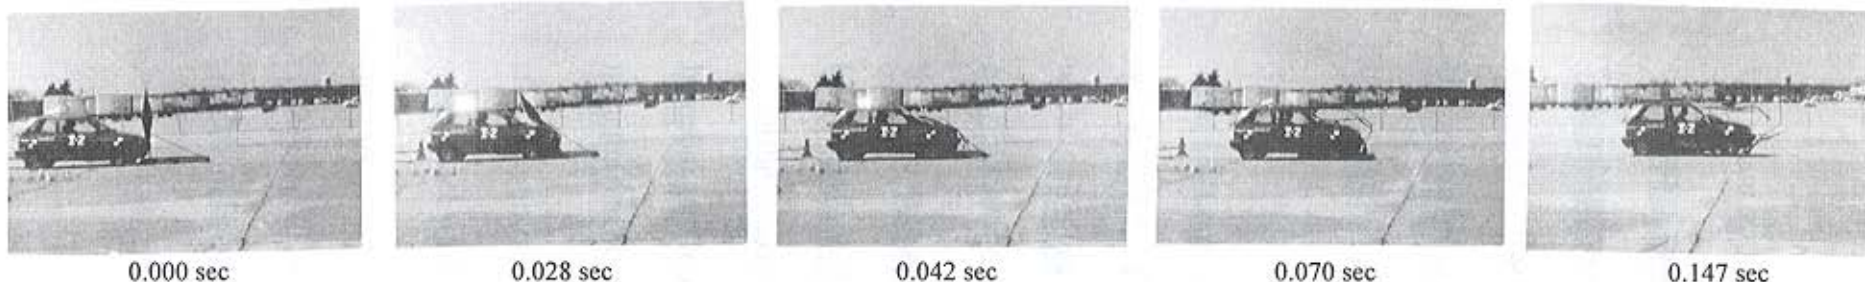
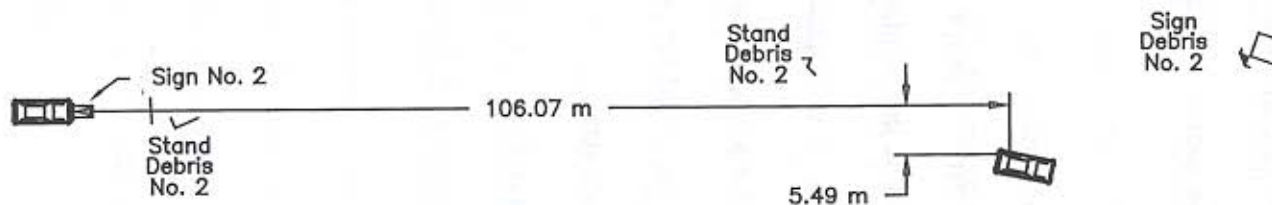
Figure 18. Summary of Test Results and Sequential Photographs, Test I-2

Following test I-2, a safety performance evaluation was conducted, and the work zone traffic control device at 0 degrees, System No. 2, was determined to be unacceptable according to the NCHRP Report No. 350 criteria. It was deemed unacceptable due to the “spider web” cracking and indentations in the windshield which resulted in obstructed driver visibility and loss of structure of both glass layers. Detached elements and debris from System No. 2 did not penetrate, but showed potential for penetrating the occupant compartment due to the indentation of the cracked windshield. Deformations of, or intrusion into, the occupant compartment did occur as the roof was indented downward toward the occupant compartment. The vehicle’s trajectory did not intrude into adjacent traffic lanes.

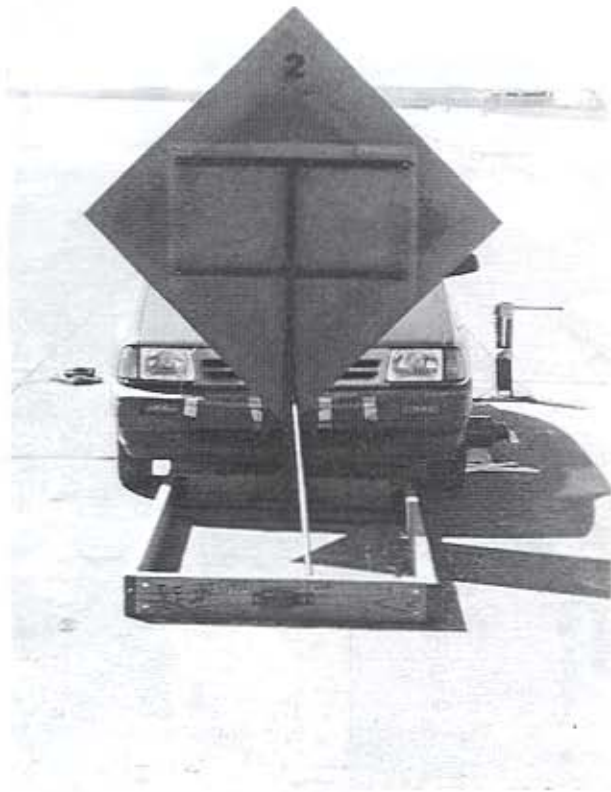
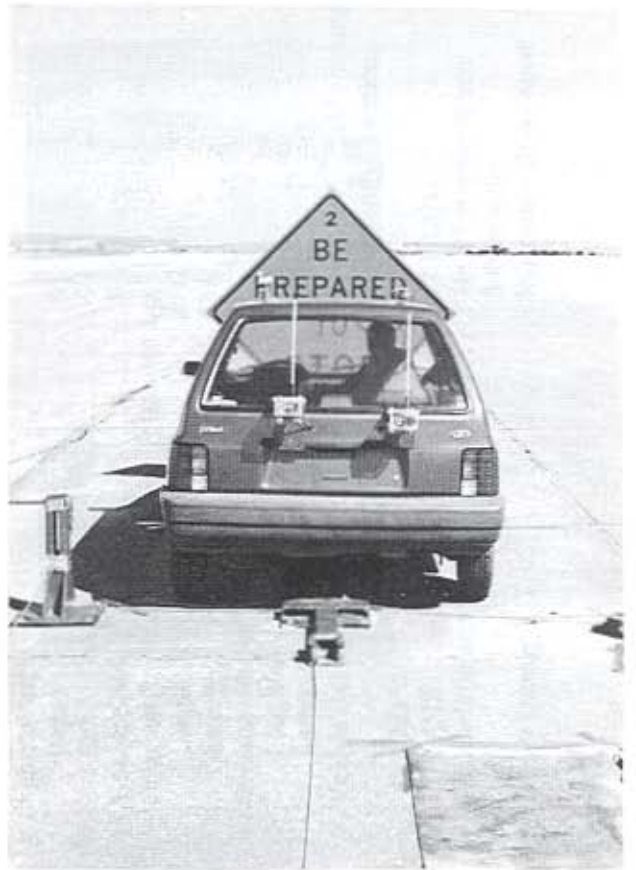
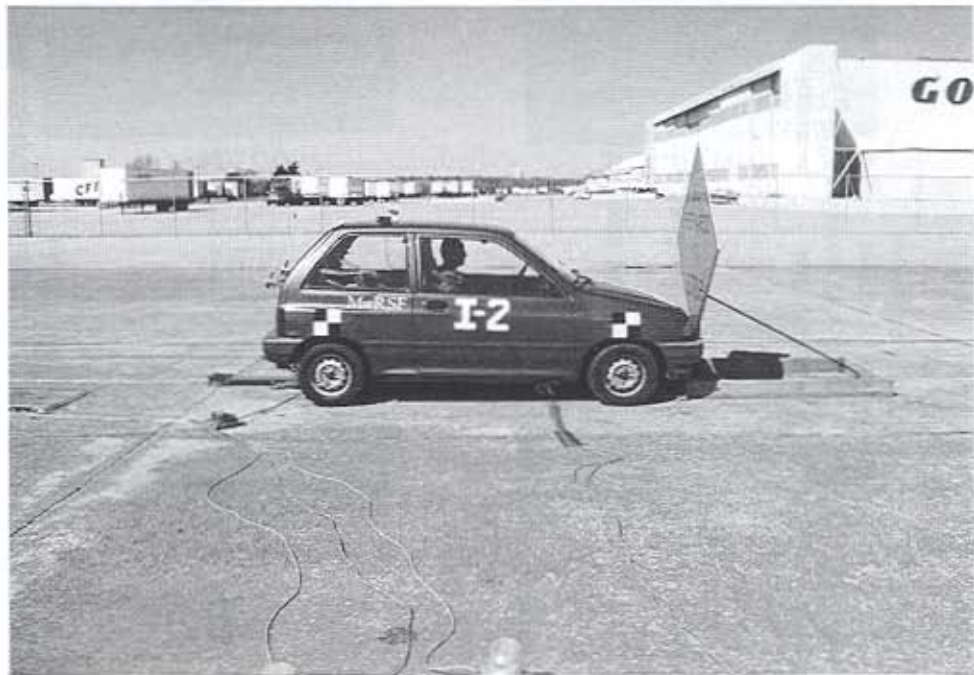
Figure 20. Impact Location, Test I-2

The test vehicle impacted System No. 2 with the centerline of the vehicle aligned with the centerline of the sign support, as shown in Figure 20. At 0.016 sec, the top of the panel flexed away from the vehicle while the vertical support deformed around the front of the vehicle. After 0.028 sec, the vertical support separated from the wooden base and the support rod separated from the vertical support. At 0.042 sec, the top of the sign panel impacted the windshield. At 0.070 sec, the vertical support and horizontal sign angle brackets flexed away from the sign panel. At this same time, the sign panel was in contact with the windshield and the hood. After 0.127 sec, the sign panel and vertical support began to lose contact with the vehicle, and the wooden base was under the vehicle. At 0.147 sec, the sign panel and attached vertical support traveled above the vehicle's hood without any contact with the vehicle. At this same time, one piece of the wooden base was in front of the left side and one was under the middle of the vehicle. After 0.255 sec, one piece of the wooden base cleared the rear of the vehicle while the other larger piece of the wooden base was in front of the vehicle. At 0.279 sec, the sign panel, with attached vertical support, traveled above and in front of the vehicle at about the same speed as the vehicle. At 0.515 sec, the sign panel and vertical support impacted the hood and the ground, respectively, traveling along with the vehicle.
