# Combining ground penetrating radar and seismic surveys in the assessment of cultural heritage buildings: The study of roofs, columns, and ground of the gothic church Santa Maria del Mar, in Barcelona (Spain)

Combined non-destructive techniques are applied in the study of a historical building in Barcelona. Santa Maria del Mar is a magnificent Mediterranean gothic church built between 1329 and 1383. Two of the most important characteristics of this building are the slender columns and the almost flat rooftop. This structure, used to create a visual impression of a unique space, transmits high loads to the tall columns. Previous to restoration, vaults, roofs, and columns were extensively assessed with non-destructive tests, in order to improve the knowledge of those structures. This information will be used in further simulations to analyse load distributions at each part of the structure. Ground and floor were also studied. The analysis of the columns was based on ground-penetrating radar (GPR) surveys and on seismic tomography. Finally, the dynamic behaviour of the structure was determined by seismic monitoring of the main nave and the bell tower. Results obtained at the radar s

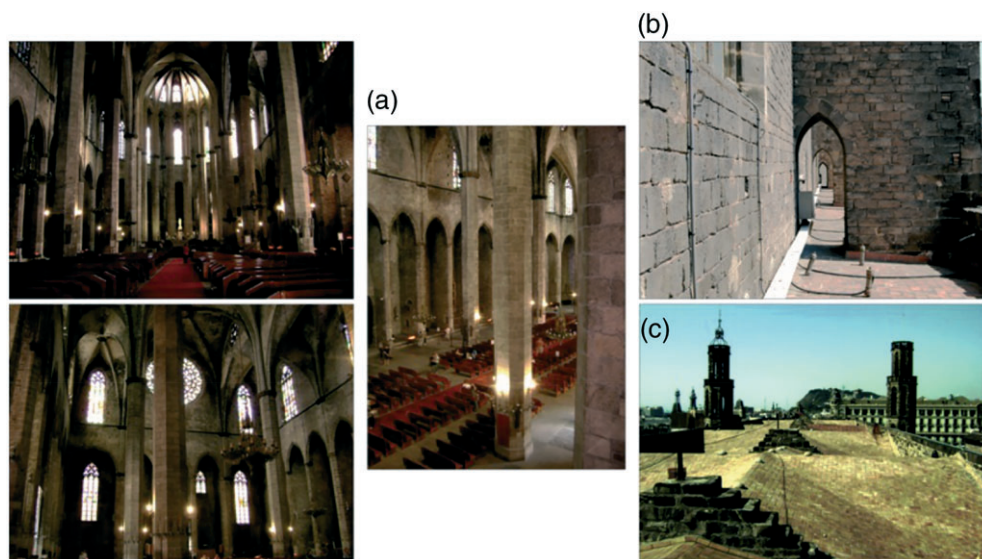
**FIGURE 1** Images of the different areas in Santa Maria del Mar basilica. (a) Interior of the church and the slender columns. (b) Roof of the lateral naves and chapels and buttresses. (c) Roof of the main nave

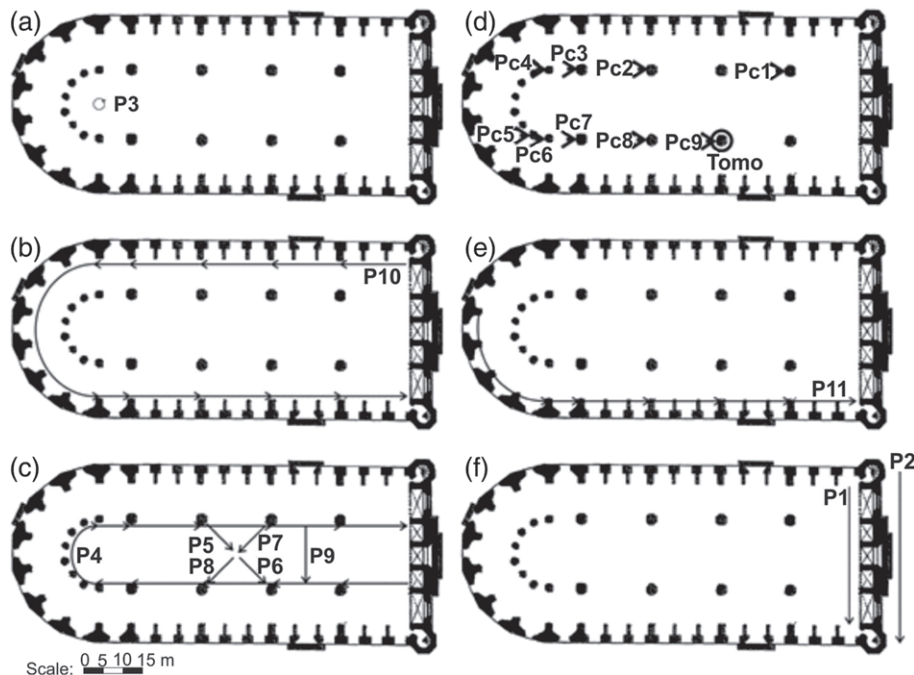
In the study of five columns on the main nave and four columns on the ambulatory (see Figure 2d), a 900-MHz antenna was used to explore them until 1.7 m high. The main objective was to detect important inner cracks and to determine their internal structural arrangement. The visual inspection indicated higher damage in the base of the columns, so the study was focused on this zone.

**FIGURE 2** Ground-penetrating radar (GPR) survey: Profiles and column tomography. (a) Profile around the cylindrical structure result of the union of the ambulatory arches in the roof of the church. (b) Profile on the roof over the lateral nave. (c) Profiles on the main nave roof. (d) Columns assessed with GPR profiles (Pcn) and column studied with tomography (marked with “Tomo”). (e) GPR profiles on the chapters roofs. (f) Profiles on the floor

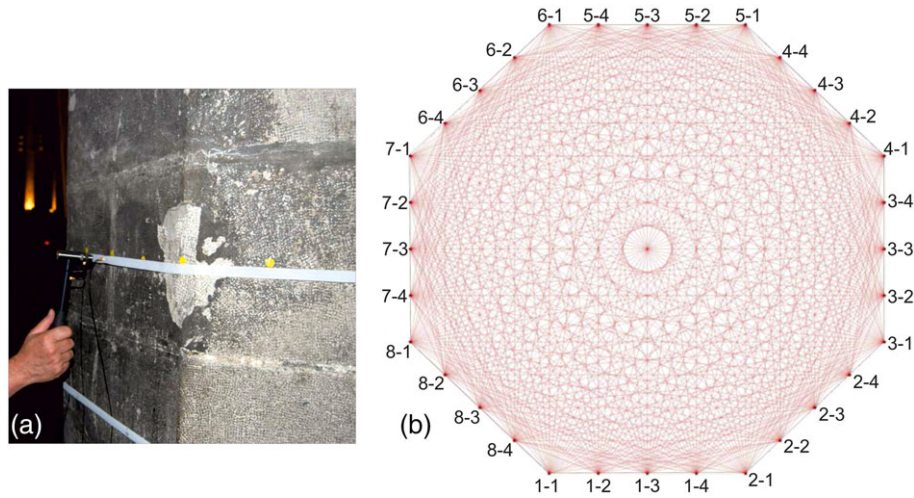
For seismic tomography, two accelerometers B&K 4393 and two 4384, an instrumented hammer and a recording and analysis system PULSE 3560B-020, were used. Seismic tomography was applied to the second column from the left line of columns of the church (Figure 2d). This column was supposed to be the most damaged of the basilica (Figure 3a). The four accelerometers were fixed on the surface, and the hammer hit at the 32 position showed in Figure 3b to obtain enough coverage and to assure sufficient resolution to find all damaged zones. Data were processed by a pulse analysis software, and tomography was computed with ReflexW one (simultaneous iterative reconstruction technique). Seismic tomography has been applied as the main technique to determine the structural configuration and to detect damaged zones of the column.

**FIGURE 3** (a) Seismic tomography of the column and (b) simulation of the coverage in the case of an ideal homogeneous column

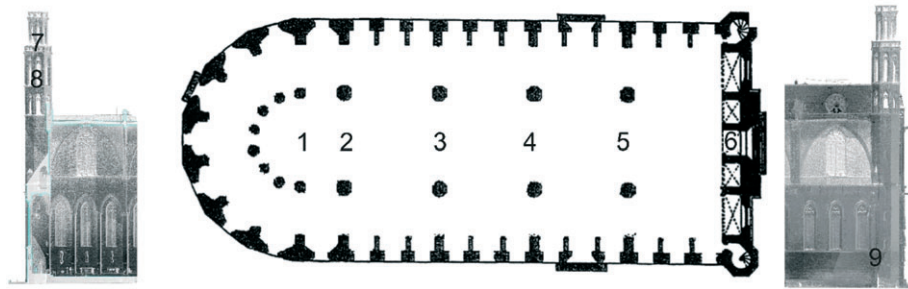
Seismic monitoring was carried out by a Lennartz seismometer LE-3D/20s recorded by a pulse 3560-B B&K system. Seismometer was located at each arch, in two positions of the tower and on the floor (Figure 4). Records lasted for 30 min to average more than 30 single spectra by an owner program.

**FIGURE 4** Location of the seismic monitoring. The numbers indicate the sensors' position

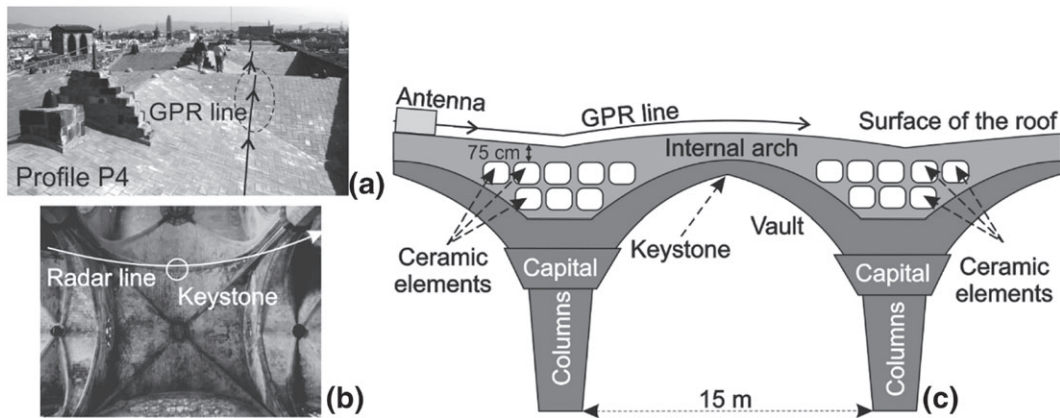
Figure 7 shows a sketch of these possible zones corresponding to the vault structure deduced from the GPR survey, indicating the respective GPR line position. The ceramic hollow vessels between the vault and the upper surface of the roof structure were a possible architectural mediaeval solution to decrease the weight of the covert without reducing the bearing capacity. Therefore, in the structure, a contrast exists between those widest parts, in which the weight was reduced by using hollow targets, and the most homogeneous zones that are composed by solid ashlars and mediaeval concrete (rubble masonry and lime mortar). The thickness of the structure near the load-bearing walls is 150 cm (Figure 8). The two-way travel time in this zone to the lower anomaly is 20 cm, indicating a wave velocity of about 15 cm/ns. This velocity is higher than the value assumed or calculated by other authors: about 10 cm/ns,<sup>24</sup> between 12 and 13 cm/ns,<sup>25</sup> near to 12 cm/ns,<sup>26</sup> and from 9.2 to 11.4 cm/ns.<sup>27</sup> The result in the materials could be consequence

**FIGURE 7** (a) Photograph of the roof showing the radar line (Profile P4). (b) Photograph of the vault showing the location of the ground-penetrating radar (GPR) line on the roof and the keystone. (c) A scheme presenting the possible GPR data interpretation of the structure in one vault

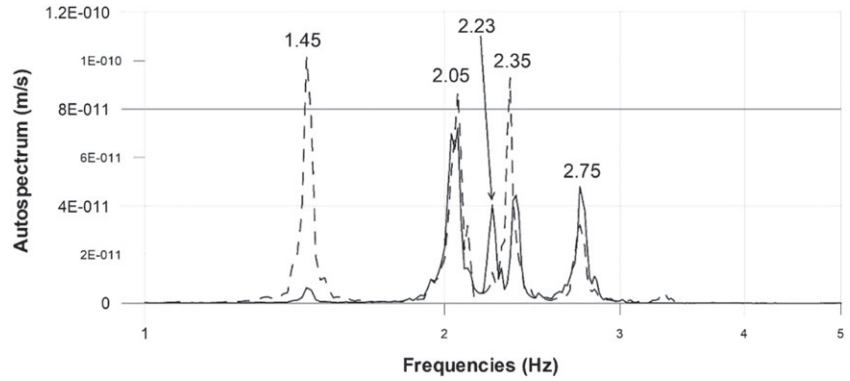
The results of the façade and the tower bell show a very similar pattern compared with the main nave (Figures 13 and 14). However, the spectrum shows a characteristic crack of the peak named breathing effect.<sup>28</sup> Also, modes 2.05, 2.35, and 2.75 Hz, in Point 7 (Figures 4, 14, and 15), are transformed from pure longitudinal to bidirectional components probably due to any asymmetry of the towers. Draws of particle motion for each mode<sup>5</sup> show different comportments.

**FIGURE 14** Longitudinal (continuous line) and transversal (dashed line) in Point 7 in the tower

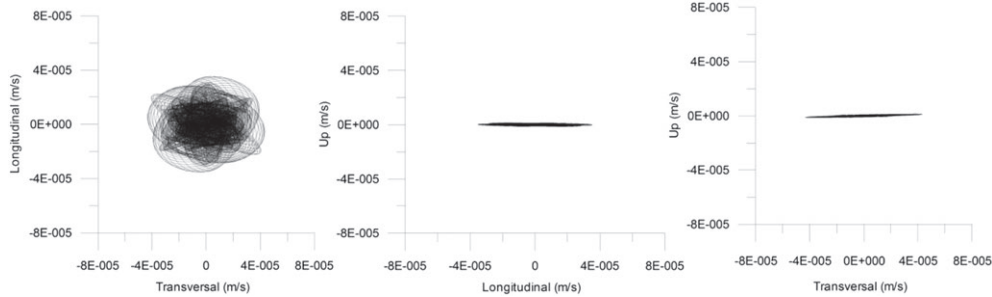
**FIGURE 15** Particle motion of the 2.35-Hz mode at Point 7 in the tower

The 2.05-Hz mode changes from pure longitudinal to 70° clockwise; the 2.70 Hz changes to 45° opposite clockwise, and the 2.13 and 2.75 Hz change to torsion mode.
