Repair of a Model Masonry Arch Bridge using FRP

Tao, Y, Chen, JF & Stratford, TJ 2009, Repair of a Model Masonry Arch Bridge using FRP. in Advanced Composites in Construction 2009. NetComposites Ltd., pp. 426-436, Advanced Composites in Construction (ACIC 09) , Edinburgh, United Kingdom, 1-3 September.

Y. Tao, J.F. Chen and T.J. Stratford

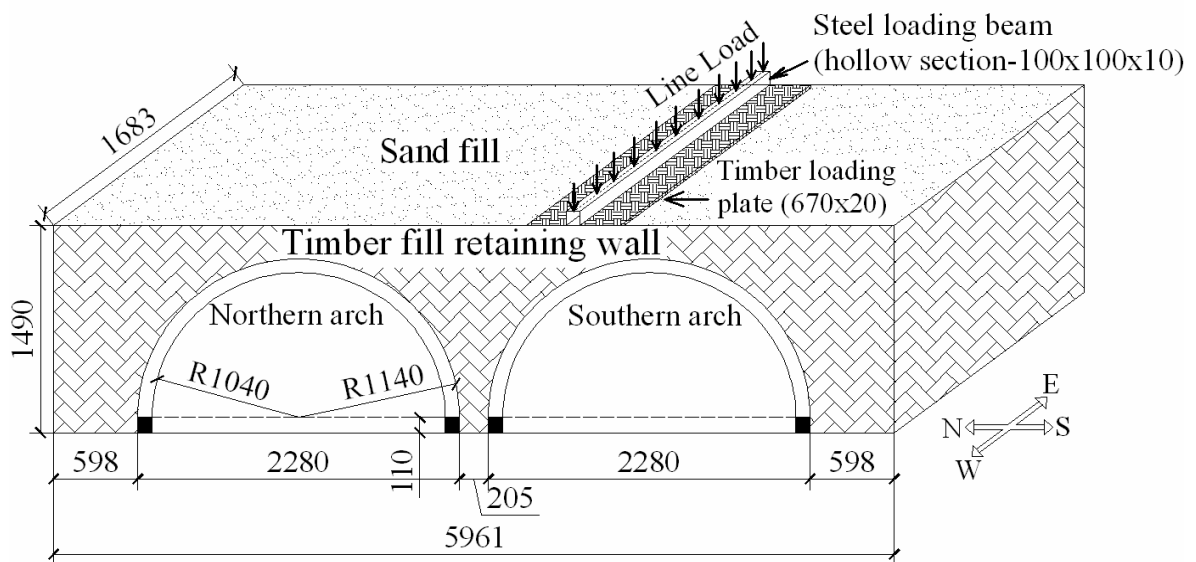
Figure 1. Overview of the arch bridge model (mm)

The arches were constructed from a single ring of concrete bricks, with the dimensions shown in Figure 1. Rigid abutments were provided to either ends using steelwork, and the abutments and side of the bridge were clad in timber to contain sand fill.

Prior to the FRP repair, each of the arches was loaded in turn to establish a four-hinge mechanism. A line load was applied at the quarter span position (shown in Figures 1 and 3a), as this is usually the worst loading position [6]. The load was applied using hydraulic jacks that acted upon a steel spreader beam and timber spreader plate. Load cells were used to measure the applied load and seven displacement transducers ($D_{S1} \sim D_{S5}$ and $D_{N1} \sim D_{N2}$) were installed beneath the arches to measure the radial displacement (Figure 3). Each arch was loaded until the four-hinge mechanism was fully developed and the load capacity of the unstrengthened arch was estimated to be almost reached.

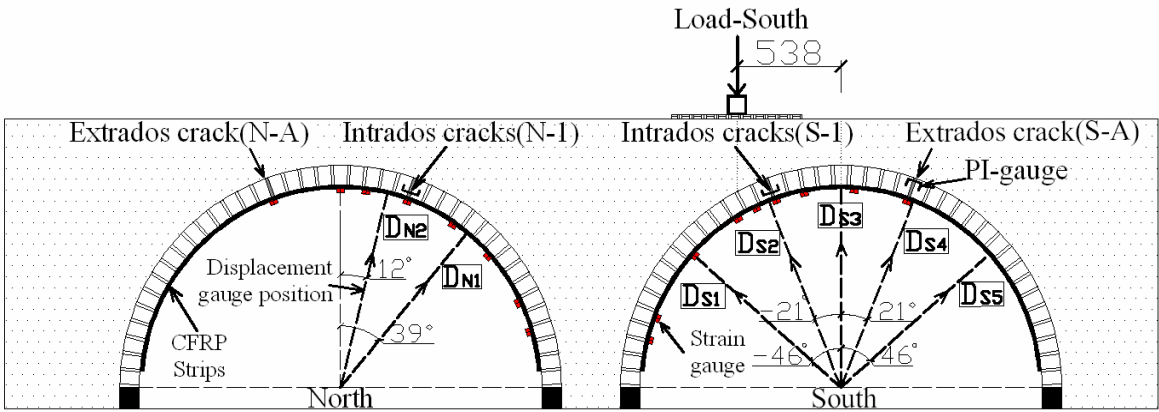
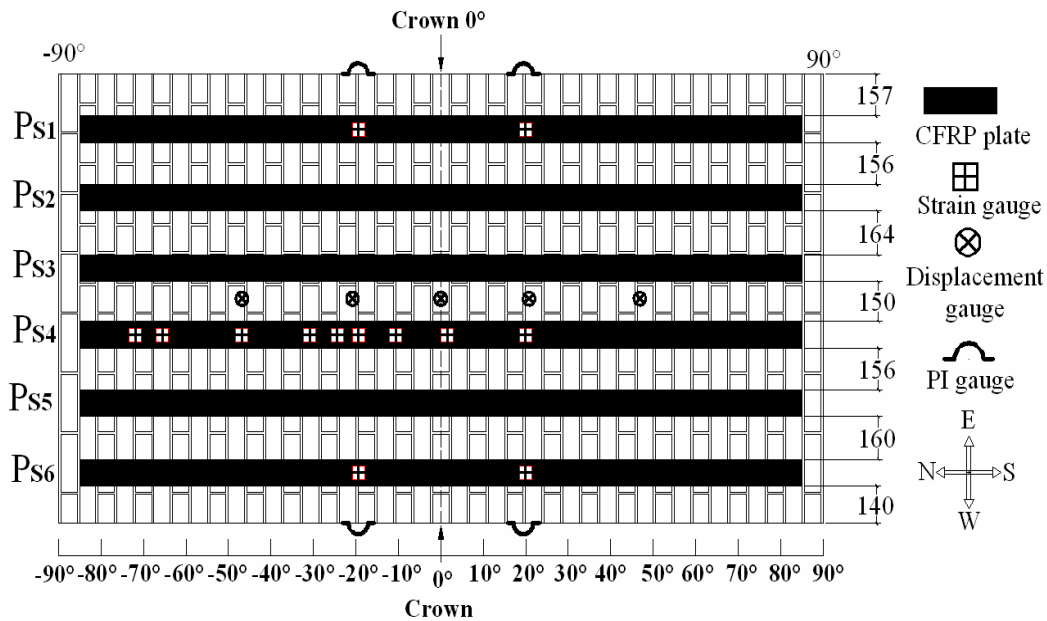
Figure 3. Positions of CFRP plates and instrumentation

In addition to the instrumentation used for the test prior to repair, 5 PI gauges were used to measure the crack opening widths on either side of the arches and 25 strain gauges (S_{S1-1} to S_{S6-2} in south arch) were applied along the centre lines of the FRP plates, as shown in Figure 3. The arches were again loaded at the quarter span.

The arches were repaired using pultruded carbon FRP (CFRP) plates, which were bonded to the intrados of the arches as shown in Figures 2 and 3. Three CFRP plates were applied to the northern arch, and six to the southern arch, evenly distributed across the width of the arch (as shown in Figure 3b for the southern arch). The CFRP plates had a cross-section of 100×1.4 mm, a Young's modulus of 170 GPa and tensile strength of 3100 MPa (based upon the manufacturer's values).

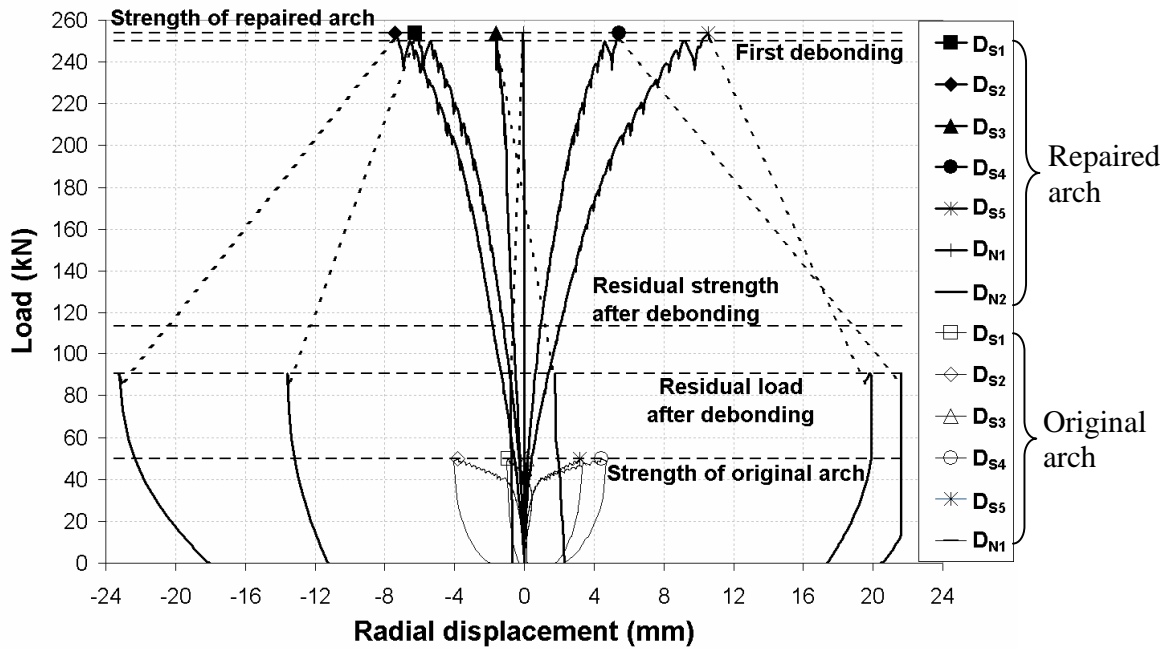
Figure 10. Load vs. radial displacement curves for the southern arch

The original arch (prior to FRP repair) was dominated by opening of the four hinge mechanism cracks. The displacement significantly increased once the mechanism established at around 39kN. The small crown displacement (D_{S3}) and the large displacements in opposite directions at D_{S2} and D_{S4} , and the smaller displacements at D_{S1} and D_{S5} correspond to the four-hinge mechanism. Negligible displacement were observed in the adjacent northern arch (D_{N1}), indicating that only small interaction exists between the two arches. Note that large residual displacements remained after unloading, as the cracks were unable to completely close. The applied load reached up to 49.7kN which was estimated to be very close to the strength of original arch.

The response of the repaired arch is stiffer, as the FRP restricts the opening of the intrados cracks. Consequently, the displacement on the north side (D_{S1}) where the FRP on the intrados restricted the opening of intrados crack, was smaller than on the south side (D_{S5}) where the FRP on the intrados did not restrict the extrados crack. After a load of about 180kN, some fluctuations occurred in the curves probably due to the progressive build up of micro-crack damage in the masonry, nonlinear deformation of masonry under compression at the hinge positions, and softening at the interface between CFRP and masonry. The deformation increased much more rapidly after that due to these nonlinear factors. The first debonding event (Figure 4) was at a load of 250.0kN, giving a drop in the load-deflection response. The capacity of the repaired arch was reached at 253.8kN when all 6 plates debonded (Figure 7), which was 511% greater than the estimated strength of the original arch.

The load dropped to 90.6kN after the debonding of all the 6 CFRP plates. It should be noted that the value of this residual load depends upon the stiffness of the hydraulic loading system. The arch was unloaded, and the instrumentation removed. Large residual deformation after unloading is clearly seen in Figure 10. The arch was reloaded to destruction. The residual strength after FRP debonding failure was determined from this process to be 113.3kN. Note that this residual strength of the FRP repaired arch was still much higher than the strength of the original (un-repaired) arch because the debonding FRP plates formed ties and altered the structural behaviour. The displacement was not recorded during the final loading process because the transducers had been removed.

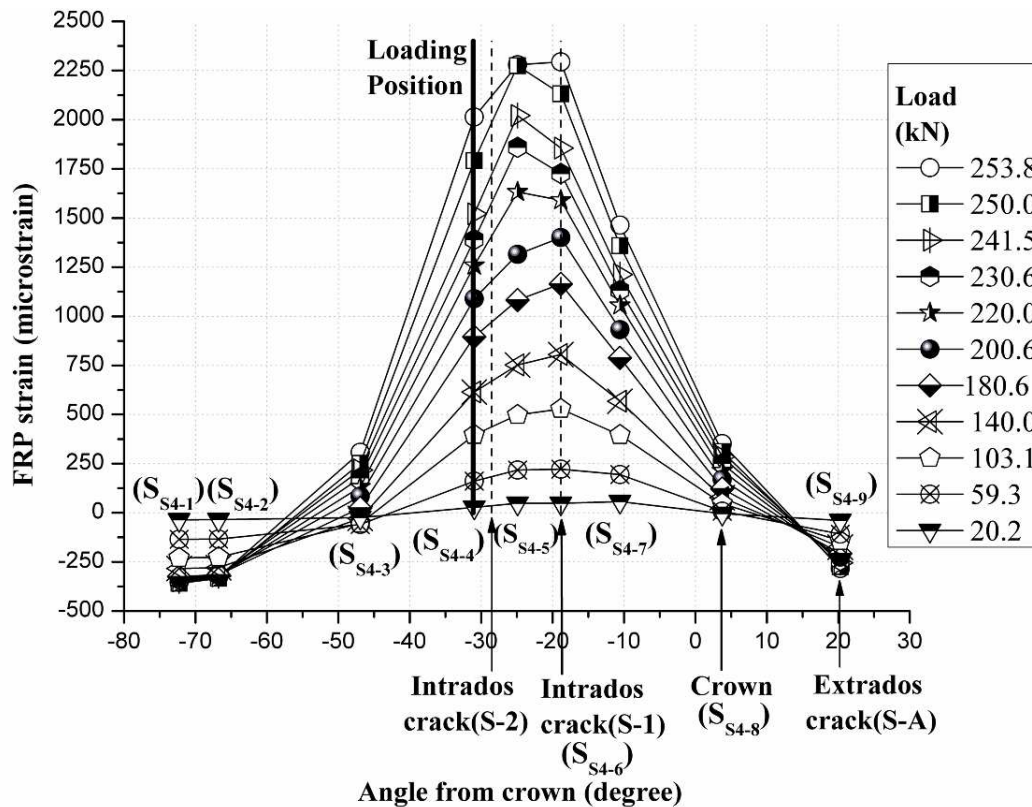
Figure 11. CFRP strain profiles for strain gauges on plate P_{s4}

Figure 11 plots the CFRP strain profiles along plate P_{S4} at different levels of load. This plate failed by debonding at the intrados crack (Figure 5d) in the region between strain gauges S_{S4-4} and S_{S4-8} .

When the load was greater than 200kN, the location of the maximum strain was shifted from S_{S4-6} to S_{S4-5} . This corresponds to the development of the second intrados crack as discussed above. The magnitude of the strain profile beyond 180kN increases rapidly with load, due to softening of the CFRP-masonry interface, in a similar manner to the load-deflection response.

A sudden increase in strain occurred from 240kN to 250kN, when the first debonding occurred on plate P_{S2} , and load was redistributed onto plate P_{S4} . Between 250kN and 253kN, the strain at gauge S_{S4-5} was constant, but the strain to either side (S_{S4-4} and S_{S4-6}) increased, as the debonded region of CFRP increased away from the hinge zone in the region of intrados cracks (S-1) and (S-2).
