### Behaviour of a concrete structure in a real compartment fire

# Behaviour of a concrete structure in a real compartment fire

**In July 2006, a full-scale compartment fire was set in an existing block of flats in Dalmarnock, Glasgow, Scotland. Prior to ignition, the structure was instrumented with deflection gauges, thermocouples and strain gauges. The growth of the fire was also carefully monitored. The resulting data provided a unique record of the behaviour of a concrete structure in fire through a heating–cooling cycle. The results show significant variation in structural temperatures within a relatively small compartment, demonstrating that the assumption of uniform temperature at any level within a fire compartment, which is implicit in many simple design fires, is incorrect. The response of the structure showed a corresponding complexity due to the combination of non-uniform spatial and temporal heating and the structural boundary conditions.**

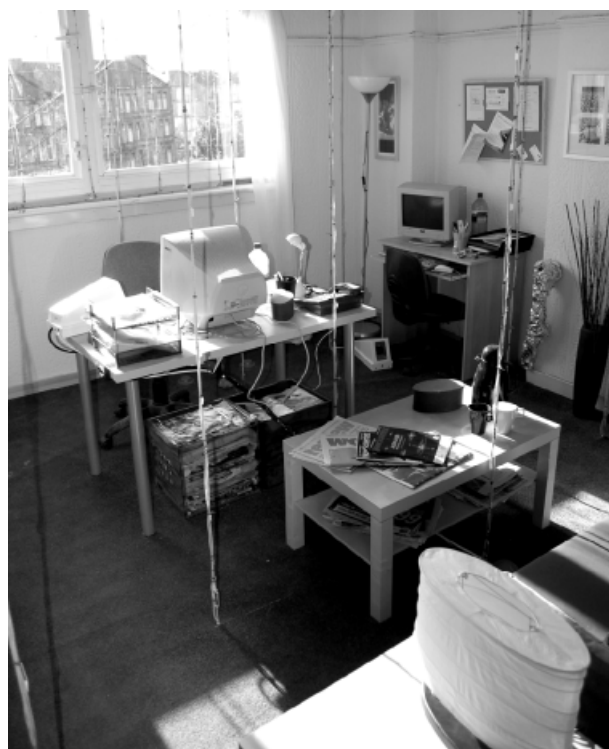
Figure 5. Photograph of the fire compartment showing the fuel loading (looking north–west)

The fire load in the compartment consisted of office furnishing, with the main fire load coming from a sofa placed in the middle of the compartment. Other items of furniture included bookshelves filled with paper, a desk, carpet, a computer and a chair. Figure 5 gives an overview of the compartment furnishings, with the sofa partly visible in the bottom right-hand side of the photograph. The fire was started by the ignition of a waste paper basket next to the sofa. Further details of the fire load can be found in Rein *et al.* (2007).

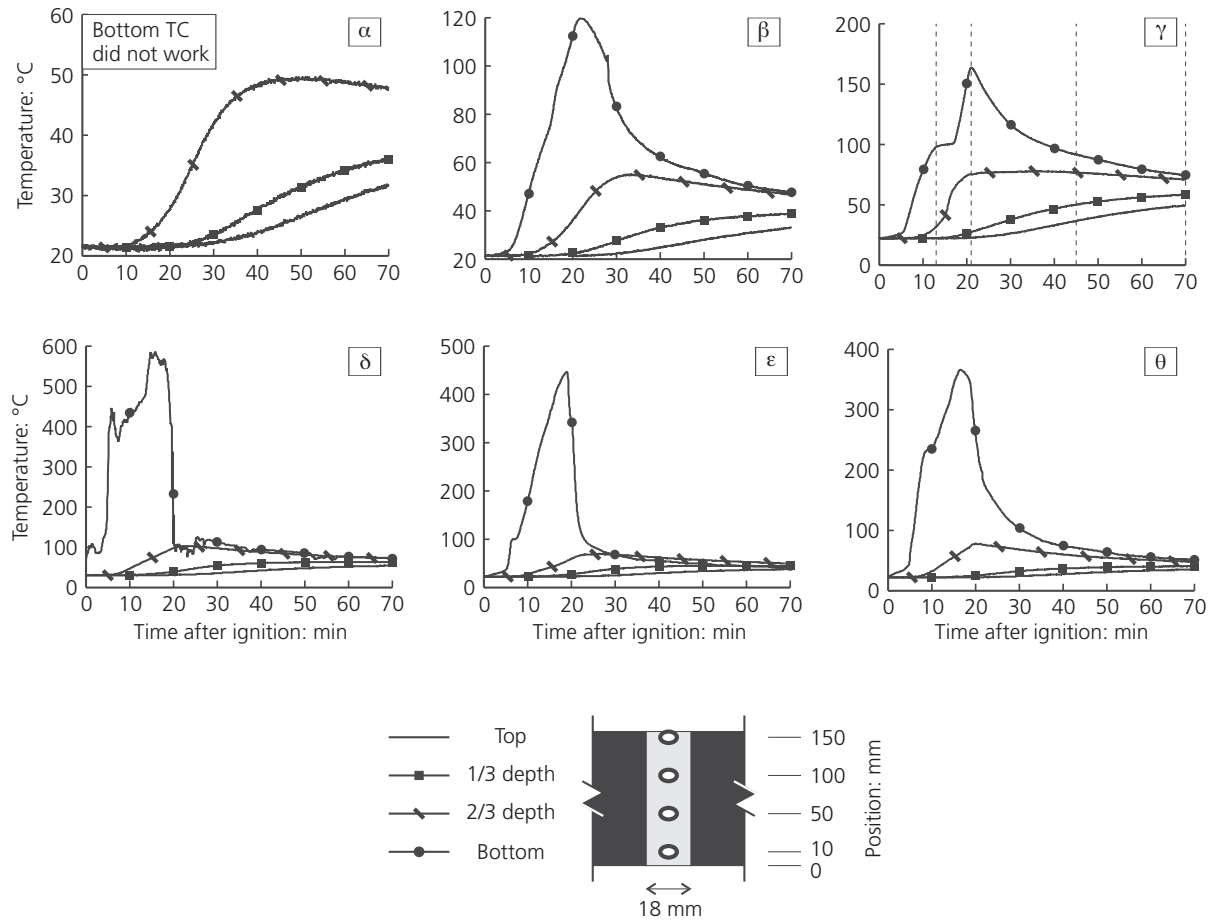
temperature of the lower surface of the slab dropped rapidly at all locations from around 20 min; this is because firefighters sprayed cold water onto the slab while extinguishing the fire. The internal portions of the slab maintained their temperatures despite fire-fighting activities; indeed, the upper layers of the slab continued to increase in temperature even after the fire was completely extinguished. For example, Figure 11 shows the temperature profile through the depth of the slab at location  $\gamma$ .

The localised nature of the heating is significant as it is almost always assumed when performing design calculations to determine the behaviour of heated structural elements that there is no variation of temperature within a compartment. For example, both the ISO standard fire curve given in ISO 834 (ISO, 1975) and Eurocode parametric curves given in BS EN 1991-1-2 (BSI, 2002b) assume uniform compartment temperatures. The results in Figure 10 show that such an assumption does not hold, even for small compartments.

Figure 10. Temperature data recorded at the locations shown in Figure 6 (note the different temperature scales used at each location)

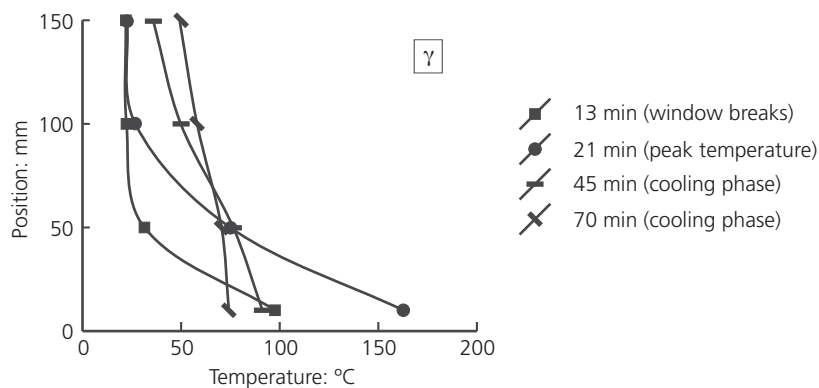
Figure 11. Temperature variation through the depth of the slab at location  $\gamma$
