Internal characterization of embankment dams using ground penetrating radar (GPR) and thermographic analysis: A case study of the Medau Zirimilis Dam (Sardinia, Italy)

To appear in: *Engineering Geology*

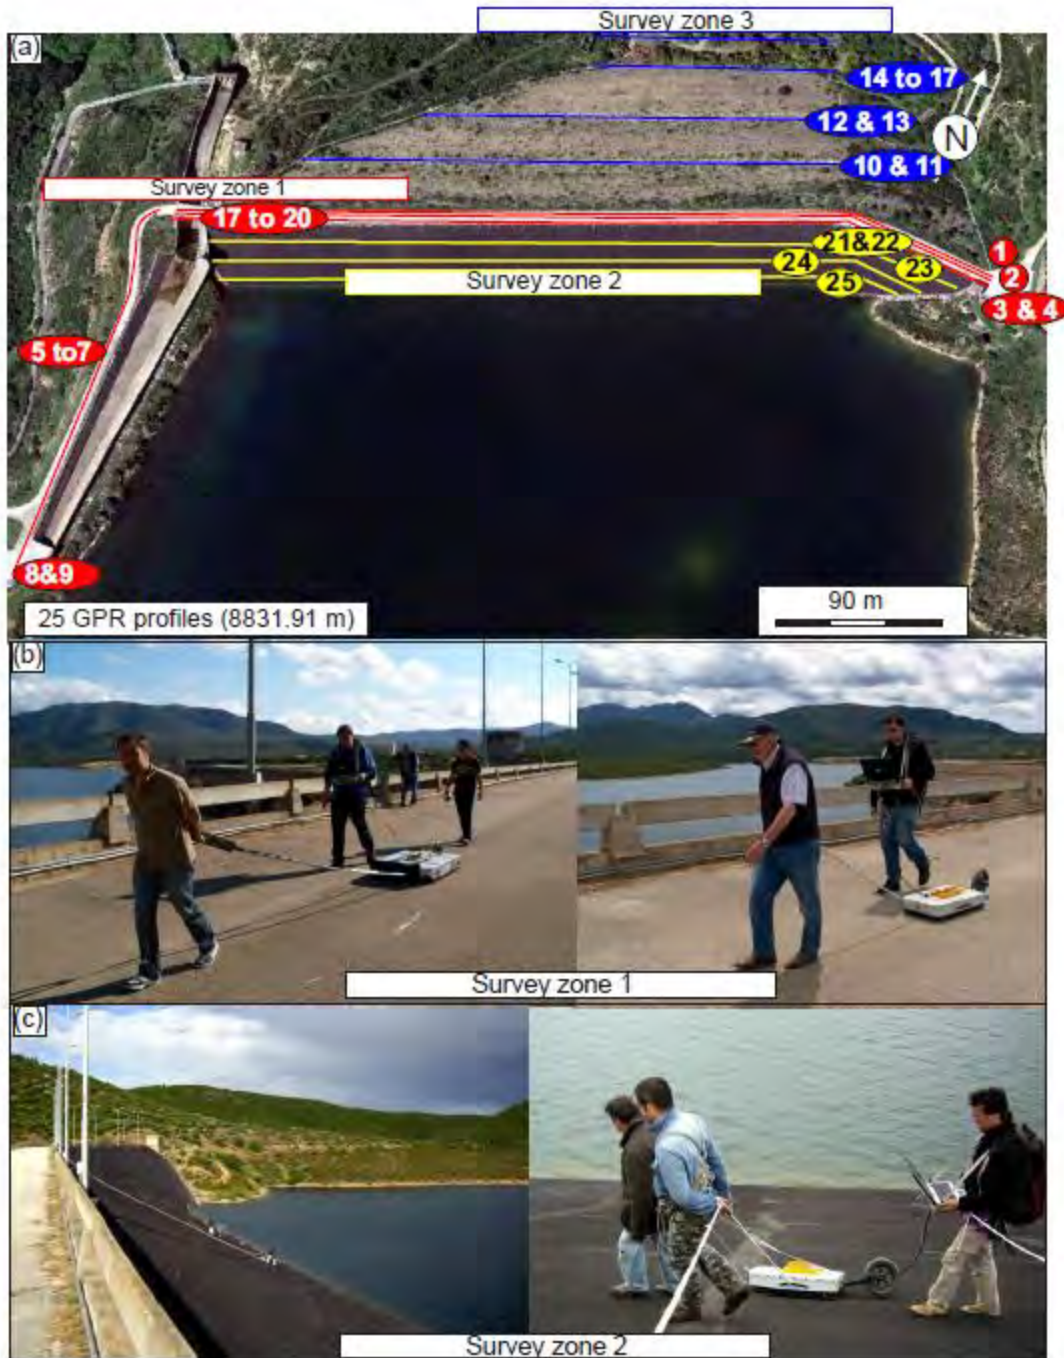
Figure 4

profiles (Fig. 4c and d), a survey was performed using the 100-MHz antenna to identify accommodation features related to syn- and post-construction modifications.

Figure 4. (a) Location of the GPR profiles (see Table 1 for characteristics); b) photographs from the studied zone during the geophysical survey for survey zone 1 over the dam, and b) at survey zone 2 along the upstream slope.
