Condensation Risk – Impact of Improvements to Part L and Robust Details on Part C

Project Reference Number: CI 71/6/1 BD2414

Interim report number 7: Final report on project fieldwork

Malcolm Bell, Melanie Smith & Dominic Miles-Shenton
Buildings and Sustainability Research Group
Leeds Metropolitan University

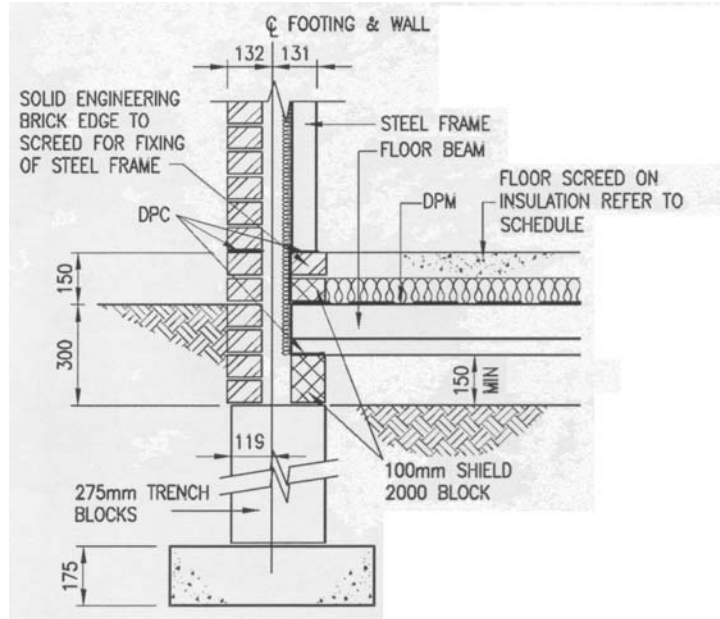
50. All ground floor/wall junction details in the Robust Details document relating to steel frame construction (details 7.07 to 7.11) rely on the continuation of the cavity insulation below floor level and this is the approach used in the designs adopted on the sites studied (see figure 3.17) However, the effectiveness of the insulation is dependant, to some extent on its closeness of fit and the avoidance of discontinuities. In order to achieve a good fit it is important that the frame lines up with the outside edge of the slab or kerb (as indicated in figure 3.17). On one of the steel frame sites visited this was not achieved. Figure 3.18 shows a mismatch between the plan shape of the base and that of the frame. This meant that, on at least one elevation, the base of the frame was not in alignment with the edge of the base resulting in a set back from the edge of around 50mm at one end of a wall section narrowing to almost zero at the other².

Figure 3.17 Ground floor detail in steel frame construction.

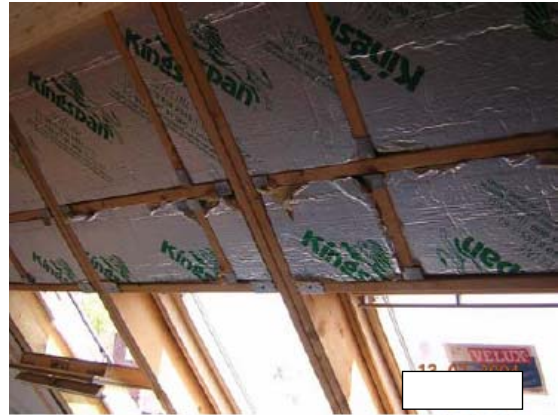
Figure 3.55 Insulation prior to fitting of insulated lining.

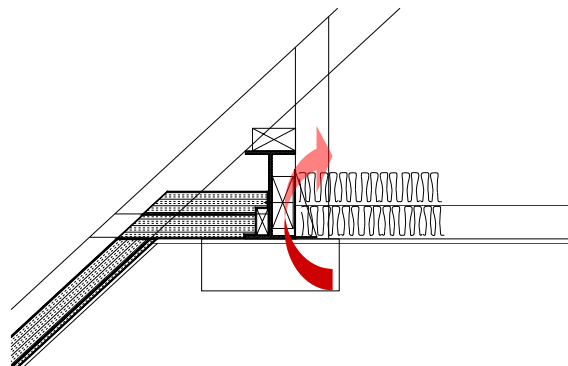
Figure 3.57 Steel purlin design – significant thermal bridge and high condensation risk³.

¹ In passing, this particular thermal bridge appears to be the largest, in terms of contribution to fabric heat loss, to be featured in this report. A rough calculation suggests that the additional heat loss is of a similar order to the heat loss through the fenestration, and effectively doubles the heat loss through the roof.

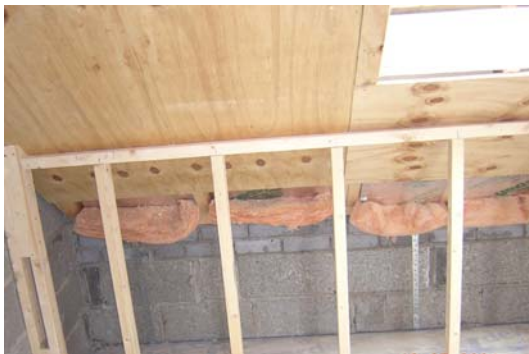
79. Maintaining the continuity of insulation at eaves was achieved in a reasonable number of cases where observation was possible. Figure 3.58 is typical of the arrangement in cavity masonry sites and figure 3.55 shows the care taken to fill small gaps at the eaves junction on one of the timber frame sites. However, concerns remain about the level of detailing in relation to airtightness since eaves junctions had little provision for air sealing. The arrangement shown in figure 3.58 is likely to be particularly leaky since the roof wall junction is likely to remain unfinished as the eaves area forms a void useable for loft type storage only. This is not the case in the timber frame example shown in figure 3.55 and as far as can be established this detail follows the recommended robust eaves detail for this type of roof (RD 6.03). However airtightness remains a problem.

Figure 3.58 Cavity wall – roof junction.

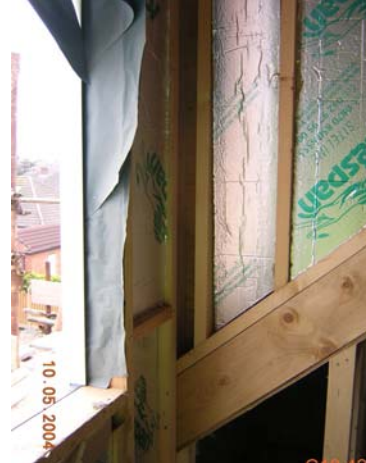
84. As in other cases the main problems related to the fitting of the insulation board. Figures 3.65 and 3.66 illustrate typical fitting problems with gaps around boards and missing insulation in small sections, sections that can be very small indeed requiring considerable attention to detail (see figure 3.64). The missing insulation in the corner section (figure 3.66) is of particular concern since this is one of the most exposed areas of the external envelope.

Figure 3.66 Omission of insulation at small strip in the corner.

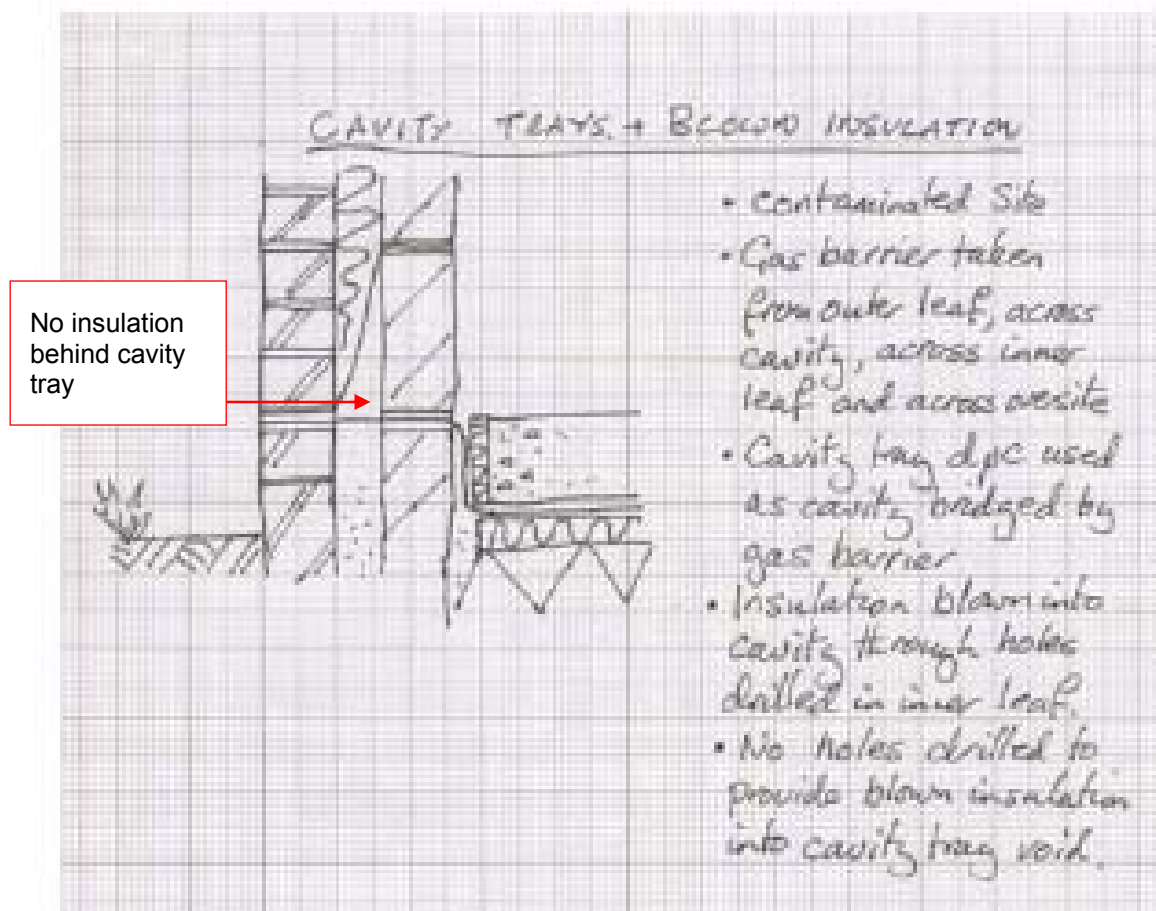
Figure 3.67 Gas barrier and cavity tray at ground floor/external wall junction.

87. The site sketch in Figure 3.67 illustrates the arrangement on one of the full-fill masonry sites. Given that cavity insulation was to be injected from the inside upon completion of the wall, filling this area would be very difficult and, in practice almost certainly omitted. In this case it would be more appropriate to ensure that insulation was placed at the same time as the cavity tray was fitted. Figure 3.68 shows clearly that this was not done, as well as illustrating the age-old problem of keeping the cavity clean. Similar difficulties arise with the placement of partial-fill insulation (see figure 3.69) since if not well fitted below the tray its performance is reduced considerably, almost to the point where it may as well not be placed at all. The effect in both the cases illustrated would be to increase the potential for localised temperature variation, the more so since, as we have discussed above, cavity insulation is often omitted at ground floor slab level. Of course, once the gas barrier is in place the lack of insulation below is hidden from view.

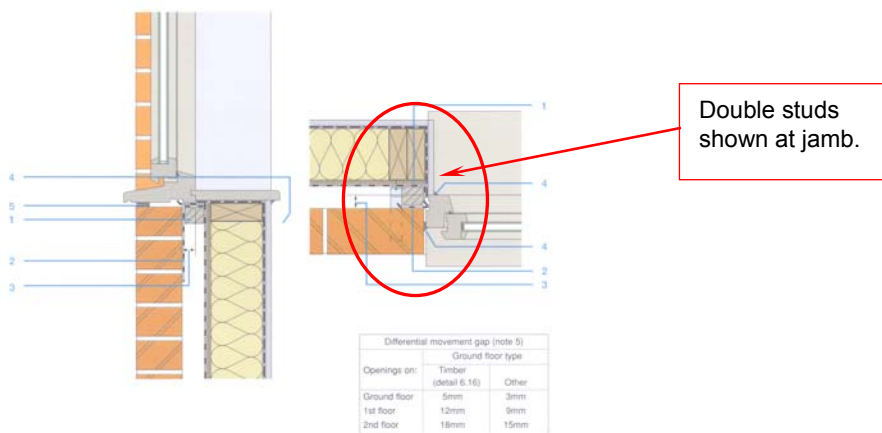
Figure 3.74 Robust Detail 6.10; Jamb and sill details in timber frame construction.

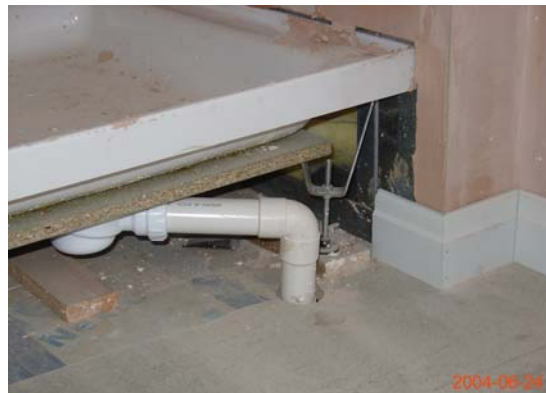
97. The sealing of the junction between wall and floor behind shower trays, baths and kitchen units is rarely done with the same degree of care as in other locations. This can be seen in Figures 3.82 and 3.83 where the internal plasterboard finish is stopped short of the floor (figure 3.82) or cut away to accommodate the fitting (figure 3.83). An air/vapour path is created which can be directly connected to the structural space. In timber frame constructions a polythene membrane is used which is lapped and stapled to the frame but where there is no plasterboard to hold the polythene air barrier tight back to the timber frame, an adequate seal is not achieved at floor level. The fact that these problems occur mainly out of sight behind the fittings in kitchens and bathrooms is of particular concern since these are areas of intermittently high vapour pressure. In warm steel frame construction, it could be argued that air movement, moist or otherwise, in the frame space is of little consequence since the condensation risk is small and a high level of airtightness is maintained as long as the external insulation layer is well fitted and all joints securely taped. This is, of course, a very reasonable position but it places considerable reliance on the integrity of the external layer. Although, on the two steel frame sites, considerable attention was given to insulation and sealing, as indicated in the ground and intermediate floor sections above, this can be compromised at junctions.

Figure 3.83 Plasterboard finish cut away to enable the shower tray to be inset, giving access to the structural space.

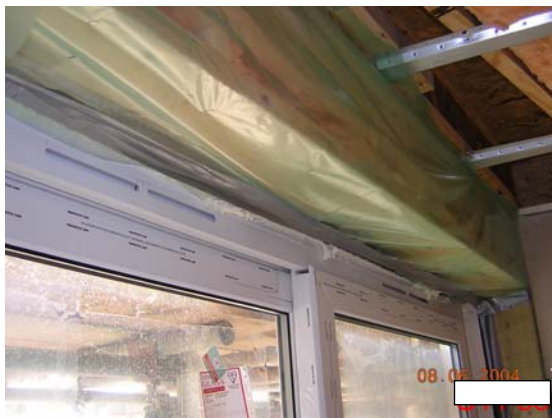
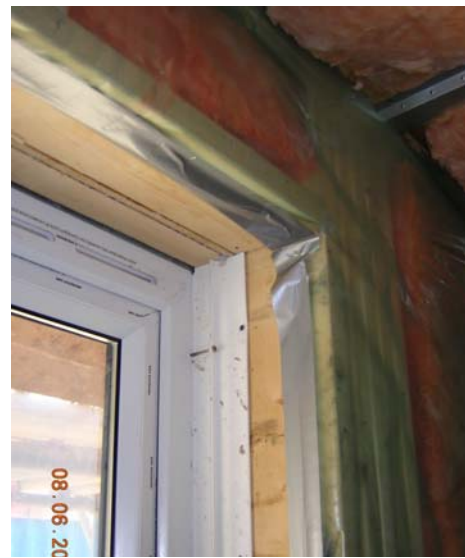
99. In order to ensure continuity of air/vapour control layers in timber frame and hybrid steel frame constructions, section 8 of the Robust Details document recommends that sheet barriers be well lapped, returned into reveals at openings and sealed with the DPC at ground floor level. In general the lapping of sheets was done with care but no lapping with the DPC was observed on any site (figure 3.87 is typical) and sealing into reveals was not dealt with consistently. The arrangement at window and door openings was generally more consistent as in most cases membranes were wrapped into reveals, sills and heads and either stapled or taped (Figure 3.88).

Figure 3.88 Vapour control layer returned in to reveals and window/door heads.
