TABLE
BAD RIVER TRIP REPORT
Assessment of Mold and Moisture Conditions

Date:
December 31, 2002

Prepared for:
U.S. Department of Housing & Urban Development
Office of Native American Programs

EXAMINING MOLD AND MOISTURE CONDITIONS OF HOMES ON THE BAD RIVER RESERVATION

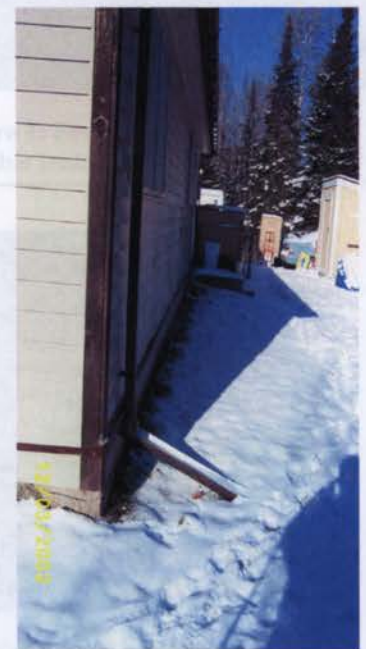
**Figure 2:** Downspout and leader at rear of house

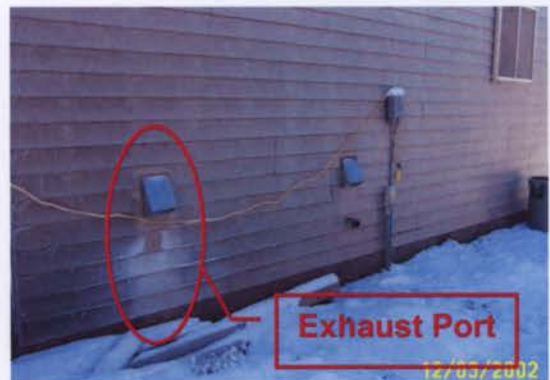
Figure 6: Exterior ports for HRV system

laundry room) showing strong flow and condensation at the exterior outlet (Figure 6). The supply inlet was plugged with dry grass and debris. In this case, it is likely that the HRV system was placing the house in negative pressure.

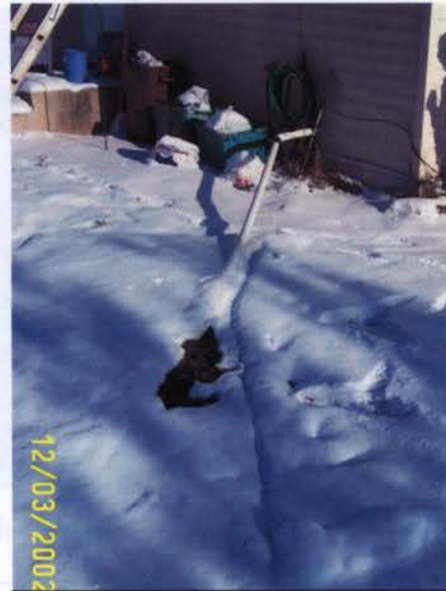
Figure 4: Outfall from basement sump pump.

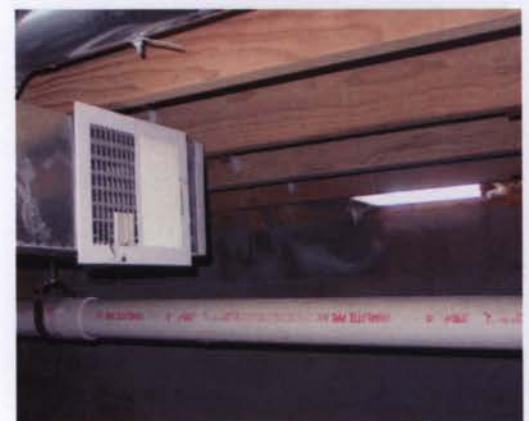
Figure 3 - Heating Register Proximate to Crawl Space Vent

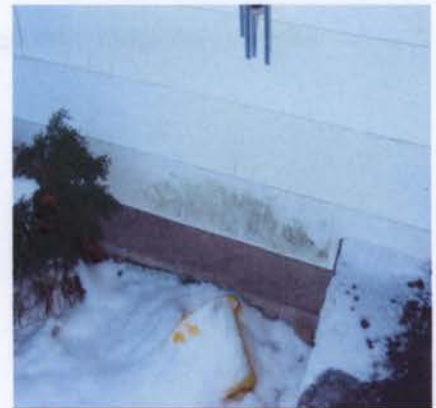
Figure 2 - Mildew on Siding

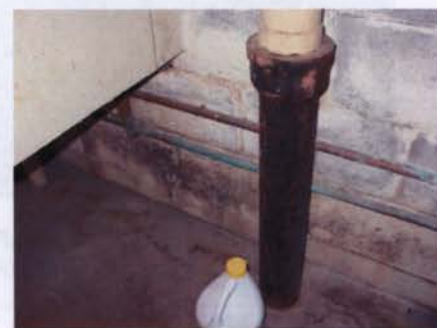
Figure 2 - Discoloration at Base of Basement Wall

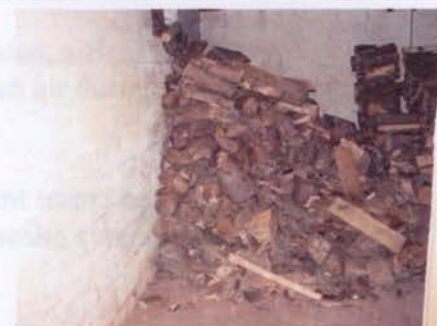
Mechanical Systems: This home had a natural gas forced-air heating system with a wood-burning stove attached to the air distribution system. Fuel for the stove was kept in the basement (Figure 3). Combustion exhaust from the forced air unit ran through a PVC pipe run horizontally through the rim joist. To keep water, snow, leaves and other contaminants out of the end of the exhaust, a 90° elbow was installed on the end of the pipe and directed downward. This exhaust blew directly into a window well. Warm moist air was immediately condensing all over the basement window and surrounding surfaces (Figure 4).

Figure 3 - Firewood Storage in Basement

1. Based on the amount of moisture present on the inside of the plastic film stretched over the exterior of the windows (Figure 6), there must be a moisture source on the interior of the building. Much of this moisture could be emanating from the large stockpile of firewood stored in the basement. Exterior storage for the primary bulk of wood would be preferred, with only a few day supply kept indoors.

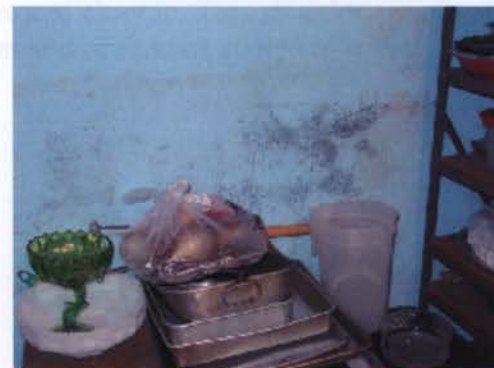
Mold and Moisture Conditions: The principal affected area was the substandard shed room at the back of the house (Figure 1 & 2). The crawl space, which could not be accessed, was a likely source of moisture.

Figure 2 – Mold growth on shed walls as consequence of substandard cladding.

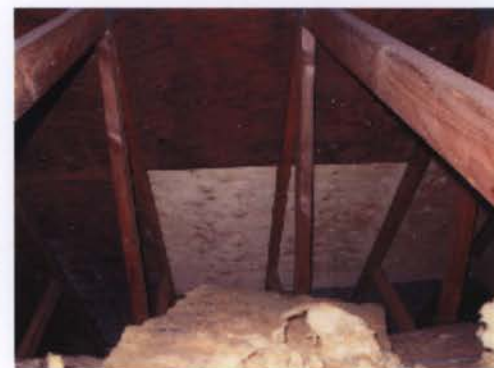
Attic: Rather severe rotting of the attic sheathing. Several sheathing panels had been replaced at the time of the recent re-roofing. There was extensive water spotting on the ceiling, a consequence of condensation of crawl space moisture on the attic sheathing (Figure 3 & Figure 4).

Figure 3 – Dark attic sheathing affected by crawl space water. Note new sheathing panel.
