# UPPER SIOUX INDIAN COMMUNITY

## TRIP REPORT

### Assessment of Mold and Moisture Conditions

Final Report

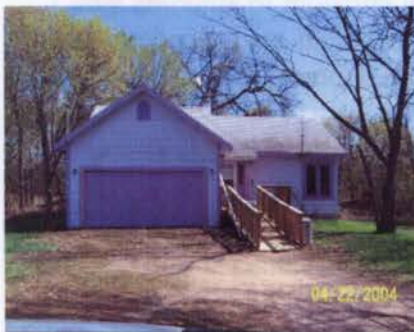
Figure 5 - Home with good site drainage

Site drainage is critical to maintaining a dry foundation that in turn helps maintain a dry home. Some homes had been severely damaged in a flood several years ago and were raised creating excellent site drainage (Figure 4). Others also had good site drainage (Figure 5). However, two homes had site drainage problems. One had the ground sloping toward the house. The other had a sub-slab drainage system that reportedly did not function properly.

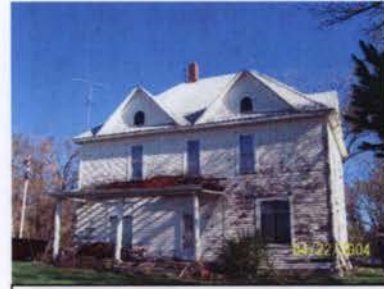
Figure 1 – 5392 240<sup>th</sup> Ave.

**Mold and Moisture Conditions:** A small patch of very old mold was found on the wallpaper in the kitchen, but no new growth of mold.

- Install low-sone bathroom exhaust fans in the bathrooms with fan delay timers, and a range hood in the kitchen vented to outside.
- Install a gutter system with leaders at the base of the downspouts.
- Clear the basement of clutter.
- Rebuild the front porch roof.
- Wet, remove, and discard the wallpaper with the old dormant mold.

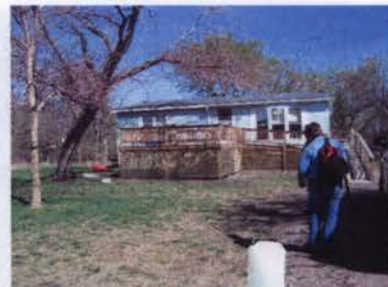
Figure 4 - 5660 266th Ave.

No occupants were home, so the inspection was limited to the exterior.

- Replace the recirculating kitchen range hood with one that exhausts to the outside.
- Install downspouts with leaders.
- Fix the problems with the flashing.
- Put the vapor barrier back over all of the soil and seal it to the perimeter of the crawl space.

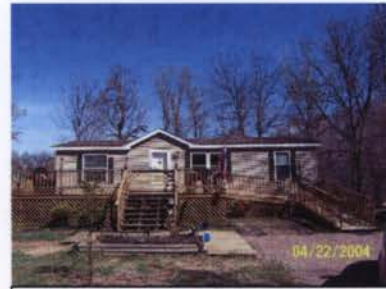
Figure 1 - 5676 266th Ave.

**Mold and Moisture Conditions:** No mold or moisture problems were found inside the house, but some algae grew on the exterior siding on the north face of the house.

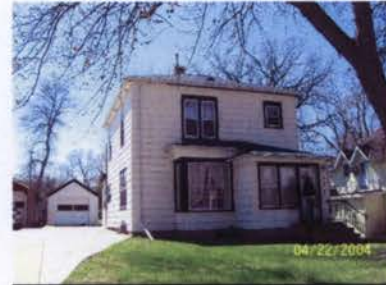
Figure 1 - 143 Washington

**Mold and Moisture Conditions:** Mold was not found in the home, but significant moisture damage was on the walls on the second floor through which the chimney ran (Figure 2).

**Rainwater Management:** The site drainage and gutter system were good. Some damage was present at the base of the exterior siding (Figure 3) and below the second story window on the front of the house (Figure 4).

- Repair the roof, walls, and chimney as needed.
- Repair furnace flue with B-vent duct.
- Install a kitchen exhaust fan that vents to the outside.
- Replace bath fan exhaust duct with insulated duct.
- Replace siding at the base of the house and under the second story window at the front of the house.

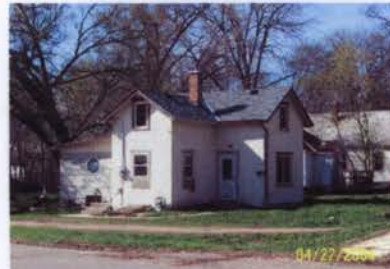
Figure 6 - 1092 6th St.

**Mold and Moisture Conditions:** No mold was found in the home.

- Install flashing above window beneath the deck on the rear of house.
- Install a gutter system with downspouts and leaders.
- Finish installing the trim around the windows and the sliding glass door.
- Repair the fascia on the gable end.

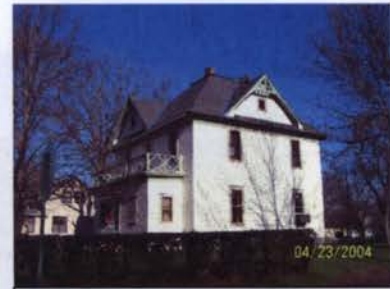
Figure 1 - 207 2nd Ave., Echo

**Mold and Moisture Conditions:** No mold was found in the home.

**Basement:** The basement was dry with carpets and cardboard boxes on the floor increasing the potential for mold (Figure 3). There was also a crack in the foundation wall (Figure 4). The termination port for the dryer vent was clogged (Figure 5).

- Finish gutter system, including downspouts and leaders.
- Remove carpet and cardboard boxes from basement floor.
- Repair cracked foundation wall.
- Unclog dryer termination port.

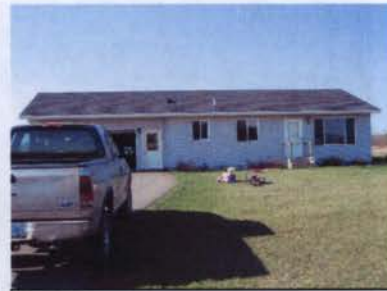
Figure 1 - 5723 Travers Lane.

**Mold and Moisture Conditions:** No mold was found in the home.

- Install gutter system, including downspouts and leaders.
- Grind out a 3/8" "V" at the cold joint and seal with a high quality concrete sealant.
- Check the furnace specifications to determine whether the Schedule 40 PVC piping is permissible.
