# 1           **Structural integrity monitoring of onshore wind turbine concrete foundations**

2           Magnus Currie<sup>1\*</sup>, Mohamed Saafi<sup>2\*</sup>, Christos Tachtatzis<sup>3</sup> and Francis Quail<sup>4</sup>

8           Signs of damage around the bottom flange of the embedded ring were identified in a large  
9           number of existing onshore concrete foundations. As a result, the embedded ring experienced  
10          excessive vertical displacement. A wireless structural integrity monitoring (SIM) technique was  
11          developed and installed in the field to monitor the stability of these turbines by measuring the  
12          displacement patterns and subsequently alerting any significant movements of the embedded  
13          ring. This was achieved by using wireless displacement sensors located in the bottom of the  
14          turbine. A wind turbine was used as a test bed to evaluate the performance of the SIM system  
15          under field operating conditions. The results obtained from the sensors and supervisory control  
16          and data acquisition (SCADA) showed that the embedded ring exhibited significant vertical

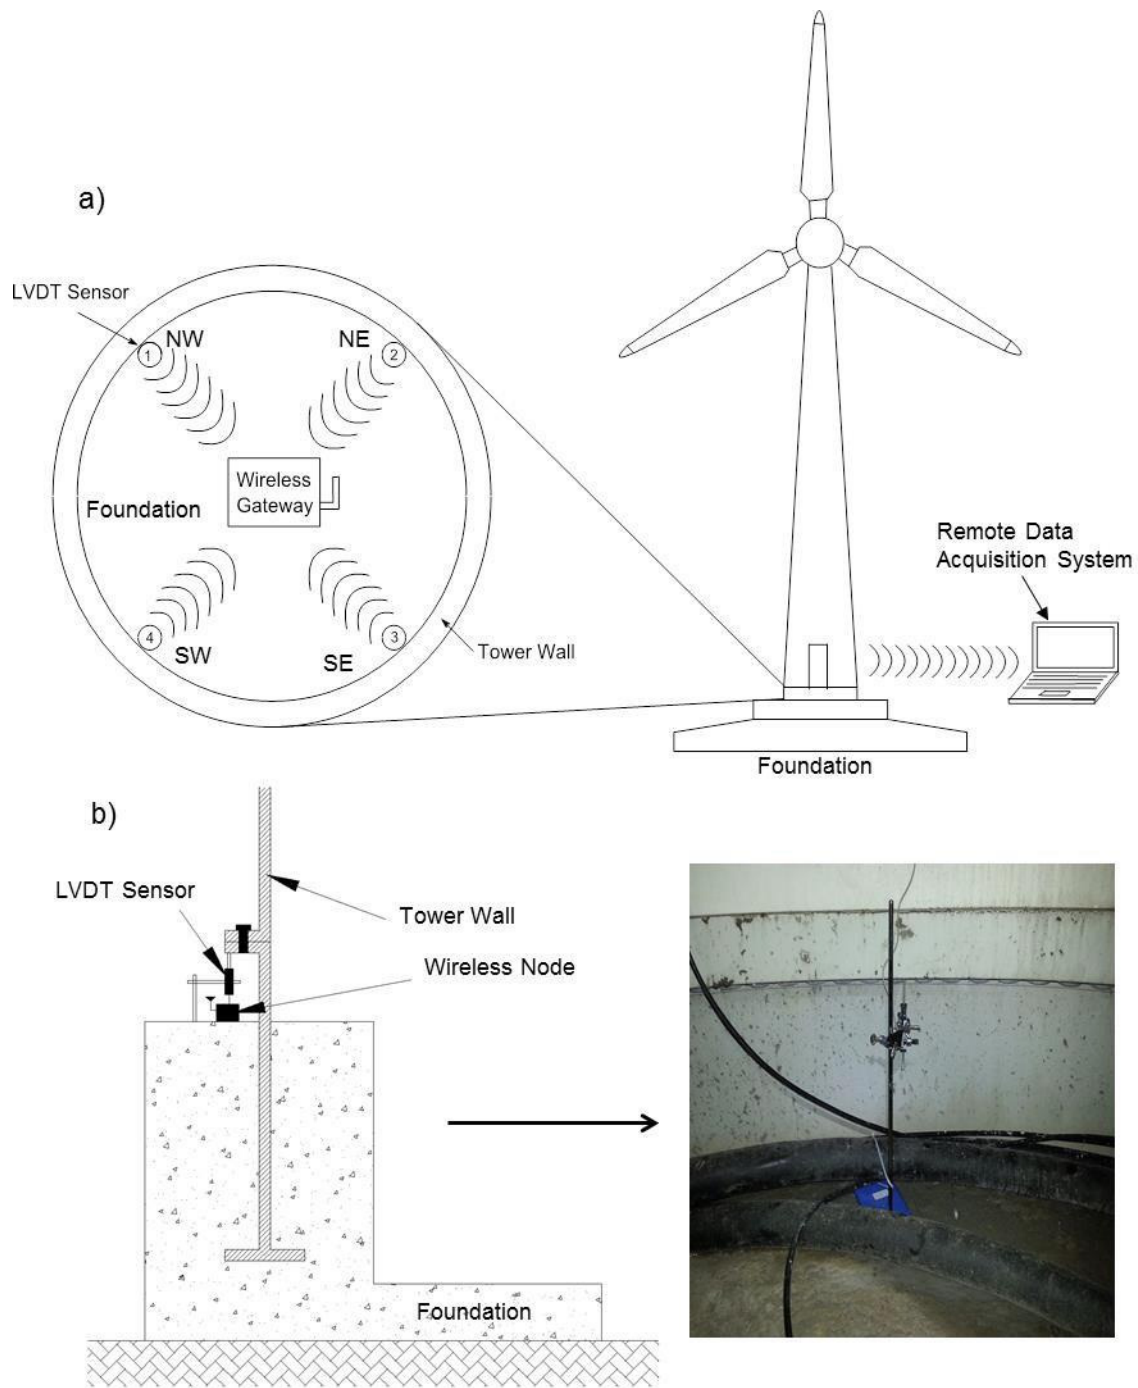
Fig. 4. a) SIM architecture and b) sensor installation.

113 As shown in Fig. 4a, four LVDT sensors were installed under the top flange of the embedded  
114 ring. Each LVDT was equipped with an off-the-shelf wireless communication node set to  
115 measure displacement at a frequency of 1Hz. This rate was deemed to be sufficient for the  
116 relatively slow movement of the turbine tower. The nodes were equipped with a 2.4 GHz  
117 CC2420 wireless radio chip from Texas Instruments, which is IEEE 802.15.4 compliant. The  
118 transmission power was set at 0 dBm while the receiver sensitivity of radio chip is -95 dBm.  
119 The wireless gateway device consisted of an off-the-shelf low cost Raspberry Pi microcomputer,  
120 a standard 4GB SD memory card and a small size battery pack, which acts as a UPS.

121 The sensors were positioned equidistant around the foundation (see Fig. 4a). The measurement  
122 points are numbered on the figure as 1 NW (North West), 2 NE (North East), 3 SE (South West)  
123 and 4 SW (South West). These points were selected because the prevailing wind conditions on  
124 the site were south-westerly in nature. Using these measurement points, the sensor array would  
125 capture the displacement on planes parallel and perpendicular to the prevailing wind. The LVDT  
126 sensors were installed to measure the displacement between the static concrete foundation and  
127 the embedded ring. It was essentially measuring the movement of the embedded ring at the  
128 connection with the tower. Retort stands were used to keep the sensors with a heavy weight base  
129 and the attachments were locked in position using thumbscrews, preventing any movement  
130 during operation. The LVDTs were set half compressed, allowing vertical upwards and

131 downwards movements to be recorded. The LVDT installed in the foundation had a maximum  
132 stroke of 50 mm; hence they were installed at a set position of 25 mm. Fig. 4-b shows the sensor  
133 location along with the method of anchoring the sensor.
