Boiler tube corrosion caused by urea injection of SNCR system

Katri Ekholm¹, Satu Tuurna², Sanni Yli-Olli²

¹Helen Ltd
Helsinki, Finland

²VTT Technical Research Centre of Finland
Espoo, Finland

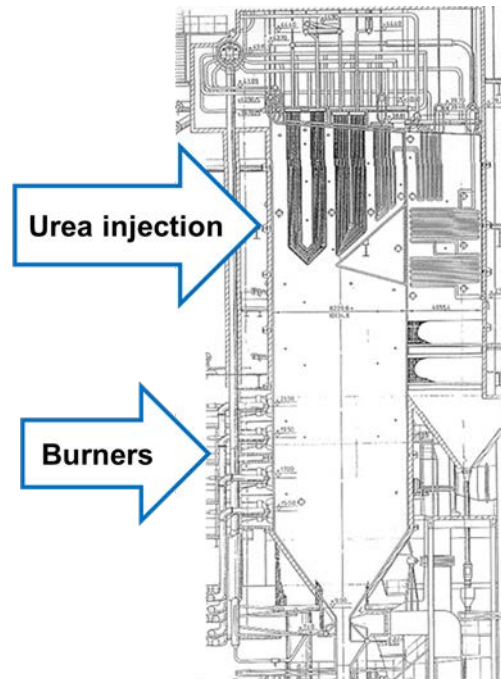
Figure 2. Arrangement of urea injection in Hanasaari boilers.

The SNCR systems are in principle similar in both boilers, with differing nozzle types. One of the boilers has a self-made injection system with thin nozzles 20 cm inside the furnace, and thin pipes working as nozzle holders, welded outside the boiler.

In Hanasaari power plant the flue gas temperature is optimal for urea injection at the level of secondary superheater, with flue gas temperature of about 1100 °C and water temperature of 350 °C in boiler tubes at that level. The urea injection nozzles are located on the front wall at three levels in the boiler.

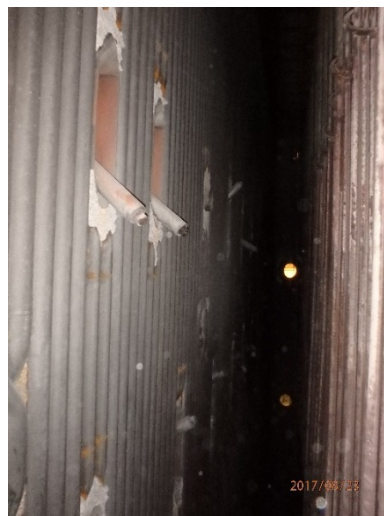
Figure 3. Commercial urea injection lances on the boiler front wall; secondary superheater on the right.

The other boiler has vertically adjustable commercial lances, Figure 3.
