Boiler tube corrosion caused by urea injection of SNCR system

Katri Ekholm¹, Satu Tuurna², Sanni Yli-Olli²

¹Helen Ltd
Helsinki, Finland

²VTT Technical Research Centre of Finland
Espoo, Finland

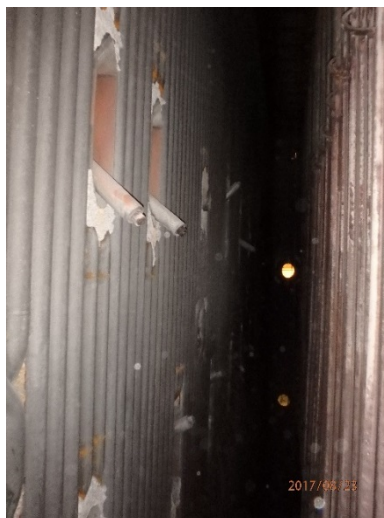
The other boiler has vertically adjustable commercial lances, Figure 3.

Figure 3. Commercial urea injection lances on the boiler front wall; secondary superheater on the right.
