EXPERIMENTAL AND NUMERICAL ANALYSIS OF A HELICAL SPRING FAILURE

Abstract. Results of experimental and numerical analysis of a broken motor vehicle helical spring are presented in this paper. Location of the fracture is on a first active coil of the spring. Experimental part of the research employed optical microscopy that revealed fractured surface microstructure and allowed for detection of inclusions. Corroded fracture surface limited scanning electron microscopy examination (SEM). Nevertheless, corrosion pits on the edge of the spring wire which served as crack initiation points could be detected by SEM along with radiating ridges left by the fracture front that propagated to the opposite edge of the wire. Optical emission spectrometer with glow discharge source sample stimulation was used to determine material chemical composition that is adequate to spring steel 61SiCr7. Additionally, hardness test was performed and obtained value was used to derive maximum tensile strength of the steel. Experimentally collected data served as input for numerical analysis of helical spring. Finite element analysis of a helical spring model was performed. Stress distribution was determined and

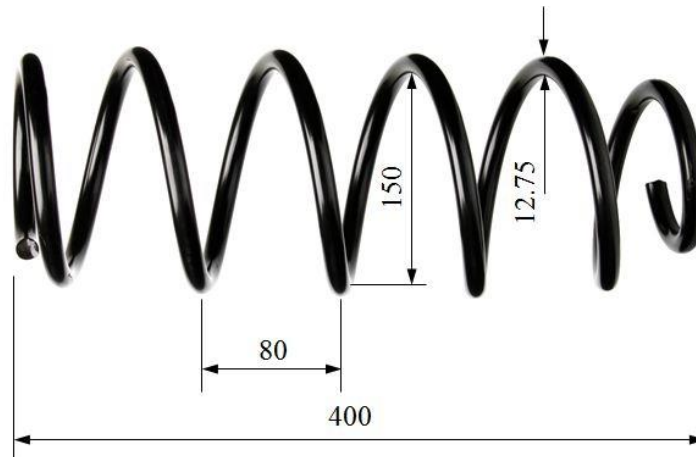
Figure 1: Helical spring dimensions (in mm)

Helical spring mounted on a front suspension of a passenger car fractured after 145.000 km and 7 years of service. Fracture occurred at the transition point from the lower bearing coil to the first upper coil. Geometry and dimensions of helical spring extracted from the car are shown in Fig. 1.

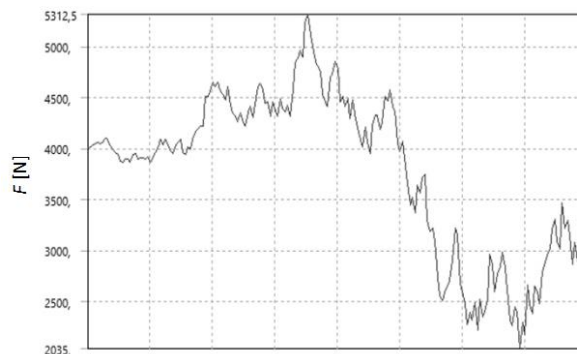
Figure 9: Non-constant amplitude load

In order to get more accurate results, loads coming from road irregularities are considered, also. Passing of the vehicle on irregular road surfaces generates oscillation of the vehicle mass with a consequent increase of the load. Final load is a combination of several factors, e.g. vehicle mass, travelling speed, type of suspension, road irregularities, etc. Quarter car model (QCM) [16] can be used to study the interaction between vehicle and road profile. Also, classification of road profiles according to ISO 8608 [17] has to be considered. The use of ISO 8608 presumes that a specific road has equal statistical properties along an examined section. In this work, ISO A-B road profile was chosen along with 70 km/h vehicle speed. A Matlab code was written [18] to calculate the behavior of a vehicle according to road irregularities and further to estimate the effect on helical spring fatigue life. Fig. 9 shows non-constant amplitude load used in the analysis.
