GEOLOGICAL CHARACTERISATION OF THE LAI PING ROAD LANDSLIDE

GEO REPORT No. 166

N.P. Koor & S.D.G. Campbell

**GEOTECHNICAL ENGINEERING OFFICE
CIVIL ENGINEERING AND DEVELOPMENT DEPARTMENT
THE GOVERNMENT OF THE HONG KONG
SPECIAL ADMINISTRATIVE REGION**

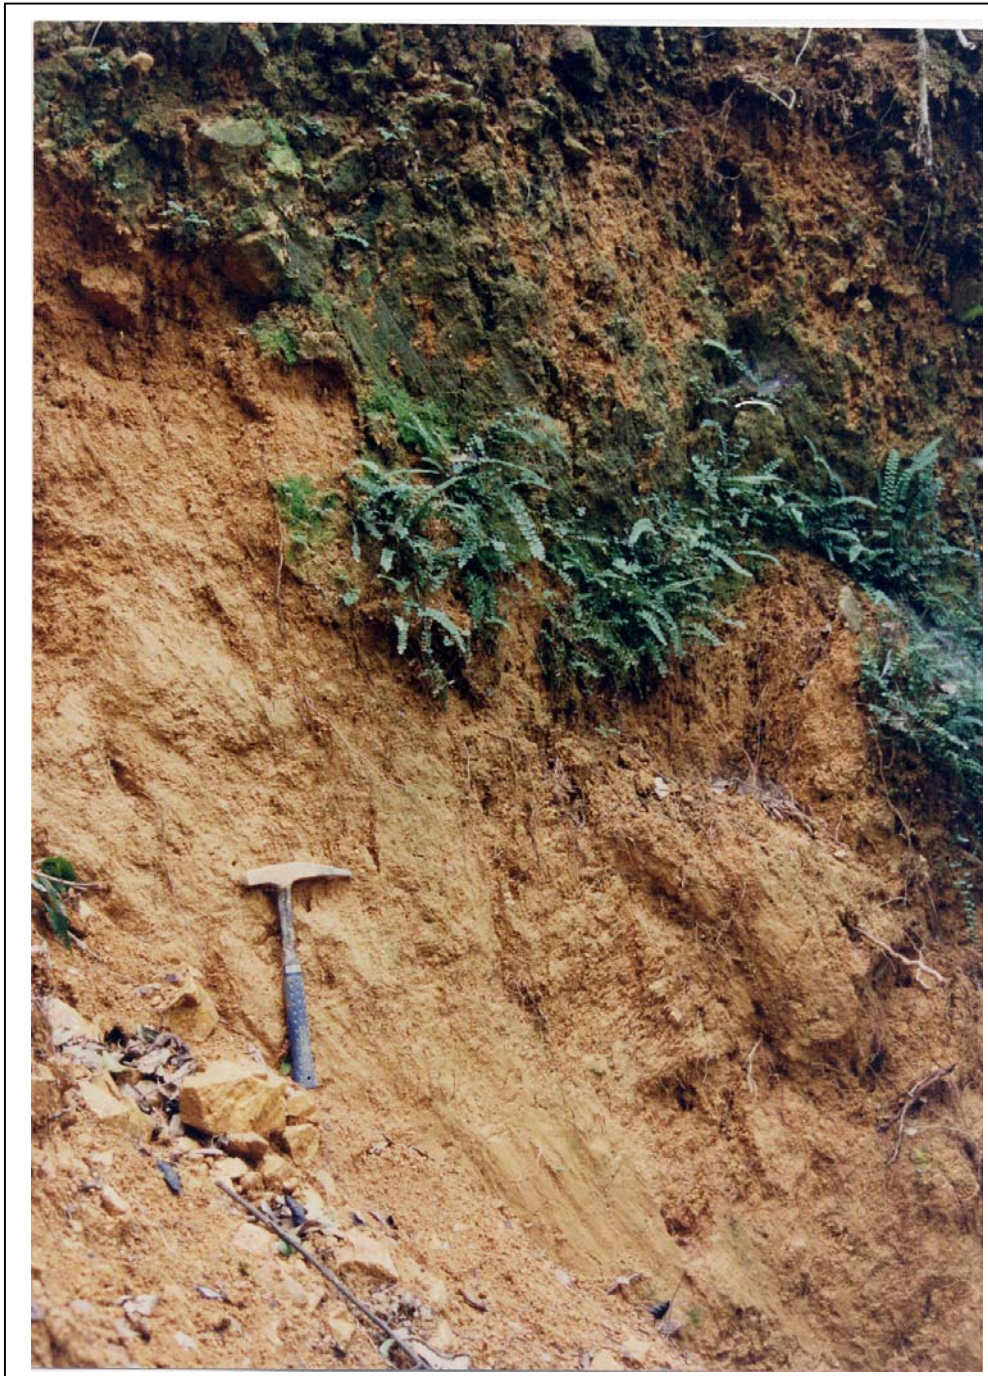
Frontispiece: The Main Scarp of the Composite Landslide with Two Generations of Slickensides and a Distinct Vegetation Line of Ferns and Moss Indicating at Least Two Phases of Landslide Development

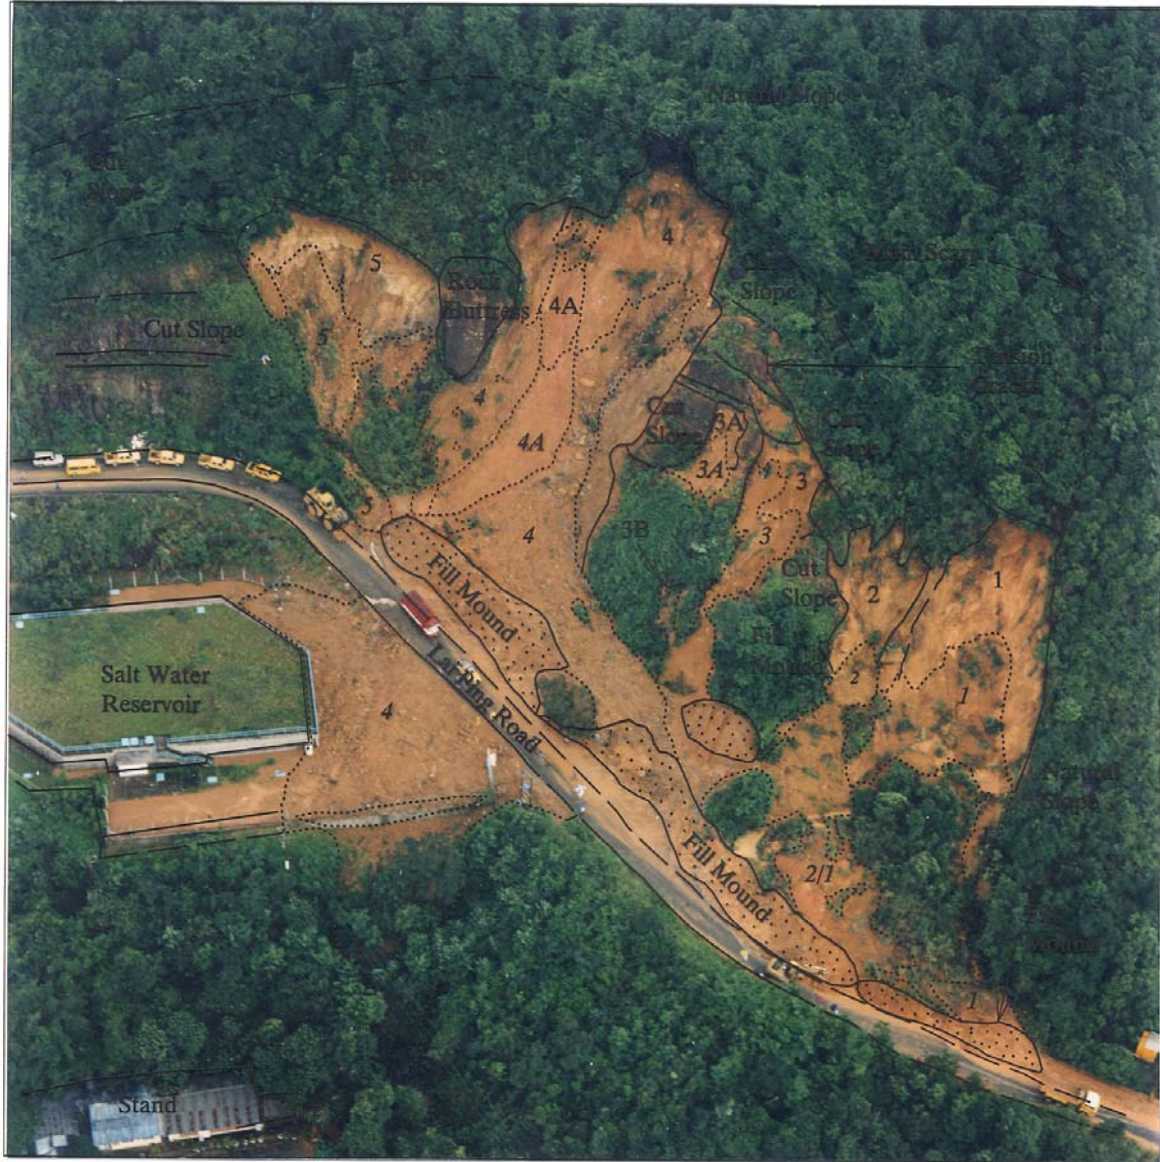
Plate 2 - Oblique Aerial View of Lai Ping Road Landslide from the South-West, Annotated to Show Landslide Scars 1-5 and Associated Debris and Part of the Main Scarp (Taken on 4/7/97)

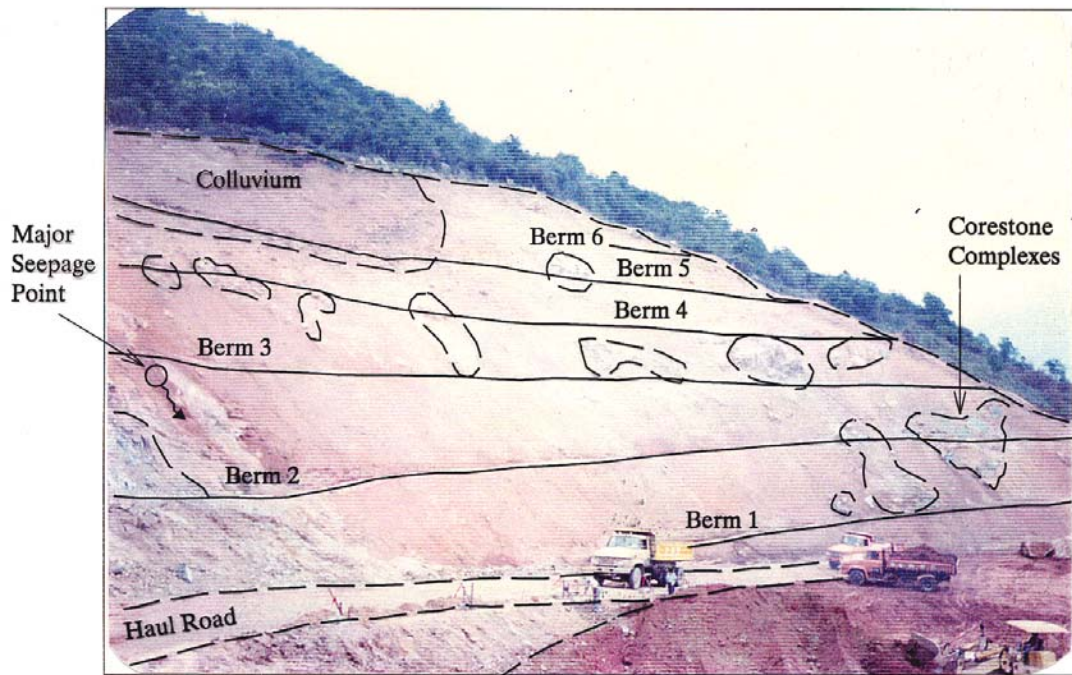
Plate 4 - Oblique View of Slope 7NE-C/C95 from the South-West Taken During Construction, Annotated to Show Colluvium Lobe and Zone of Seepage (Taken 3/3/78).

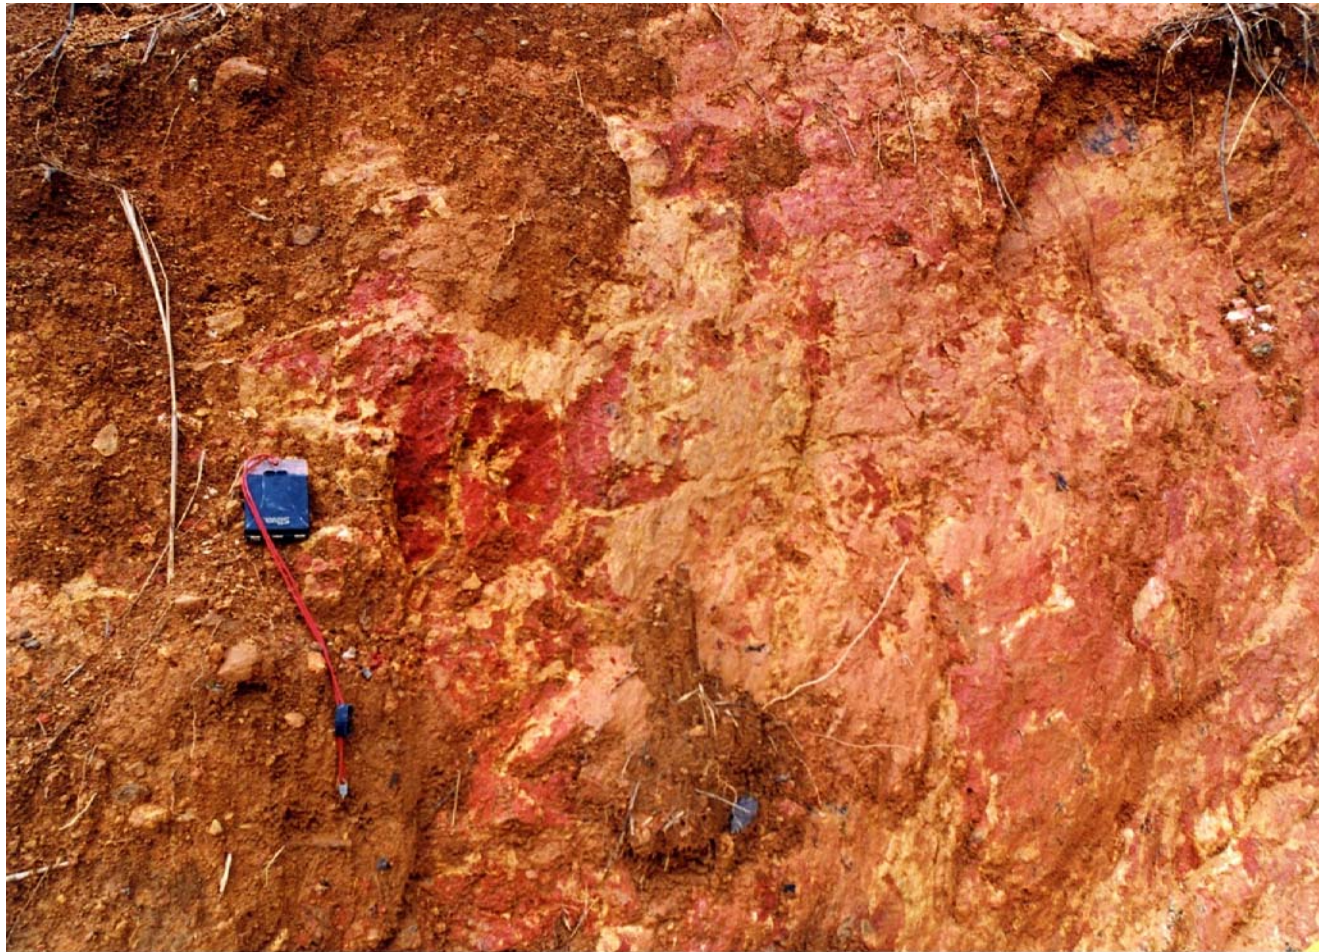
A zone of intense alteration within the saprolite can be traced from north-west to south-east across landslide scars 4, 3 and 2. The zone is characterised by a deep red to reddish pink coloration (iron and manganese staining), and the common development of white to buff, kaolin-infilled relict joints, with some dark brown manganiferous deposits (Plate 7a & 7b). The kaolin infills are up to 30 mm thick. The altered zone appears to dip into the hillside, towards the north-north-east at c. 25-40°, and in the same general direction as the fabric and stratification within the tuff. A discontinuous rhyolite intrusion (sill?) is also emplaced along the zone of alteration in landslide scar 4 (Drawing No. EG 499). Although many of the alteration features of the zone are consistent with weathering of the tuff and rhyolite, the zone may be one of pre-existing hydrothermal alteration. The altered tuff is extremely weak, and when broken down by finger pressure its constituents initially feel silt sized. However, with further pressure the altered tuff quickly becomes very clayey and greasy and appears to release some water.

Plate 7(a) - Intensely Altered Coarse Ash Crystal Tuff Exposed in Landslide Scar 4A (Plate Location Shown on Drawing EG503) (Taken on 6/8/97)

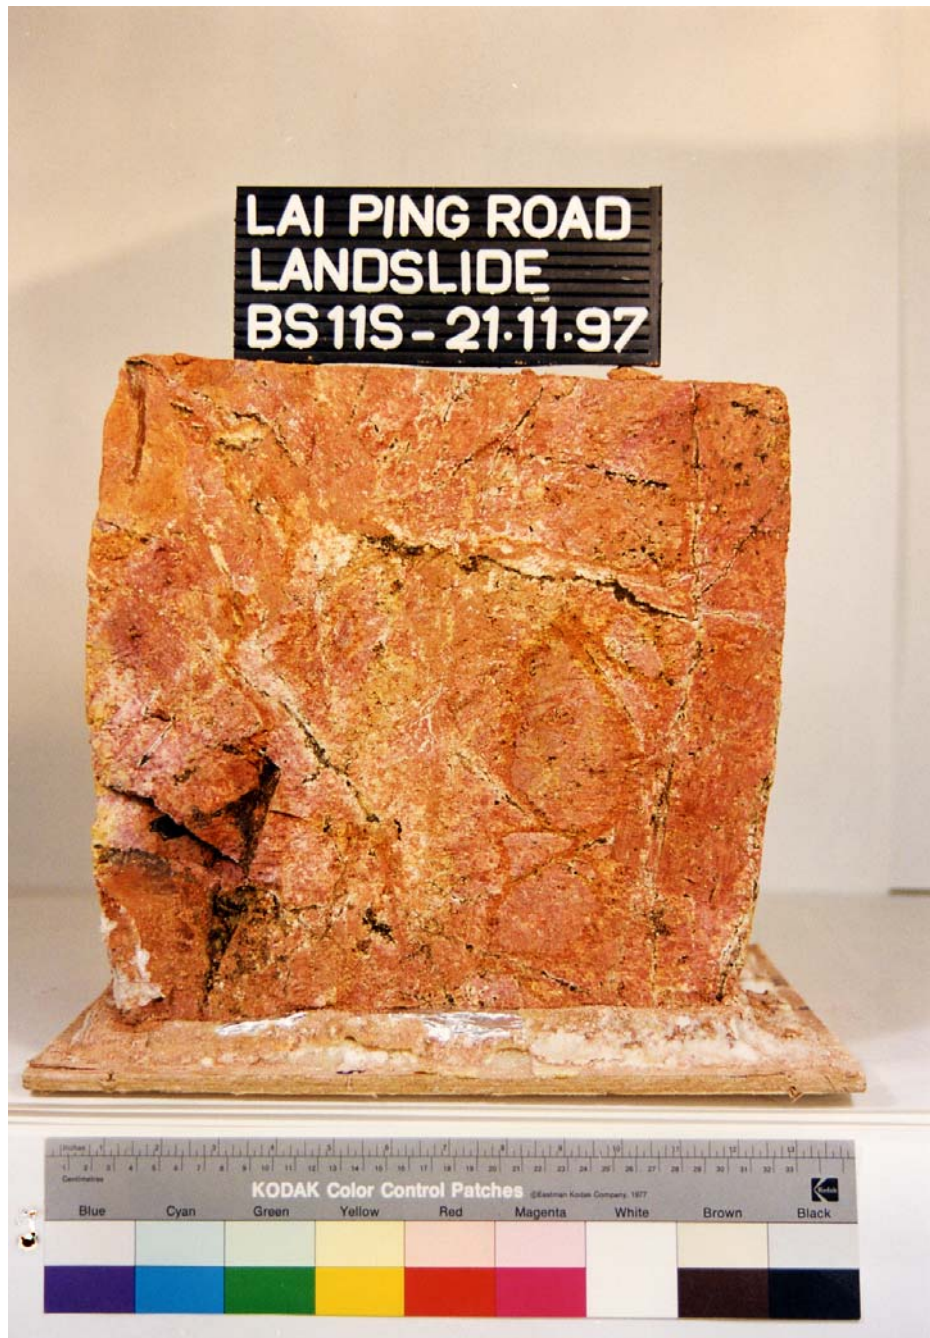
Plate 7(b) - Southern Face of Block Sample 11 - Intensely Altered Tuff - Note Contorted Relict Joints Infilled with White Kaolin and Manganiferous Deposits (Plate Location Shown on Drawing EG503) (Taken on 21/11/97)

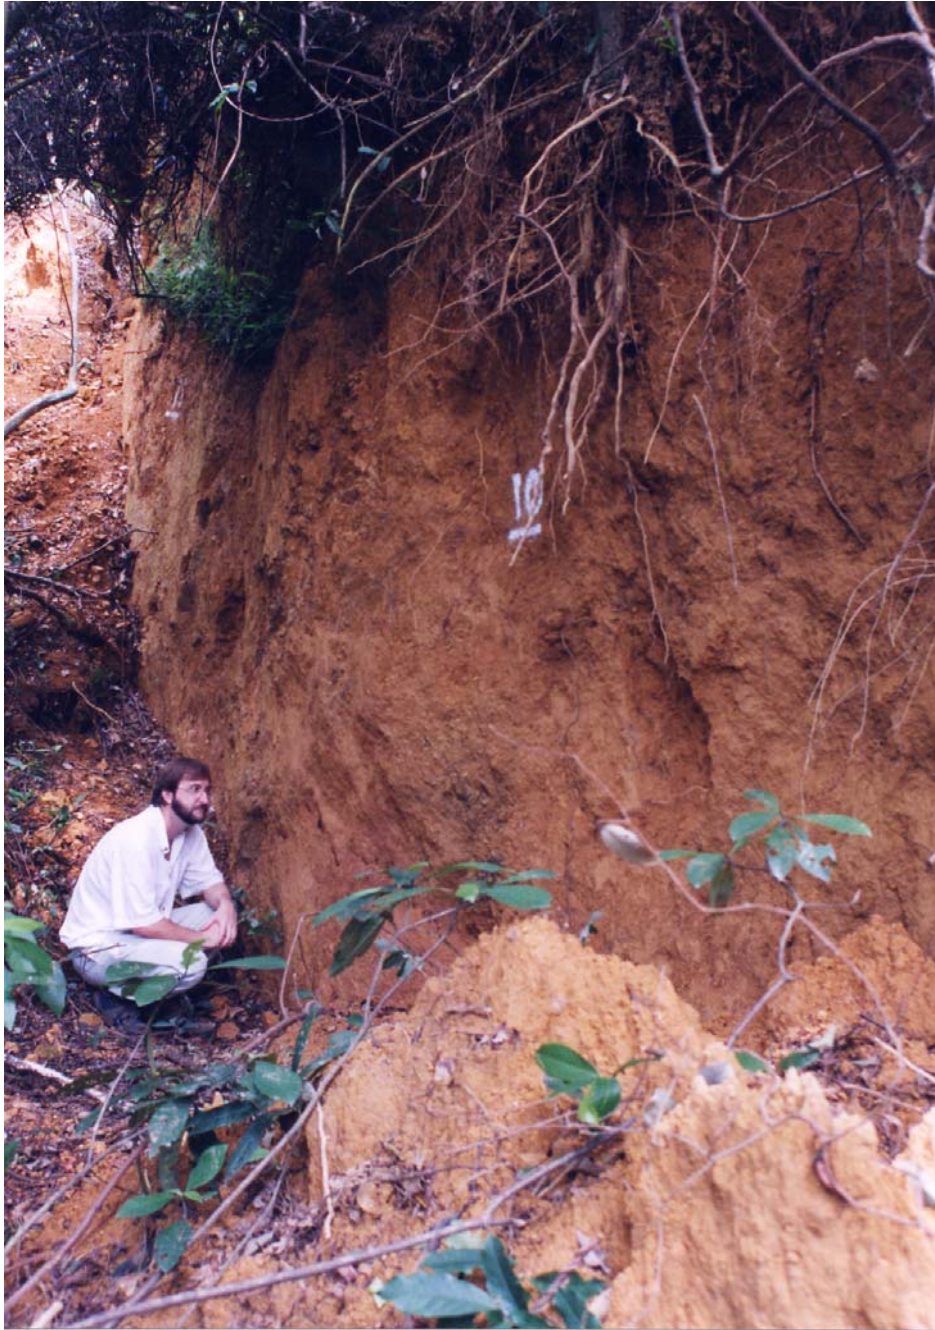
The main scarp of the system, marking the apparent up-slope limit of the deformation, extends to a maximum elevation of +156.6 mPD, some 24.8 m above and 56 m beyond (in plan view) the highest point of any of landslide scars 1 to 5. The scarps are typically steep. They have differential vertical offsets of up to 3.8 m (Plate 8) and horizontal extensions of up to 4.2 m. Most scarps dip directly or obliquely down-slope, consistent with the down-slope mass movement. However, a few scarps dip up-slope. Some reflect locally generated compression, i.e. heave (Plate 9), within the moving mass, while others are the down-slope margins of extensional grabens. Individual scarps extend laterally for up to 100 m. In plan (Drawing No. EG 502), the array of scarps displays a wide range of forms varying from curvilinear to rectilinear segments, and includes bifurcations, conjugate shear sets, left- and right-stepping *en echelon* sets, S- and Z-shaped inflections, duplexes, and other complex movement transfer zones. Segments nearer the cut slope are generally shorter (typically < 8 m long) than those further up-slope, close to and including parts of the main scarp. Only one linear segment, forming part of the main scarp on the north-east side of the landslide, is greater than 15 m in length. The scarps nearer the cut slope are generally considered to be older features than those further up-slope, and many were not activated during the recent slope movements. Their comparatively short lengths reflect truncations caused by the progressive development of younger scarps.

Plate 8 - Main Scarp, Vertical Displacement at this Point is 3.8 m
(Plate Location Shown on Drawing EG503) (Taken on
26/9/97)

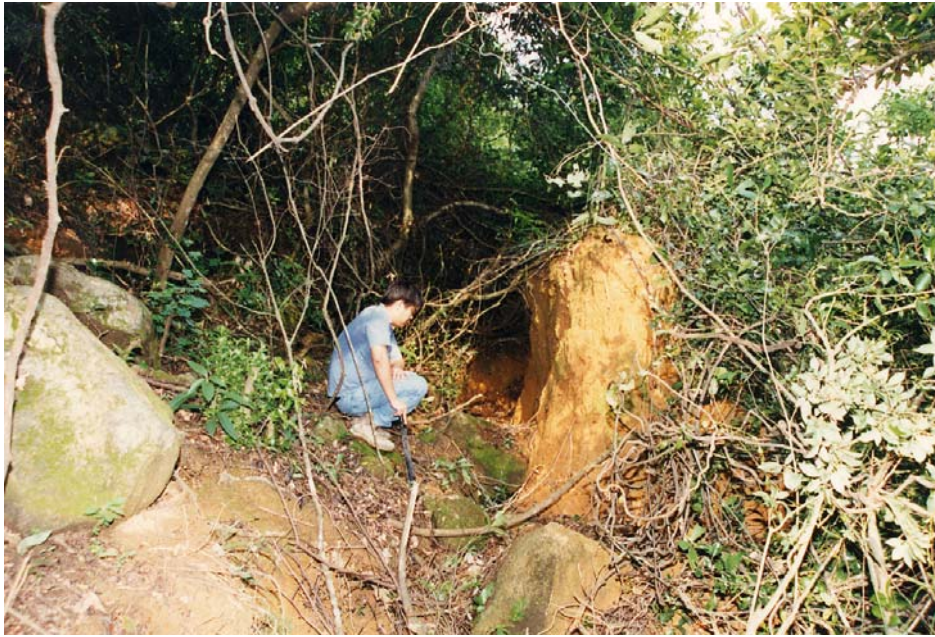
Plate 9 - Heaved Block of Saprolite or “Pop-Up Structure” within Main and Minor Scarp Complex (Plate Location Shown on Drawing EG503)
(Taken on 3/9/97)

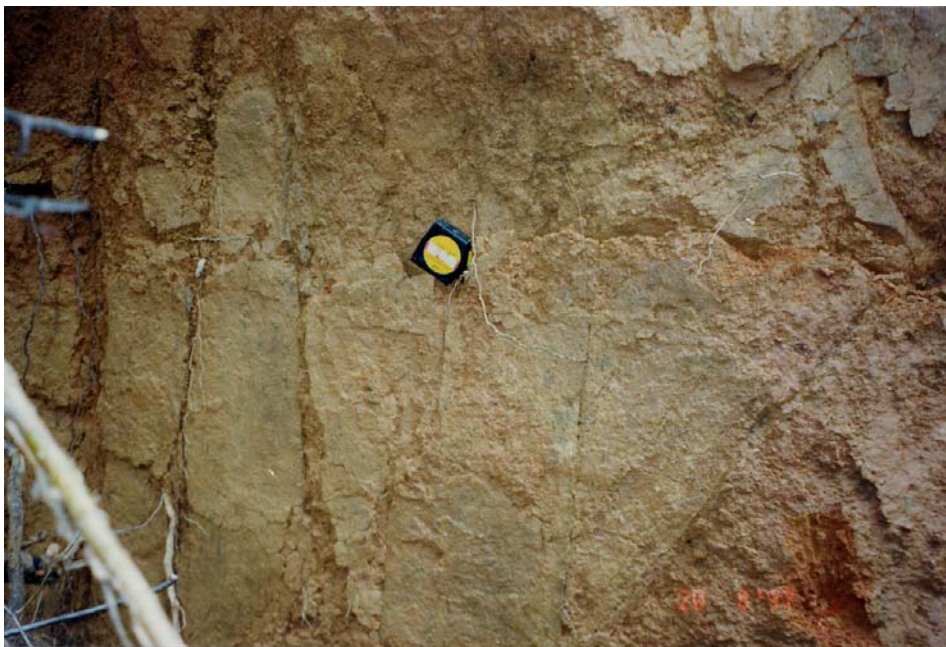
Locally, the scarps follow relict joint surfaces (Plate 10) but generally, no such structural control can be observed at ground level. However, deeper-seated structural control of the orientation of the scarps is apparent from the similar dip directions of linear segments of the scarps and the dominant joint sets (see Section 3.3.4). There is also a relatively regular spacing of the scarps. First order scarps, traceable laterally for distances of several tens of metres, being typically about 15 m apart, whereas second order features, traceable laterally for up to about 20, are approximately 7 to 8 m apart. The regular spacing of the first and second order scarps suggests that they are geologically controlled.

Plate 10 - Main Scarp Controlled by Relic Joints within Saprolite (Plate Location Shown on Drawing EG503) (Taken on 20/8/97)

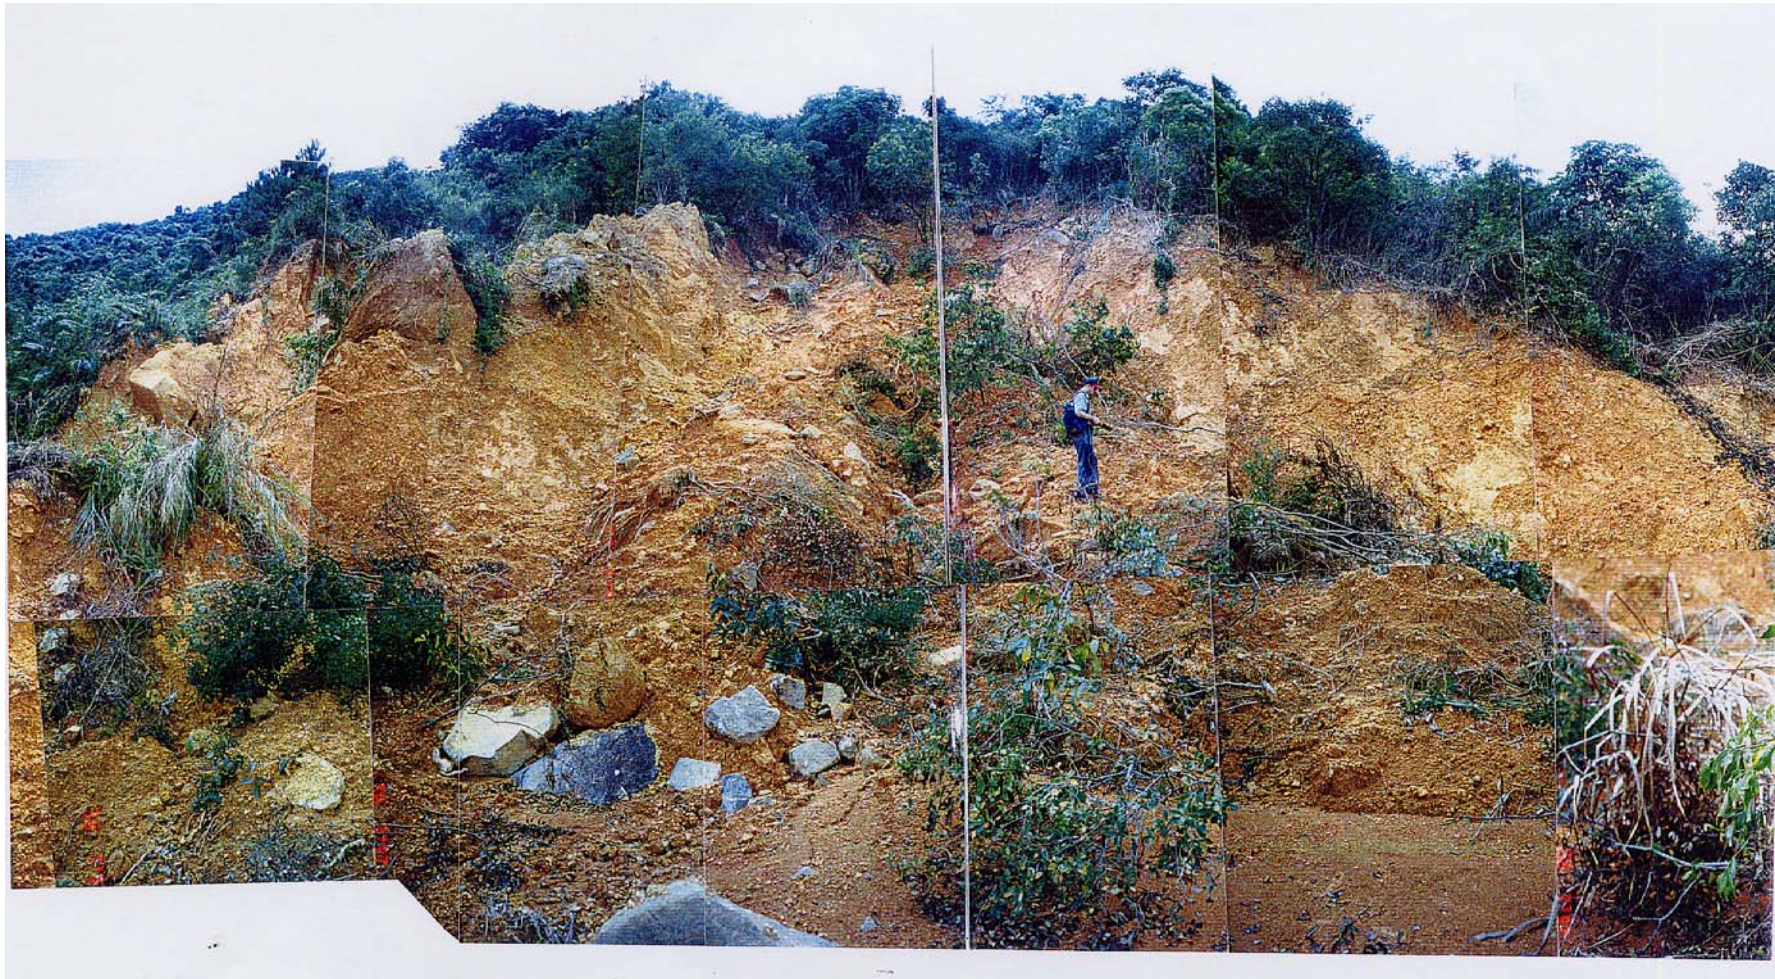
(a) Landslide scar 1 (Plate 11) has its toe within the original cut slope and its crown within quasi-natural terrain, 20 m to the east of the cut slope (Figure 1). The main scarp is generally trapezoidal in plan, being 13 m wide at the crown, 25 m wide at the toe and 52 m long. At the crown, the main scarp is sub-vertical and about 1.5 m high and is intersected by tension cracks that continue up-slope. The left hand flank of the main scarp is up to 5 m high and inclined at 45°. The right hand flank is up to 4 m high and ranges from sub-vertical to inclined at 45°. The landslide occurred in mainly residual soil grading to completely decomposed tuff in places. Pods of rhyolite dyke are also present (Drawing No. EG 499). Planar slickensided surfaces of rupture are present within the gully eroded surface below the crown of the slide (Plate 12 & Drawing No. EG 499). The slickensides indicate a direction of landslide movement towards 190° at an inclination of between 32° and 45°.

Plate 11 - View of Landslide Scar 1 Looking Up Towards the Main Scarp (Plate Location shown on Drawing EG503) (Taken on 30/7/97)

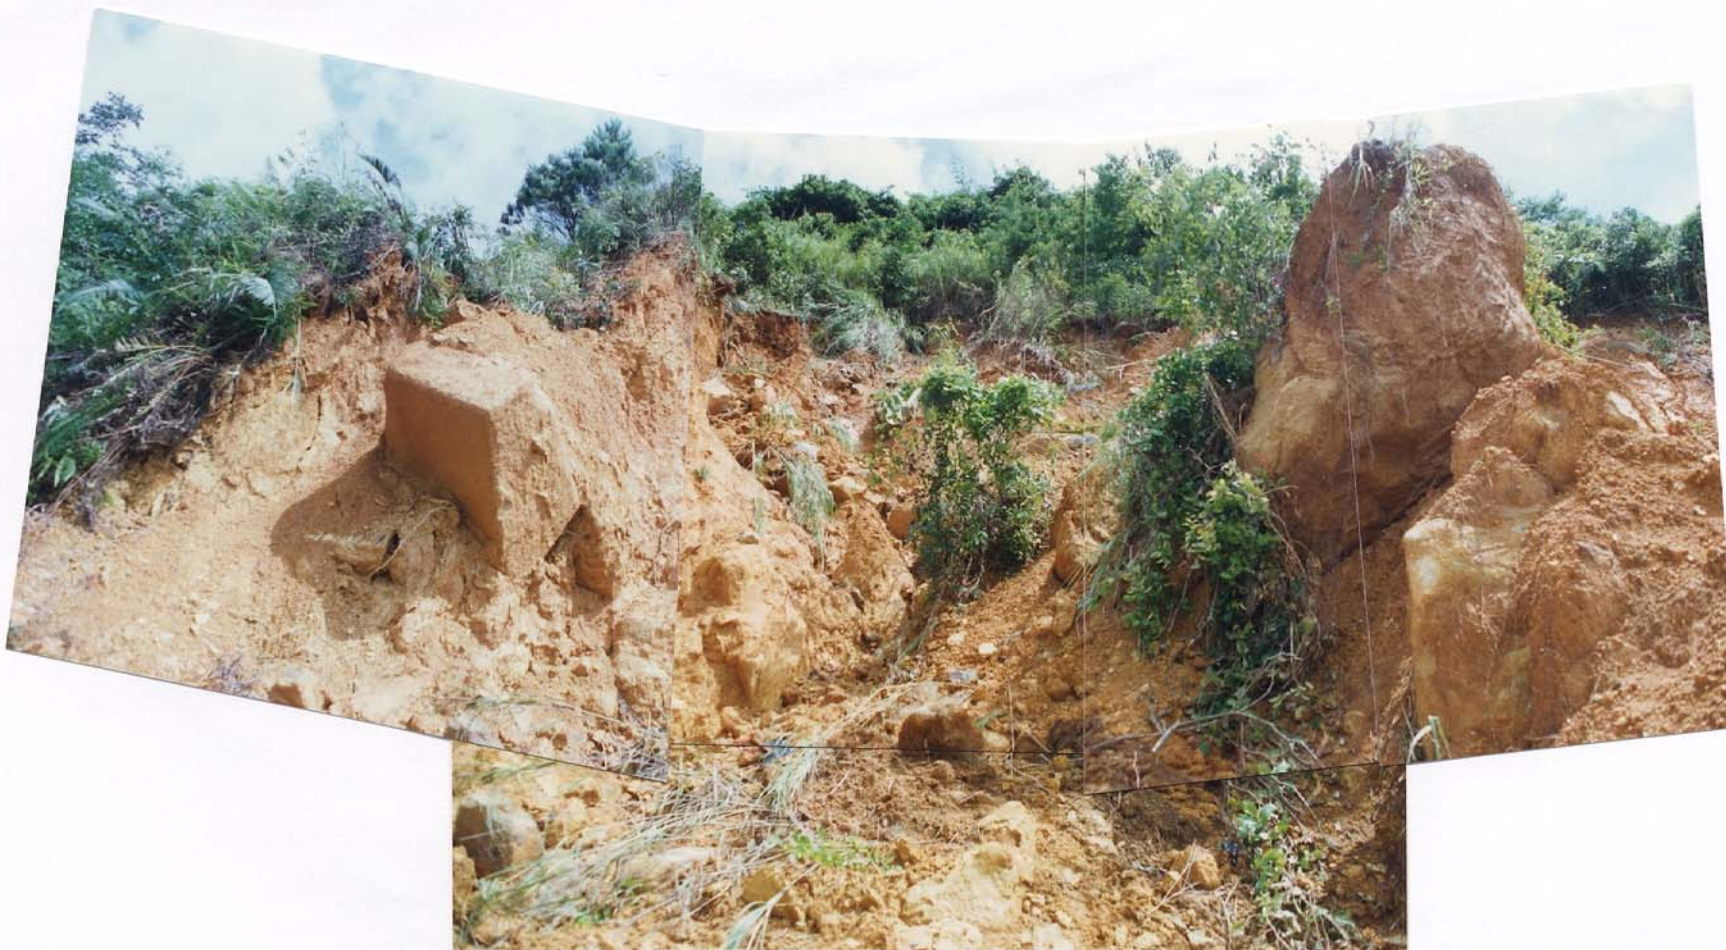
(b) Landslide scar 2 (Plate 14) is located within the original cut slope, apart from its extreme north-east corner, and is a re-activation of instability initiated in 1979 (Figure 5). The main scarp is irregular in plan, being about 12 m wide and 35 m long. The crest drainage U-channel of the original cut slope feeds directly into the failure scar. The main scarp is sub-vertical to vertical along the crown and right hand flank and between 0.5 m and 4 m high. The left hand flank is up to 3 m high and inclined at 45° and forms part of the steep ridge separating landslide scars 1 and 2 (Drawing No. EG 499). The landslide occurred in residual soil and completely decomposed tuff with large corestones, some of which have been rotated in the down slope direction (Plate 15). A zone of intensely altered tuff outcrops in both flanks. Locally, made ground, up to 1 m thick, is present in the main scarp (Plate 16). Below the main scarp, steep gullies have been eroded into the saprolite forming prominent ridges, up to 1 m high. No distinct surfaces of rupture were observed.

Plate 14 - View of Landslide Scar 2 Looking Up Towards the Main Scarp (Plate Location Shown on Drawing EG503) (Taken on 14/7/97)

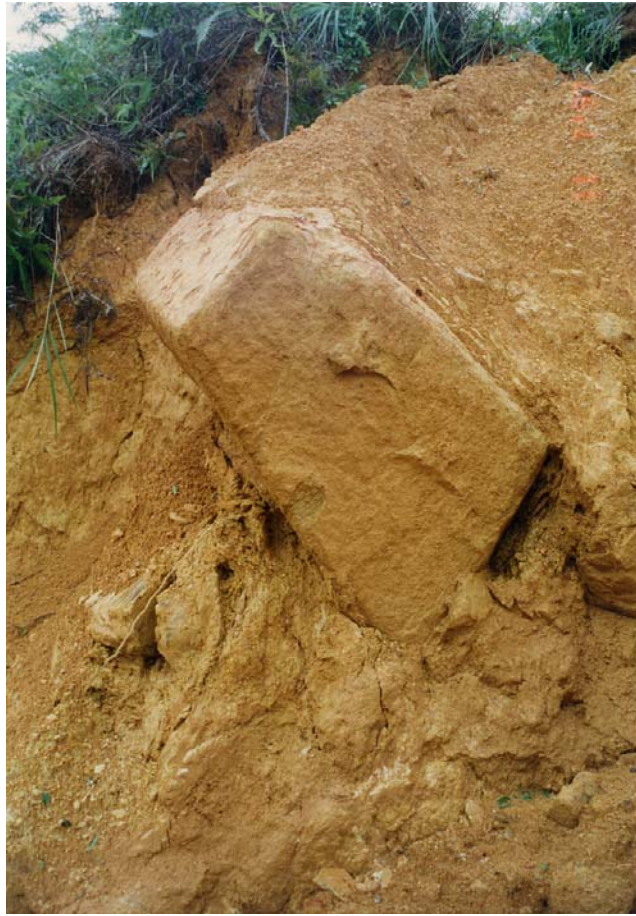
Plate 15 - Corestone Showing Evidence of Rotation Exposed in Right Hand Flank of
Landslide Scar 2 (Plate Location Shown on Drawing EG503) (Taken on 10/7/97)
EG 97/89/29

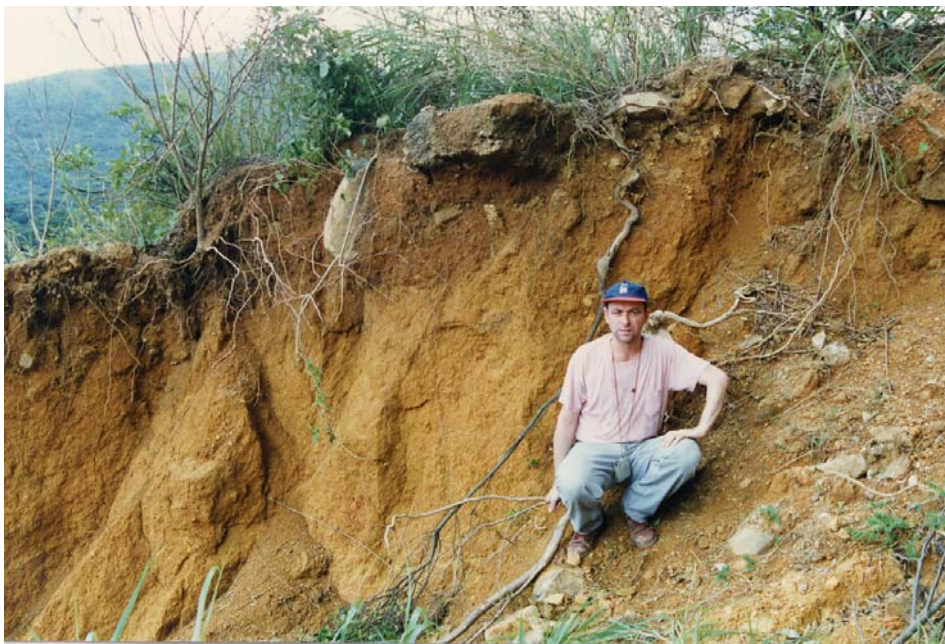
Plate 16 - Made Ground Exposed in the Main Scarp of Landslide Scar 2 (Plate Location
Shown on Drawing EG503) (Taken on 7/8/97)
GS 97/93C/14

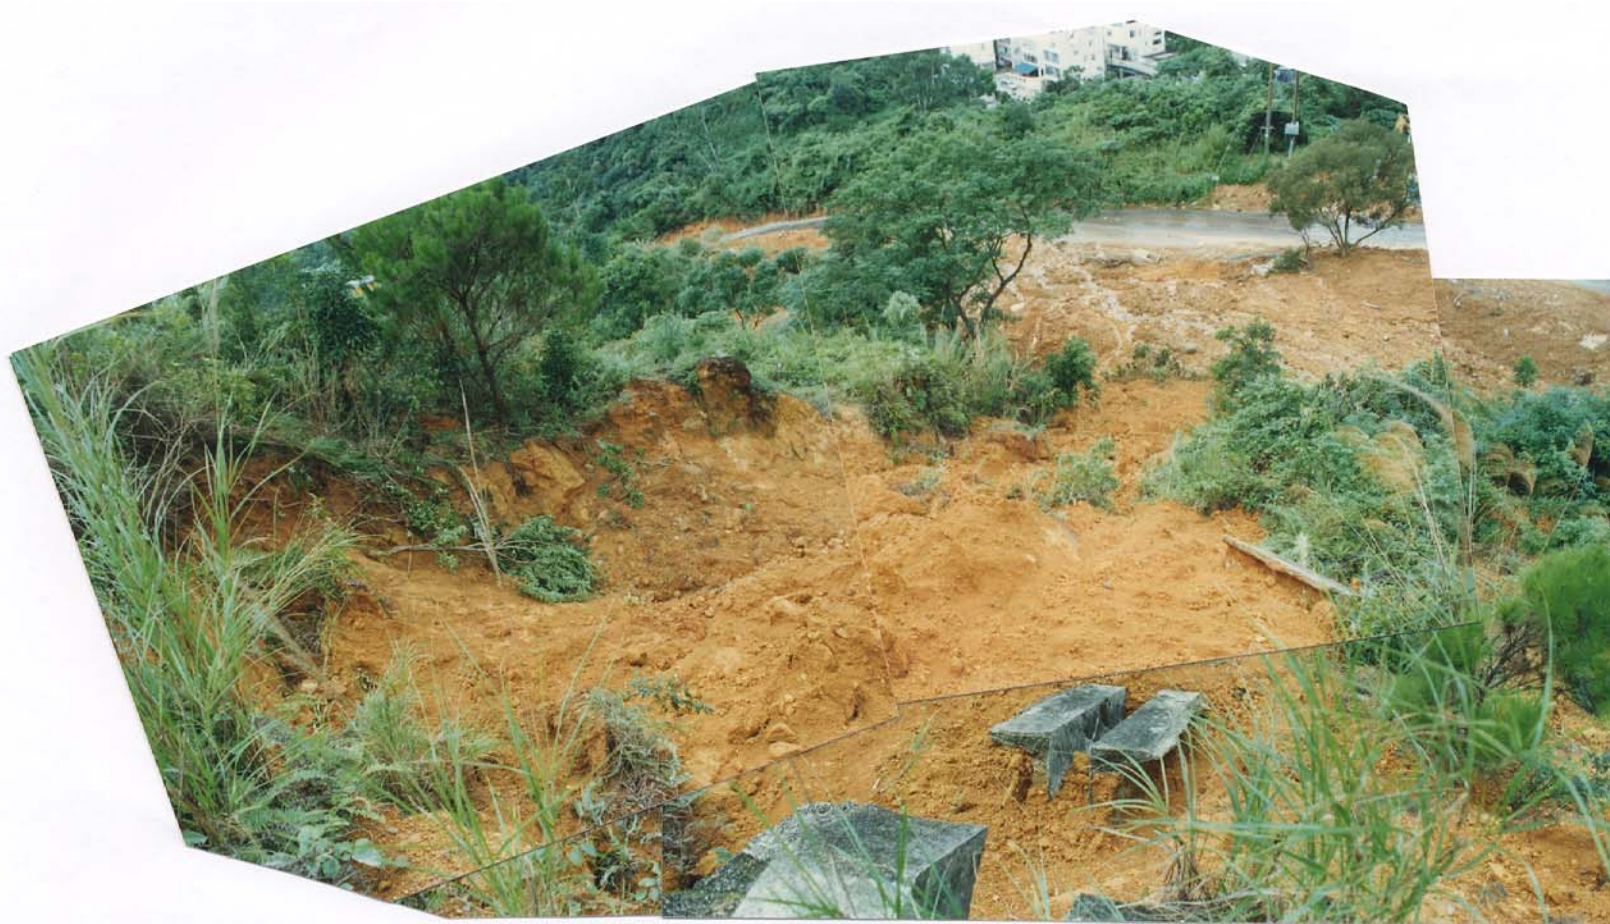
Plate 17 - View of Landslide Scar 3 Looking Down Towards the Left Hand Flank (Plate Location Shown on Drawing EG503) (Taken on 7/7/97)

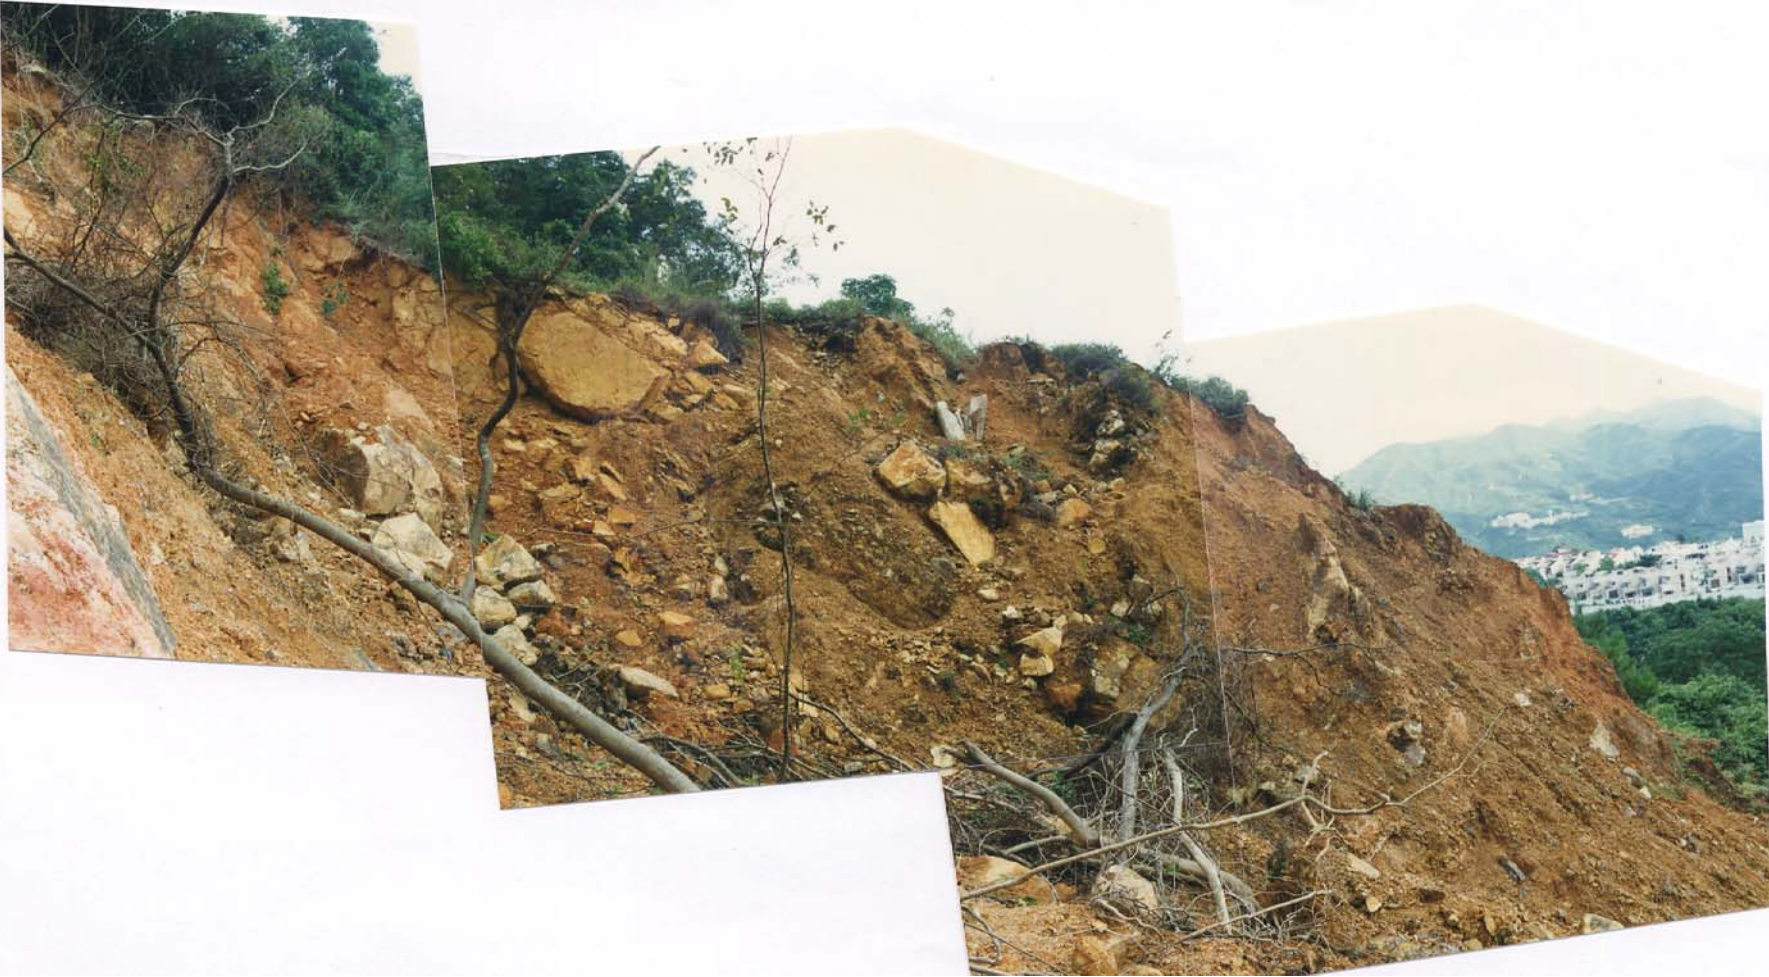
Plate 22 - Left Hand Flank of Landslide Scar 4 Showing Disrupted Rock Mass (Plate Location Shown on Drawing EG503) (Taken on 6/8/97)

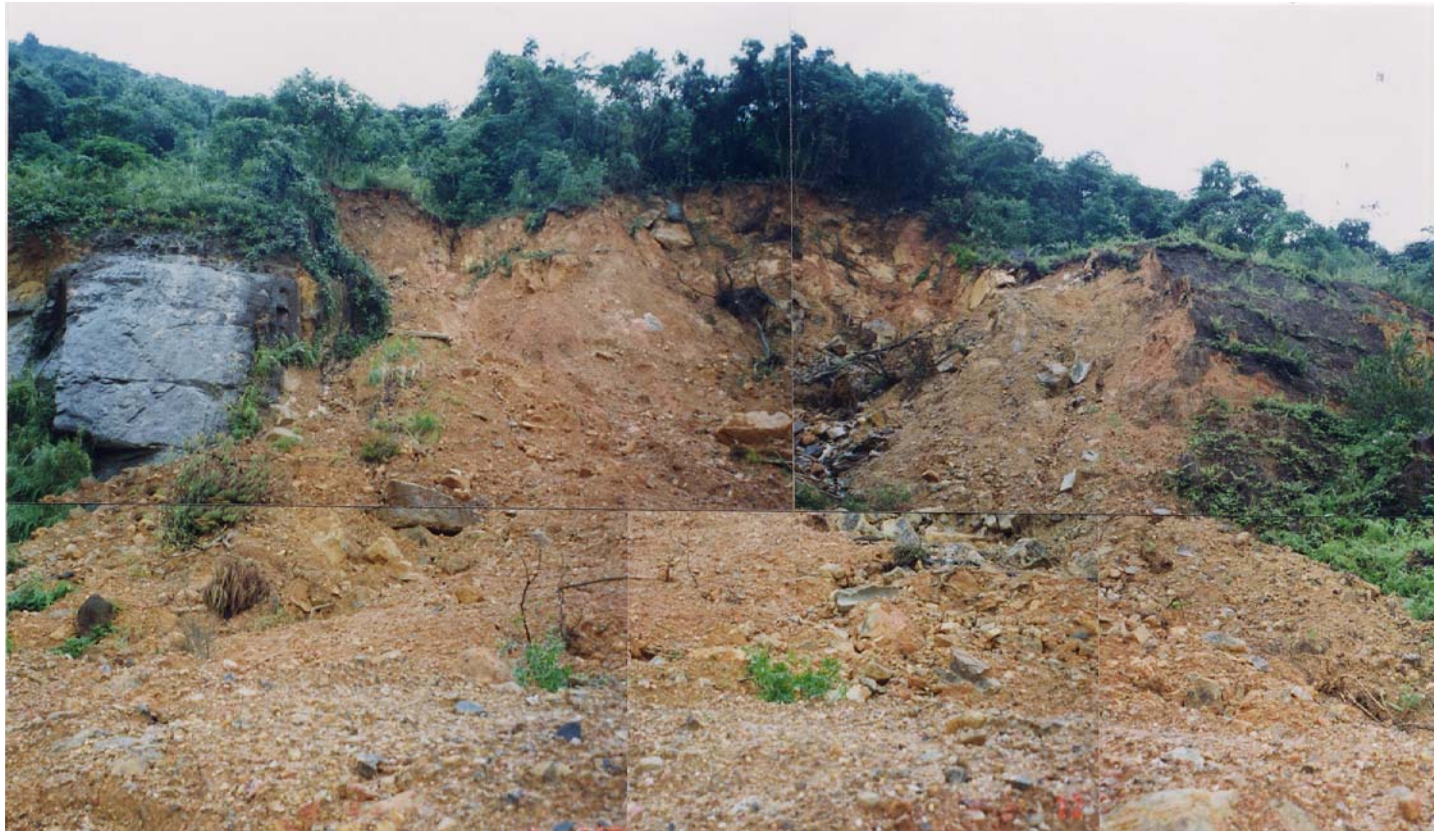
Plate 26 - View of Landslide Scar 5 from the South-East (Plate Location Shown on Drawing EG503)
(Taken on 12/8/97)

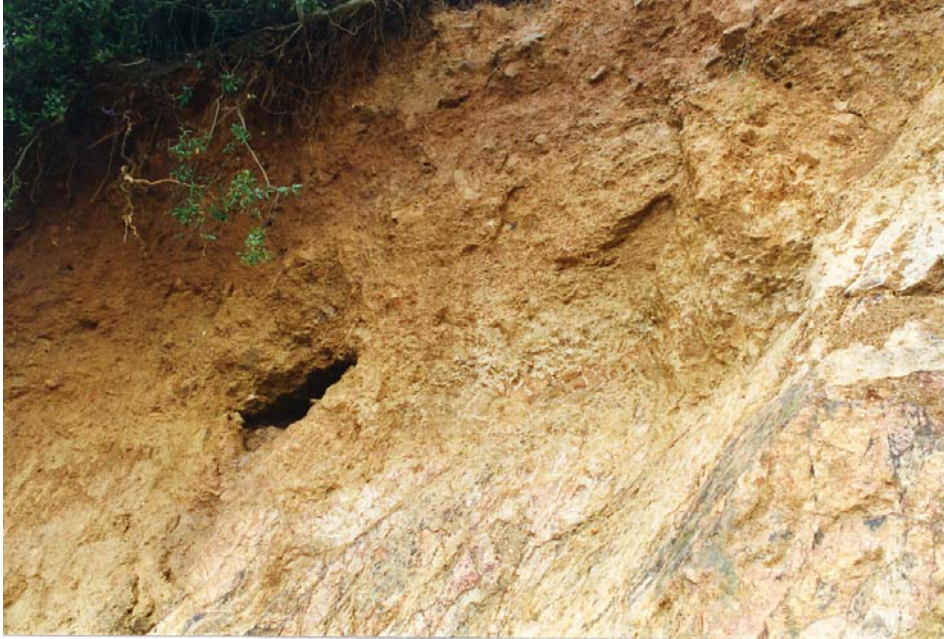
Plate 28(a) - A Large 1.5 m Wide Soil Pipe at the Old Colluvium-New Colluvium Interface Exposed in the Main Scarp of Landslide Scar 5 - Note Slight Seepage (Plate Location Shown on Drawing EG503) (Taken on 7/7/97)
GS 97/53/07

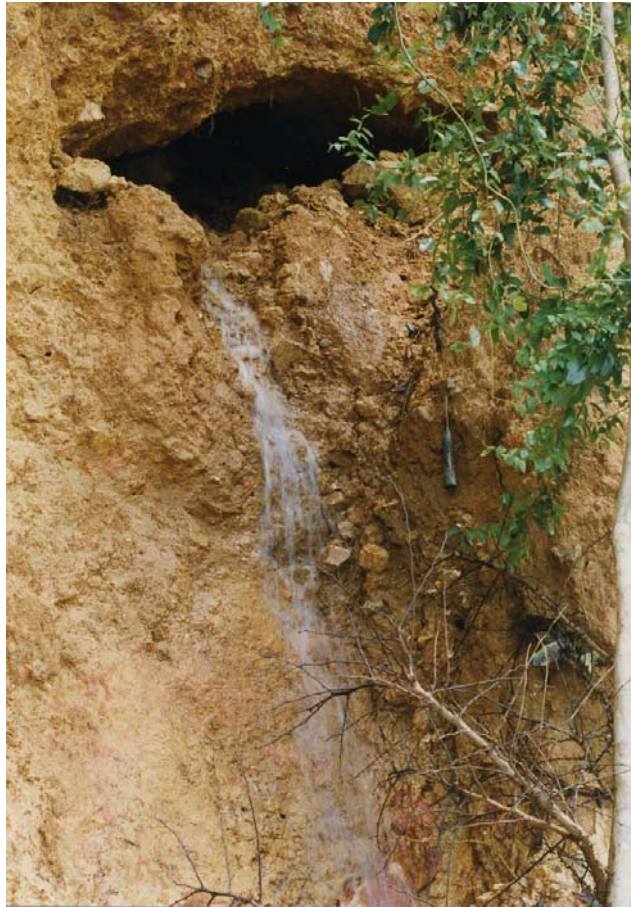
Plate 28(b) - Soil Pipe with Medium Flow (Plate Location Shown on Drawing EG503) (Taken on 8/8/97)
GS 97/107C/30

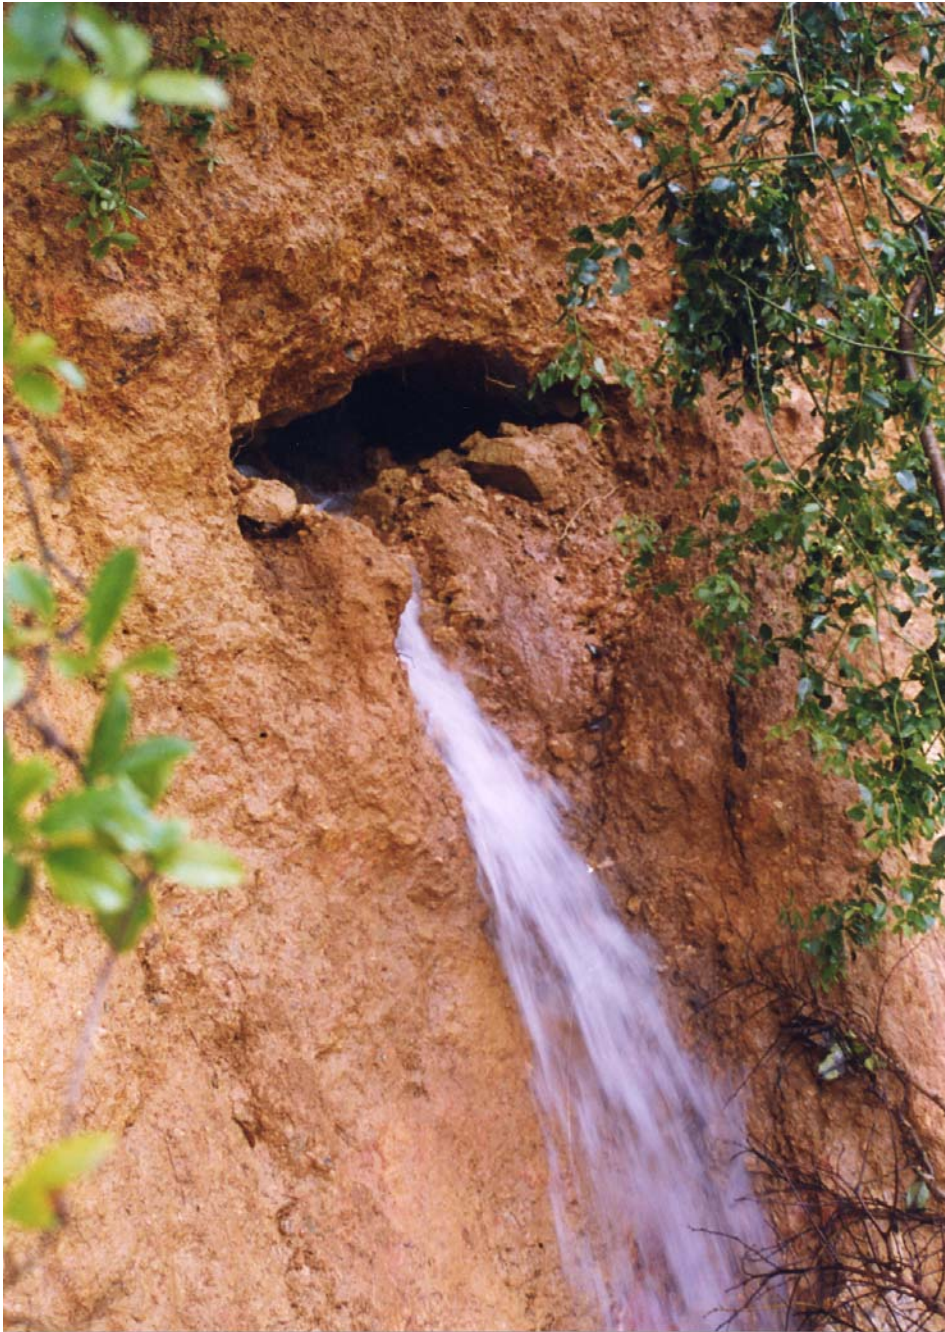
Plate 28(c) - Soil Pipe with Heavy Flow (Plate Location Shown on Drawing EG503) (Taken on 9/9/97)

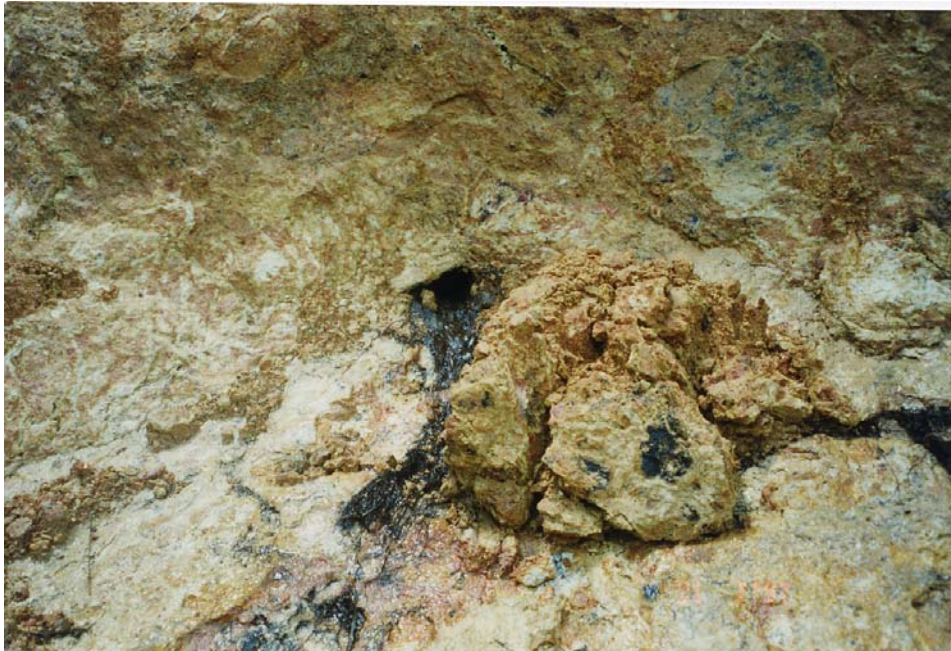
GS 97/107C/08

Extensive seepage was noted within the main scarp issuing from soil pipes between 1.5 m and 40 mm in diameter (Plates 28 & 29). The smaller pipes increased in size and number over the first few months after the landslide occurred, suggesting that active eluviation was taking place within the saprolite mass.
