GEOLOGICAL CHARACTERISATION OF THE LAI PING ROAD LANDSLIDE

GEO REPORT No. 166

N.P. Koor & S.D.G. Campbell

**GEOTECHNICAL ENGINEERING OFFICE
CIVIL ENGINEERING AND DEVELOPMENT DEPARTMENT
THE GOVERNMENT OF THE HONG KONG
SPECIAL ADMINISTRATIVE REGION**

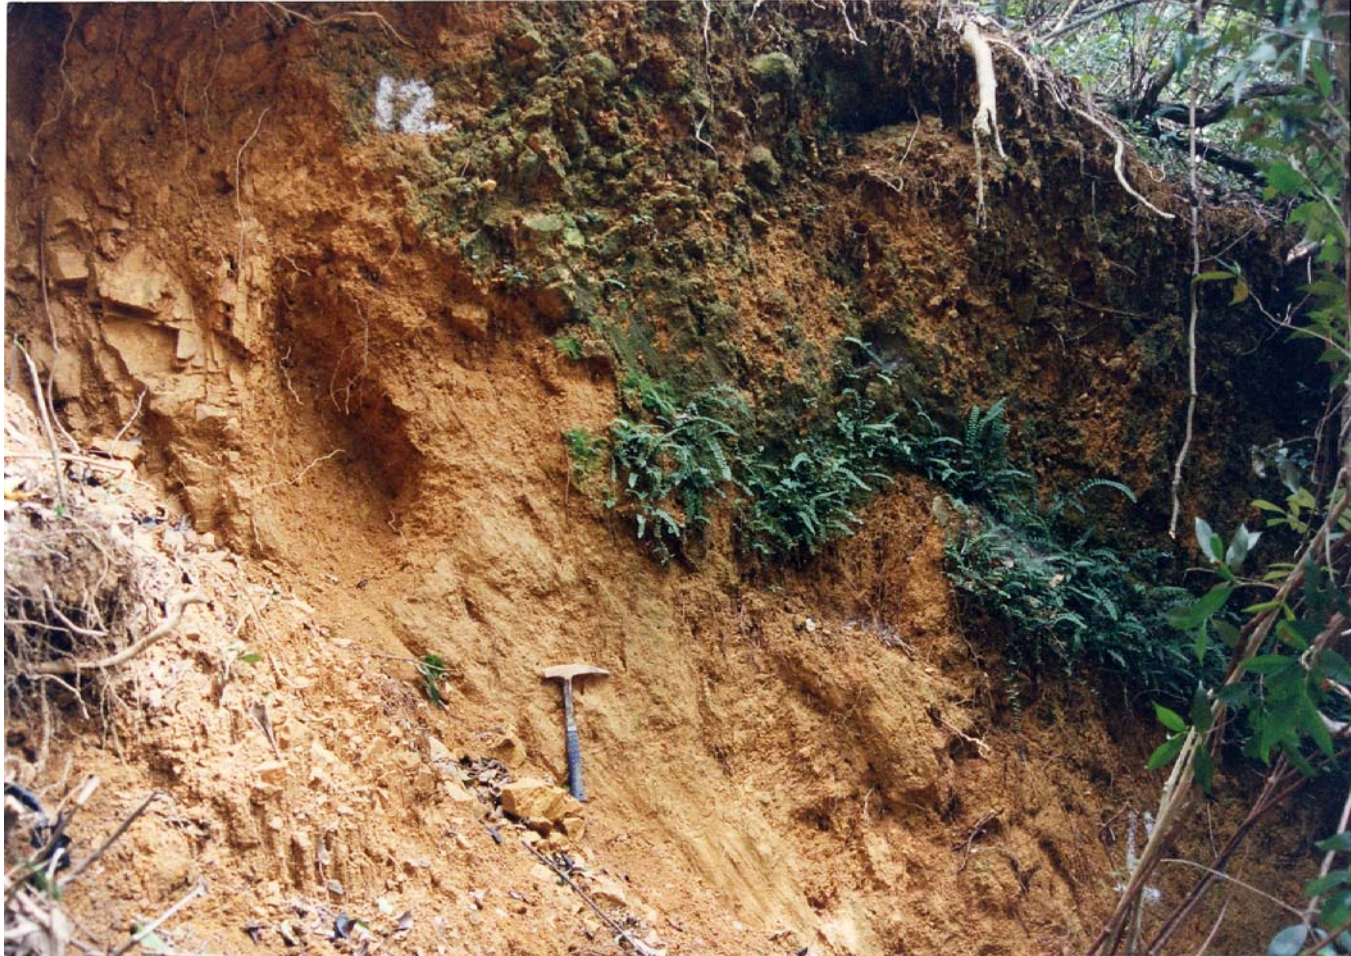
GS 97/82/06

With respect to the age of development of the scarps, site observations clearly indicate movement predating the recent phase of failure, on and after, the 2nd July 1997. The scarps formed recently lack vegetation and contrast markedly with older vegetated scarps. In some instances, the uppermost parts of some scarps have a coating of vegetation (moss, ferns etc.), whereas the lower parts, formed during the most recent activity, are bare. This indicates recent reactivation of a pre-existing scarp (Plate 35). Occasionally, it was possible to measure slickensides related to both recent and older phases of movement on the same scarp (Plate 36a & 36b). During the period of surveying, it was noted that the pristine, recently formed scarps began to acquire a thin cover of moss within two months of their development.

Plate 35 - Minor Scarp Showing at Least Two Phases of Displacement
Recognisable by the Vegetation Line of Moss - Scarp Height
1.8 m - Old Displacement 1.6 m - New Displacement 0.2 m
(Plate Location Shown on Drawing EG503) (Taken on 24/7/97)

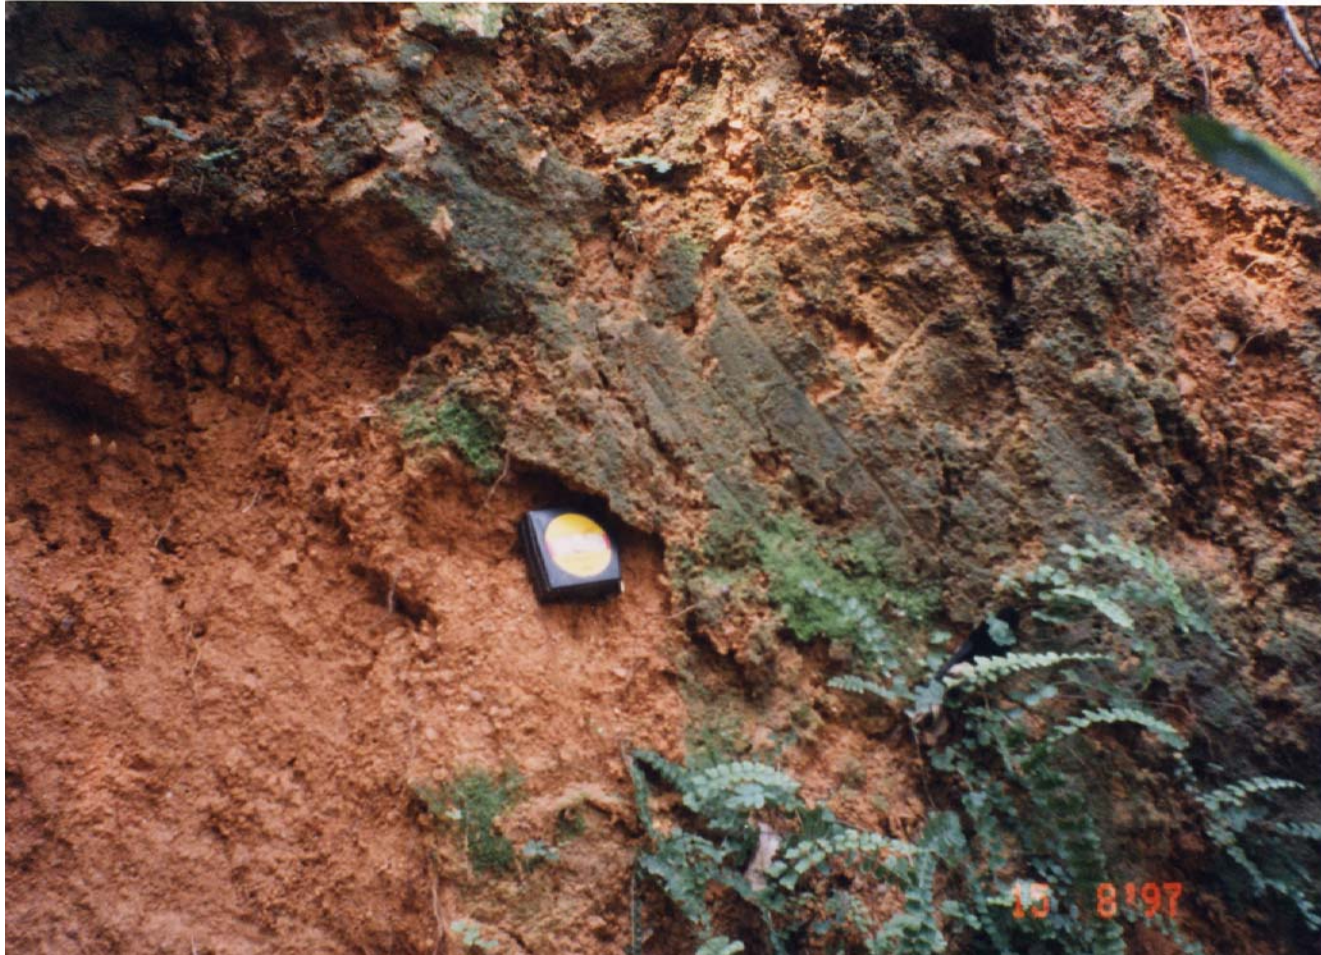
EG 97/117/24

Plate 36(a) - Main Scarp Showing Vegetation Line Indicating at Least Two Phases of Movement Together with Old and Recent Slickensides on the Scarp Surface and a Rhyolite Dyke Contact (Plate Location Shown on Drawing EG503) (Taken on 26/9/97)

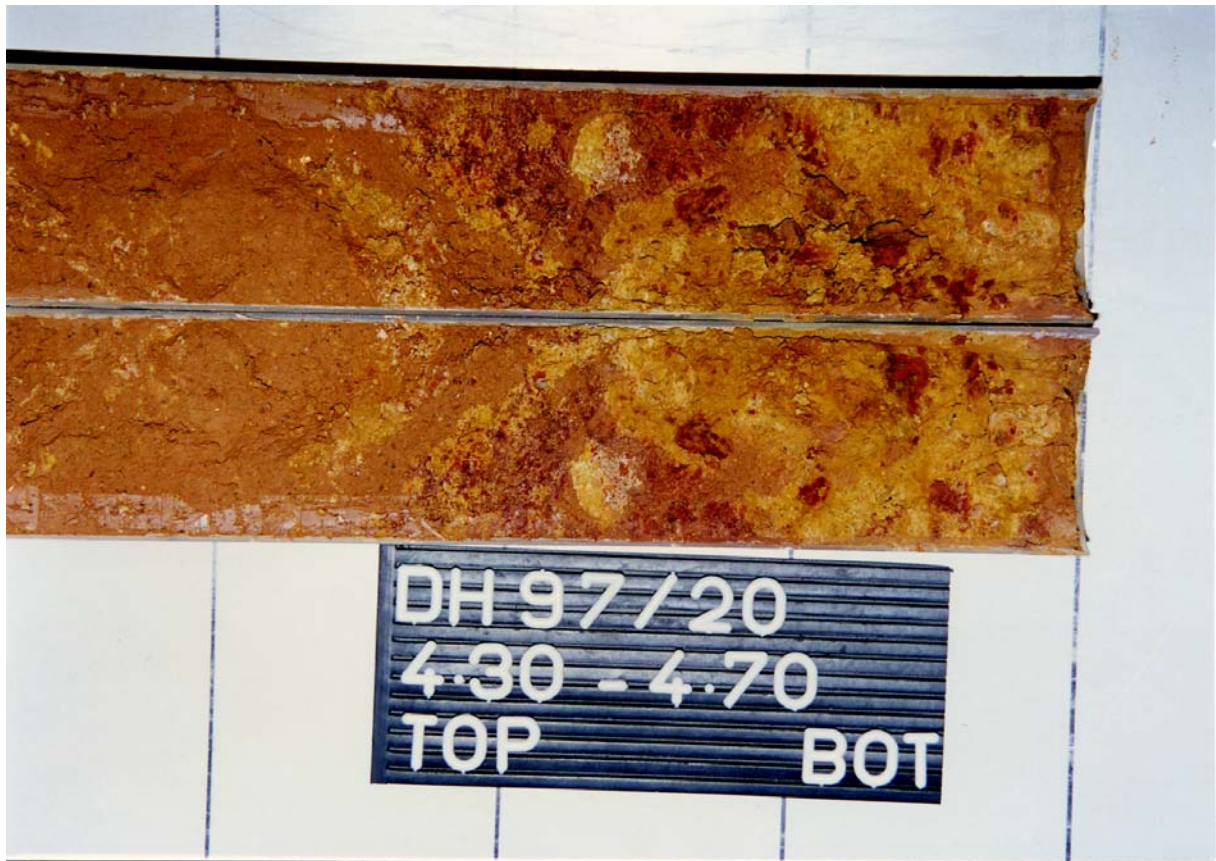
Plate B1 - Drillhole 97/20 - Split Maizier 4.30 m to 4.70 m Transition Zone from Residual Soil into Saprolite.

4.30 m - 4.45 m. Stiff orangish-brown occasionally mottled yellow and pinkish-red very silty CLAY with much angular coarse quartz sand and fine angular gravel (RESIDUAL SOIL) with zones of extremely weak yellow mottled white completely decomposed coarse ash TUFF.

4.45 m to 4.70 m. Very weak brownish-orangish-yellow mottled purplish-red highly decomposed coarse ash TUFF.

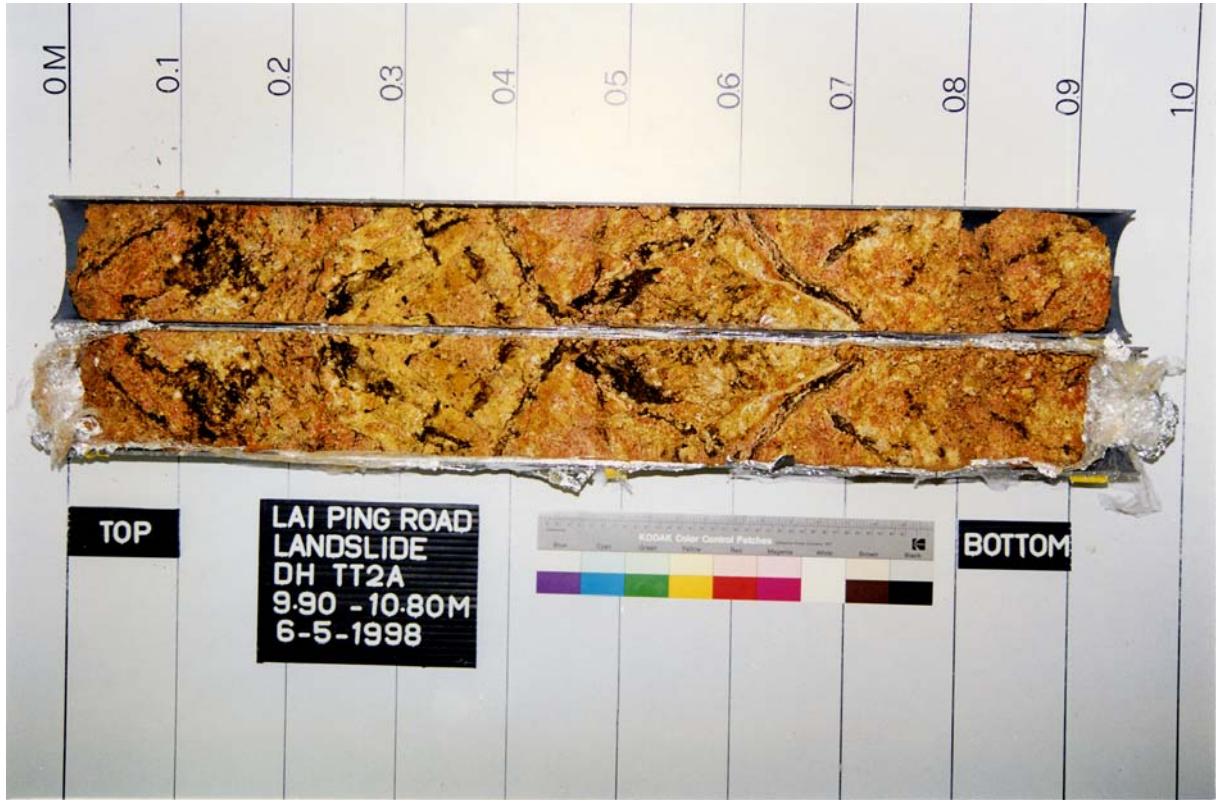
Plate B2 - Drillhole TT2A - Split 4CMLC Core 9.90 m to 10.80m. Typical Completely Decomposed Tuff.

9.90 m to 10.80 m. Extremely weak yellowish-brown mottled reddish-pinkish-brown, white and black and streaked black completely decomposed coarse ash TUFF with very closely-spaced, rough planar, extremely narrow, 70° joints infilled with manganiferous deposits and white clay (kaolin). 30° - 40° moderately spaced joint set with up to 10mm of intercolated white clay and manganiferous deposits between 10.30 m and 10.60 m (clayey SILT with much angular coarse quartz sand and fine angular gravel).

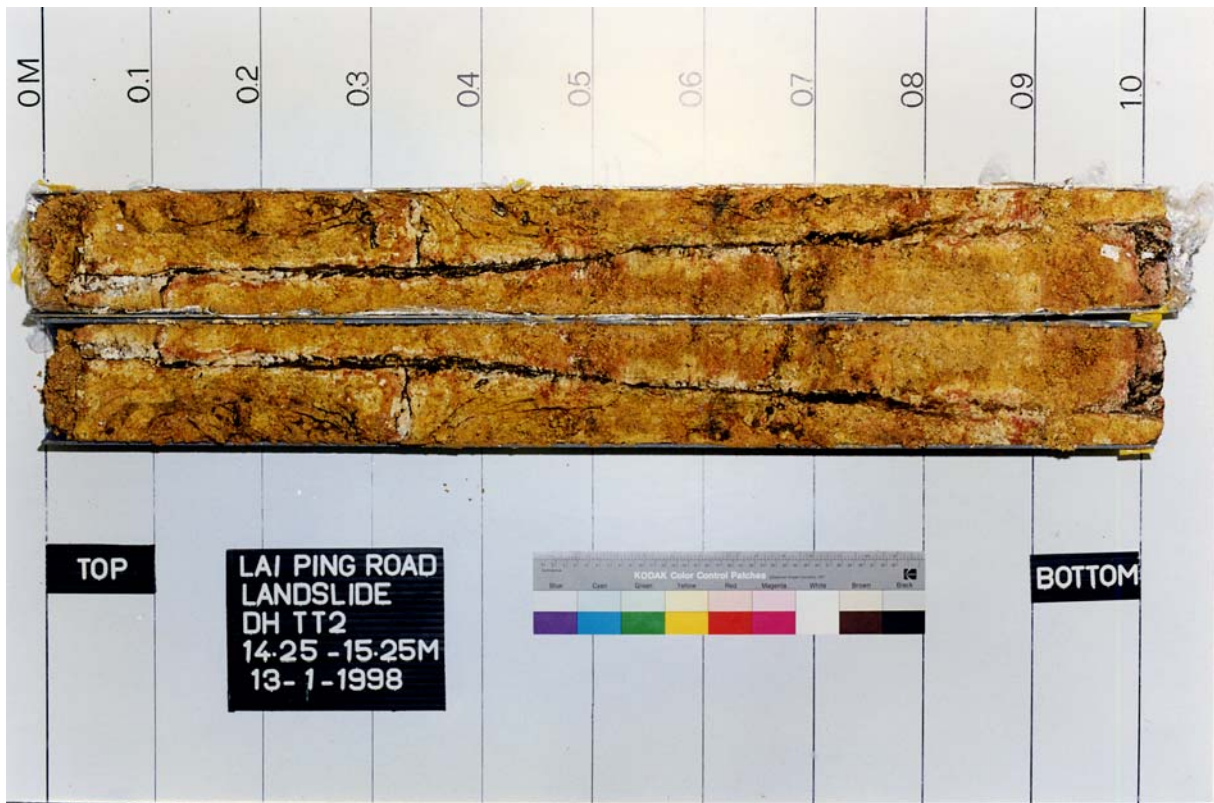
Plate B3 - Drillhole TT2 - Split 4CMLC Core 14.25 m to 15.25 m. Typical Sub-vertical Joint in Completely Decomposed Tuff.

14.25 m to 15.25 m. Extremely weak yellowish-brown mottled pinkish-red and white, completely decomposed coarse ash TUFF (clayey SILT with much angular coarse quartz sand and fine angular gravel).with sub-vertical slickensided undulating, narrow joint with up to 18 mm of white clay (kaolin) and 1 mm manganiferous deposit infill at 14.25 m to 14.55 m with managniferous deposits becoming dominant below 14.55 m. At 15.00 m, 3 mm of manganiferous deposits and no kaolin. Occasional sub-horizontal joints displaced along main sub-vertical joint.

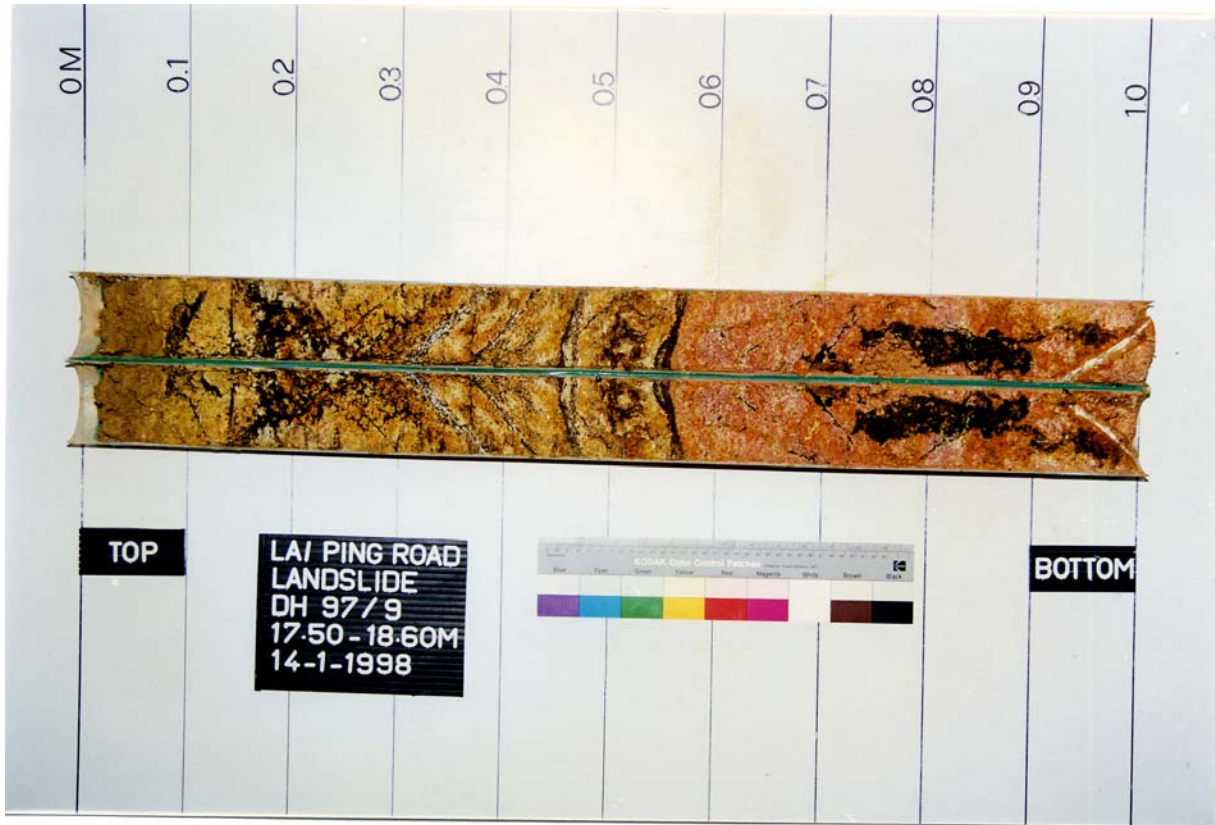
Plate B4 - Drillhole DH 97/9 - Split Maizier 17.50 m to 18.60 m. Sharp Junction between Completely Decomposed Tuff and Highly Altered Completely Decomposed Tuff.

18.05 m to 18.60 m. Extremely weak reddish-purple mottled white, ginger and dark brown and spotted grey completely decomposed coarse ash TUFF (Highly Altered Tuff - stiff silty CLAY) with very closely-spaced 40° to 70° very narrow relic joints infilled with white clay (kaolin) and manganiferous deposits. Where present the kaolin surrounds the manganiferous joint infill deposits.

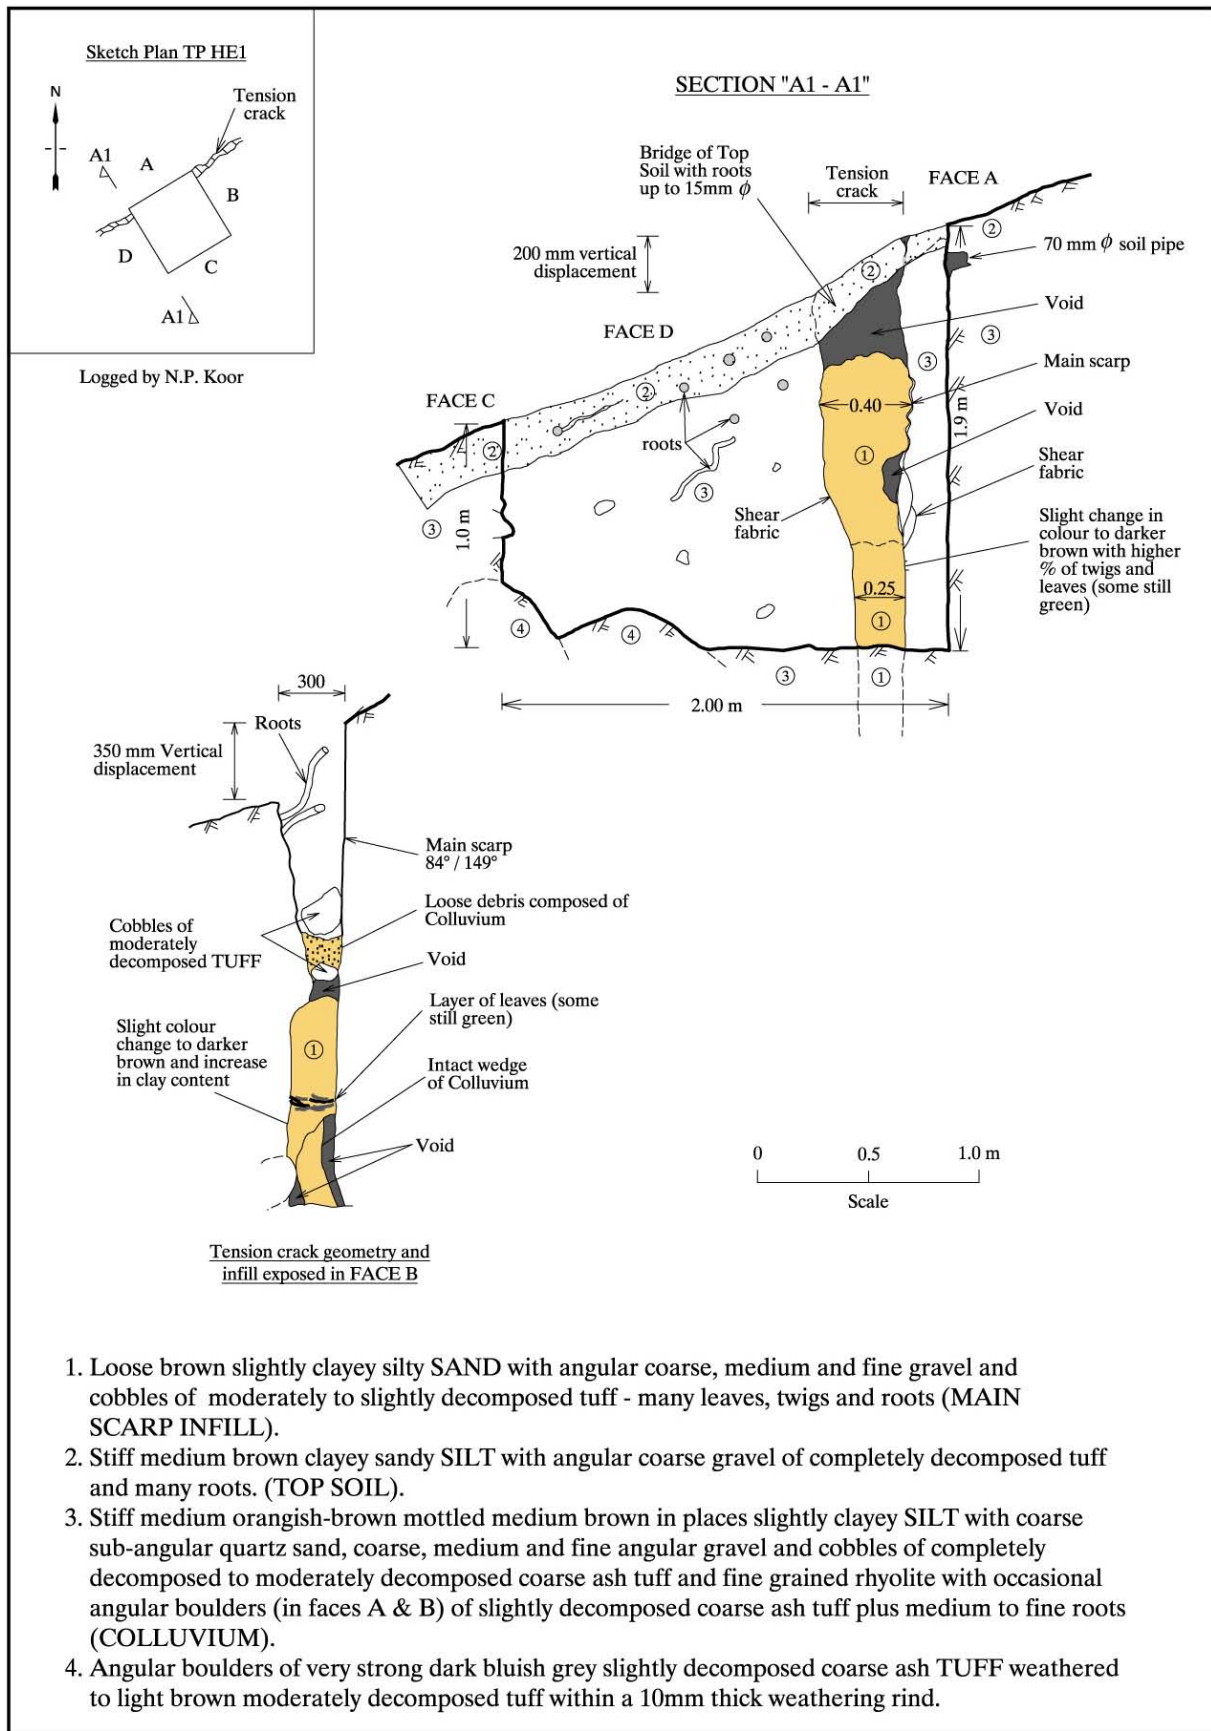
Figure C1 - Lai Ping Road Land Investigation Trial Pit HE1 - Section "A1 - A1"

1. a simple, open tension crack, irregular in profile, with little vertical displacement (see HE1, Figure C1) and no slickensides, up to 300 mm wide and infilled with debris composed of loose, brown, clayey, sand with angular gravel and cobbles, twigs and leaves, to
2. a highly complex zone, grading from an infilled tension crack into a disrupted zone composed of a sheared weathered rock mass with many voids (c. < 10 mm wide) (see HE3, Figure C3 and Plate 31).

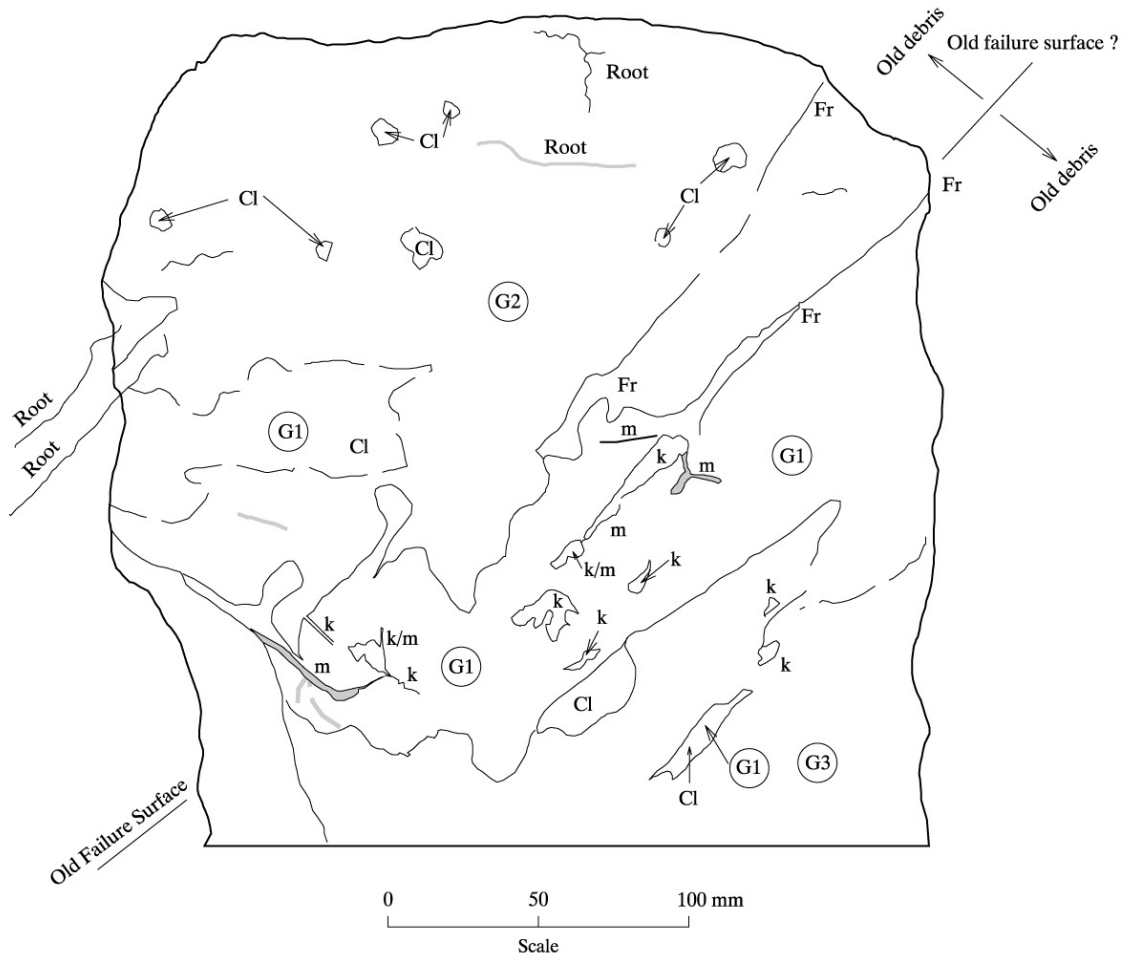
Figure D11 - Block Sample BS 9 - Description of East Face

- ⒸG1 Dense medium pinkish red very sandy clayey SILT (LANDSLIDE DEBRIS CLAST) with wisps of white clay and crinulated extremely narrow very dark brown manganiferous deposits infilled joints.
- ⒸG2 Firm to stiff medium brown mottled reddish brown very clayey SILT with occasional angular to sub-rounded coarse, medium and fine gravel of stiff red silt and moderately decomposed coarse ash tuff and occasional fine roots (LANDSLIDE DEBRIS MATRIX).
- ⒸG3 Firm light brownish yellow sandy very clayey SILT (RESIDUAL SOIL).
- k - Firm white silty CLAY (KAOLIN) - Kaolin often rimmed with manganiferous deposits.
- m - Firm dark brown SILT (MANGANIFEROUS DEPOSITS).
- Fr - Fracture in sample.
- Cl - Debris clast.

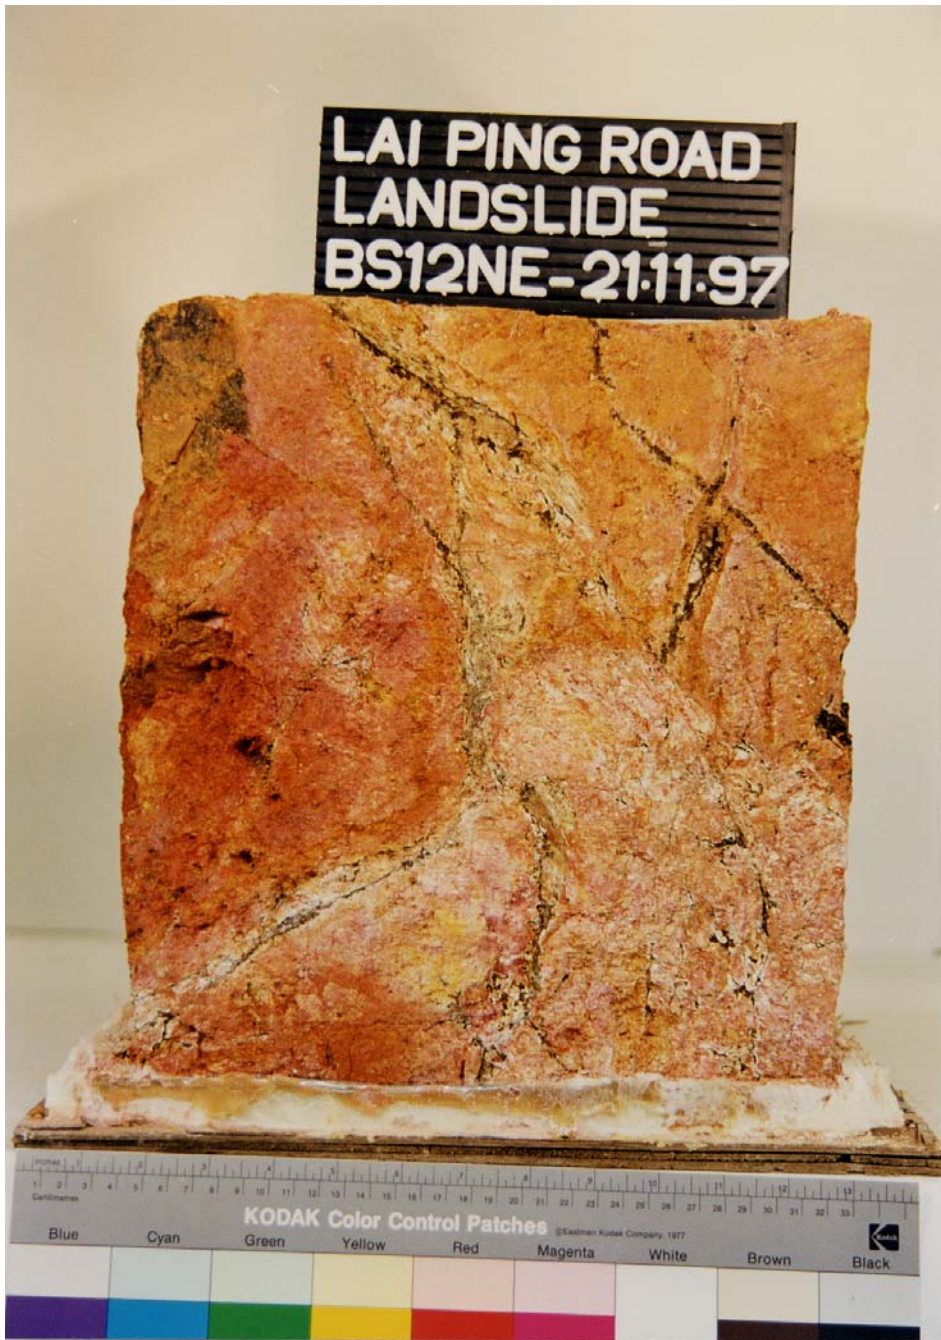
Plate D12 - Block Sample BS 12 - Northeast Face

Block Sample BS 12 - Northeast Face
Sample taken - 30-10-97
First Unpacked - 21-11-97
Date Described - 21-11-97 by N.P. Koor
Sample Condition - Good.

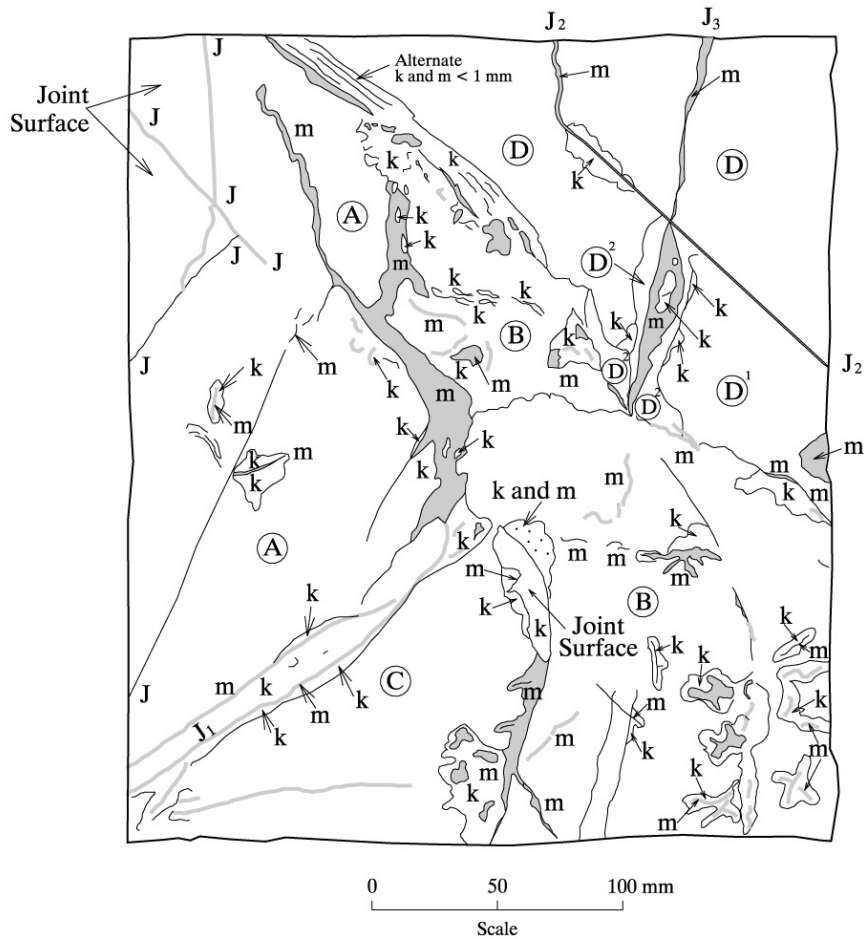
- (A) - Extremely weak dark brownish red mottled pink and white completely decomposed fine ash TUFF with tight manganiferous deposits infilled joints (J) often surrounded by thin veneer of white clay (Dense slightly clayey SILT with very occasional coarse sub-rounded quartz sand).

- (B) - Stiff light pink mottled white occasionally light brown and black silty CLAY with very occasional coarse sub-rounded quartz sand (Highly altered tuff appears to have been replaced with white and pink clay. Manganiferous deposits infill to contorted joints often surrounded by white clay.

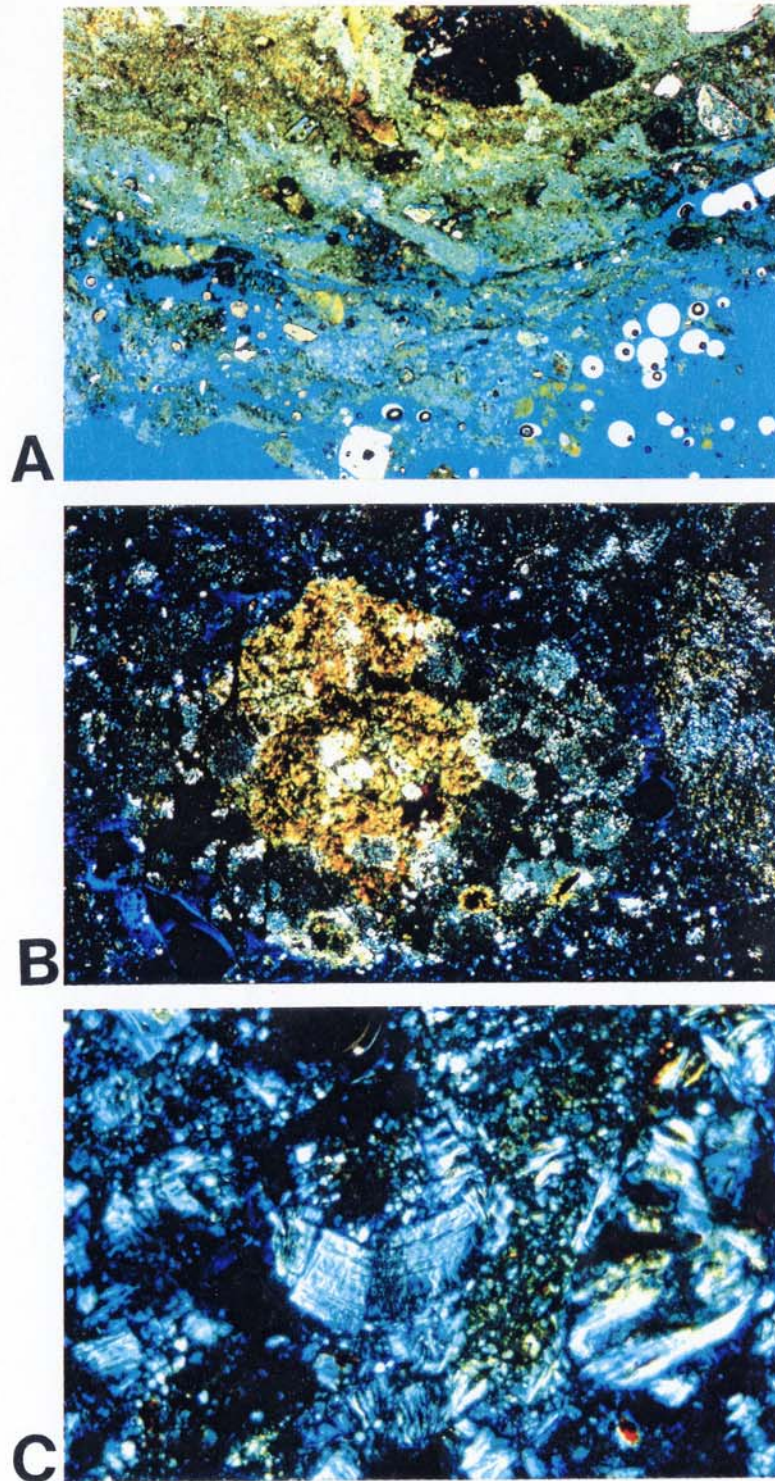
crystals (flakes) stacked on 001, up to 1.0 mm thick, and in places these have also been deformed (Plate 1C). Deformation of the books has resulted in the bending and fracturing of the planar kaolinite crystals which are replaced by anastomosing intergrowths of a fibrous mineral, possibly halloysite, and granular ferromanganese minerals (Plate 2A). Ferromanganese minerals also occur as clasts and as a replacement of the clay matrix.

1A. Sample BS5/A5/D. Lai Ping Road landslide. Optical photomicrograph of clay-rich saprolite with dark-brown fragments of ferromanganese minerals. The clay is impregnated with blue-stained resin (plane-polarized light; field width 9 mm).

1B. Sample BS5/A5/D. Lai Ping Road landslide. Optical photomicrograph of igneous grain partially replaced by intergrowths of yellow-brown biotite (cross-polarized light; field width 4.5 mm).

1C. Sample BS5/A5/D. Lai Ping Road landslide. Optical photomicrograph of deformed kaolinite 'books' in the clay matrix. (cross-polarized light; field width 1.1 mm).

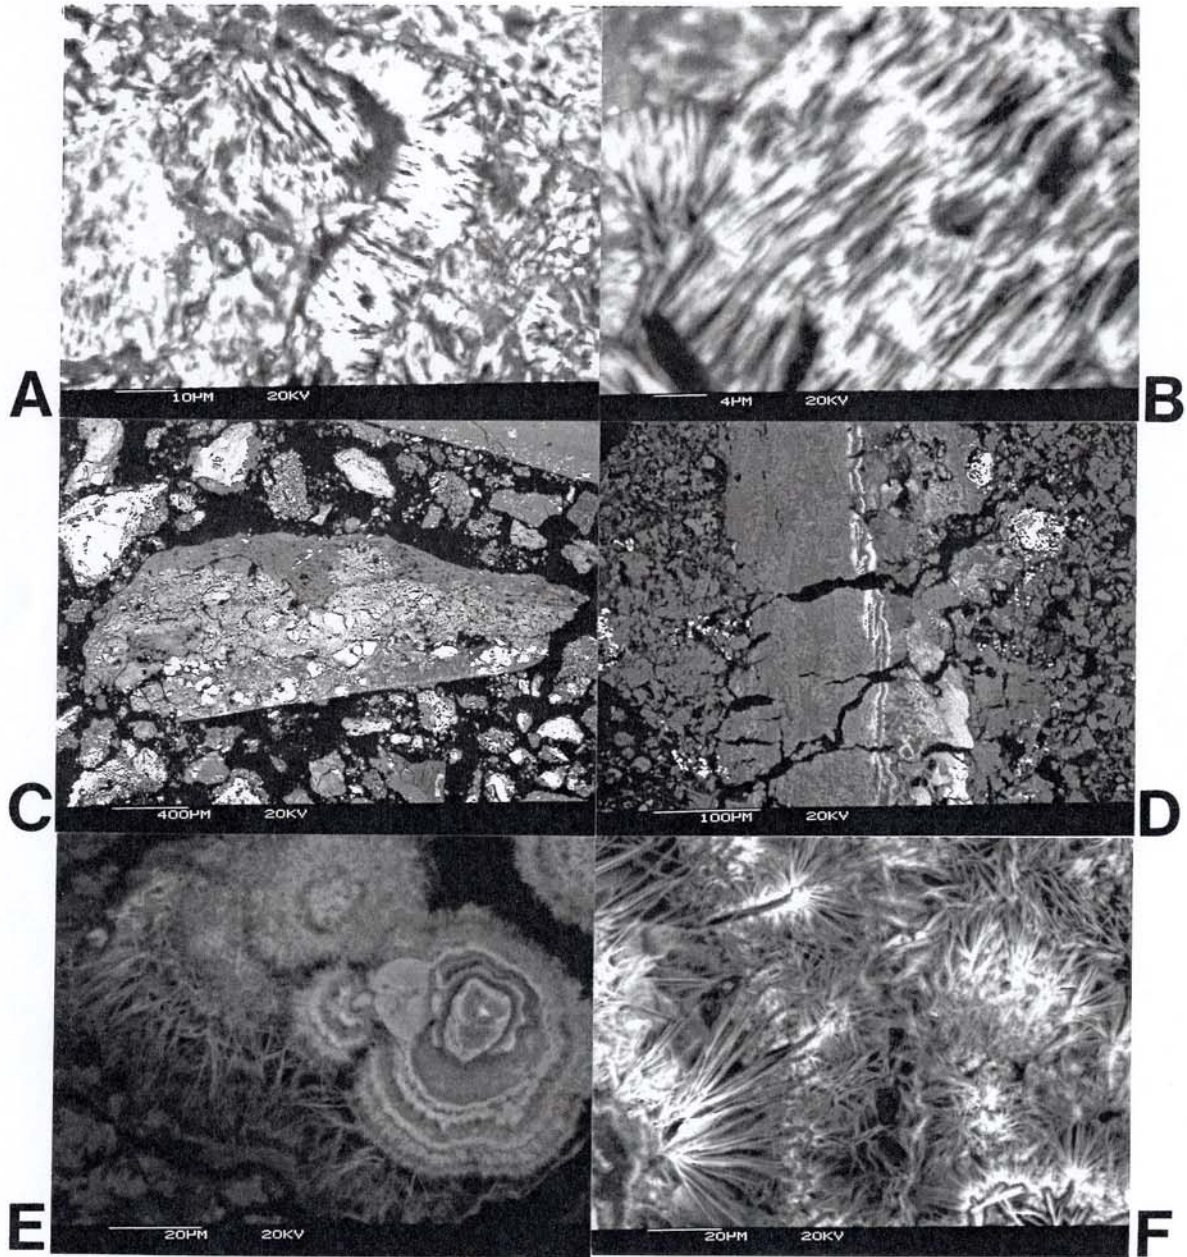
3A. Sample BS7/A7/C. Lai Ping Road landslide. Backscattered secondary electron photomicrograph of deformed kaolinite book in the clay matrix.

3B. Sample BS7/A7/C. Lai Ping Road landslide. Backscattered secondary electron photomicrograph of deformed book-like kaolinite plates partially replaced by fibrous halloysite.

3E. Sample BS8/A8/B. Lai Ping Road landslide. Backscattered secondary electron photomicrograph of Mn-oxide showing concentric growth of thin platy crystals.

3F. Sample BS8/A8/B. Lai Ping Road landslide. Backscattered secondary electron photomicrograph of Mn-oxide showing radial clusters of thin platy crystals.

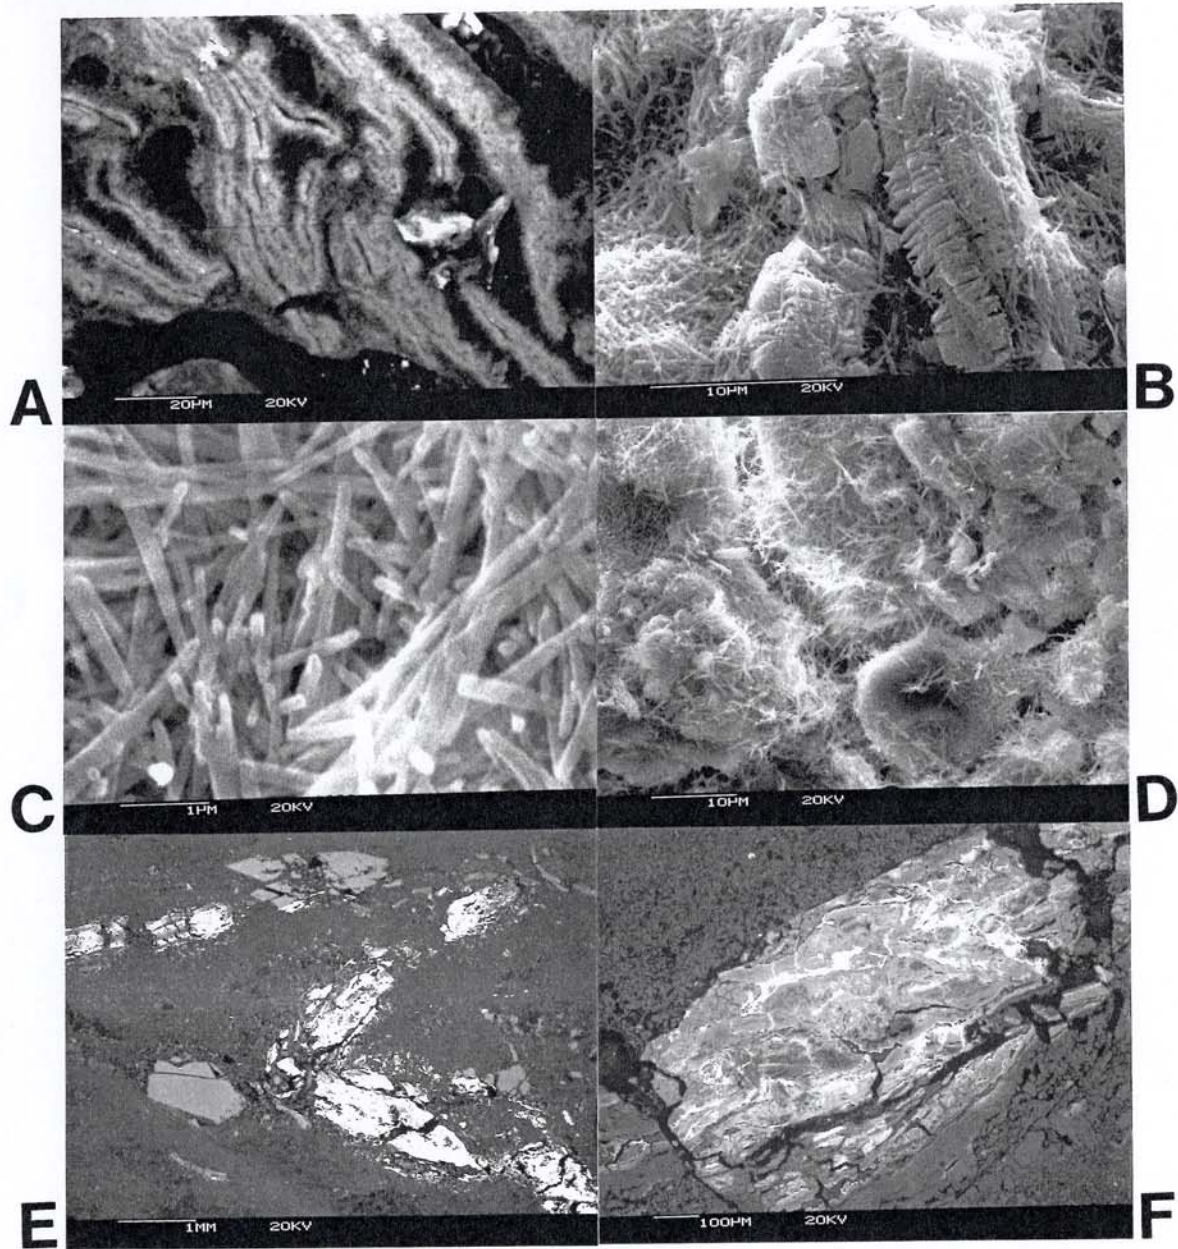
Within the gouge, slip clay fragments consisting of kaolin and ferromanganese laminae have been deformed and disrupted (Plate 6E). Some are compound fragments showing internal deformation of the slip clay and associated Mn-oxide (Plate 6F). Fe-oxyhydroxides are also found in the fragments, in clusters of radiating platy crystals (Plate 9A). Granules of a Ce-rich mineral (?carbonate) are associated with some Fe-oxyhydroxide clusters (Plate 9B). The appearance and structure of the clay fragments in the gouge suggest that they are pre-existing slip clays or tension gash fills which were detached and deformed by earlier movements on a slip plane.

6A. Sample BS8/A8/B. Lai Ping Road landslide. Backscattered secondary electron photomicrograph of orientated domains of kaolin clay with overgrowths of fibrous halloysite.

6B. Sample BS8/A8/B. Lai Ping Road landslide. Backscattered secondary electron photomicrograph of kaolinite books with overgrowths of fibrous halloysite.

6E. Sample BS12/B1/A. Lai Ping Road landslide. Backscattered secondary electron photomicrograph showing deformed and disrupted ferromanganese laminae (bright grey) and quartz grains (mid-grey).

6F. Sample BS12/B1/A. Lai Ping Road landslide. Backscattered secondary electron photomicrograph of a compound slip clay fragment. Folded and disrupted slip clay comprising mid-grey kaolin and bright grey Mn-oxide formed early. Later slip clay and Mn-oxide is undeformed (bottom right of fragment).

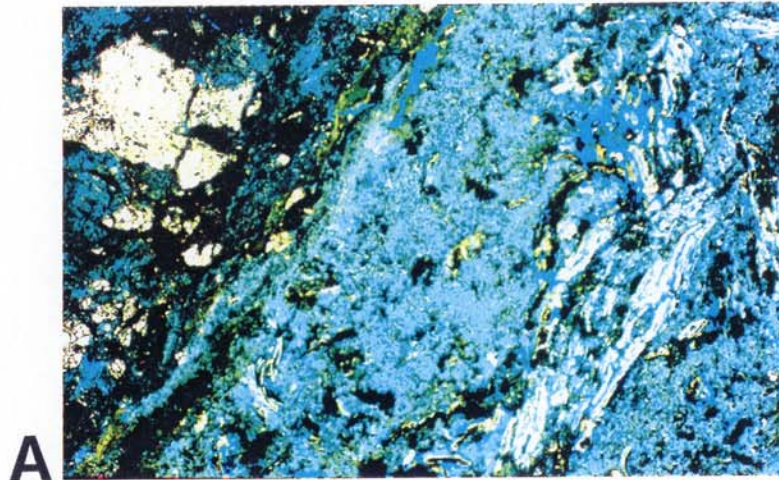
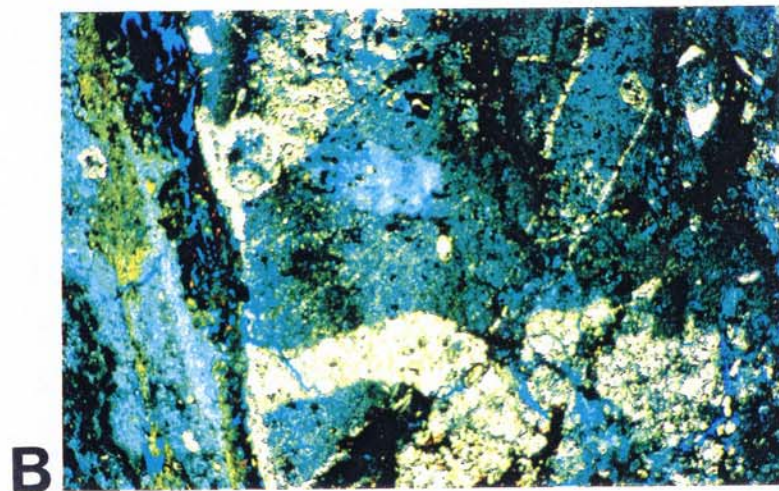
7A. Sample BS12/B1/B. Lai Ping Road landslide. Optical photomicrograph showing a pale blue clay gouge with slip clay fragments. The blue-green clay (top left) forms part of a slip plane against a quartz-rich protolith stained dark-brown by ferromanganese minerals (plane-polarized light; field width 9 mm).

7B. Sample BS12/B1/B. Lai Ping Road landslide. Optical photomicrograph of quartz-filled tensional veins in the protolith, normal to a slip plane (subvertical, left of field). Two quartz-filled veins have also formed along the slip plane together with dark-brown ferromanganese laminae (plane-polarized light; field width 4.5 mm).

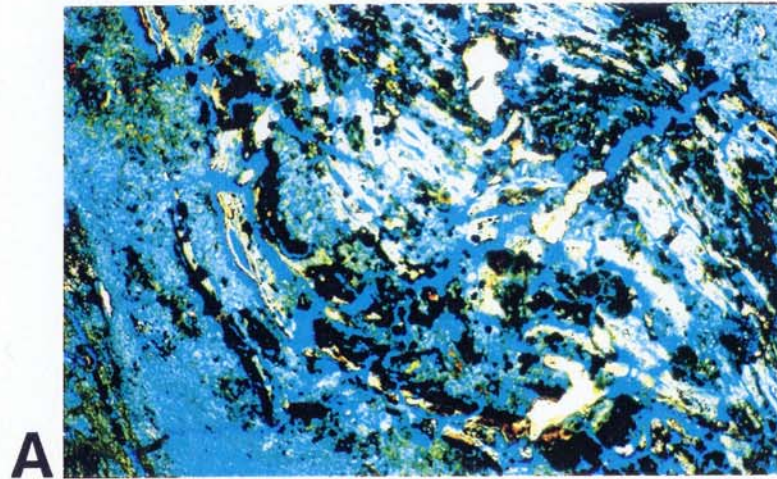
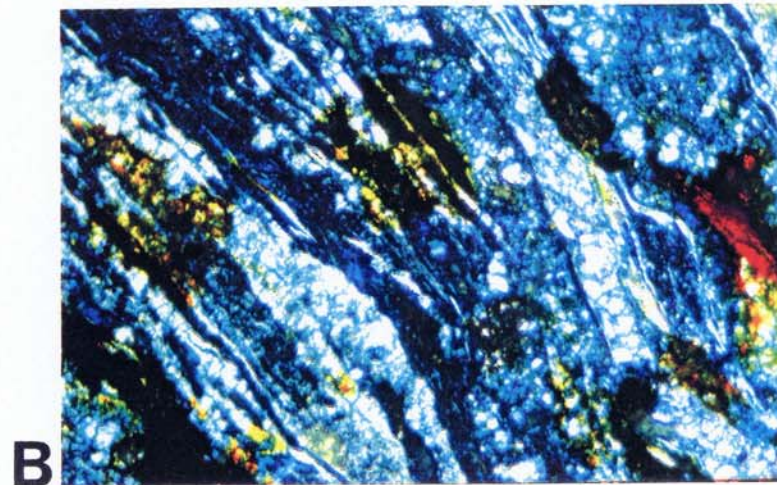
8A. Sample BS12/B1/B. Lai Ping Road landslide. Optical photomicrograph showing contorted slivers of slip clay consisting of whitish or pale-blue orientated domains of kaolin with dark-brown ferromanganese minerals (plane-polarized light; field width 4.5 mm).

8B. Sample BS12/B1/B. Lai Ping Road landslide. Optical photomicrograph of slip clay. Dark blue orientated domains of kaolin minerals alternate with whitish or pale-blue random domains. Brown and yellow staining is from ferromanganese minerals (cross-polarized light; field width 1.1 mm).

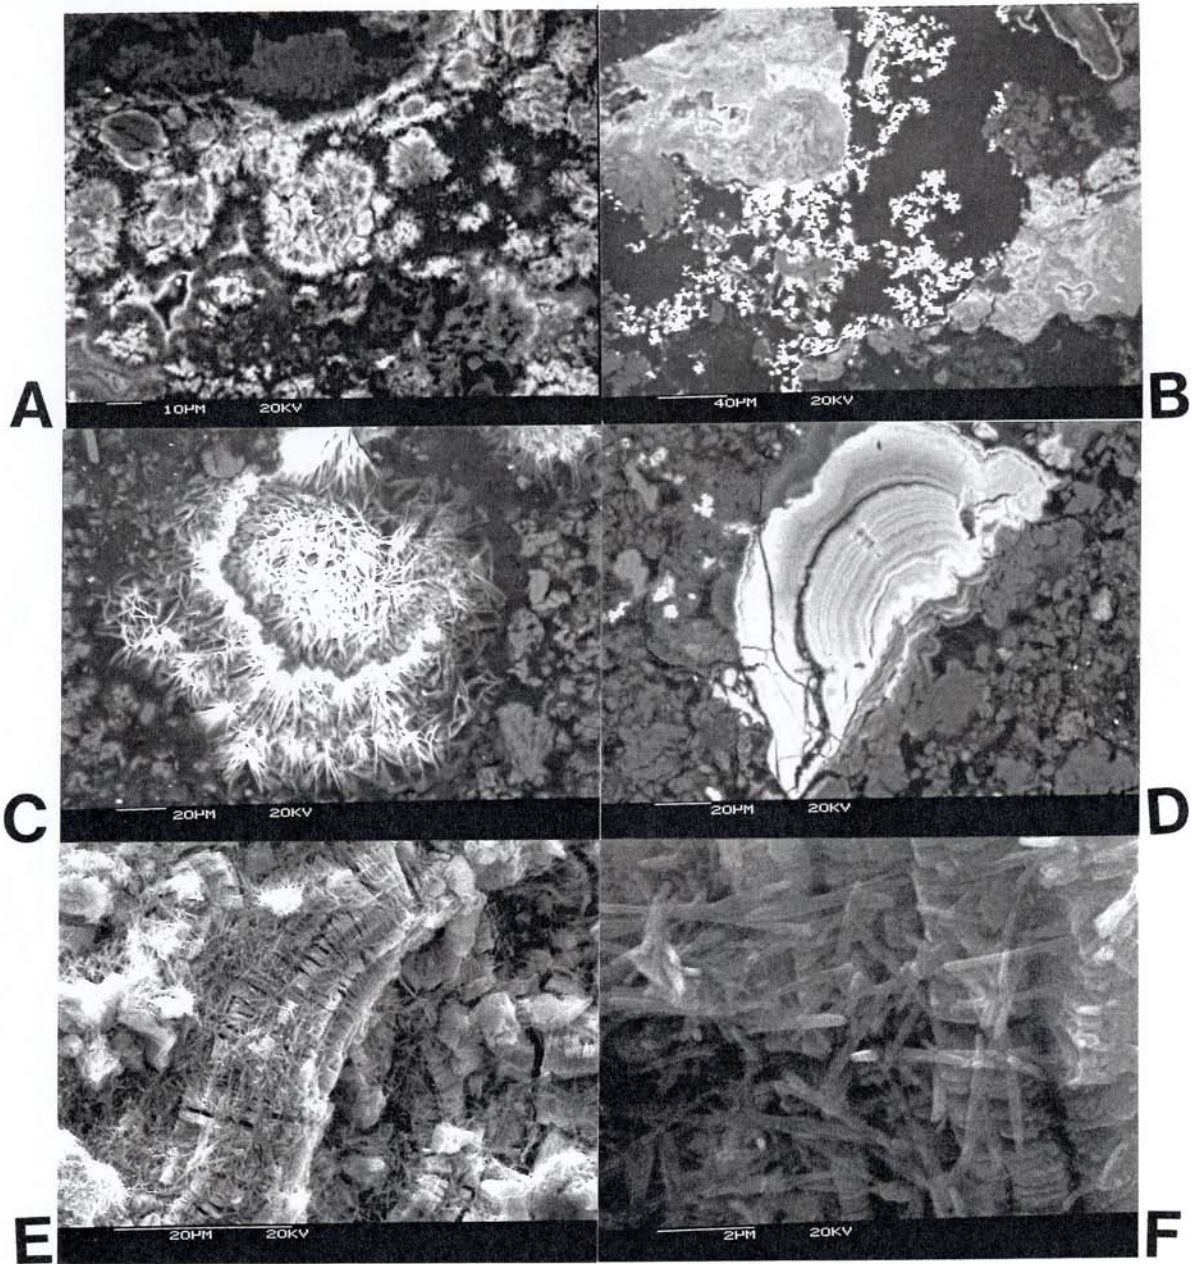
9A. Sample BS12/B1/A. Lai Ping Road landslide. Backscattered secondary electron photomicrograph of Fe-oxyhydroxide forming clusters of radiating platy crystals in slip clay fragments.
9B. Sample BS12/B1/A. Lai Ping Road landslide. Backscattered secondary electron photomicrograph of Ce-rich mineral forming granules in slip clay fragment.
9C. Sample BS12/B1/B. Lai Ping Road landslide. Backscattered secondary electron photomicrograph showing concentric growth of Mn-oxide.
9D. Sample BS12/B1/B. Lai Ping Road landslide. Backscattered secondary electron photomicrograph of well developed concentric growth pattern in Fe-oxyhydroxide.
9E. Sample BS12/B1/B. Lai Ping Road landslide. Backscattered secondary electron photomicrograph of kaolinite books heavily replaced and overgrown by fibrous halloysite.
9F. Sample BS12/B1/B. Lai Ping Road landslide. Backscattered secondary electron photomicrograph of halloysite fibres replacing books of kaolinite crystals.
