**PERFORMANCE EVALUATION OF THE PERMANENT NEW JERSEY  
SAFETY SHAPE BARRIER – UPDATE TO NCHRP 350 TEST NO.  
4-12 (2214NJ-2)**

**MIDWEST ROADSIDE SAFETY FACILITY**

MwRSF Research Report No. TRP-03-178-06

October 13, 2006

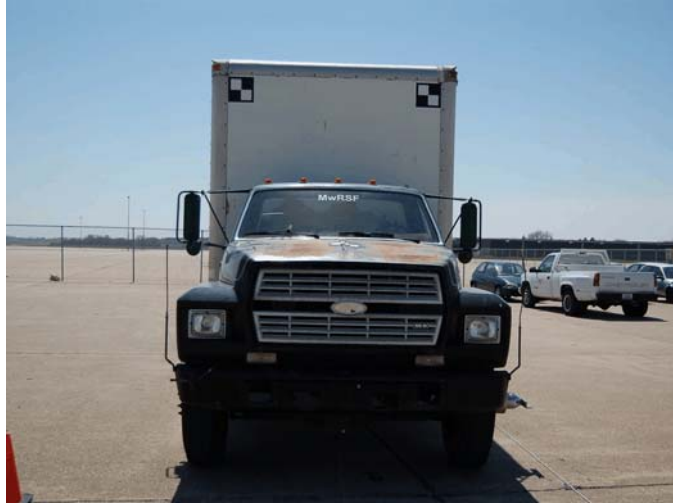
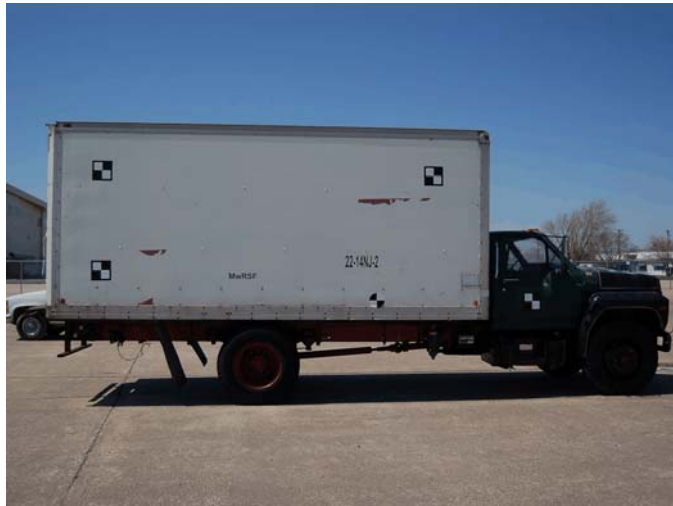
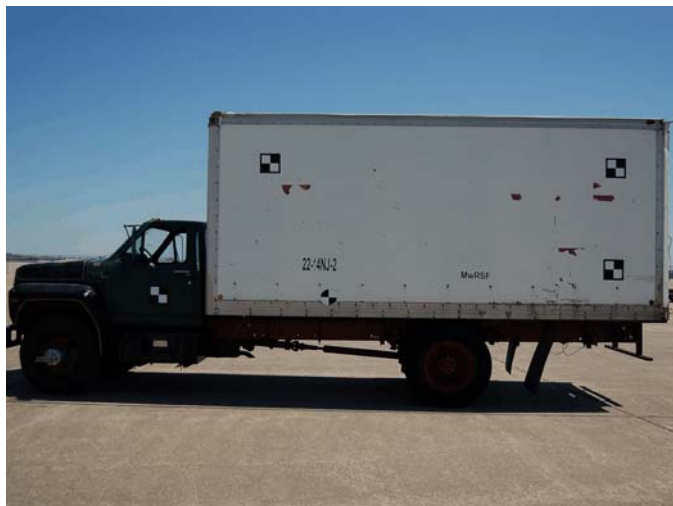
Figure 1. Test Vehicle, Test 2214NJ-2

For test 2214NJ-2, a 1989 Ford F-800 was used as the test vehicle. The test inertial and gross static weights were 9,999 kg (22,045 lbs). The test vehicle is shown in Figure 1, and vehicle dimensions are shown in Figure 2.

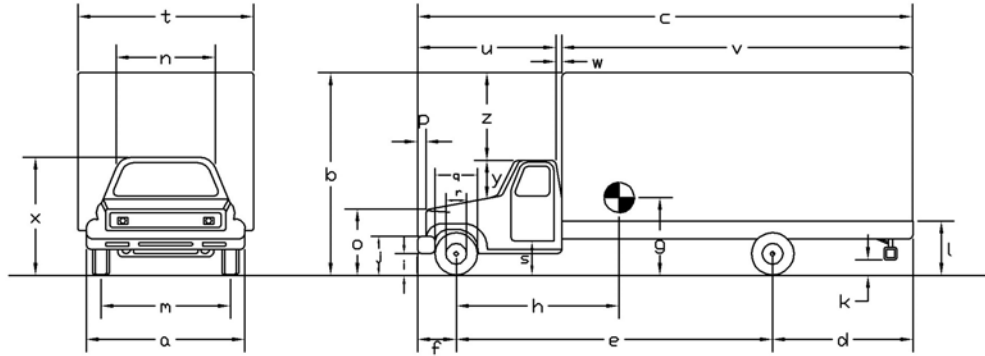
Figure 2. Vehicle Dimensions, Test 2214NJ-2

Note any damage prior to test: Rusty Cab Floor

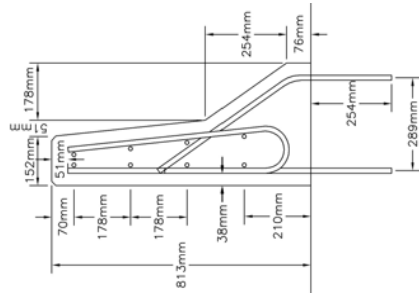
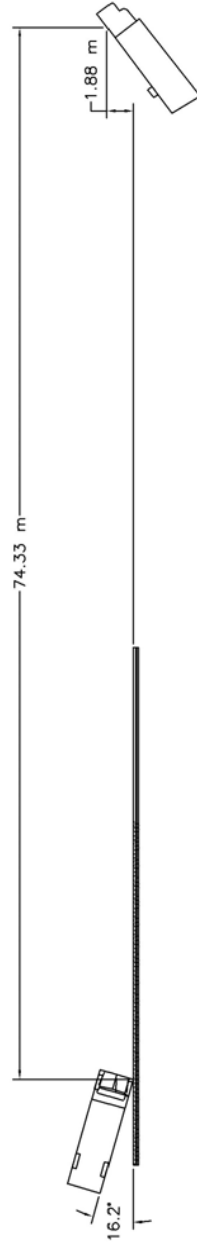
The analysis of the test results for test no. 2214NJ-2 showed that the permanent New Jersey safety shape concrete barrier system impacted with the 1000S vehicle of the Update to NCHRP Report No. 350 did not adequately contain the vehicle on the traffic-side face of the barrier system. It also did not safely redirect the vehicle since the vehicle did not remain upright after collision with the barrier. There were no detached elements nor fragments which showed potential for penetrating the occupant compartment nor presented undue hazard to other traffic. Deformations of, or intrusion into, the occupant compartment that could have caused serious injury did not occur. After collision, the vehicle did not exit the barrier as it rolled over the top of the barrier. Therefore, test no. 2214NJ-2 conducted on the permanent New Jersey safety shape concrete barrier system was determined to be unacceptable according to the TL-4 safety performance criteria found in Update to NCHRP Report No. 350 due to vehicle penetration and rollover the top of the barrier.

● Test Agency	MwRSF	● Post-Impact Trajectory	Unsatisfactory
● Test Number	2214NJ-2	● Vehicle Stability	74.33 m downstream
● Date	4/13/06	● Stopping Distance	1.88 m laterally behind
● NCHRP 350 Update Test Designation	4-12	● Occupant Impact Velocity (350 Update)	
● Appurtenance	Permanent New Jersey Safety Shape Barrier	Longitudinal (not required)	-1.99 m/s
● Total Length	36.58 m	Lateral (not required)	-4.15 m/s
● Key Elements - Barrier		● Occupant Ridedown Deceleration (350 Update)	
Description	Half-Section New Jersey Shape Barrier	Longitudinal (not required)	-22.39 Gs
Base Width	381 mm	Lateral (not required)	-8.84 Gs
Height	813 mm	● THIV (not required)	NA
Concrete Material	Nebraska 47-BD Mix	● PHD (not required)	NA
Reinforcing Steel Material	Grade 60 Rebar	● Test Article Damage	Minimal
Type of Soil	NA	● Test Article Deflections	
● Test Vehicle		Permanent Set	NA
Type/Designation	10000S	Dynamic	NA
Make and Model	1989 Ford F-800	Working Width	NA

Curb	5,439 kg	● Vehicle Damage	Extensive (rollover)
Test Inertial	9,999 kg	VDS <sup>5</sup>	1-RFQ-5 & 1-RD-6
Gross Static	9,999 kg	CDC <sup>6</sup>	1-RDAS9
● Impact Conditions		Maximum Deformation	NA
Speed	90.9 km/h		
Angle	16.2 degrees		
Impact Location	6.10 m downstream from upstream end		
● Exit Conditions			
Speed	NA		
Angle	NA		
Exit Box Criterion	Fail

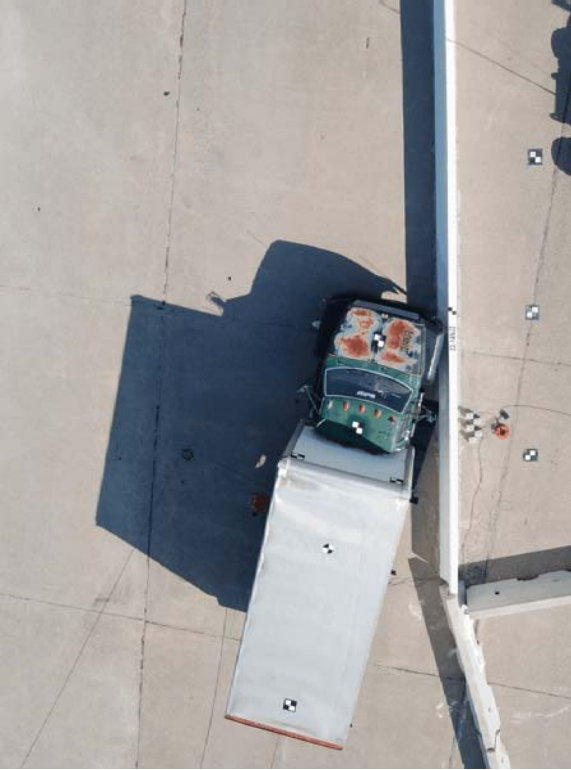
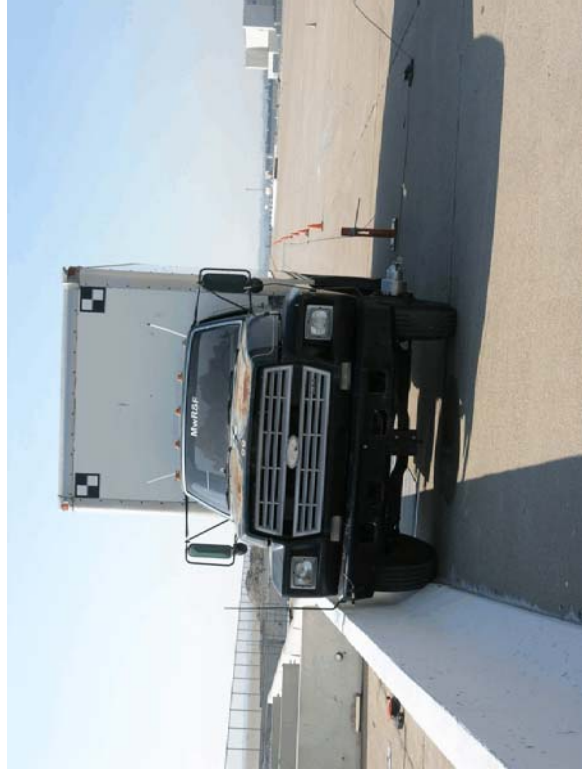
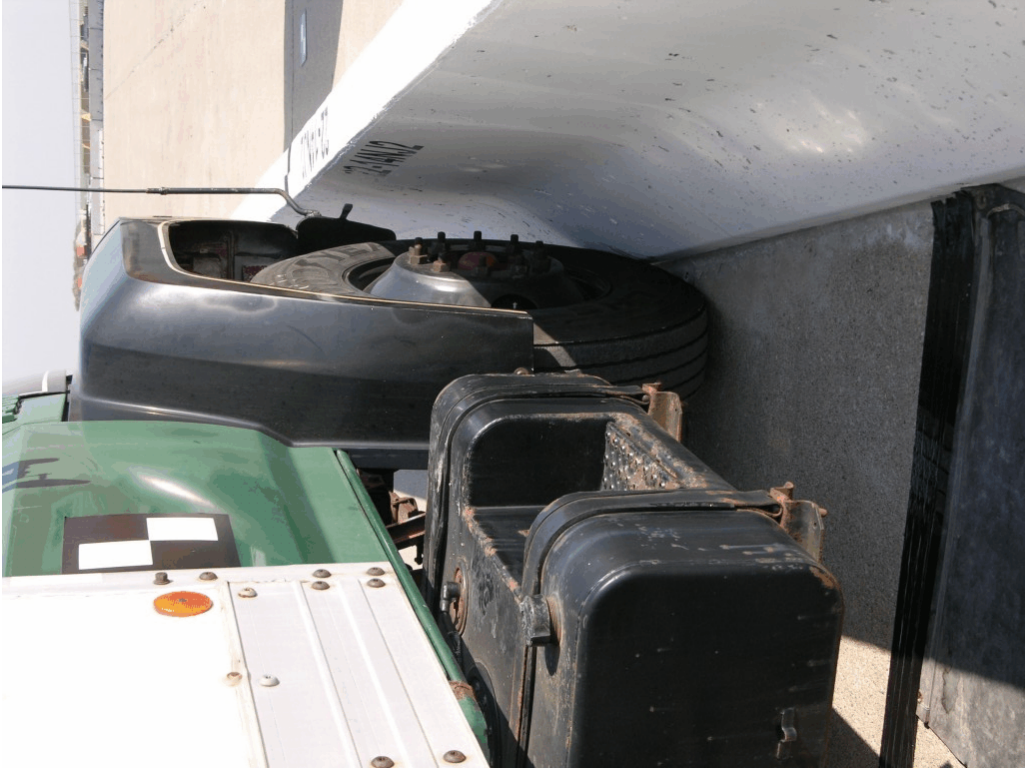
Figure 18. Impact Location, Test 2214NJ-2

Initial vehicle impact was to occur 6.10 m (20 ft) downstream from the upstream end of the barrier, as shown in Figure 18. Actual vehicle impact occurred at the targeted impact. At 0.064 sec after impact, the vehicle began to redirect. At 0.084 sec, the right-front corner of the vehicle protruded over the top of the barrier. At 0.120 sec, the cab portion of the vehicle encountered counter-clockwise (CCW) roll away from the barrier. At this same time, the right side of the cab rode on top of the barrier and the box contacted the barrier. At 0.140 sec, the cab and box twisted while the box rolled clockwise (CW) toward the barrier. At 0.220 sec, the rear of the box redirected into the barrier as the cab continued to slide along the top of the barrier. At 0.264 sec, the CW roll of the box increased significantly. At 0.310 sec, the roll of the cab ceased. At 0.410 sec, the left-rear tire was airborne. At 0.470 sec, the entire truck rolled CW over the top of the barrier. At 0.526 sec, the left-front tire became airborne. At 0.758 sec, the front axle disengaged from the truck. At 0.850 sec, all tires were airborne. At 1.202 sec, the vehicle had rolled CW to a position of the right side being parallel to the ground. At 1.342 sec, the right side of the vehicle contacted the ground behind
