SAFETY PERFORMANCE EVALUATION OF MICHIGAN'S 4X5 PORTABLE SIGN SUPPORT

MIDWEST ROADSIDE SAFETY FACILITY

MwRSF Research Report No. TRP-03-135-03

June 20, 2003

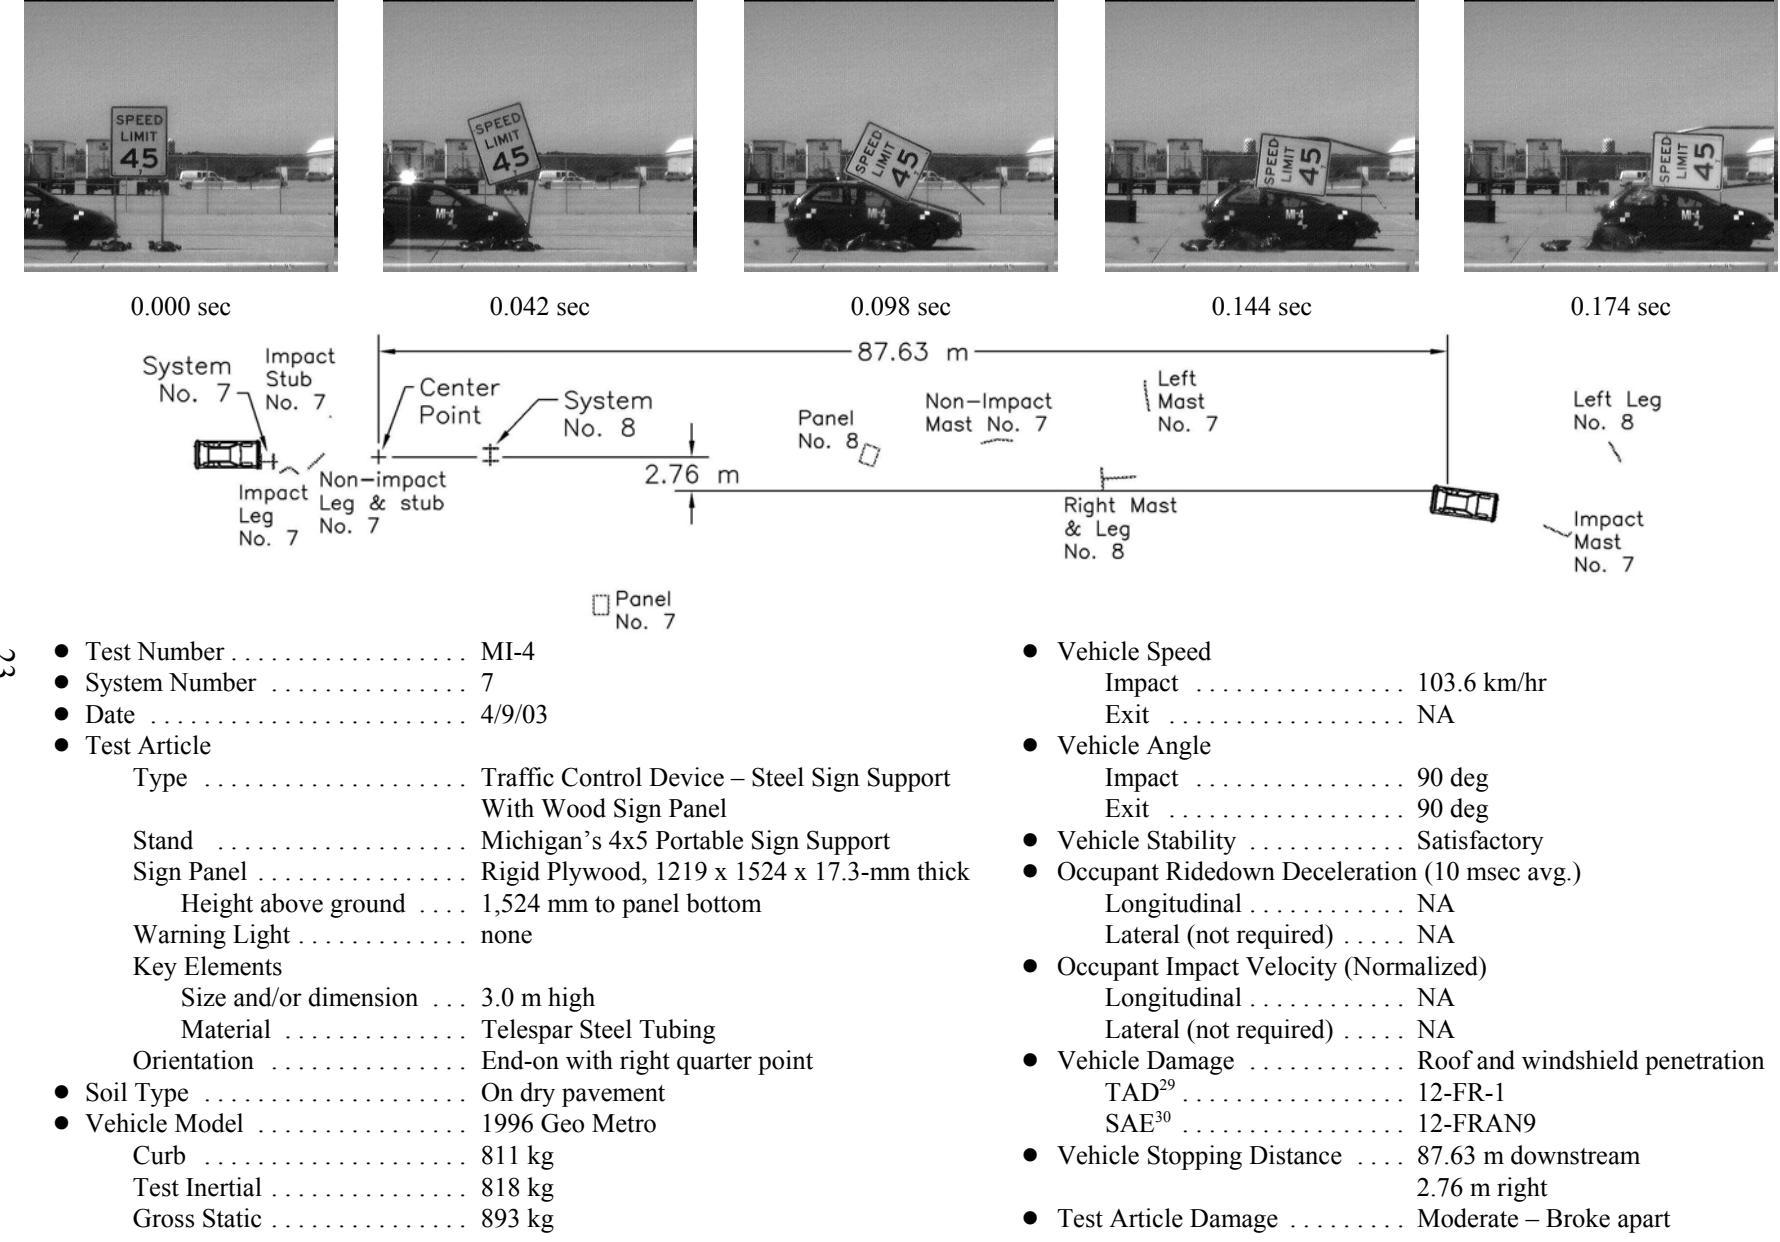
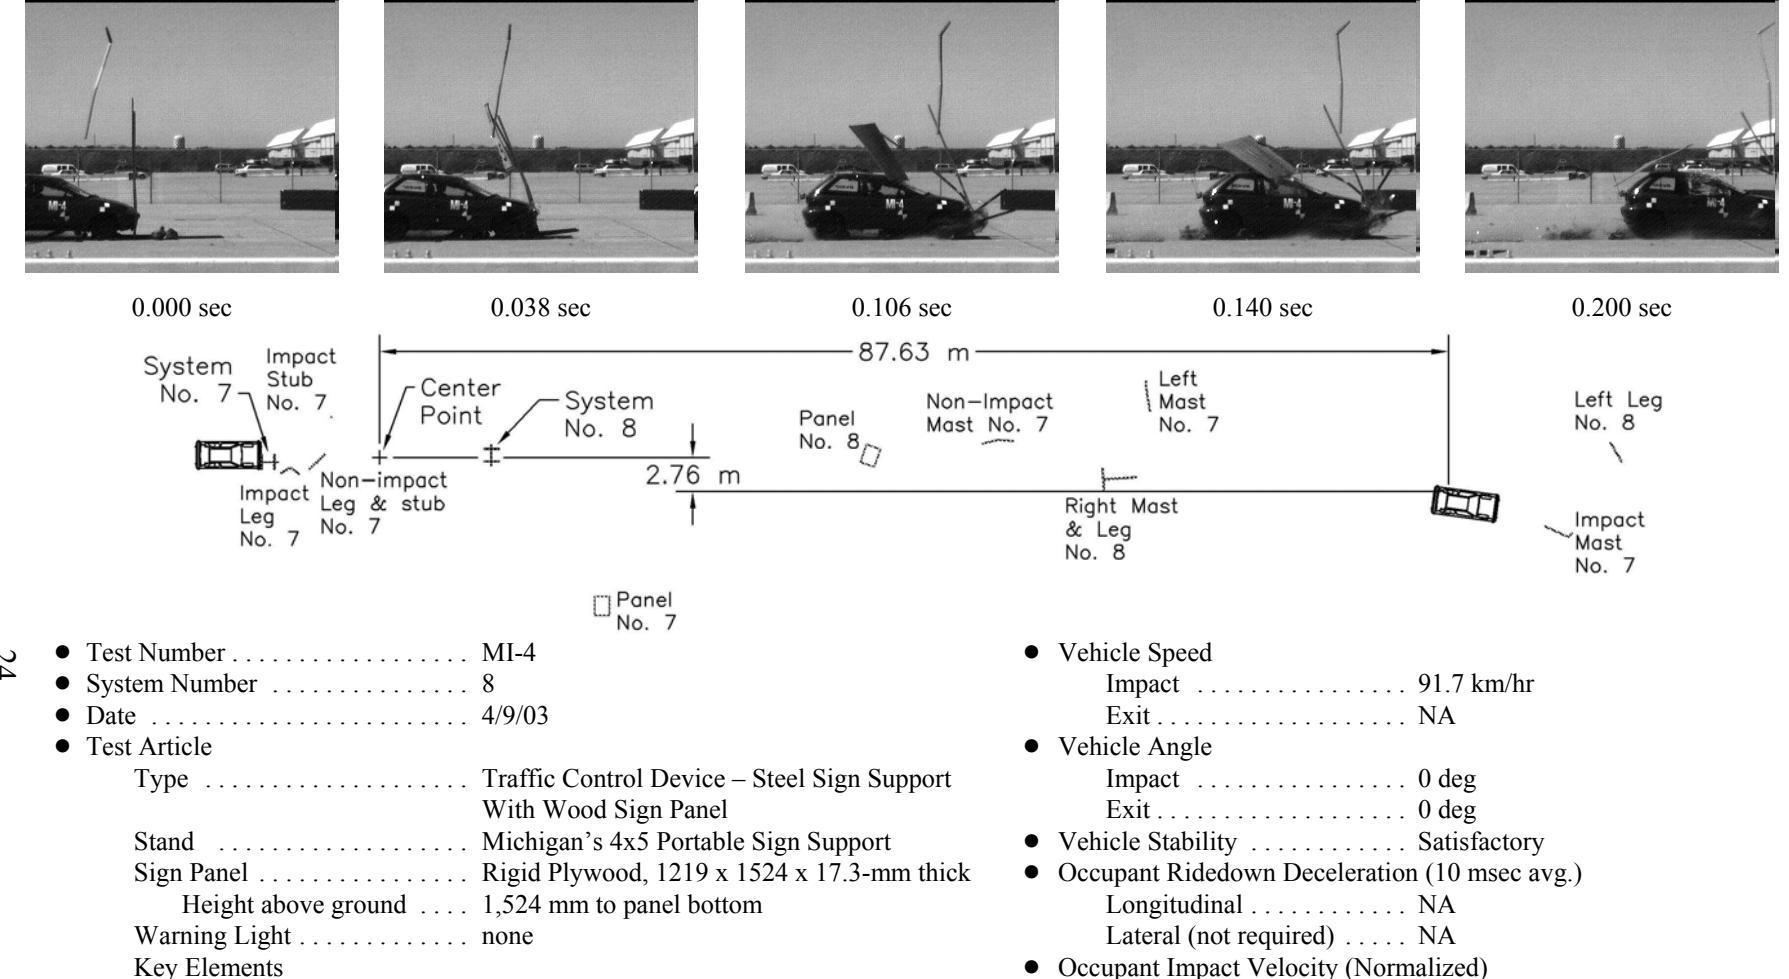
Figure 8. Summary of Test Results and Sequential Photographs, Test MI-4, Impact No. 1

Following test MI-4, a safety performance evaluation was conducted, and the work-zone traffic control devices, System Nos. 7 and 8 were determined to be unacceptable according to the NCHRP Report No. 350 criteria. It was deemed unacceptable due to the "spider web" cracking, indentation, and hole in the windshield, resulting in obstructed driver visibility and loss of structure of both glass layers. In addition, deformations of, or intrusion into, the occupant compartment did occur. Detached elements and debris from System No. 7 penetrated the right region of the windshield and the right side of the roof. Detached elements and debris from System No. 8 deformed the upper middle region of the windshield. In addition, the severity of the impact with System Nos. 7 and 8 caused the right-side rear and right-side door windows to shatter, respectively. The vehicle's trajectory did not intrude into adjacent traffic lanes.

• Test Article Damage Moderate – Broke apart

• Vehicle Damage Windshield cracking and indentation

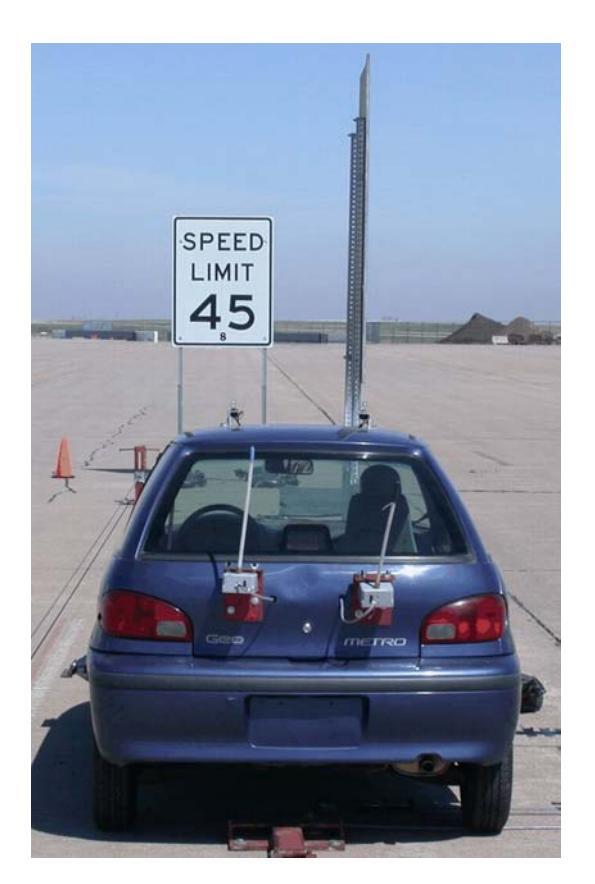
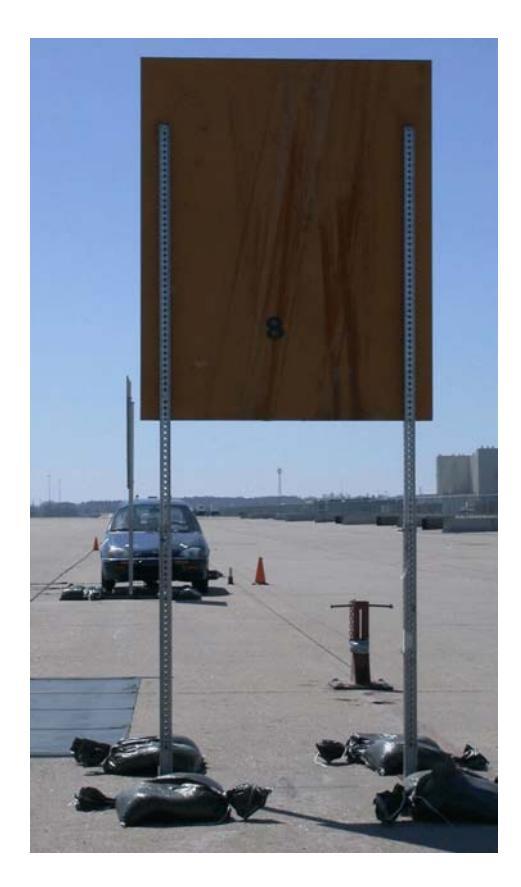
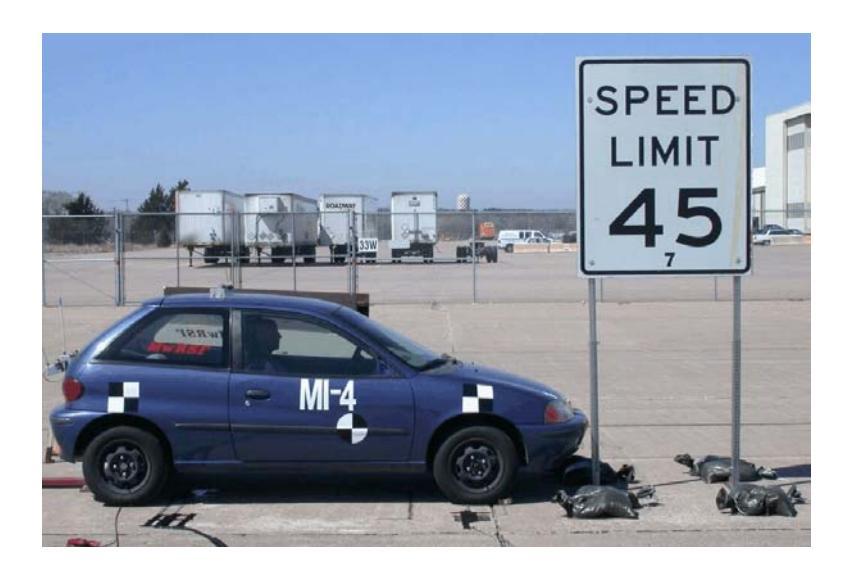
Figure 16. Impact Location, Test MI-4

The test vehicle impacted System No. 7 with the right-front quarter point of the vehicle aligned with the centerline of the sign support, as shown in Figure 16. At 0.014 sec after initial contact, the impacted mast deformed around the front of the vehicle and translated toward the non-impacted mast. At 0.042 sec, the sign panel rotated counter-clockwise (CCW) down toward the vehicle as the non-impacted mast rotated away from the vehicle. At this same time, the impacted mast deformed around the front of the vehicle and contacted the non-impacted mast. Shortly thereafter, the non-impacted leg disengaged from the mast. At 0.062 sec, the impacted mast disengaged from the leg and was deformed to approximately a 90 degree angle around the front of the vehicle. At this same time, the sign panel continued to rotate CCW toward the vehicle. At 0.098 sec, the sign panel contacted the roof and windshield. At 0.118 sec, the sign panel crushed the roof inward toward the occupant compartment. At 0.144 sec, the sign panel, which was positioned

Approximately 0.73 sec after impact with System No. 7, the vehicle impacted System No. 8 with the centerline of the vehicle aligned with the centerline of the sign support, as shown in Figure 16. At 0.020 sec, both masts deformed around the front of the vehicle as the top of the sign panel rotated down toward the vehicle. At 0.038 sec, the sign panel, both masts, and both legs all still intact traveled along with the vehicle. Shortly after this time, the sign panel released from the top-left, bottom-left, and the bottom-right panel bolts. At 0.064 sec, the masts were still in contact with the front of the vehicle as they rotated about the front of the vehicle. At this same time, the sign panel descended toward the vehicle. At 0.106 sec, the bottom of the sign panel contacted the roof and upper region of the windshield. At this same time, the top of the left mast remained attached to the sign panel. At 0.140 sec, the entire sign panel was in contact with the roof as the right-side

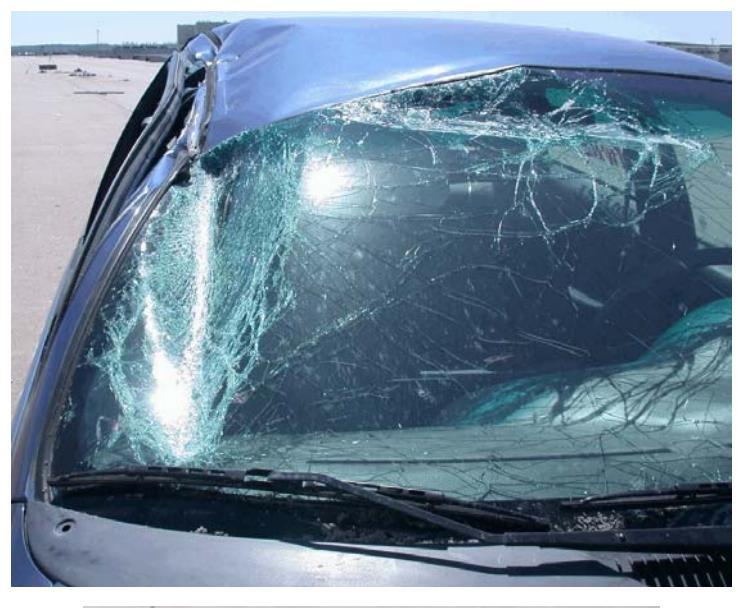
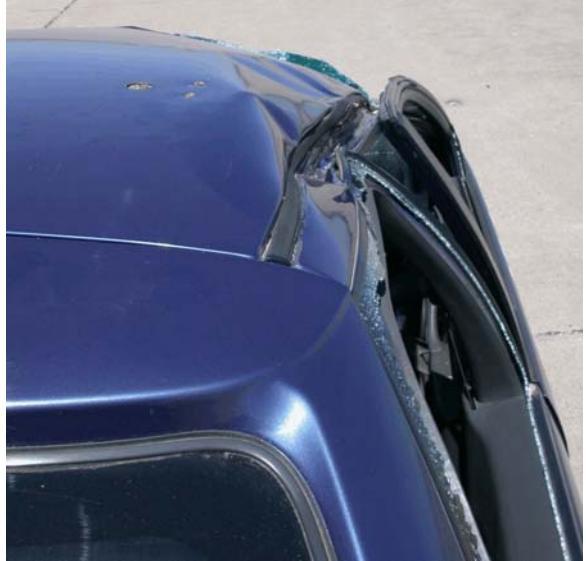
During the 0-degree impact event, the vehicle struck the masts, causing the right mast to separate from the sign panel. Furthermore, the panel was supported in the air by the top of the left mast. Subsequently, the mast rotated about the front of the vehicle causing the panel to contact the roof and windshield. As a result of the panel contact, the vehicle's right-side door window was shattered and the windshield encountered major "spider web" cracking with a concentrated impact area.
