COMPLIANCE TESTING OF IOWA'S SKID-MOUNTED SIGN DEVICE

MIDWEST ROADSIDE SAFETY FACILITY

MwRSF Research Report No. TRP-03-86-99

July 23, 1999

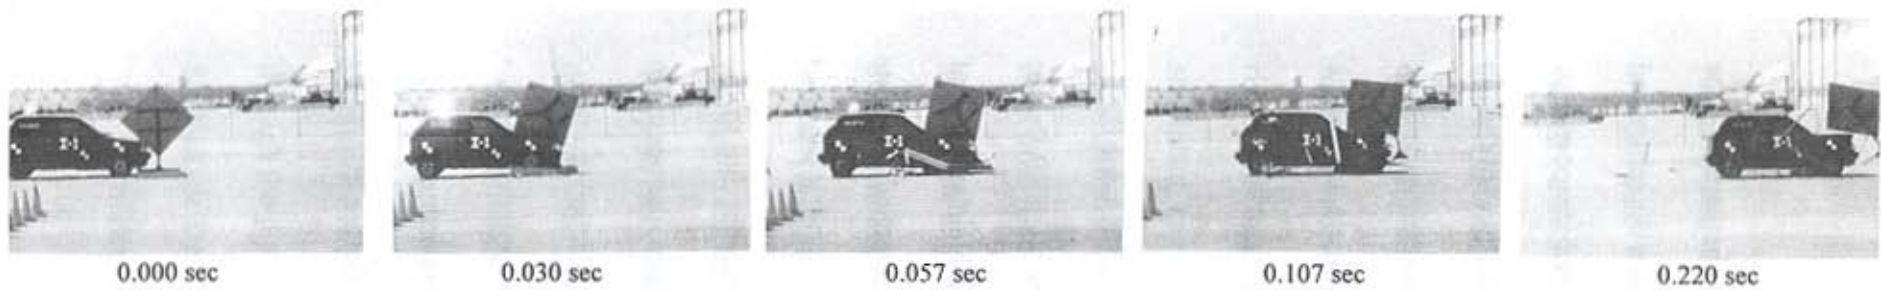
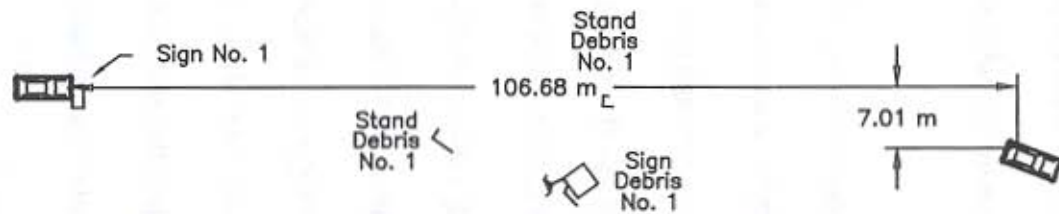
Following test I-1, a safety performance evaluation was conducted, and the work zone traffic control device, System No. 1, was determined to be unacceptable according to the NCHRP Report No. 350 criteria. It was deemed unacceptable due to penetration through the windshield and loss of structure of both glass layers which could result in obstructed driver visibility. Detached elements and debris from System No. 1 slightly penetrated the lower middle of the windshield. Detached elements and debris also showed potential for penetrating the occupant compartment due to the cracked lower-middle region of the windshield. Deformations of, or intrusion into, the occupant compartment did occur. The vehicle’s trajectory did not intrude into adjacent traffic lanes.

Note: The wooden base broke into two large pieces and many smaller pieces with a scatter pattern of 3.81 m left, 3.81 m right, and 24.38 m downstream from the original position of the sign.

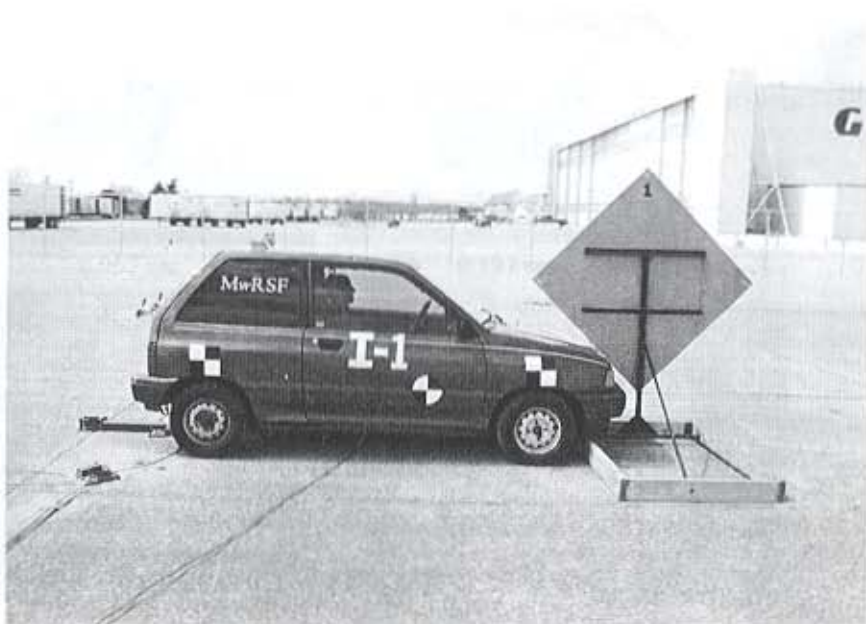
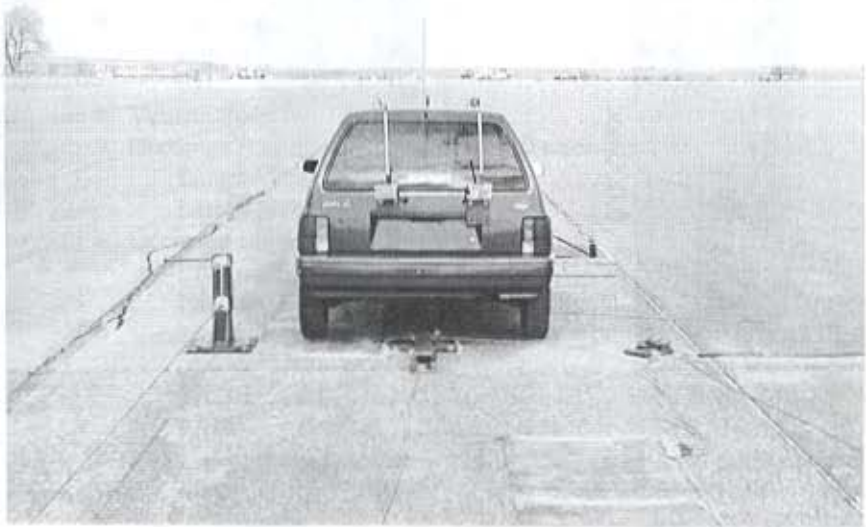
Figure 13. Impact Location, Test I-1

The test vehicle impacted System No. 1 with the centerline of the vehicle aligned with the centerline of the sign support, as shown in Figure 13. At 0.014 sec after impact, the hood was creased down the center and the outside edges buckled upward around the sign panel. At this same time, the vertical support deformed about the vehicle's bumper which caused the top of the sign panel to rotate toward the vehicle. After 0.030 sec, the corner of the sign panel closest to the vehicle impacted the lower-center of the windshield. At 0.032 sec, the vertical support ripped away from the wooden base as the vehicle began to travel over it. After 0.057 sec, the wooden base broke into several pieces. At this same time, the sign panel, with the vertical support still attached, was still in contact with the windshield and hood and continued to travel with the vehicle. At 0.107 sec, the sign panel, which was not in contact with the vehicle, traveled along in front of and at about the same speed as the vehicle. One of the larger pieces of the wooden base was along side the right-front side of the vehicle at 0.110 sec. At 0.179 sec, the sign panel and vertical support began to rotate counter-clockwise (CCW) in front and above the vehicle. At 0.220 sec, the sign panel was above the vehicle's hood and continuing to rotate CCW. At 0.275 sec, the large piece of the wooden base was near the right-side door, while the sign panel continued to rotate CCW.

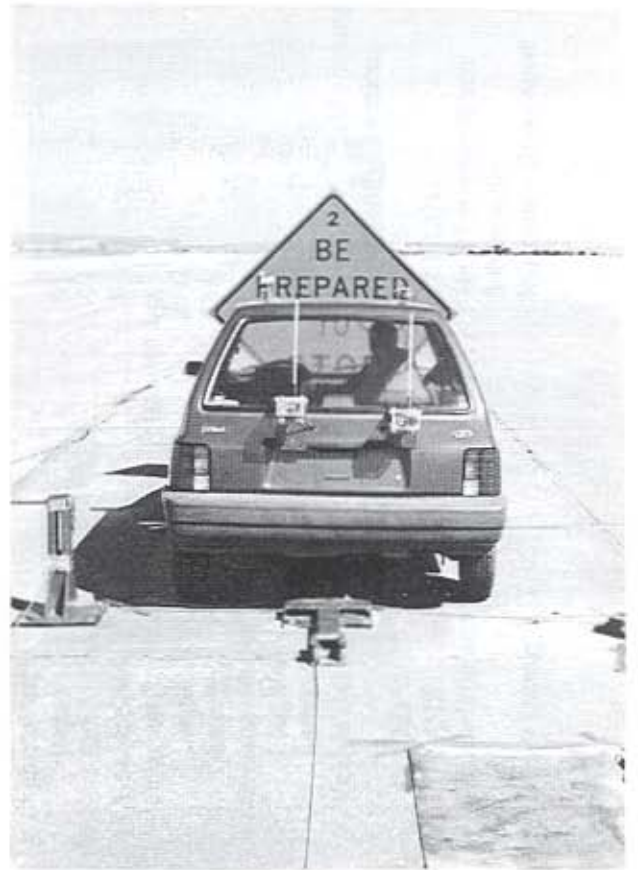
Figure 20. Impact Location, Test I-2

The test vehicle impacted System No. 2 with the centerline of the vehicle aligned with the centerline of the sign support, as shown in Figure 20. At 0.016 sec, the top of the panel flexed away from the vehicle while the vertical support deformed around the front of the vehicle. After 0.028 sec, the vertical support separated from the wooden base and the support rod separated from the vertical support. At 0.042 sec, the top of the sign panel impacted the windshield. At 0.070 sec, the vertical support and horizontal sign angle brackets flexed away from the sign panel. At this same time, the sign panel was in contact with the windshield and the hood. After 0.127 sec, the sign panel and vertical support began to lose contact with the vehicle, and the wooden base was under the vehicle. At 0.147 sec, the sign panel and attached vertical support traveled above the vehicle's hood without any contact with the vehicle. At this same time, one piece of the wooden base was in front of the left side and one was under the middle of the vehicle. After 0.255 sec, one piece of the wooden base cleared the rear of the vehicle while the other larger piece of the wooden base was in front of the vehicle. At 0.279 sec, the sign panel, with attached vertical support, traveled above and in front of the vehicle at about the same speed as the vehicle. At 0.515 sec, the sign panel and vertical support impacted the hood and the ground, respectively, traveling along with the vehicle.
