# **RESEARCH FINAL REPORT**

**FRGS15-192-0433**

**IDENTIFYING THE MINIMUM INVASIVE ACTIVE FIRE PROTECTION MEASURES FOR  
MALAYSIAN HERITAGE BUILDINGS TOWARDS BETTER PRESERVATION OF THE BUILT  
HERITAGE**

**18 SEPTEMBER 2018**

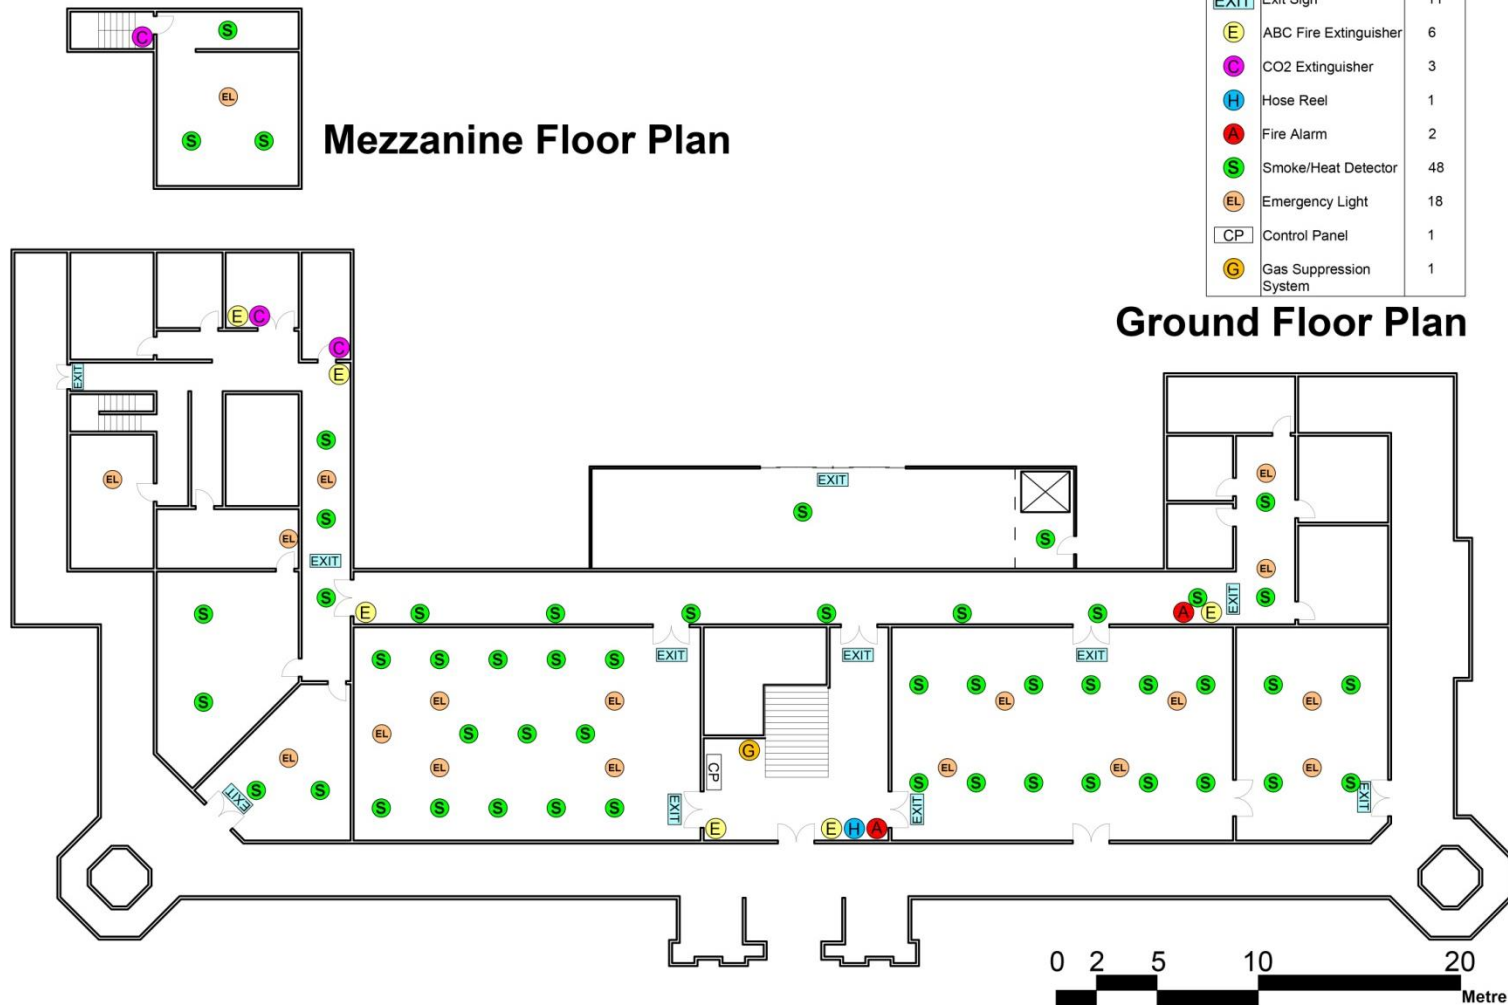
Figure 2: Location of active fire protection measures in Ground Floor Level of National Textile Museum

In most part of the building, equipment such as fire extinguisher, hose reel, and fire alarm are only found within the corridor. They are mostly installed close to one another and situated right next to a column located near to a door. Gas suppression system can also be found on the ground floor of the building situated by the reception counter and control panel at the entrance. Based on the number of gas cylinders seen, it is most likely that the system only covers a certain particular area of the building.

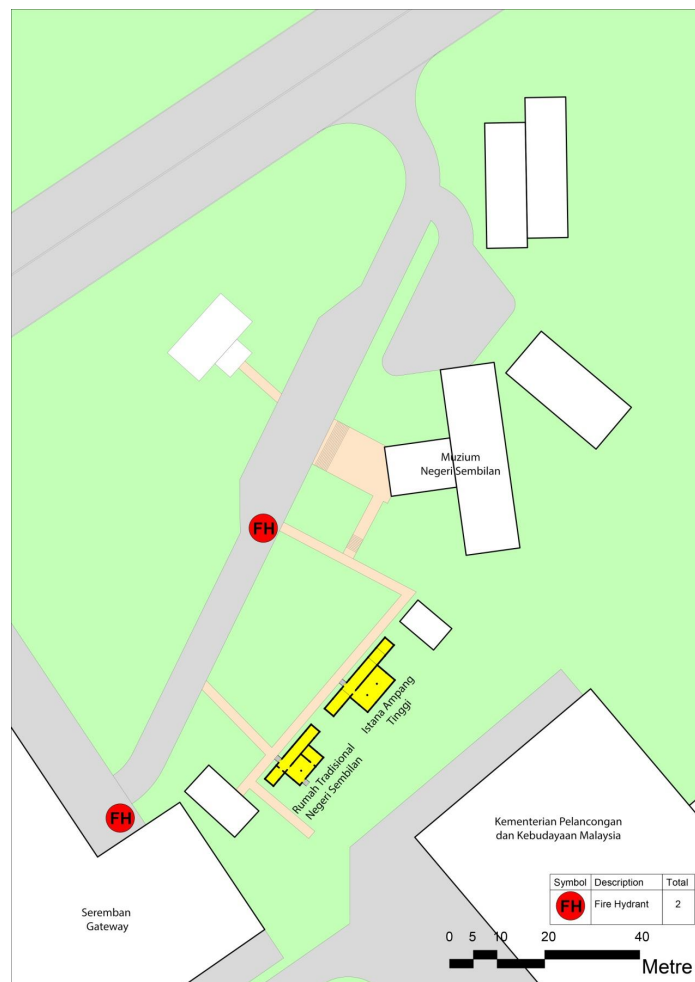
Figure 6: Location of fire hydrants at Istana Lama Ampang Tinggi, Negeri Sembilan

Due to the small size of Istana Ampang Tinggi, only a few types of active fire system are implemented in the building. Based on observation, only one fire extinguisher is provided inside the building. However, since the building is located quite close to two fire hydrants within the compound of the Cultural Complex, one fire extinguisher for just the building is sufficient. Two emergency lights are provided within each area of the building and were installed at appropriate places.

As for the smoke or heat detector, three of them can be found within the verandah area whereas another three is located inside the living area. The coverage for the living area is adequate but as for the verandah, the current placement of each detector may limit the coverage due to the length of the area. The left end of the verandah may be left exposed since the closest detector is about 10 metres away.

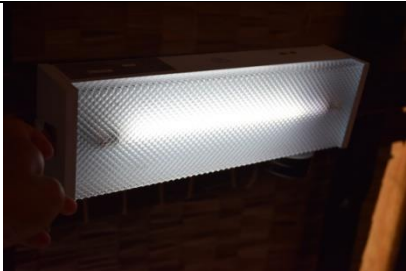
<p>Several emergency lights were installed inside the building and still working properly. They are attached to the roof structure at the centre of the room. Both rooms have 2 light each and the wiring pipes are hidden by painting it with the same colour of the structure.</p>

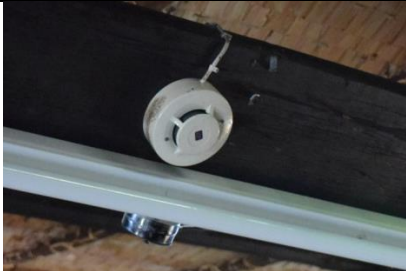
<p>Smoke detectors were installed in both areas of the building. They are attached to the roof structure at the centre of the room. Both rooms have several detectors each. Some of the wiring is hidden by painting it with the same colour of the structure while a minority is left with the original wiring colour.</p>

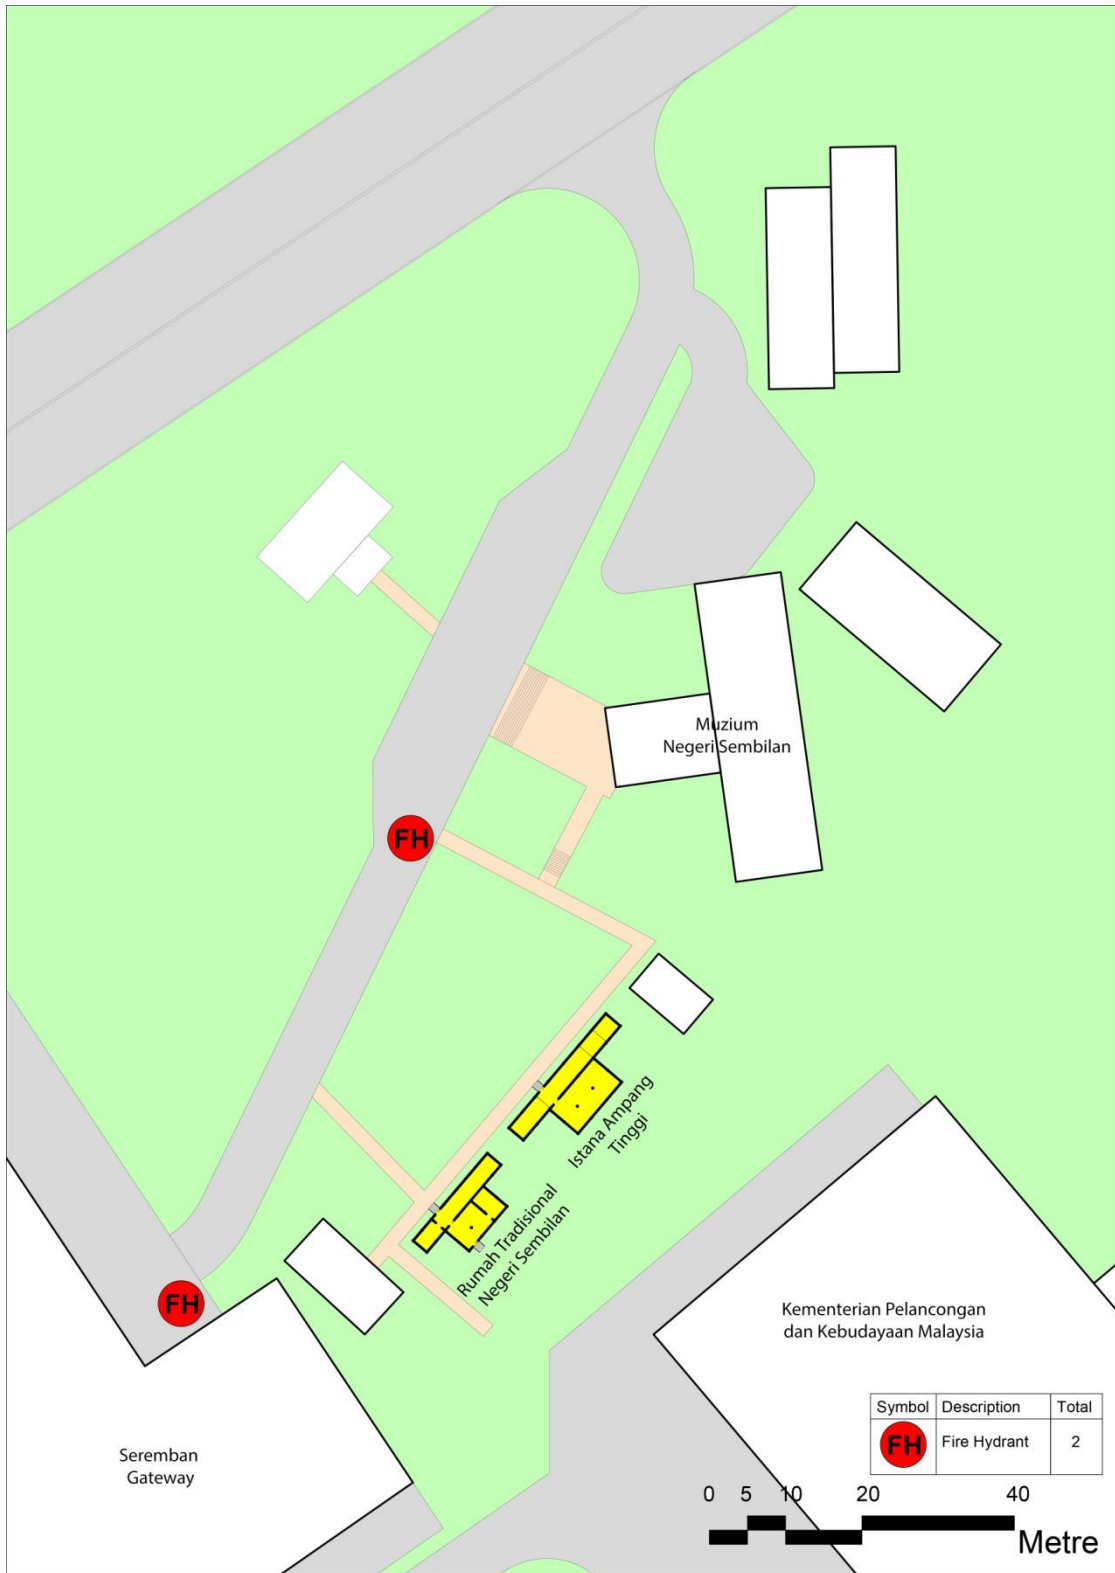
Figure 9: Location of fire hydrants at Rumah Tradisional Negeri Sembilan

Since the size of Negeri Sembilan Traditional House is slightly smaller than Istana Ampang Tinggi, the building has less active fire systems implemented. Similar to Istana Ampang Tinggi, only one fire extinguisher is provided since the building is located within the coverage of two fire hydrants inside the compound of the Cultural Complex. Two emergency lights were installed within the verandah area

and another one inside the living area. Based on observation, no smoke or heat detector is installed inside the building.

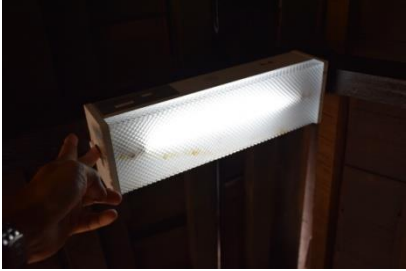
<p>3 emergency lights were installed inside the building and still working properly. They are attached to the roof structure at the centre of each area and another one at the left of the building. The wiring pipes are hidden by painting it with the same colour of the structure.</p>

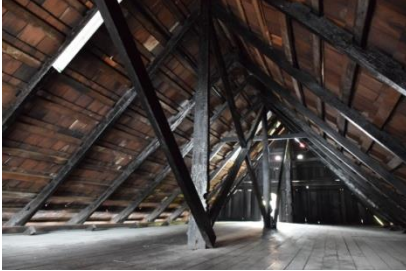
<p>No smoke detectors were installed in any area of the building.</p>

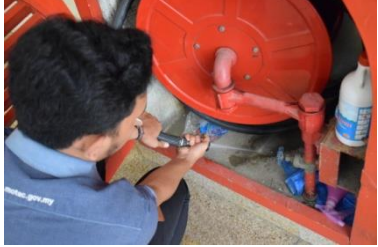
<p>Water flow for the hose reels operates at an appropriate pressure.</p>

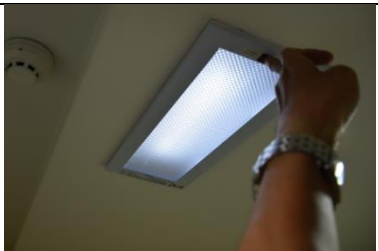
<p>The installation of the emergency light was designed to be as part of the ceiling. The wirings are hidden within the ceiling. Emergency light were installed in every area of the building and appears to be working properly.</p>

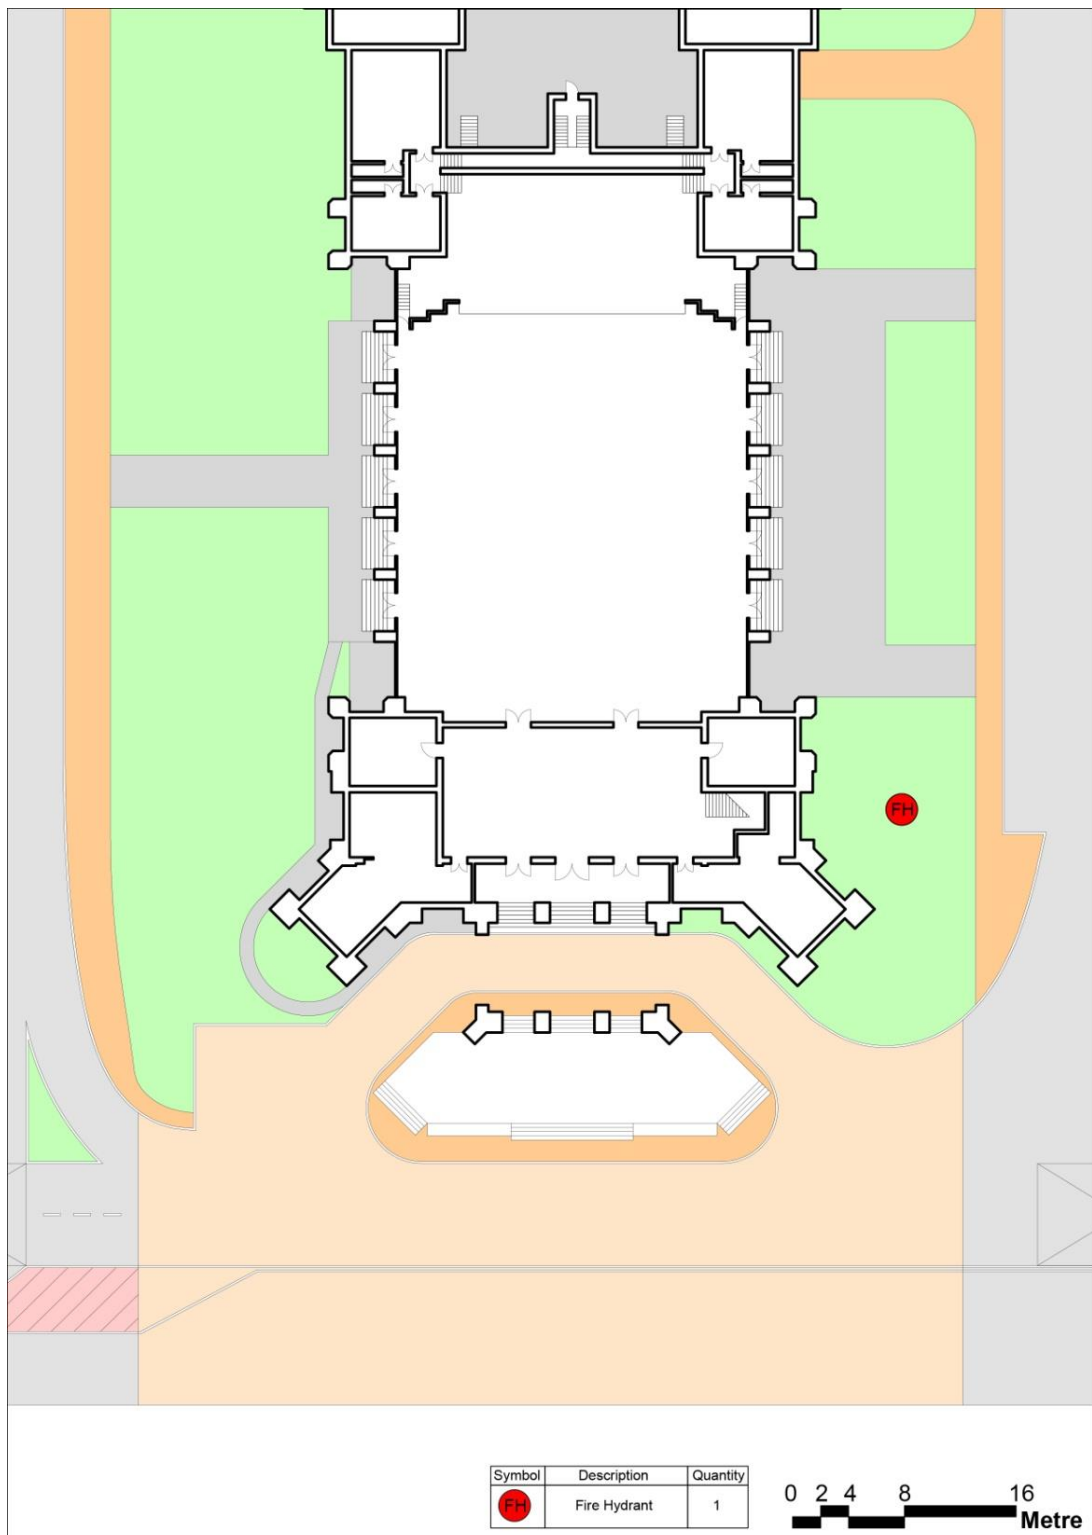
Figure 22: Location of fire hydrant at Ipoh City Hall

Regardless of its size, the City Hall building seems to be severely lacking in terms of fire protection system. Upon observation, only two fire safety equipments were identified throughout the whole building which consists of exit signs and ABC powder fire extinguishers. The placement of exit signs can only be seen in the main hall area. The signs are installed on top of the doors on each side of the hall. However, despite the building's size, only three fire extinguishers can be found throughout the whole building. One is located in the lobby and the other two are situated hidden at the back of the stage.

Several hooks for holding the fire extinguisher are seen in most part of the building even though no other fire extinguisher can be found.

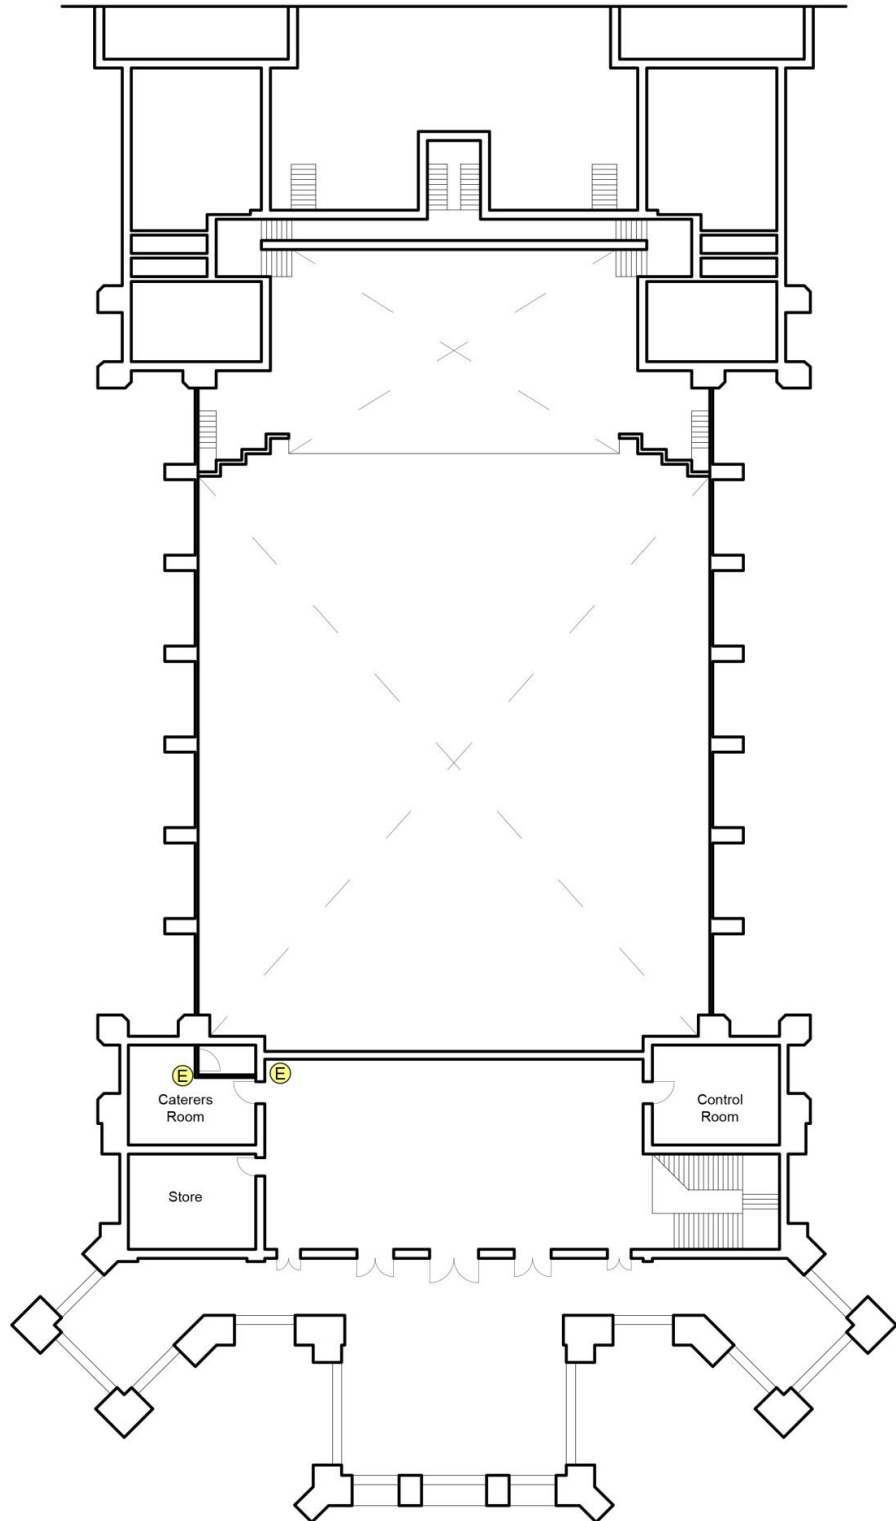
**Ipoh City Hall  
1st Floor Plan**

Picture	Description
 	<p>Several ABC fire extinguishers can be found on both floor of the building. However, the placement of each extinguisher barely covers any parts of the building. The distances between them are either too far apart or too close to one another. The main hall area is left without any extinguisher available.</p>

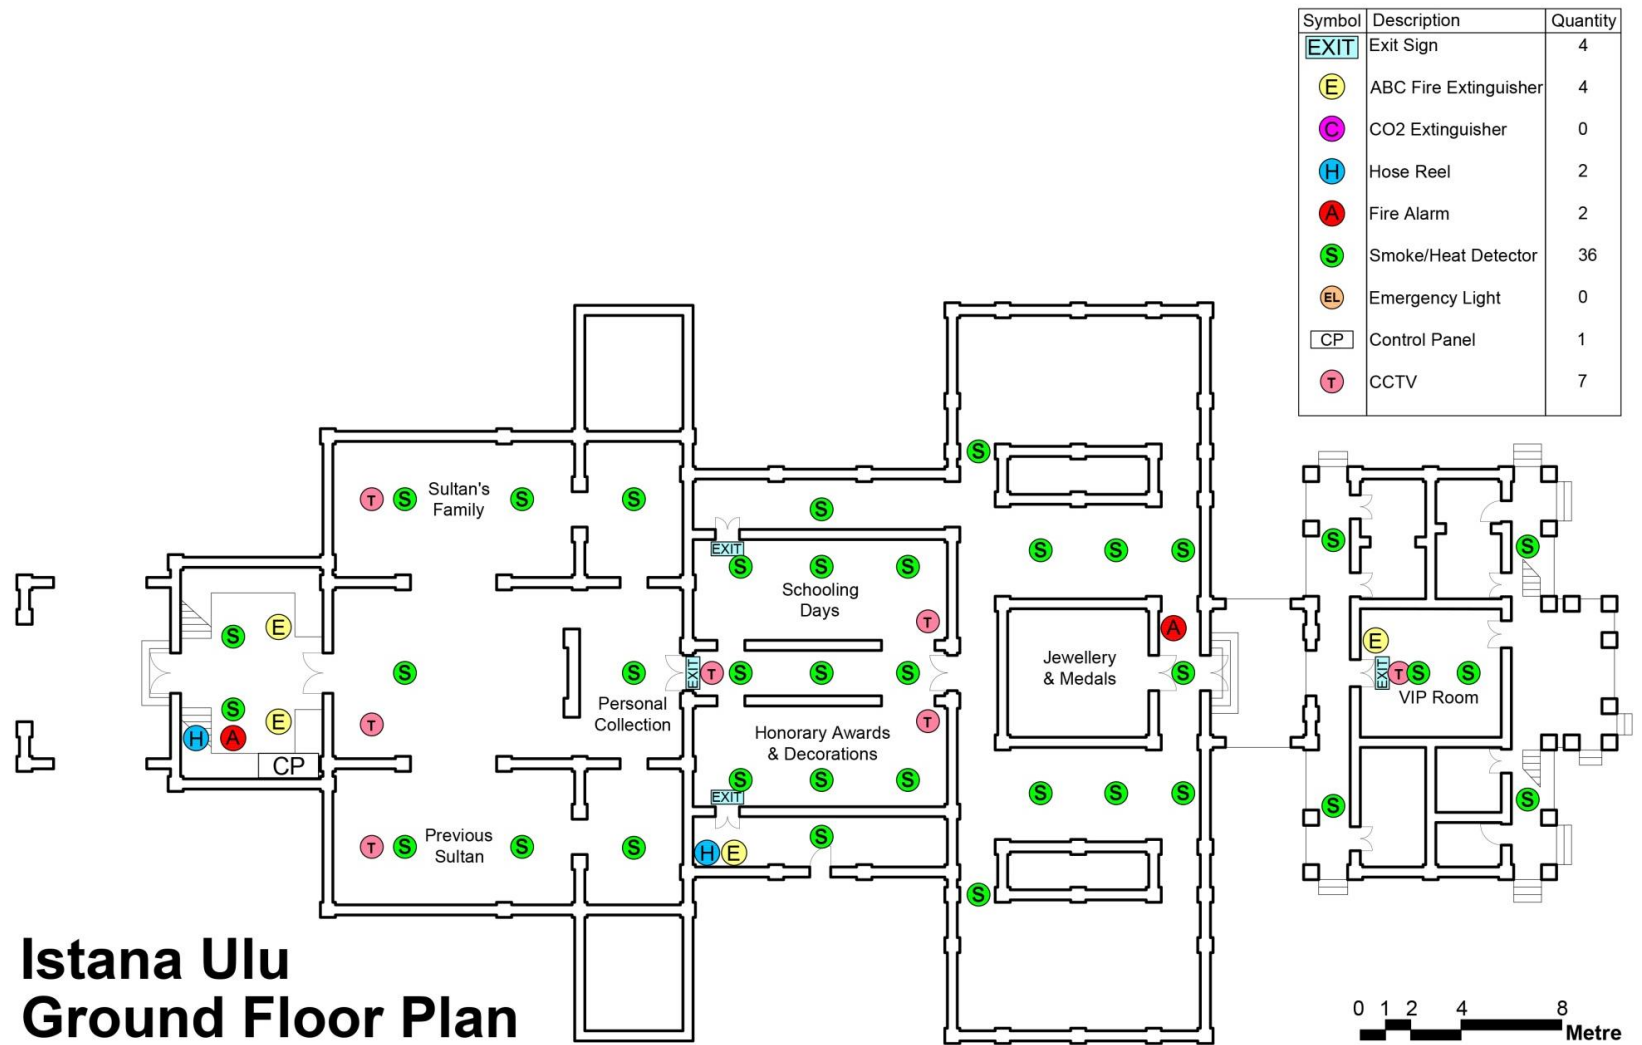
Figure 27: Location of active fire protection measures at Ground Floor Level of Sultan Azlan Shah Gallery

As for the means of escape, only the usage of exit sign can be identified throughout the whole building. However, only limited amounts are installed and are mostly situated in a certain area of the building. For the ground floor, the exit signs can only be seen in the centre area of the building and another one at the rear section of the building. As for the first floor, one is located close to the stairs at the entrance and another one at the centre of the building. Another two can also be found close to the centre of the building. Similar to the ground floor, another exit sign can be found situated at the rear section of the building.

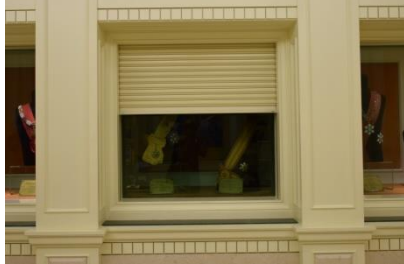
<p>Some of the fire extinguisher and hose reel storages are blocked or hidden by displayed item. Most of the display cases are quite large and heavy. As a result, these equipments cannot be easily access or identified during emergency situation.</p>

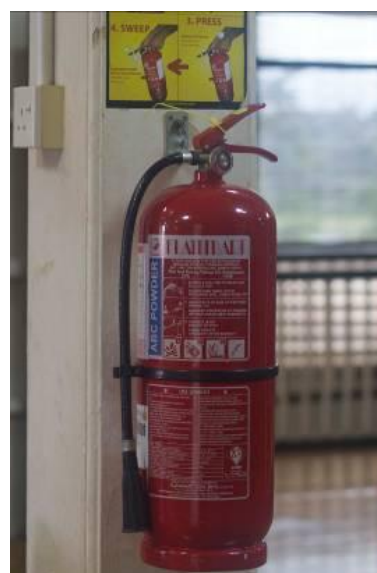
**Figure 9. ABC Powder fire extinguishers**

One of the similar methods which can be identified in all of the four buildings is the usage of ABC Powder fire extinguisher as their main fire suppression system. However, due to the small size of the building, only one ABC Powder fire extinguisher is provided each for Istana Ampang Tinggi and Rumah Tradisional

Negeri Sembilan whereas Muzium Kota Kuala Kedah is equipped with two ABC Powder fire extinguishers. Since Muzium Matang consists of two separate floors and larger floor area, it is equipped with six ABC Powder fire extinguishers, one on the ground floor and five on the first floor. In addition, two CO<sup>2</sup> fire extinguishers were also equipped on the ground floor of Muzium Matang as shown in Figure 8. This is most likely due to the presence of the control panel used for the alarm system next to the registration counter. While ABC Powder fire extinguishers are commonly used in most situations, CO<sup>2</sup> fire extinguishers are deemed as an appropriate type of extinguisher when dealing with electrical fire since it is harmless to electrical equipment.

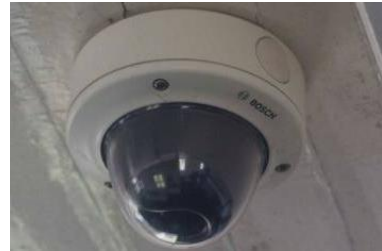
**Figure 12. CCTV camera (right)**

As for the detection system, only Istana Ampang Tinggi incorporates the usage of a photoelectric smoke detector inside the building as shown in Figure 11. Even though Rumah Tradisional Negeri Sembilan is situated just right next to it, no fire detection system can be found within the building. Similarly, both Muzium Matang and Muzium Kuala Kedah also did not incorporate any fire detection system but relies solely on the usage of closed-circuit television (CCTV) system to monitor the building condition which can be seen in Figure 12. The system is closely monitored 24 hours a day by the security guard on duty. However, the smoke detector system is considered as a more viable option since it can detect the presence of smoke particles faster which may not be visible or easy to be seen through the camera.

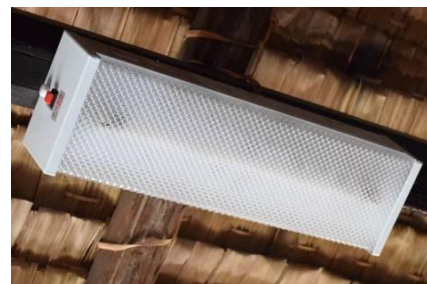
**Figure 13. LED Emergency Light**

With the exception of Muzium Kota Kuala Kedah, each of the heritage timber buildings is equipped with LED emergency lights as shown in Figure 13. These lights will help the occupants to navigate through the exits or escape routes during the evacuation process of the building in the event of loss of primary power. The positioning of each light are spread out throughout the whole building to provide the minimum level of coverage to each area of the building.

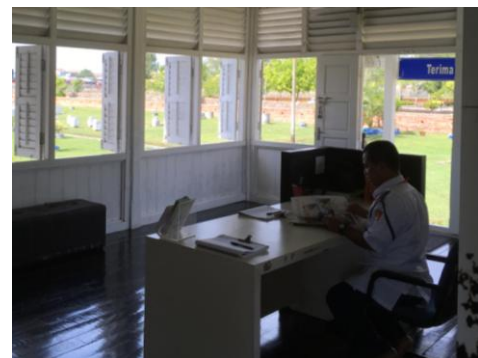
**Figure 15. Security guard on duty at Muzium Kota Kuala Kedah**

Negeri Sembilan, both of these buildings contain precious artefacts as well as various kinds of display items. Thus, this would also raise security concerns aside from fire safety related matters. The usage of CCTV system is considered as the most viable option since it can act as both the surveillance system as well as fire detection system at the same time. However, the main concern is that the system relies on a human presence in order to monitor the status of the building.
