The restoration of San Paolo Church in Pisa: geotechnical aspects

Nunziante Squeglia,* Stefano Stacul,* Elena Diddi**

Summary

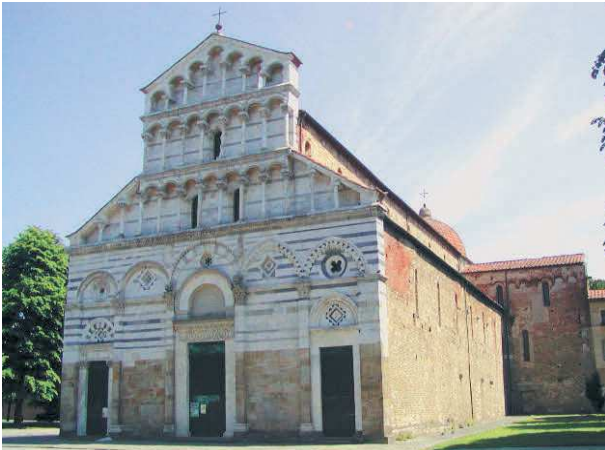
Fig. 1 – Facade of the Church of San Paolo a Ripa d'Arno in Pisa.

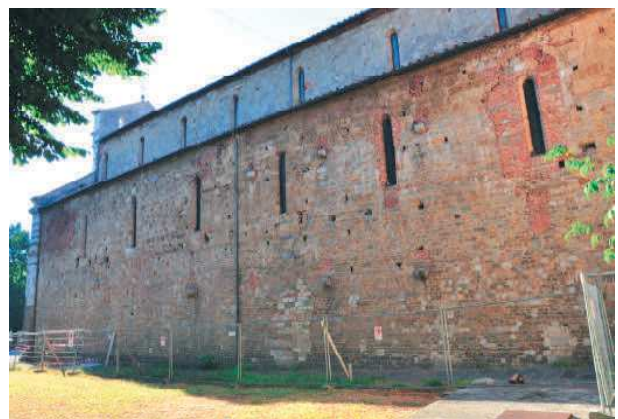
thern wall (Fig. 3) is different from the southern one (Fig. 4) thanks to the monastery that bordered the Church. The layout of the foundations was also influenced by the different phases of construction; as a matter of fact, the different portions of the Church have a different geometry of foundation. It is well known that the southern wall is weaker than the northern one and poorly arranged not only in the reconstructed portion, but also in the original one.

Fig. 4 – South side of the Church.

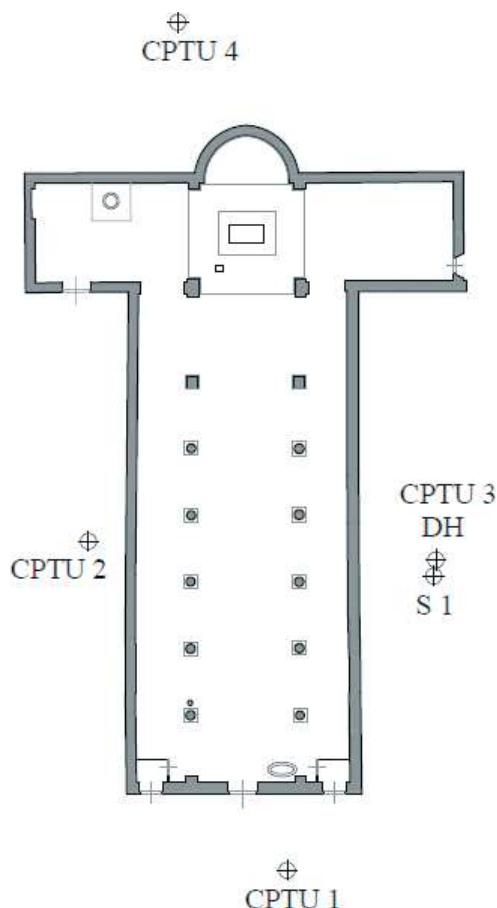
Fig. 5 – Plan of geotechnical investigations.
Fig. 5 – Planimetria delle indagini effettuate.

A brief research revealed that there was a complete lack of information about the subsoil; accordingly, a 40 m borehole and four CPTU profiles were performed at the beginning of 2014 (Fig. 5). Eleven undisturbed samples have been retrieved in the borehole between 3.00 and 36.00 m depth by means of an Osterberg sampler (Tab. I); furthermore, a Casagrande type piezometer was installed at the depth of 11 m.

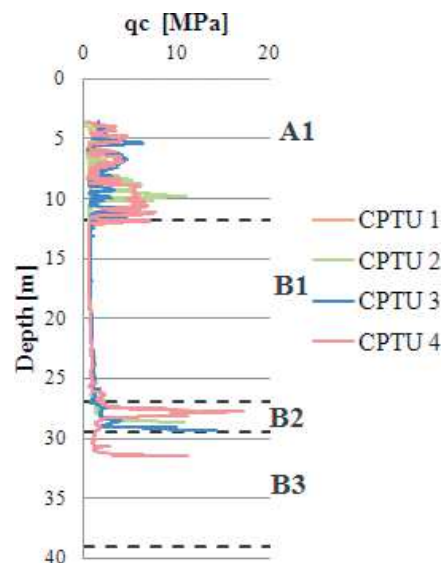
Soil profiles deduced by borehole and CPTUs revealed an essentially horizontal layering (Fig. 6). The sequence of strata is very similar to that of Leaning Tower subsoil [VIGGIANI and PEPE, 2005]; the same denomination of strata was therefore adopted (Fig. 7).

Fig. 6 – CPTU point resistance profiles.
Fig. 6 – Andamento con la profondità della resistenza alla punta.

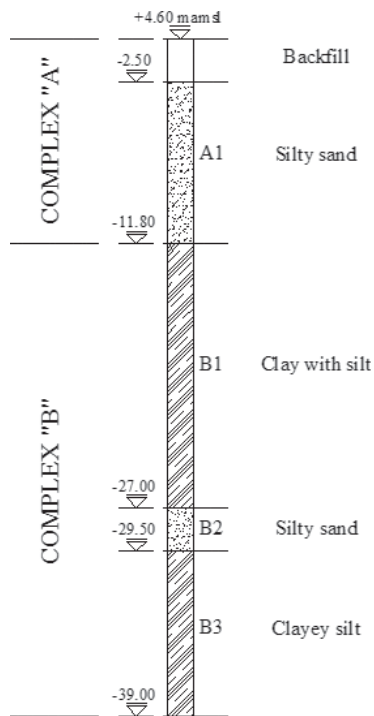
The soils that were found between the ground surface and a depth of 11.8 m are named Complex A. Below a shallow layer of made ground about 2.5 m thick, Complex A consists mainly of silty sand with a thickness of about 9 m. This layer features a very high value of friction angle (about 40 degrees (Fig. 8), as deduced by triaxial tests on undisturbed samples).

Fig. 7 – Stratigraphic model.
Fig. 7 – Rappresentazione del modello stratigrafico.

turn into three different layers. The shallower layer B1, between 11.8 m and 27 m depth, consists of a very compressible clay with silt, normally consolidated or slightly overconsolidated (OCR lower than 2, with an average value of 1.3). Layer B2 is a silty sand and layer B3 is a clayey silt with a PI lower than layer B1.

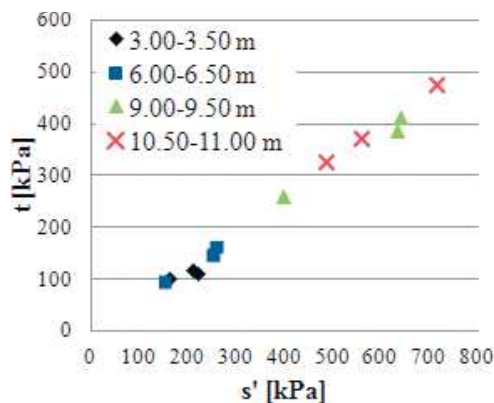
Fig. 8 – Failure stresses of A1 layer.
Fig. 8 – Stato tensionale in condizioni di rottura per lo strato A1.

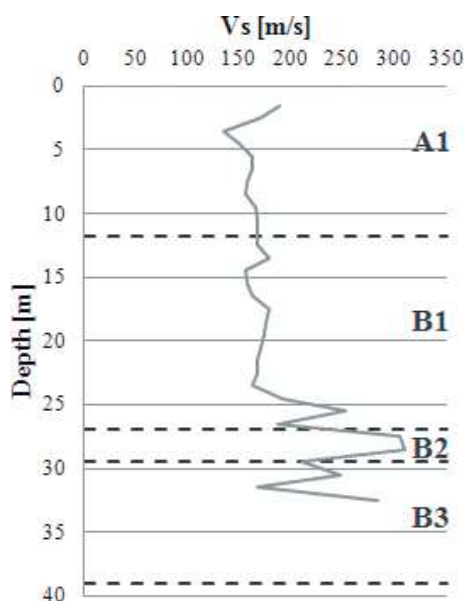
From the point of view of dynamic properties, figure 12 shows the profile of Vs as determined in CPTU 3; it is evident that the value of Vs is lower than 200 m/s down to 25 m depth.

Fig. 12 – Profile of shear wave velocity.
Fig. 12 – Andamento con la profondità della velocità delle onde di taglio.

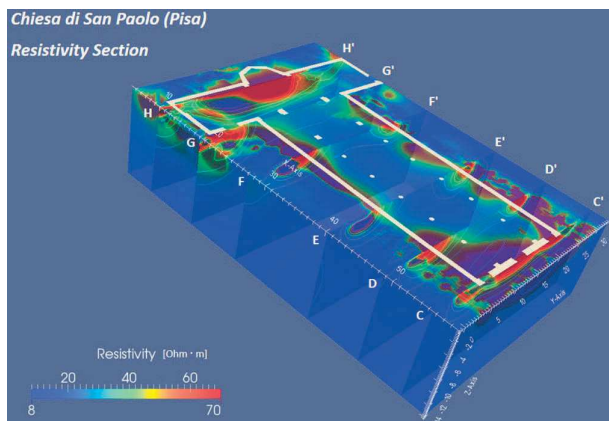
sent case an increment of resistivity has been associated to the occurrence of masonry; in figure 16 the foundation seems 2.5 m deep and some meters wide. As reported in figure 15, information about foundation of columns is not available. Such lack of information is due to presence of a metallic grid below internal pavement, discovered after ERT execution.

An accurate analysis of electric tomography and a comparison with direct inspection (say excavation) revealed that the information deduced by means of ERT is not reliable. The reasons of such unreliability are probably connected to the small difference in resistivity between the foundation walls and the ground, rather than the presence of the metallic grid. In fact, similar results have been obtained at the Baptistery in Piazza dei Miracoli, in which the metallic grid below the internal pavement is not present, while the material of foundation masonry is similar (Fig. 17). Further investigation revealed that the foundation were deeper than 2.5 m and the ERT tests have been discarded since the technique was evidently unable to discriminate the masonry from the ground.

Fig. 15 – Results of electrical tomography.
Fig. 15 – Vista d'insieme dei risultati delle tomografie elettriche.

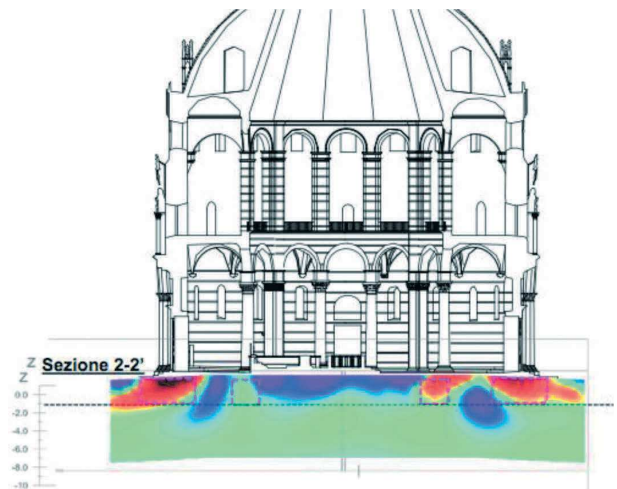
Fig. 17 – Results of ERT for Baptistery.
Fig. 17 – Risultati delle tomografie elettriche sul Battistero di Piazza Duomo. Si noti la “presenza” della fondazione anche sul lato esterno.

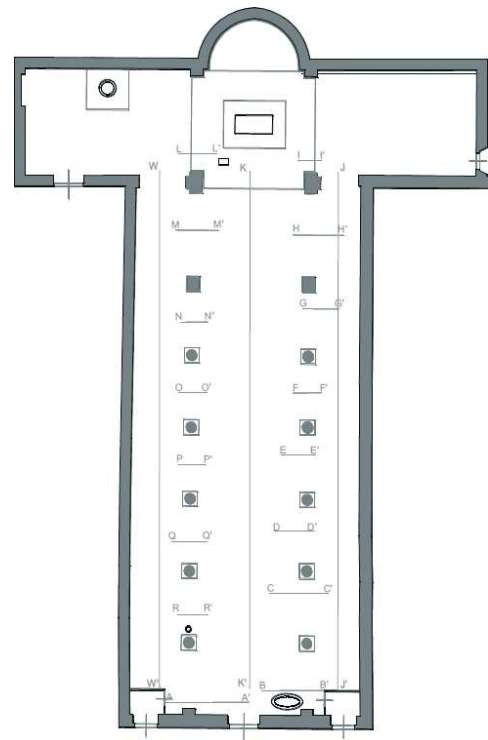
Fig. 18 – Plan of ground penetrating radar investigation.
Fig. 18 – Tracciato delle prospezioni tramite georadar. Il tracciato tiene conto anche della presenza del ponteggio di sostegno della copertura.

with physical properties different from the surrounding materials. In the case of buried structures the GPR technique allows the individuation of upper boundaries only. This limitation is due to the fact that the emitted signal has a single wavelength; in order to change the depth of exploration a change in wavelength would be needed, and usually the apparatuses do not allow the modulation in wavelength. Figure 18 shows the traces of nineteen paths used for the investigation. The paths were chosen taking into account the presence of a very pervasive scaffold sustaining the whole roof.

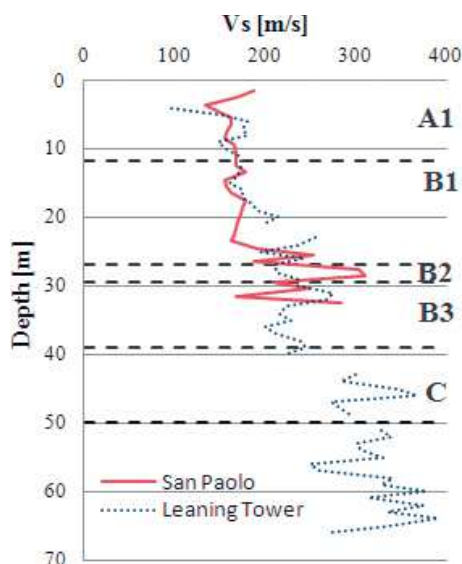
To define the dynamic properties of layer C, reference has been made to cross-hole measurement performed near the Leaning Tower. Figure 23 shows a comparison between Vs profile of Church site and Leaning Tower site, in which the satisfactory overlap of the two profiles is evident. About G/G₀ decay and dumping variation, the curves proposed by IDRISI [1990] have been used.

Fig. 23 – Comparison between V_s profile of Church site and Leaning Tower site.

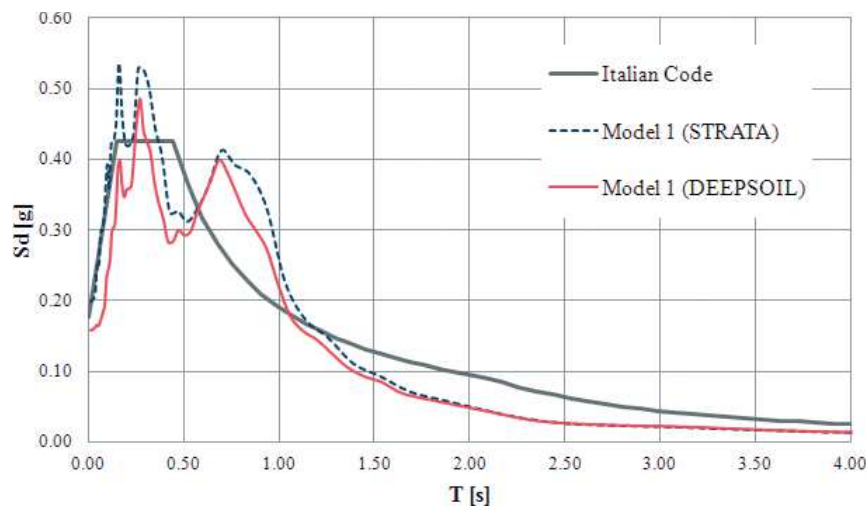
Figures 25 and 26 shows the results of a linear equivalent site effect analysis for both the subsoil models considered. For sake of comparison, the response spectrum provided by the Italian Code has been also reported in both figures. The similarity of results is quite evident, showing the substantial equivalence of the two software. The effect of the different soil model seems to consist in a more regular diagram below a period equal to 0.75 second and in a significant relative increase of amplitudes above the same limit.

Fig. 25 – Comparison between results of two software for Model 1.

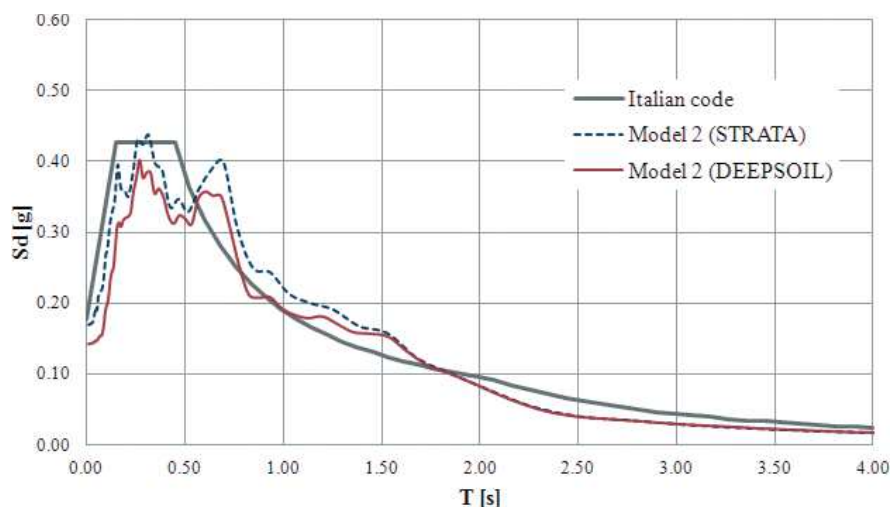
Fig. 26 – Comparison between results of two software for Model 2.

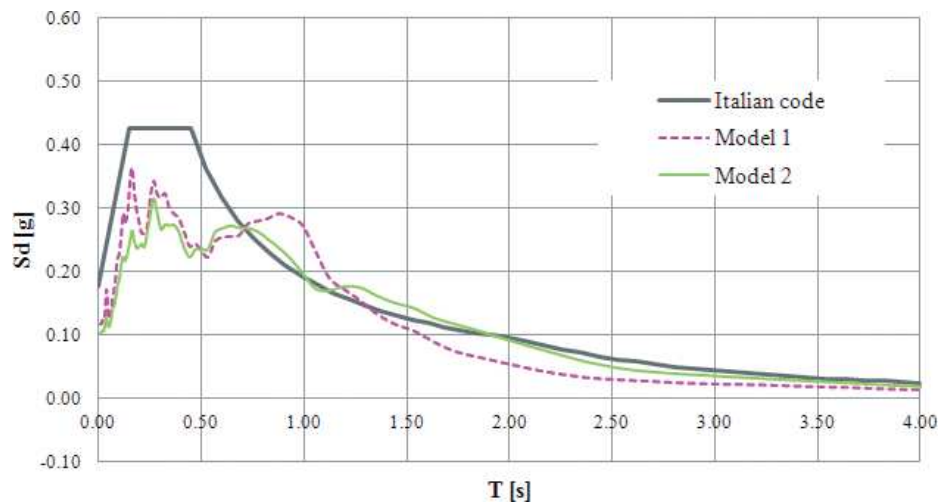
Figure 27 shows the results of the non linear analysis performed by means of DEEPSOIL. In this case the differences between the two soil models are again evident above the period of 0.75 seconds, but the amplitudes in the first part of the spectrum are smaller than those of the previous case.

Fig. 27 – Comparison between results of two model in non linear analyses.
