Rapid assessment of geo-hydrological hazards in Antananarivo (Madagascar) historical centre for damage prevention

Andrea Ciampalini, William Frodella, Claudio Margottini & Nicola Casagli

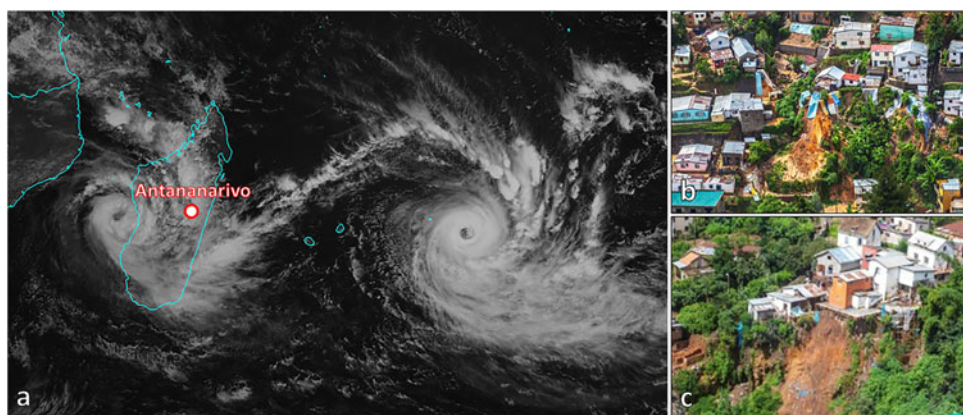
Figure 1. Twin cyclones Bansi and Chedza hitting Madagascar East coast on 16 January 2015 (a) (modified after European meteorological satellite EUMESAT image; available at: www.eumetsat.int); aerial pictures of the triggered shallow landslides within the city on March 5th event (b, c) (BNGRC - Bureau National de Gestion des Risques et des Catastrophes; <http://www.bngrc.mg>).

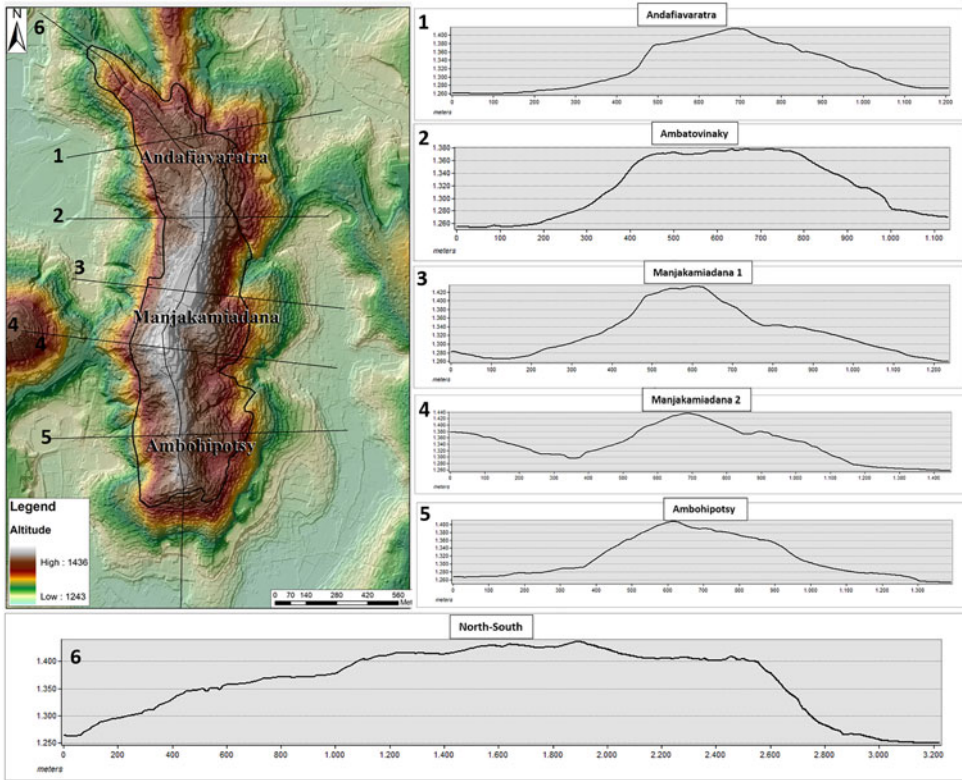
The Analamanga hilltop is represented by a flat area (1436 m a.s.l. at its highest point, in correspondence of the Rova) rising gradually from north and alternating southward with three saddles (Figure 6). The hill is bounded on the south sector by slopes with angles from 30° to 50°, where the crystalline granite bedrock widely crops out in correspondence of quarry cuts (Figures 6–8). The western hillside is characterized by high slope angles from 50° to 80°, due to the presence of a continuous sub-vertical rock wall (bedrock) and several scarps, mainly N-S oriented (Figures 4(c), 7(a,b) and 8). The western slope foot is characterized by low energy surfaces formed by lateritic soils with a thickness up to tens of metres, gently linking with the Ikopa river plain alluvial deposits (Figures 6–8). On the contrary, the eastern hillside (more exposed to the cyclones coming from the Indian Ocean) has a minor slope angle (between 20

Figure 6. Analamanga hill DEM altitude map (the black boundary represents the UNESCO buffer zone), including with E-W (1–5) and N-S (6) profiles. Source: Author

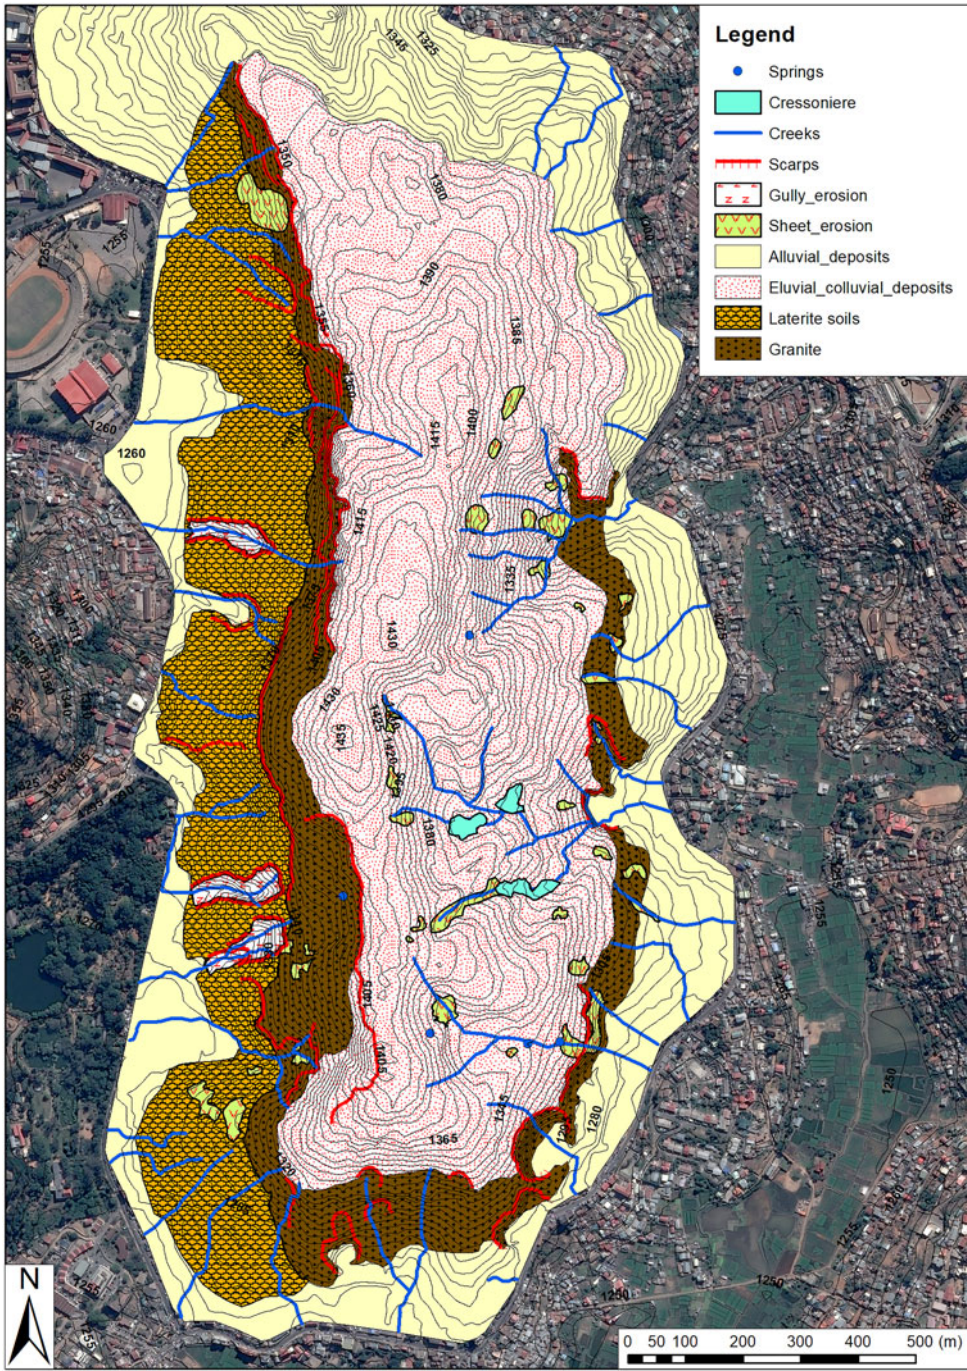
and 40°) (Figures 4(b), 5 and 6(a)). The granite bedrock herein rarely crops out and is covered by widespread eluvial-colluvial deposits (Figures 7(a,e,f) and 8), formed by the weathering and erosion of the bedrock. These deposits, which maximum thickness in correspondence of the hilltop is about 30 m, as estimated both directly on the field and considering the available ancillary data (Hyvert 1994), alternatively overly directly on the bedrock or on the regolith, at times with the interposition of a few metres thick lateritic soil (Figures 5, 6(e,f) and 8). This slope cover hosts the aquifer that feeds the springs in the Upper Town area, which develop a complex dendritic-like hydrographic network (Figure 8). The contact between the slope cover and the granitic substratum gently dips toward East, for this reason most of the springs are located along the eastern slope. On the contrary the loamy laterite soils are affected by a simpler hydrographic network characterized by a low order stream network (Figure 8).

Figure 8. Geological-geomorphological map of Analamanga hill. Source: Author

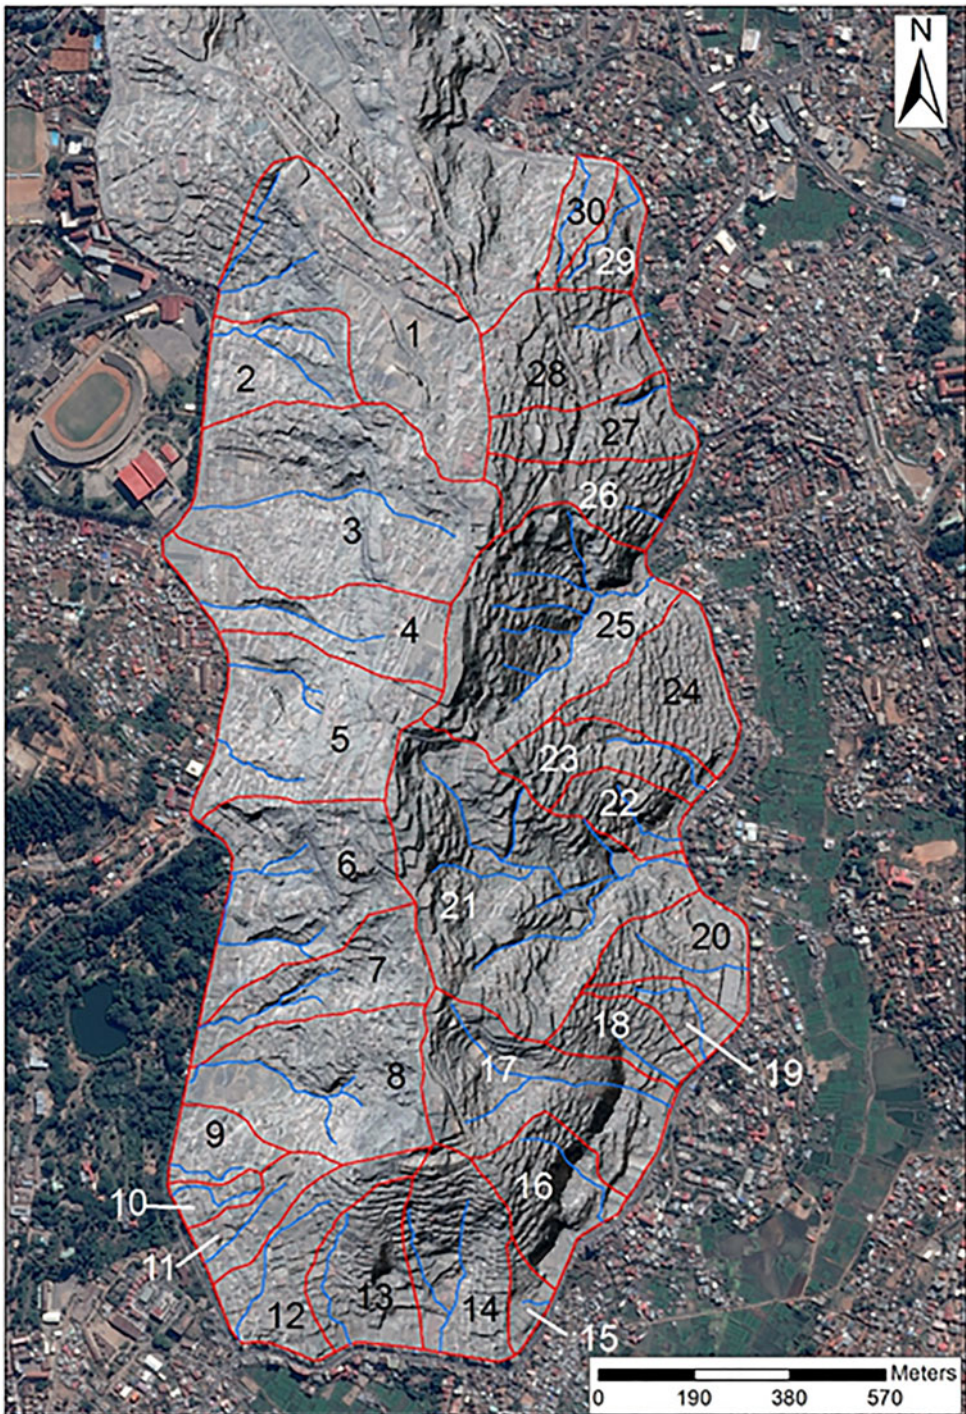
Through the field survey 11 basins were mapped along the western slope, 4 basins along the southern slope and 15 basins along the eastern slope (Figure 9). The Analamanga hill is characterized by a radial-like pattern, which creeks deeply erode

Figure 9. Hydrographic network (in blue) and hydrographic basins (in red) of the Analamanga hill. Source: Author

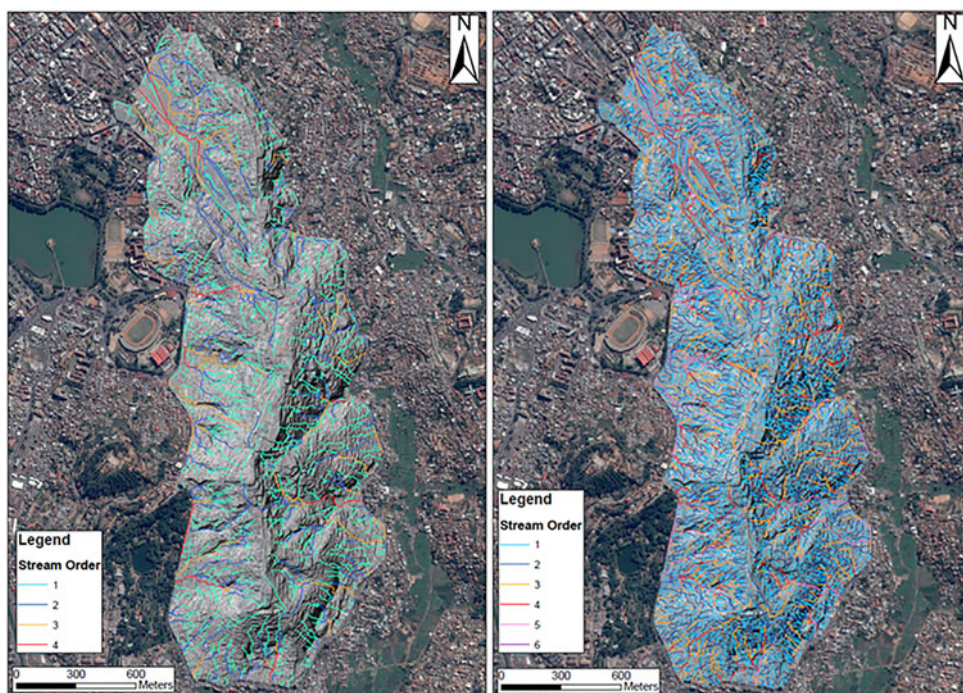
Figure 10. Analamanga hill hydrographic map by using the 2 m resolution DEM (on the left) and the LiDAR (on the right). Source: Author

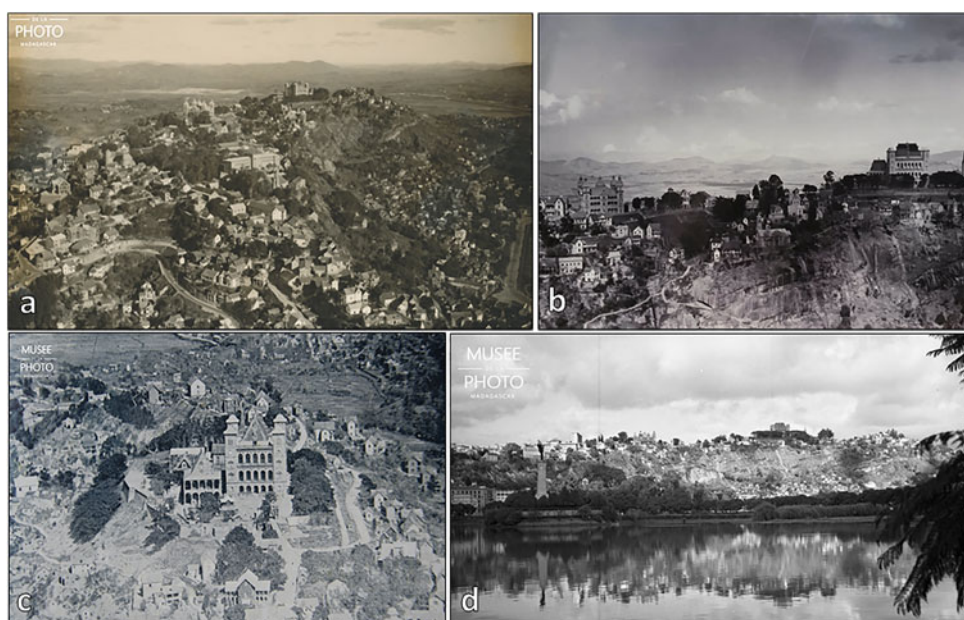
Figure 13. Historical aerial (a–c) and terrestrial (d) pictures of the Rova complex (first half of the twentieth century) and the surrounding Analamanga hill slopes. The comparison with the current setting of the Analamanga hill (Figure 4) shows the evidence of the progressive deforestation and increase of urbanization of the Upper and Middle town. Source: Author
