In situ measured cross section geometry of old timber structures and its influence on structural safety

Paulo B. Lourenço¹, Helder S. Sousa², Ricardo D. Brites³, Luís C. Neves⁴

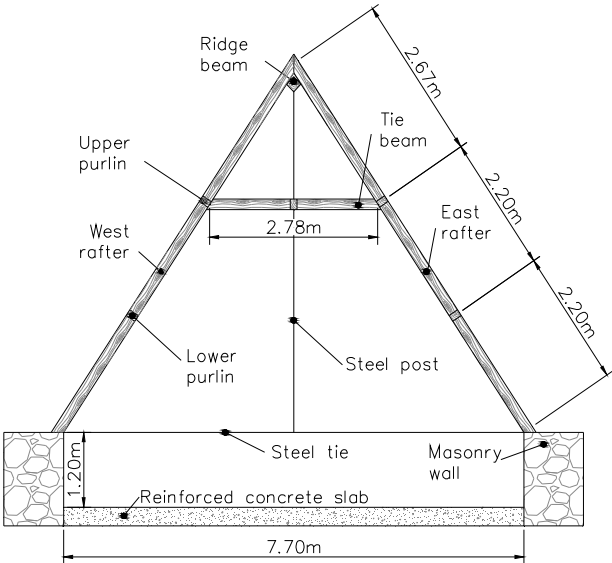
Figure 1: Surveyed roof structures in Portugal, designation and average size of members:
 a) Monastery of Arouca; b) Chimico Laboratory; c) Ducal Palace of Bragança; d) Sanctuary of St. Torcato

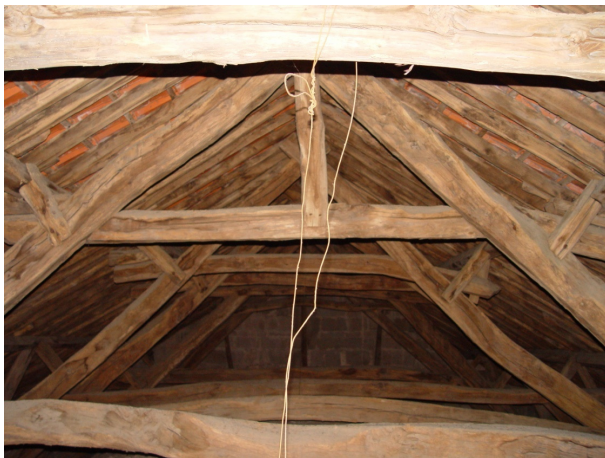
Figure 2: Examples of existing timber roof structures: a) pre-industrialization with round cross sections, Arouca Monastery; b) post-industrialization with rectangular cross sections, Ducal Palace of Bragança

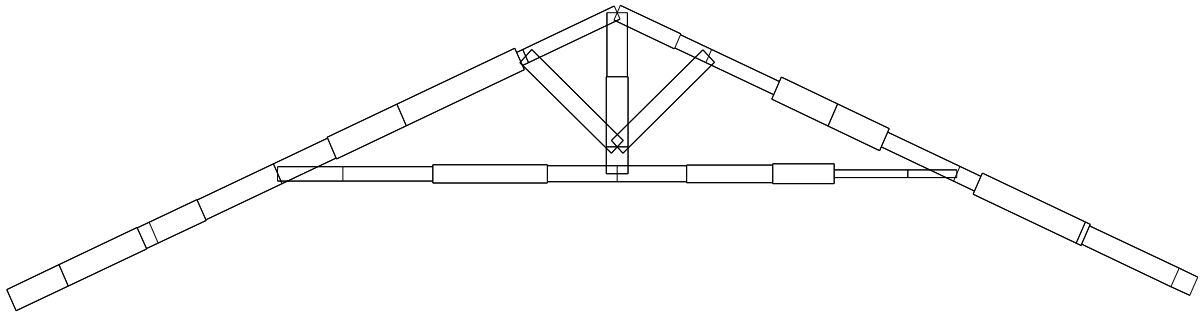
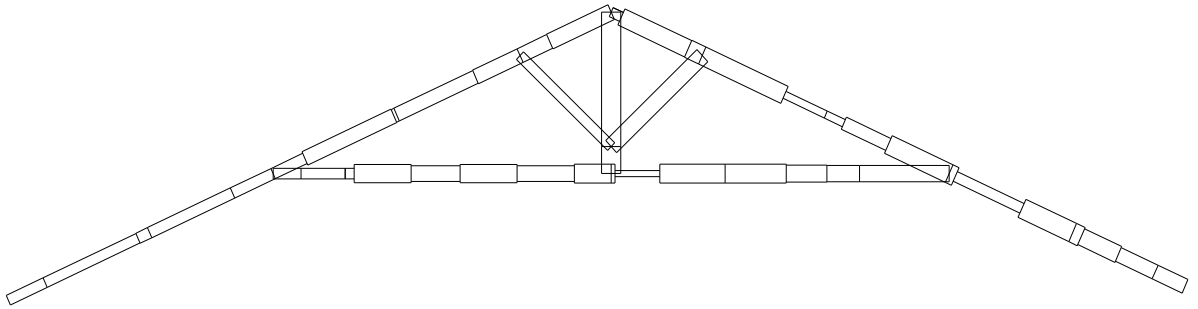
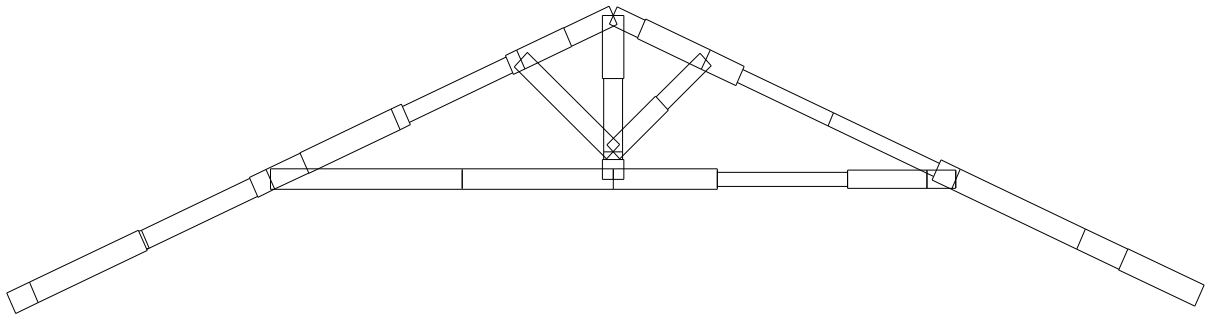
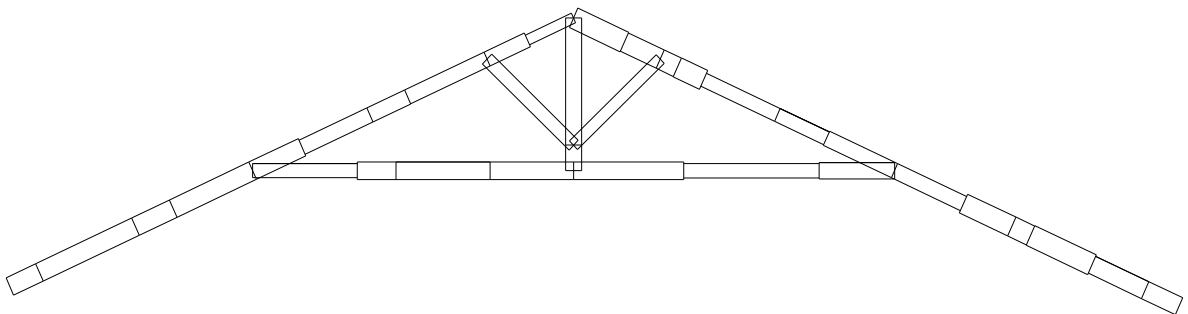
In order to define the cross section geometry, four models were assumed taking into consideration the results of the survey and assuming that the area affected by biological agents offered no contribution to resistance (Figure 5). The existing strengthening of two of the trusses is not included in the analysis, as the objective here is to discuss the usage of different geometric models and not to provide an accurate safety level of the trusses. The first three models are defined by a deterministic approach based on the in situ measurements, as: (i) the observed values at different sections; (ii) the mean of the observed values for each element and (iii) the minimum of the values observed for each element. A fourth model assumed the cross section dimensions as random variables, assuming a two-parameter lognormal distribution, with mean value given by the mean of the observed values for each member and *CoV* of 10%.

Figure 5: Equivalent cross sections used in the structural models: a) truss #1; b) truss #2; c) truss #3; d) truss #4.

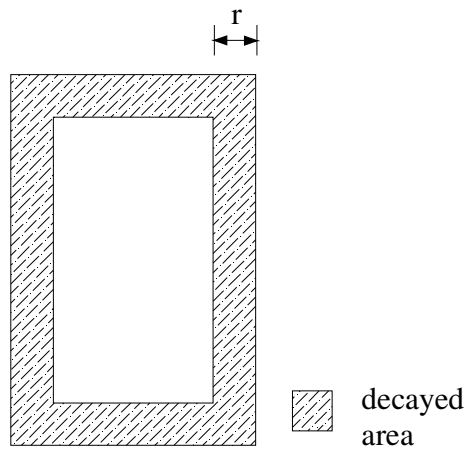
Figure 8: Progress of decay: a) idealized model, adapted from Leicester (2001); b) damage penetration on a decayed cross section
