Seismic performance of bridges during the 2016 Central Italy earthquakes

Di Sarno L., da Porto, F. , Guerrini, G., Calvi, P.M., Camata, G. and Prota, A.

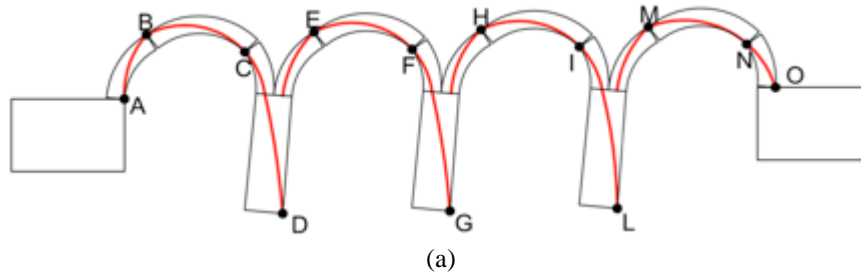
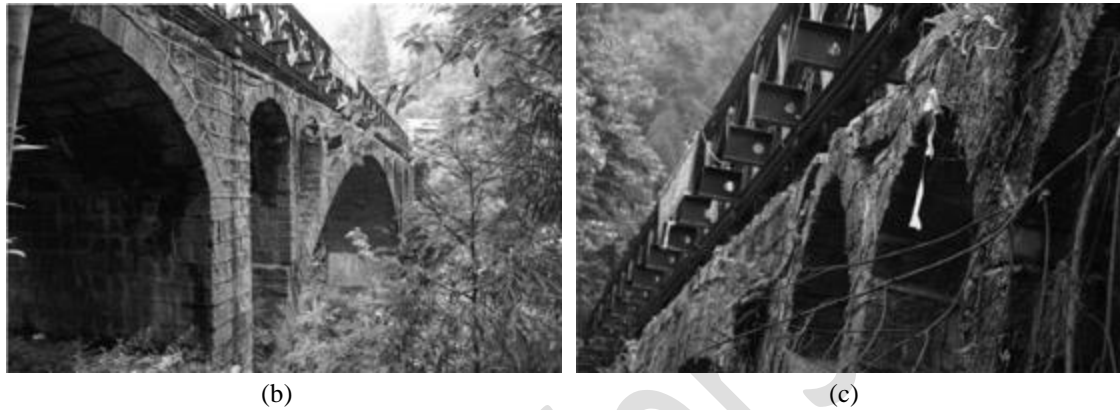
92 China, an unreinforced sandstone masonry arch bridge hit by the 2008 Wenchuan earthquake
 93 (Figures 2b and 2c).

99 Figure 2 - Multi-span bridges: (a) overall longitudinal arch-pier mechanism (AP-L); (b, c) damage to the
 100 Guantong Bridge, China, due to large displacements in the longitudinal direction in the 2008 Wenchuan
 101 earthquake (after [13]).
 102
 103
 104

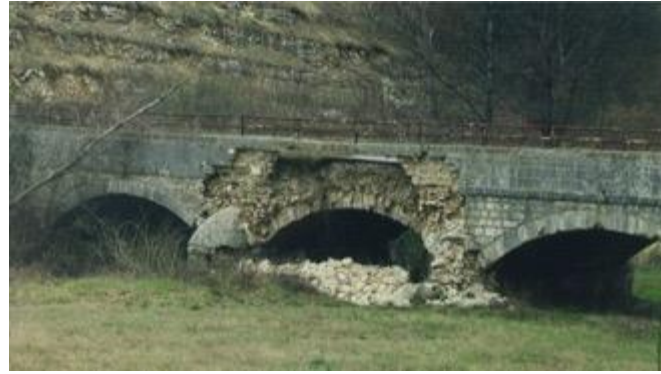
105 Considering the response in the transverse direction, spandrel walls are often the most vulnerable
 106 elements and may easily rotate out-of-plane in a spandrel-wall transverse mechanism (mechanism
 107 SW-T, Figure 3a). Damage or overturning of these secondary elements does not generally
 108 jeopardize the overall structural safety of the bridge. However, subsequent loss of infill material
 109 may compromise road pavement support and hence bridge functionality. These local collapse
 110 mechanisms are usually related to the lowest limit accelerations and simple retrofit to prevent
 111 spandrel overturning can be very effective [16]. Other local out-of-plane failures involve
 112 abutment wing walls and parapets. Examples of overturning of spandrel walls (Figure 3b),
 113 spandrel walls and parapets (Figure 3c), and wing walls and parapets (Figure 3d) have been often
 114 reported in recent earthquakes.

130 Figure 3 - Local transverse mechanisms: (a) out-of-plane overturning of spandrel wall (SW-T); (b) out-of-
 131 plane collapse of a spandrel wall in the 1997 Umbria and Marche earthquake, Italy (after [19]); (c) damage
 132 to a railway masonry arch bridge in the 2001 Bhuj earthquake, India (after [20]); (d) collapse of wing wall
 133 and parapet of the Kahu Road East Bridge in the 2011 New Zealand earthquake (after [21]).
 134

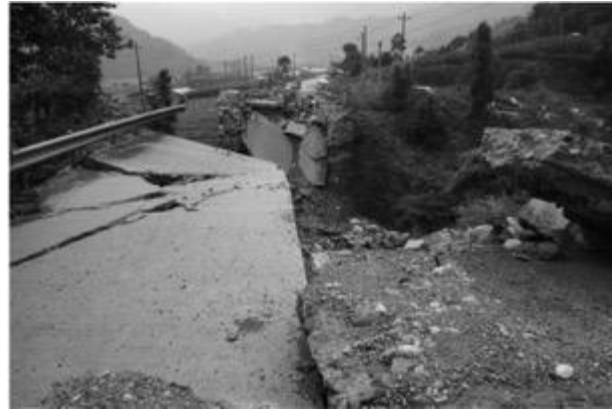
157 Figure 4 - Overall transverse mechanisms: (a) overall AP-T mechanism of multi-span bridges; (b) collapse
 158 of the Yingchun Bridge in the 2008 Wenchuan earthquake, China (after [13]); (c, d): collapse of the Río
 159 Claro Bridge in the 2010 Maule earthquake, Chile (after [23]).
 160
 161
 162

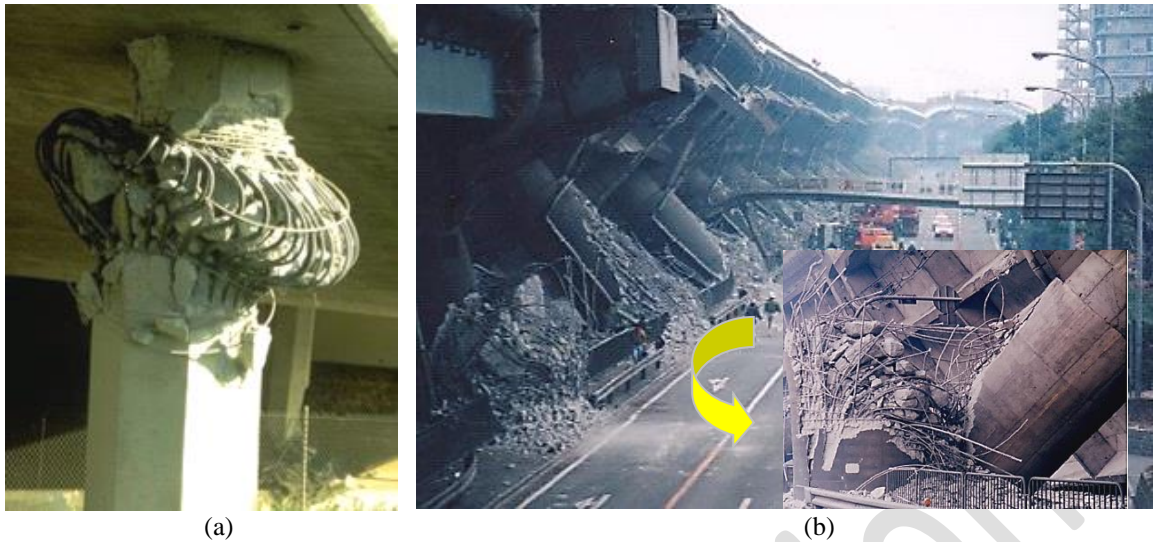
167 As primary components of the gravity and lateral force-resisting system of bridges, piers are
 168 subjected to intense forces during earthquakes. Damage to piers depends largely on bridge
 169 geometry, structural design and seismic details, if any. Short, stout piers are more susceptible to
 170 shear failure. Lack of specific design details, such as insufficient reinforcement lap length or
 171 inadequate transverse reinforcement, can lead to premature failure, as surveyed for example in
 172 the aftermath of the 1994 Northridge (California) and 1995 Kobe (Japan) earthquakes (Figure 5).
 173 Additionally, because of flexure-torsion interaction, many RC bridge piers of curved and skewed
 174 bridges suffered severe damages during the 2008 Wenchuan earthquake in China [12, 25].

184 Figure 5 - Typical failure of bridge piers: (a) confinement failure at a bridge pier top during the 1994
 185 Northridge earthquake (courtesy of NISEE) and (b) flexural failure above base of columns of the Hanshin
 186 expressway, due to premature termination of longitudinal reinforcement and inadequate confinement in the
 187 1995 Kobe earthquake: overall collapse (top) and close-up view of the failure mechanism (courtesy of
 188 Kawashima).
 189

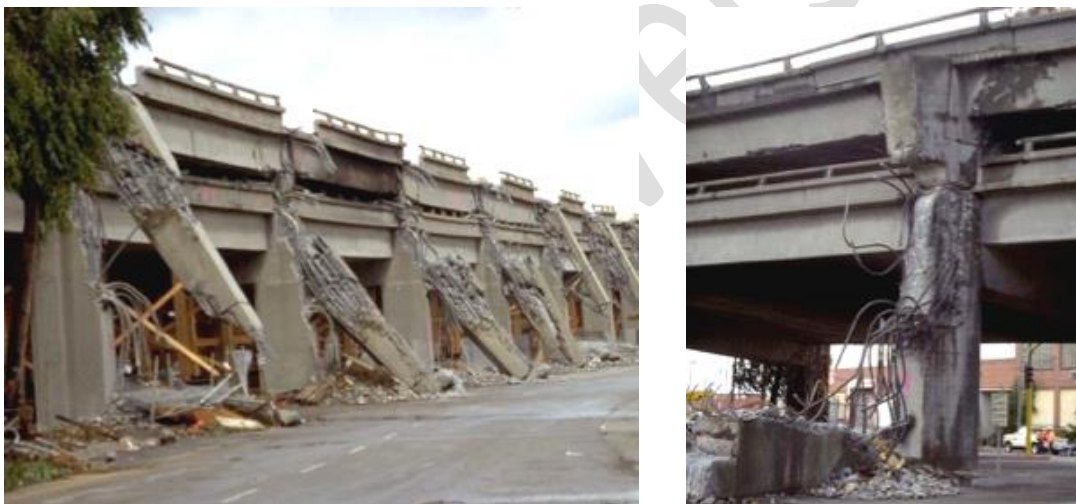
175 High shear demands typically develop within joints between piers and superstructure. The heavy
 176 damage observed on several RC bridges in the San Francisco Bay Area during the 1989 Loma
 177 Prieta earthquake dramatically highlighted this problem (Figure 6). Current design philosophies
 178 aim at capacity designing these connections in order to force inelastic actions to occur in beams
 179 and columns. Without adequate transverse reinforcement, concrete diagonal cracks occur in the
 180 joint regions, because of excessive shear-induced tensile stresses (Figure 6). Moreover, beam
 181 longitudinal bars do not anchor properly if bent within poorly confined joints, with the risk of
 182 bond failure.
 183

190 Figure 6 - Shear failure of pier-bent cap joints, and anchorage failure of beam longitudinal bars of the
 191 Cypress viaduct in Oakland, California, during the 1989 Loma Prieta earthquake (courtesy of NISEE).
 192
 193

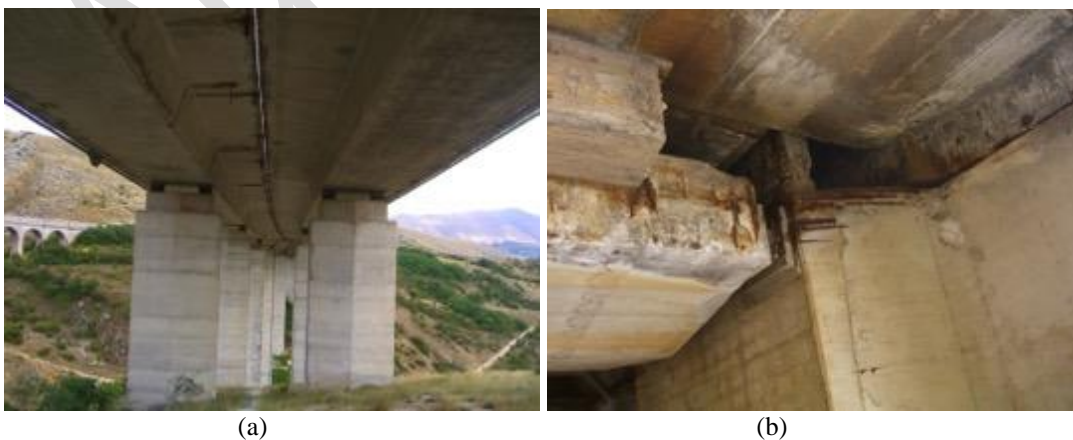
225 Highways A24 and A25 are two major infrastructures that connect the East coast with the West
226 coast of Italy, and run through the area affected by the 2009 L'Aquila earthquake. The double
227 carriageway bridge decks consist mostly of simply supported, single-span, precast pre-stressed
228 elements, resting on bearings on top of RC piers, as shown in Figure 7 for the "Della Valle" bridge
229 along A24. Bearings and gaps were designed to allow deck thermal deformations and were not
230 conceived to resist horizontal and vertical seismic loads or displacements: many of these supports
231 were unbolted and they could resist lateral loads relying solely on friction. These highways were
232 closed for inspection in the aftermath of the 2009 L'Aquila earthquake and reopened a few days
233 later: no structural damage to the bridges was generally observed, but some interventions were
234 needed to repair the damage induced by pounding, movement or failure of the bearings. Due to

Figure 7 - "Della Valle" bridge along Highway A24, Italy: (a) bridge configuration; (b) typical damage due to lack of maintenance.

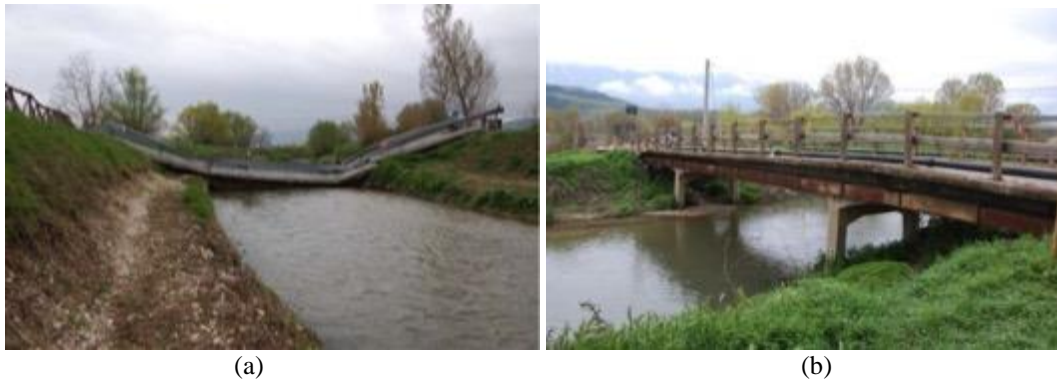
237 Only a 35-m-long multi-span RC bridge collapsed along a secondary road near the town of Fossa
238 (Figure 8a). The collapse was probably caused by pier failure due to lack of maintenance [26]:
239 the steel reinforcing bars were protected by a thin concrete cover and appeared to be severely
240 corroded. Another 3-span RC bridge, close to the town of Onna (Figure 8b), suffered some
241 damage at the top of the piers: again, damage was mainly due to poor maintenance.

250
251
252 Figure 8 - Bridge damage in the 209 L'Aquila earthquake, Italy: (a) bridge collapse near Fossa; (b) deck
253 failure near Onna (after [26]).
254

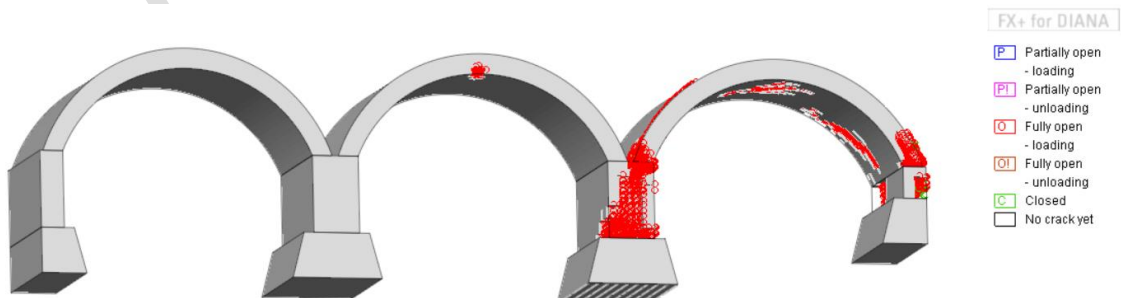
651
652 The yielding acceleration of the bilinear relationship in the longitudinal direction is 0.275 g, which
653 is consistent with the value of 0.278 g calculated according to the simplified method in Section
654 4.1, for the AP-L mechanism. In the transversal direction, however, the yielding acceleration is
655 only 0.121 g, which is less than one third of the simplified result. This is consistent with what
656 happened in reality, as a global transverse mechanism occurred and cracks related to longitudinal
657 mechanisms have not been observed. Figure 22 shows the crack pattern obtained with non-linear
658 static analysis in the transverse direction. It can be seen that the numerical crack pattern is fully
659 compatible with the one observed after the earthquake, as shown in Figure 19.
660

662 Figure 22 - Crack pattern predicted by the pushover analysis in the transverse direction.
663
