Investigation of High Energy Arcing Fault Events in Nuclear Power Plants

Heinz Peter Berg¹ and Marina Röwekamp²

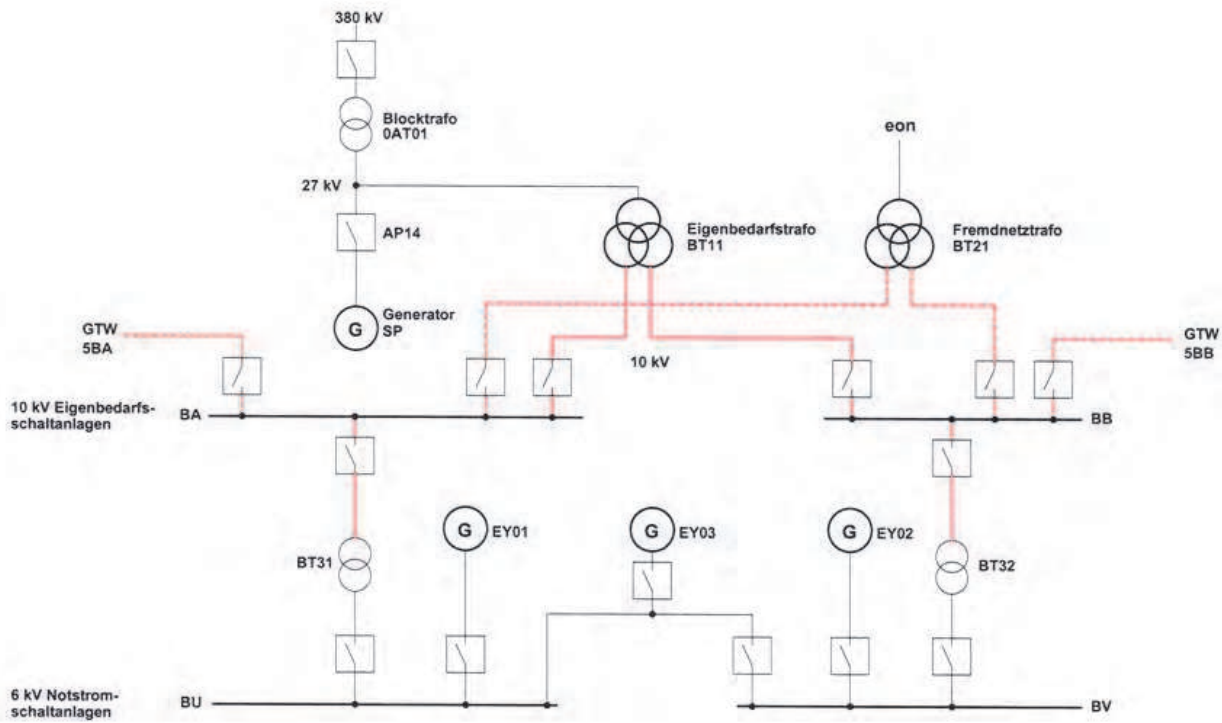
Fig. 1. Scheme of the electric circuit affected

This event, which occurred in a 10 kV cable at a BWR type plant, has been analyzed in detail by the responsible expert organization on behalf of the regulator in charge (Berg & Katzer et al., 2009). Details on the electric circuit are provided in Figure 1.

The overpressure arising from the high voltage short circuit was relieved via open cable conduits to the transformer and leakages.

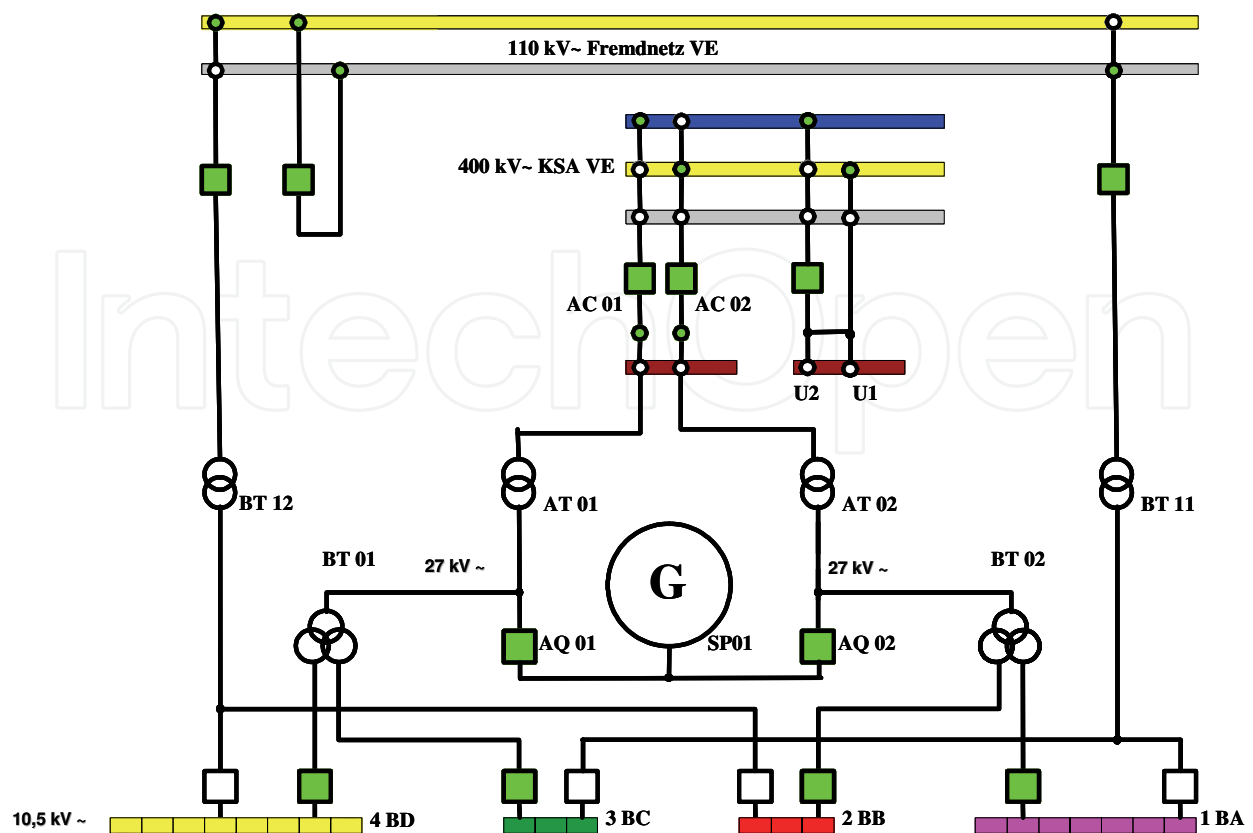
Fig. 7. Simplified diagram of the station service supply and the grid connection of the nuclear power plant

At the same time, de-excitation of the generator was actuated. The short circuit was thereby isolated. In addition, two of the four station service supply bus bars (3BC and 4BD) were switched to the 110 kV standby grid (VE). A simplified diagram is given in Figure 7 (Berg & Fritze, 2011).

Within 0.5 s, the generator protection system (initiating 'generator distance relay' by remaining current during de-excitation of the generator which still feeds the short circuit) caused the second circuit breaker between the 380 kV grid connection and the intact generator transformer (AC02) to open. Subsequently the two other station service supply bus bars (2BB and 1BA) were also switched to the standby grid. After approx. 1.7 s, station service supply was re-established by the standby grid.

Due to the short low voltage signalization on station service supply bus bars the reactor protection system triggered a reactor trip.

A detailed root cause analysis regarding the different deviations from the expected event sequence was carried out. The cause of the fire was a short circuit in the windings of the generator transformer. Due to the damages to the transformer it was not possible to resolve the failure mechanisms in all details.
