# Lessons Learned from Recent Earthquakes – Geoscience and Geotechnical Perspectives

Robert C. Lo<sup>1</sup> and Yumei Wang<sup>2</sup>

<sup>1</sup>*Klohn Crippen Berger Ltd., Vancouver, B.C.*

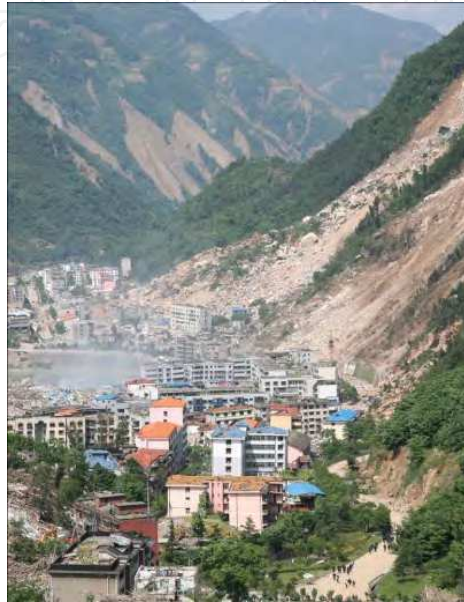
Due to the steep and rugged topography in the affected mountainous region, wide spread landslides (see Figs. 9 and 10) have been major destructing factors, besides strong earthquake shaking (EEEV 2008, EERI 2008). About 20,000 fatalities, near one-fourth of the total, were caused by 15,000 geohazards in the form of landslides, debris flows and rockfalls, with the largest landslide involving a volume of 1.1 billion m<sup>3</sup>. In the high, steep slopes (see Fig. 10) along the 270 km long Longmenshan tectonic belt, the large vertical acceleration and topographic amplification of ground motion have resulted in more than 10,000 potential geohazard sites after the event (Yin et al. 2011).

Fig. 9. Landslides in Proximity of Old Beichuan Town. <http://www.agu.org/news>

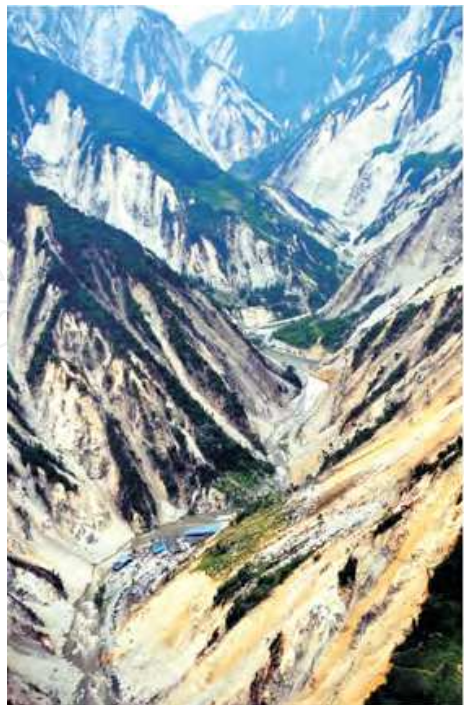
Fig. 10. Landslides along Minjiang River near Wenchuan County. (EEEV 2008)

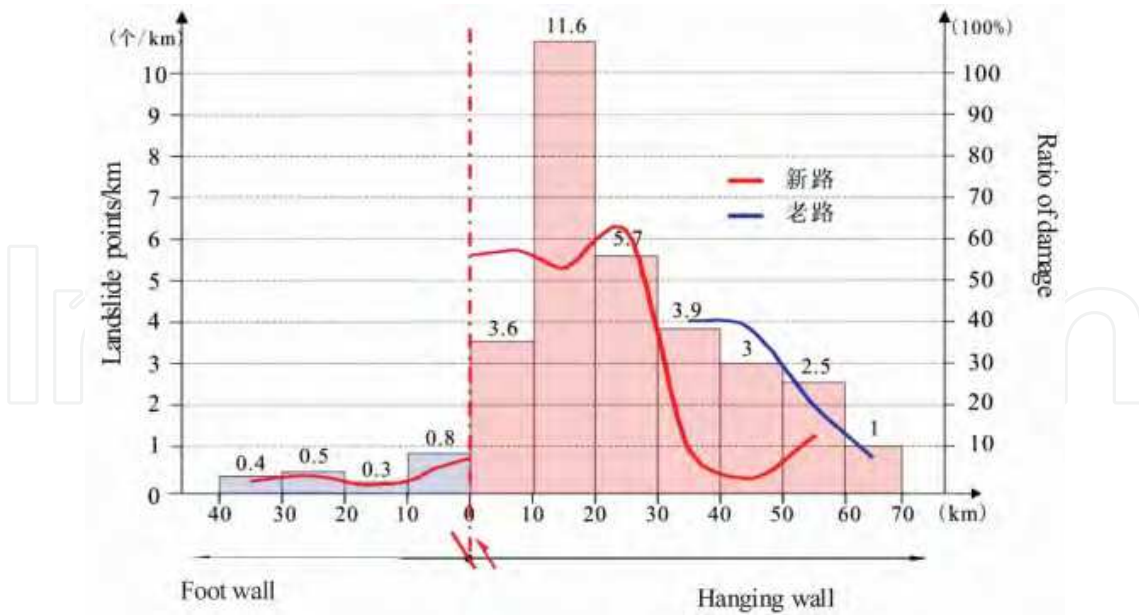
Figure 12 shows the number and severity of landslides per km of National Highway Route #213 over the hanging wall versus foot wall. As expected in a thrust-fault earthquake (Sommerville 2000), there is substantially more damage over the hanging wall as compared to that over the foot wall. Similarly, there is more damage in the area along the earthquake propagation direction than in the opposite direction.

Fig. 12. Landslide Activities above Hanging Wall versus Foot Wall. (EEEV 2008).

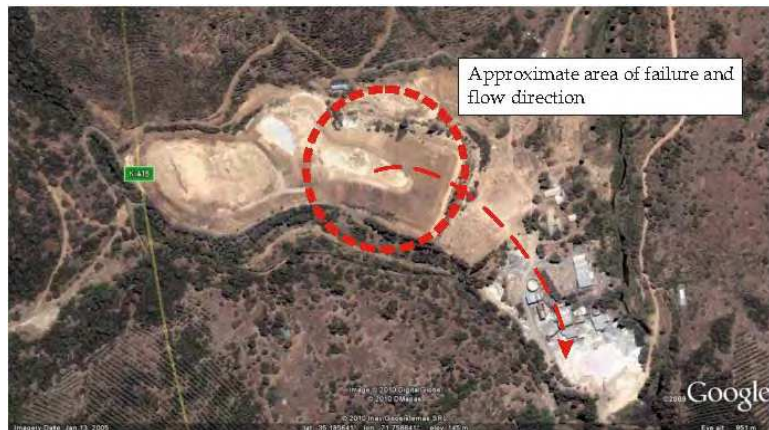
The flow failure of a tailings dam triggered by the earthquake is shown in Figs. 23 and 24 (GEER 2010). Compared with a large number of tailings dam failures in the 1965 La Ligua earthquake and two failures in the 1985 Santiago earthquake, tailings dam performance in this event seems to show some improvement. Compacted engineering fills and structures supported by improved ground using stone columns and micro-piles were reported to perform well.

Fig. 23. Bird's-eye View of Las Palmas Tailings Impoundment Prior to Failure. (GEER 2010)

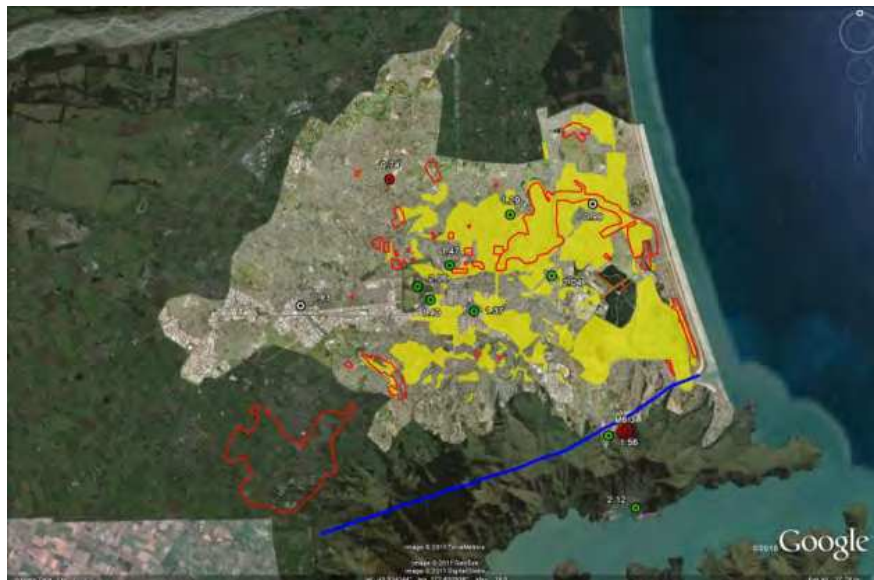
Both the September 2010 Mw 7.0 Darfield and February 2011 Mw 6.1 events were shallow crustal earthquakes, which triggered wide-spread liquefaction in the fluvial and diluvial deposits in the epicentral region (see Figs. 25 and 26). Peak ground accelerations spiking above 1 g, often with higher vertical than horizontal acceleration, were reported in the epicentral areas of both events. In the central business district of Christchurch, the largest city on the South Island, peak acceleration reached about 0.7 g on February 22, 2011 as compared to about 0.3 g on September 4, 2010. Figure 27 shows the horizontal acceleration response spectra for Christchurch Hospital with 5% damping. It illustrates that the aftershock is reflected by the current New Zealand 2,500-year design spectrum, while the main shock is corresponding to the 500-year design spectrum. Proposal to increase the design spectrum for periods less than 1.5 sec is being considered (EERI 2010/2011).

Fig. 25. Liquefaction Maps: Sept. 2010 (Red) and Feb. 2011 (Yellow). (GEER 2011)

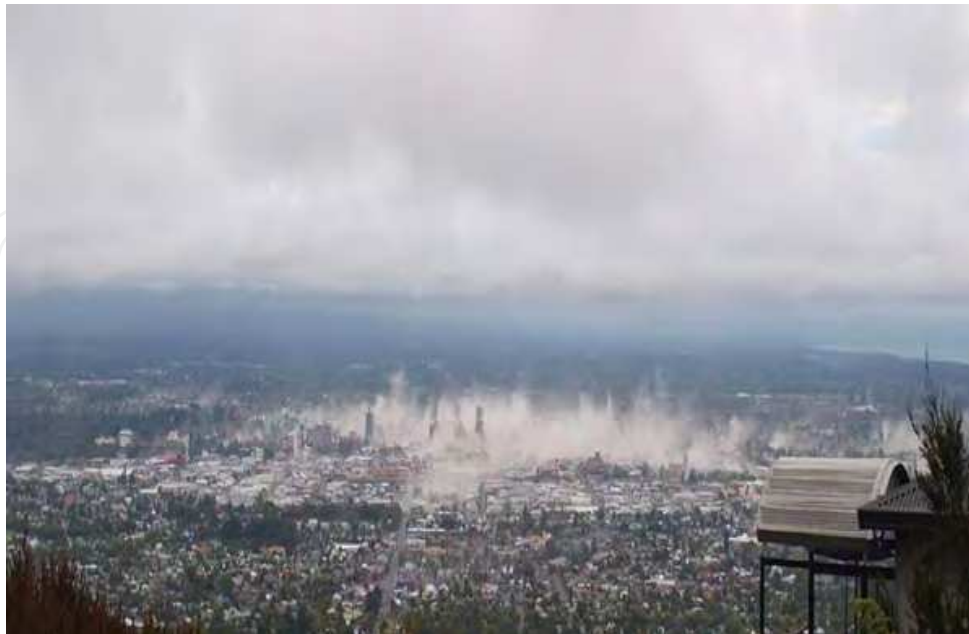
The smaller aftershock caused significant casualties and heavier structure damages in Christchurch (see Figs. 28, 29 and 30) than the main event, because it occurred much closer to the central business district, where many buildings had already suffered varying degrees of damage due to the prior event.

Fig. 28. Scene of Downtown Christchurch Captured by a Tourist During Earthquake, 2011.  
[http://otilya.com/view/christchurch\\_as\\_the\\_quake\\_hits.html](http://otilya.com/view/christchurch_as_the_quake_hits.html)

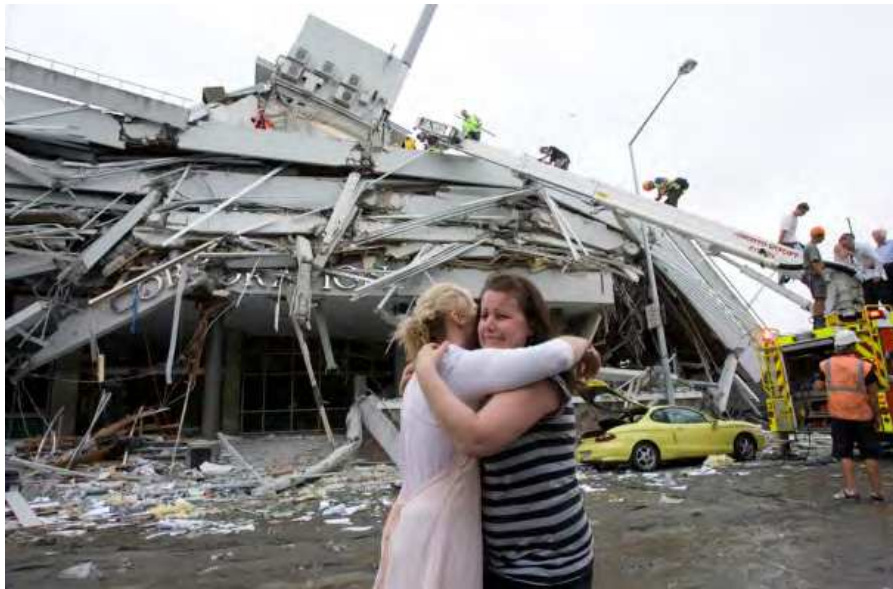
Unreinforced masonry and non-ductile reinforced concrete buildings suffered most structural damages, while liquefaction and lateral spreading contributed to foundation failures or differential settlement of buildings and pipeline breaks. Non-structural damages to building components and content caused food-supply shortage and slowed down business recovery. Other damages were caused by rock falls in the Port Hills area.

Fig. 29. Two Survivors Comforting Each Other During Rescue Operation at Pyne Gould Building, 2011. <http://www.kiwiblog.co.nz/2011/03/News/Asia-Pacific/New-Zealand>

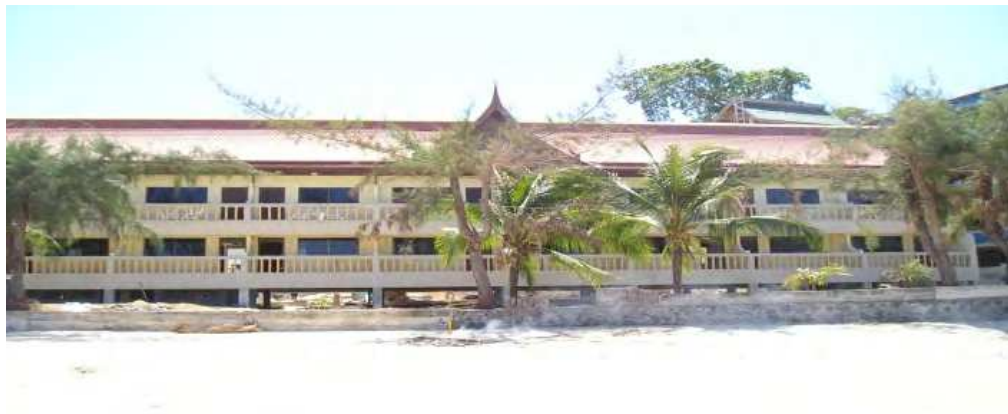
- Forces associated with tsunami – In addition to the inundation effect of rapidly moving waves, tsunami also exerts additional physical forces to structures such as hydrodynamic pressure including uplift (see Figs. 36, 37 and 38), debris impact and wave scour (see Figs. 39 and 40). The overturning of seawalls could be caused by the combined effect of tsunami hydrodynamic pressure, uplift and scour. Both passive and active measures are used to mitigate tsunami damage. Passive measures are use of buffer zone and/or natural barriers such as mangroves and sand dunes to avoid building structures in near shore areas. Where structures are required in tsunami-vulnerable zone, both inundation effect and tsunami-related forces have to be considered in the overall design and operation of these structures. Well designed concrete buildings, which have crawl space on the first floor to allow tsunami flowing through, performed well (see Figs. 41 and 42). However, the “soft-story” effect under seismic loading condition should be carefully evaluated.

Fig. 41. Building with Crawl Space on the First Floor, Kamala Beach, Phuket Province, Thailand, 2004.

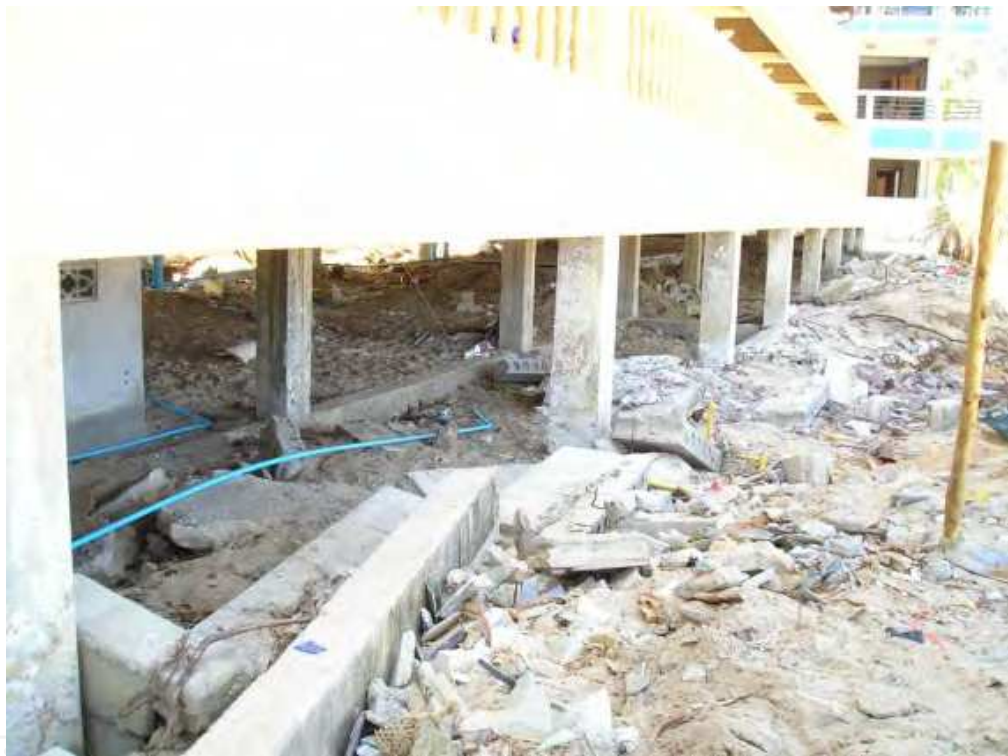
Fig. 42. Close-up of Fig. 41, Showing Inter-connected Grade Beams and Columns.

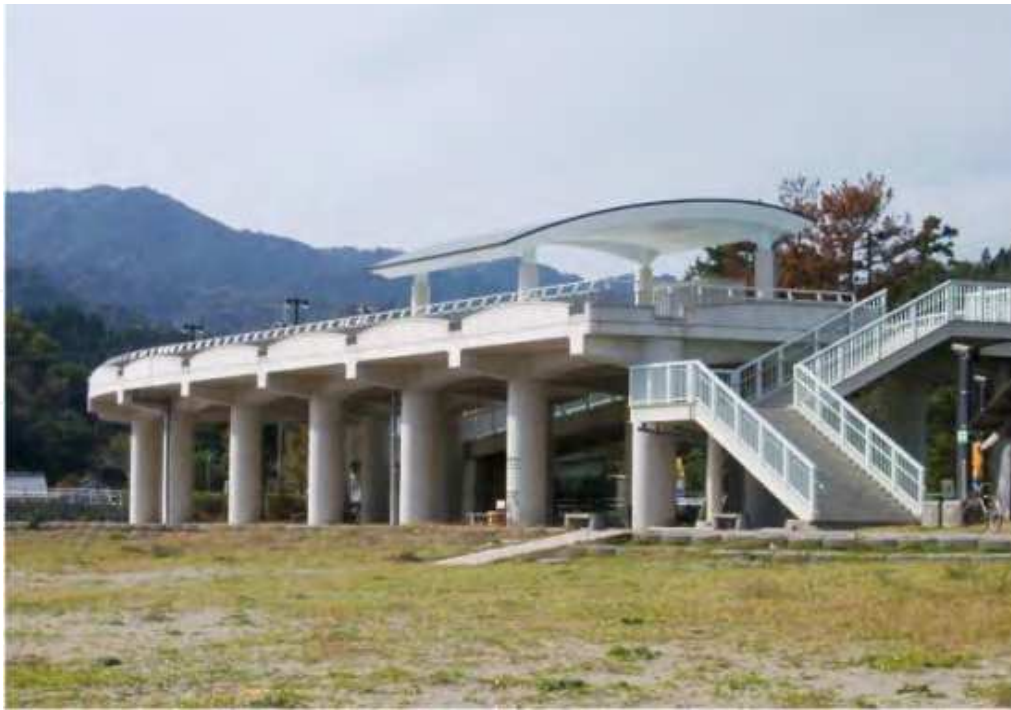
- Tsunami vertical evacuation refuges - are an engineering option for enhancing public safety against near-field earthquakes (FEMA 2008/2009). These structures should be clearly identified as tsunami-proof refuges. They need to be designed for both earthquake and tsunami loads, as well as to a safe height above the tsunami run-up, allowing for rapid public ingress and upward movement (see Fig. 48). As a cost-effective measure, any elevated structure in a tsunami-vulnerable zone such as water tower, lighthouse or fire-lookout tower could be designed with additional capacity and features to accommodate tsunami-escapees looking for an escape path.

Fig. 48. Vertical Evacuation Structure at Shirahama Beach Resort in Japan. (FEMA 2009)

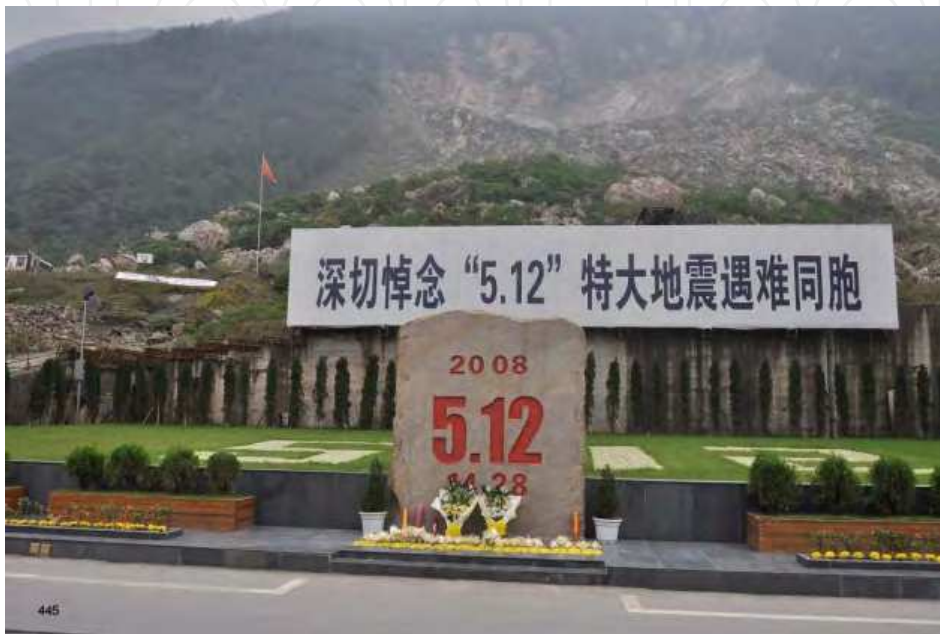
- Emergency response and public education – Drills of emergency response need to be practiced regularly to enhance the capability of response agencies and personnel, and public awareness. Preservation of certain damaged or failed structures in the earthquake-stricken areas as memorial sites would go a long way to remind and educate the public about the importance of adequate seismic design and earthquake preparedness. Figure 49 shows the memorial park established at the preserved old Beichuan townsite in honour of the victims, and Figure 50 shows the public taking a sober earthquake lesson at the park.

Fig. 49. Memorial Park at Old Beichuan Town. <http://www.eeri.org/site/meetings/us-china-symposium>

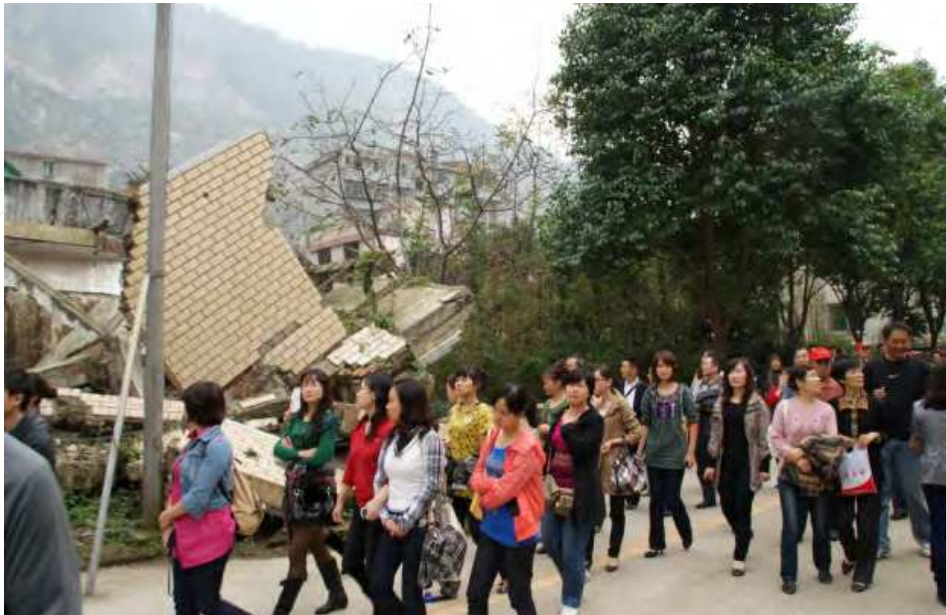
Fig. 50. Educational Tour of Memorial Park. <http://www.eeri.org/site/meetings/us-china-symposium>
