# Abrasive Effects Observed in Concrete Hydraulic Surfaces of Dams and Application of Repair Materials

José Carlos Alves Galvão,  
Kleber Franke Portella and Aline Christiane Morales Kormann  
*Federal Technological University of Paraná, Institute of Technology for Development,  
Federal University of Paraná  
Brazil*

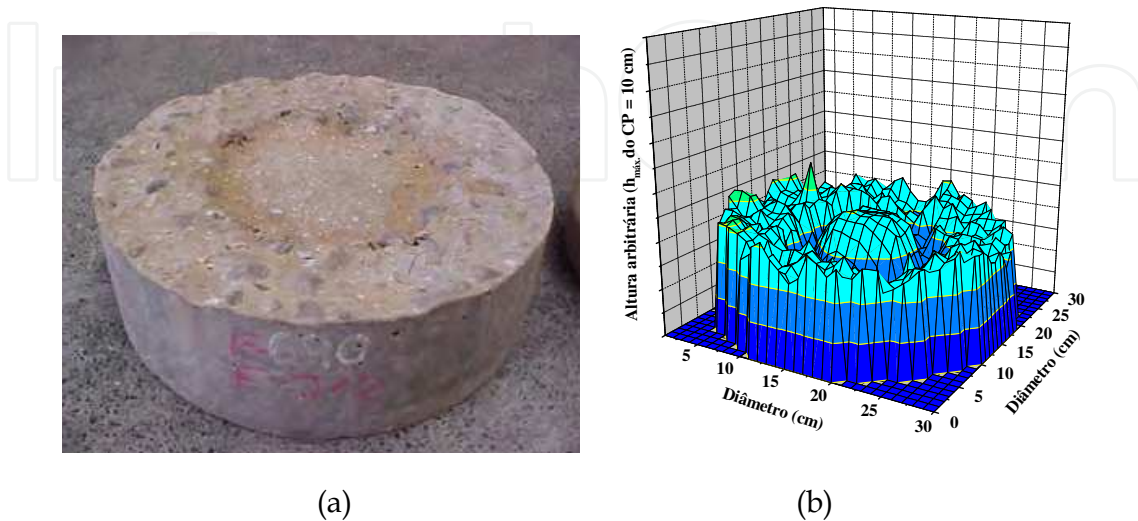
The average mass loss for the substrate system | mortar with silica fume was 5.53% and was virtually in the region of the substrate and the interface between both materials.

Fig. 4, shows the performance of the system substrate | mortar with silica fume, 72 hours after the test.

Fig. 4. Results of testing of abrasion resistance of the RM with silica fume. (a) Specimen after test. (b) 3D schematic graph of wear occurred in the abrasion resistance test (underwater method).

As shown in the graphs of Fig. 4 - 7, may be the poorest performance of the mortars with silica fume and polymer mortar, respectively, the second has more wear. The substrate system | concrete with steel fibers showed a good performance and wear observed was widespread. Already, for the substrate system | epoxy mortar, the wear was observed on the substrate with little or no loss of epoxy mortar.

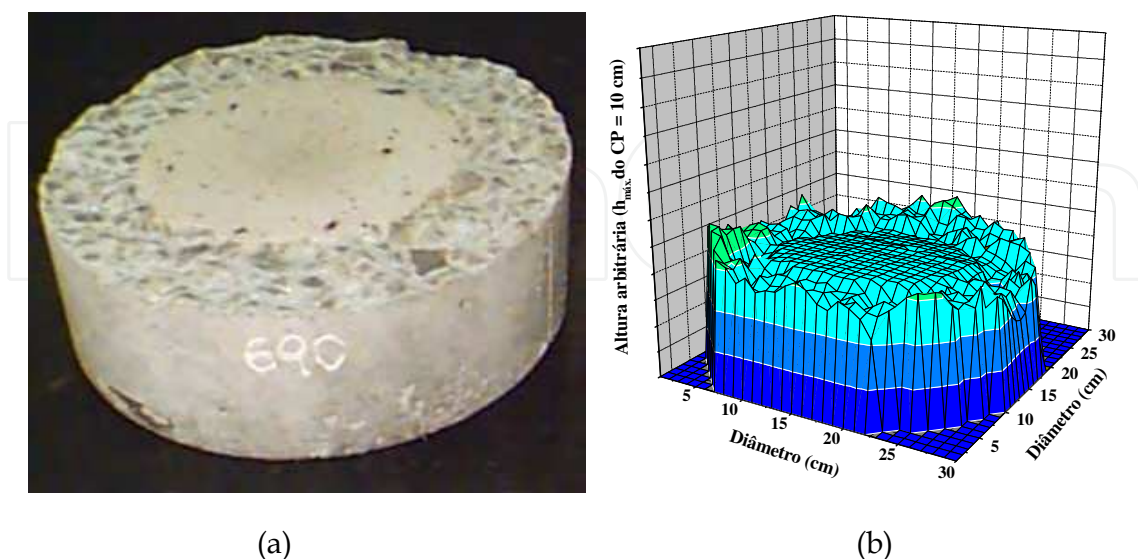
The mass loss for the substrate system | epoxy mortar was averaging 2%. It can be seen in Fig. 5 that much of the material was extracted from the substrate, with little influence in the region of interface. This effect can be attributed to high compressive strength of the material (over 90 MPa).

Fig. 5. Results of testing of abrasion resistance of the RM with epoxy mortar. (a) Specimen after test. (b) 3D schematic graph of wear occurred in the abrasion resistance test (underwater method).

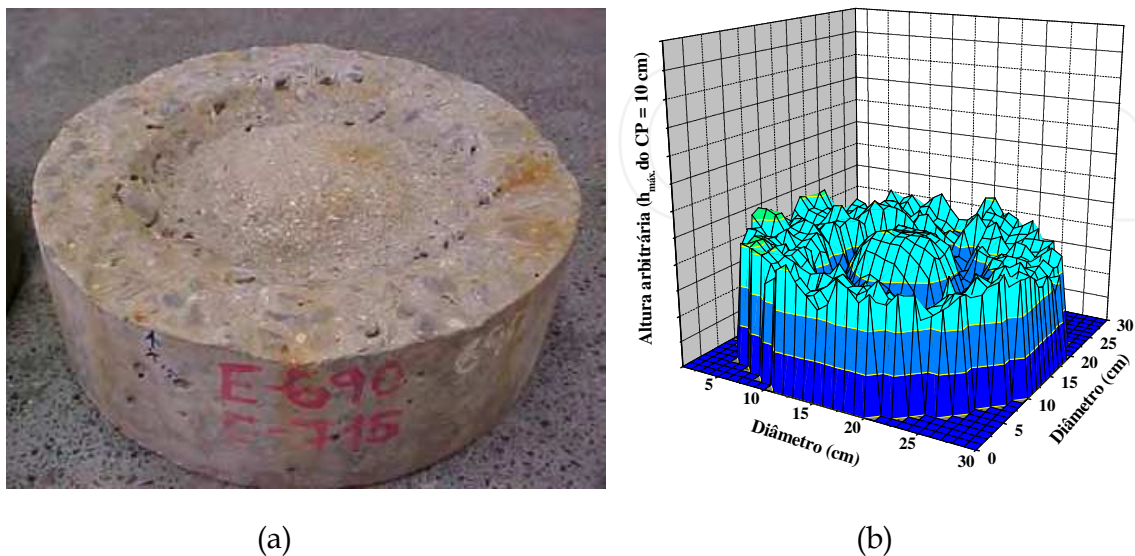
In Fig. 6, shows the performance of the system substrate | polymer mortar. The average weight loss was 6.4% and located in the substrate interface | polymer mortar.

Fig. 6. Results of testing of abrasion resistance of the RM with polymer mortar . (a) Specimen after test. (b) 3D schematic graph of wear occurred in the abrasion resistance test (underwater method).

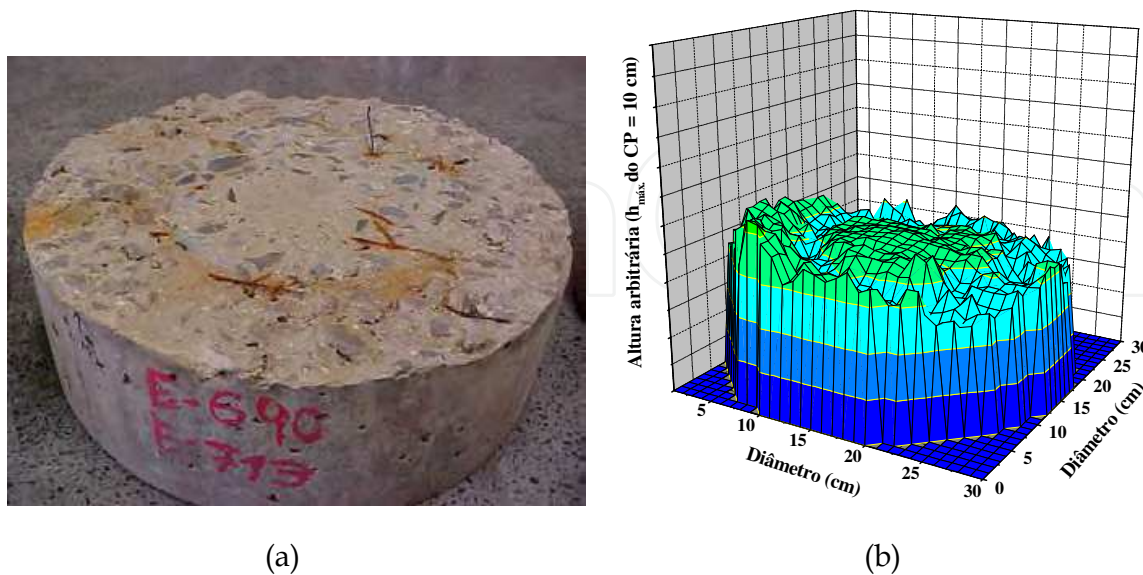
The effect of abrasion on the test substrate system | concrete with steel fibers was also not very pronounced. The mass loss was more intense in the region of RC, as shown in Fig. 7.

Fig. 7. Results of testing of abrasion resistance of the RM with concrete with steel fibers. (a) Specimen after test. (b) 3D schematic graph of wear occurred in the abrasion resistance test (underwater method).
