Fracture Analysis of Generator Fan Blades

Mahmood Sameezadeh and Hassan Farhangi

This chapter reports the failure investigation of a rotating axial flow fan of the Iran Montazer-Ghaem-VI 123 MW capacity generator unit. The unit was equipped with two rotating fans, one at each end namely at the turbine side and the exciter side of the generator. The failed fan consisting of 11 blades was mounted on the generator-rotor at the

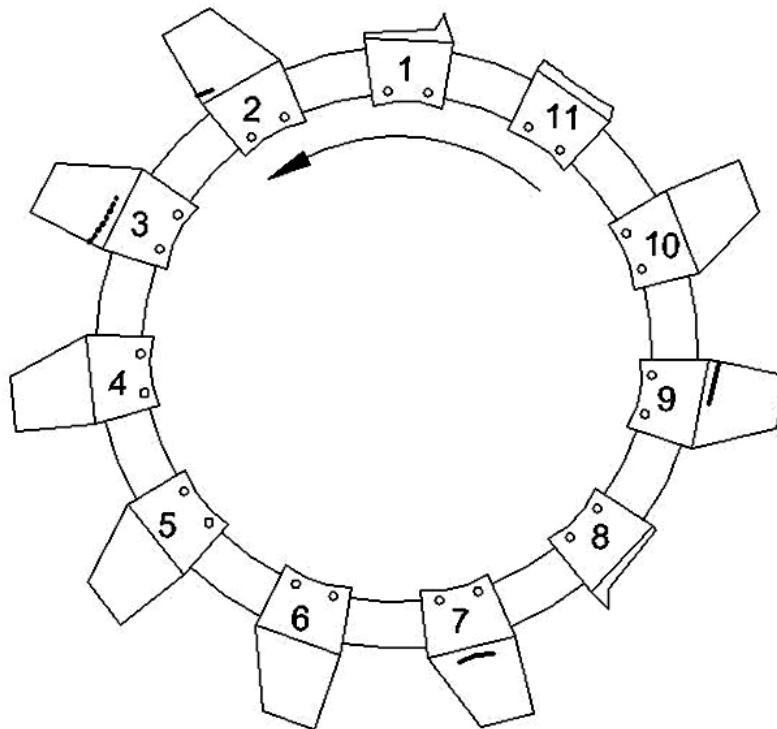
Figure 10. Schematic drawing of the fan with location of damaged blades

Faint beach marks indicative of the progressive nature of crack growth in the semi-elliptical region can be seen in Fig. 8. Parallel microscopic fracture surface markings can also be observed in this region at higher magnifications in SEM micrograph as shown in Fig. 9. A schematic drawing of the fan with the location of damaged blades is presented in Fig. 10. Visual inspections and fractographic assessments revealed that the sequence of fracture for the broken blades has been blade No. 1, blade No. 8 and blade No. 11 respectively (Sameezadeh, 2005).
