# Failure Analysis of High Pressure High Temperature Super-Heater Outlet Header Tube in Heat Recovery Steam Generator

Ainul Akmar Mokhtar and  
Muhammad Kamil Kamarul Bahrin

Heat Recovery Steam Generator (HRSG) tube failure is one of the most frequent causes of power plant forced outage. In one of the local power plants, one of the boilers has experienced several defects and failures after running approximately 85,000 hours. 17 tube failures were found at the High Pressure High Temperature Superheater (HPHTSH) outlet header. The aim of this study is to find the root cause of the tube failures and to suggest the remedial action to prevent repetitive failure event. Several analysis methods were conducted to ascertain the potential cause(s) of failure. The results showed that the tubes failed due to long-term creep and thermal fatigue based on the cracking behaviour. Furthermore, the power plant has been operating as a peaking plant which concluded that the tubes have undergone the thermal stress due to frequent temperature change in the tubes. Flow correcting device (FCD) was also found damaged, causing flow imbalance in the tubes. Flow imbalance accelerated the creep degradation o

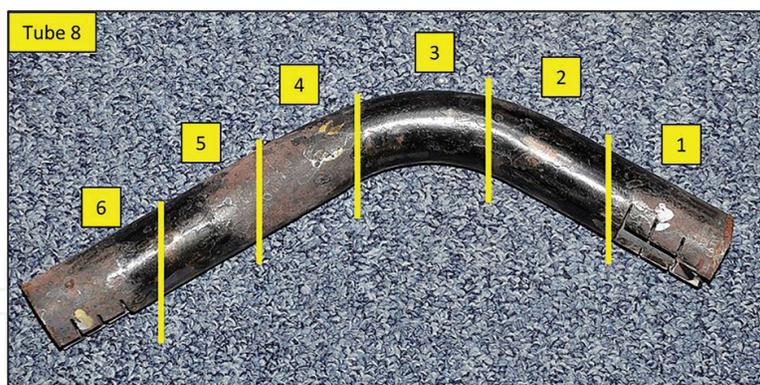
Tube 8 and Tube 18 were cut at an interval length of 50 mm. The sections are designated 1–6 as shown in **Figure 6**. The OD, ID and thickness of each cutting location were measured by Vernier calliper at the area shown in **Figure 7**. The results are recorded in **Tables 4** and **5**.

Figure 6. Tube 8 was cut into six sections.

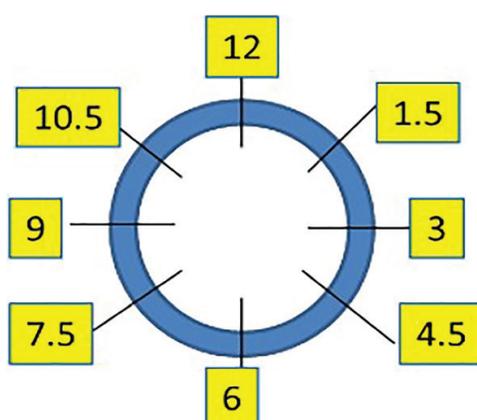
Figure 7. Dimensional reference of OD and ID tube.

The OD and ID for both tubes did not show any significant signs of tube bulging, deformation and wall thinning over the length, as compared to the design values, where OD was 31.8 mm and ID was 26.2 mm.

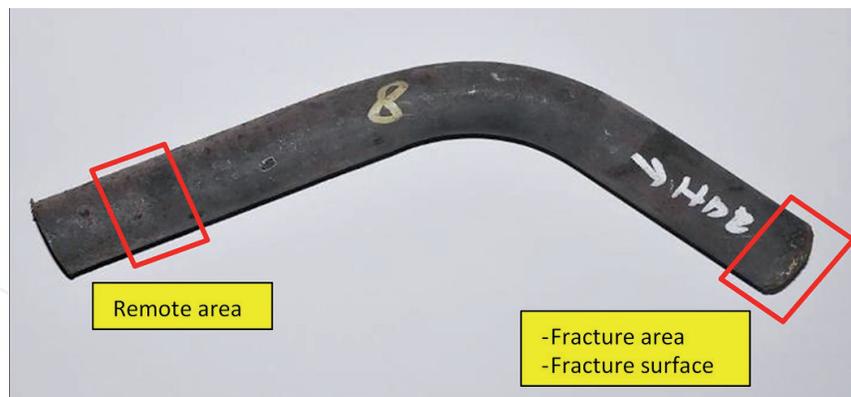
Figure 9. Dimensional reference of oxide thickness measurement.

The location of interest for internal oxide assessment for Tube 8 and Tube 18 is shown in **Figure 9**.
