3D Digital Simulation for Material Damage Mechanism Identification in a Railway Carriage Pressure Vessel

Alessandra Caggiano and Roberto Teti

<http://dx.doi.org/10.5772/intechopen.73233>

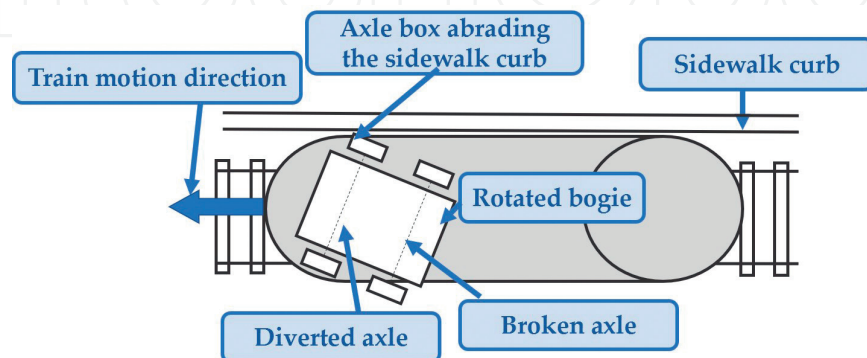
Figure 4. Relative positions, after derailment, of carriage no. 1, right front axle box, and sidewalk curb.

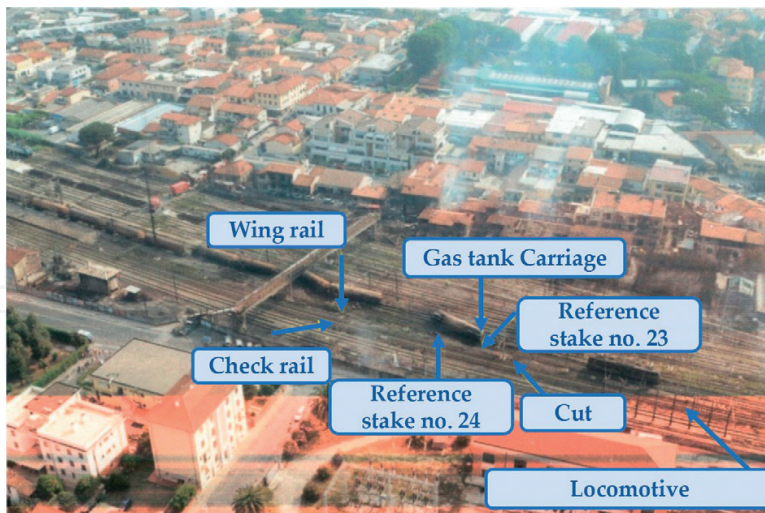
Figure 10 shows the aerial view of the accident scenario with indication of the potentially responsible elements that could have generated the cut on the tank shell through a mechanism similar to the action of a metal cutting tool. The positions of the elements are reported in more details in **Figure 11**.

Figure 10. Aerial view of the accident with indication of the elements potentially responsible for the opening of the cut on the tank shell.

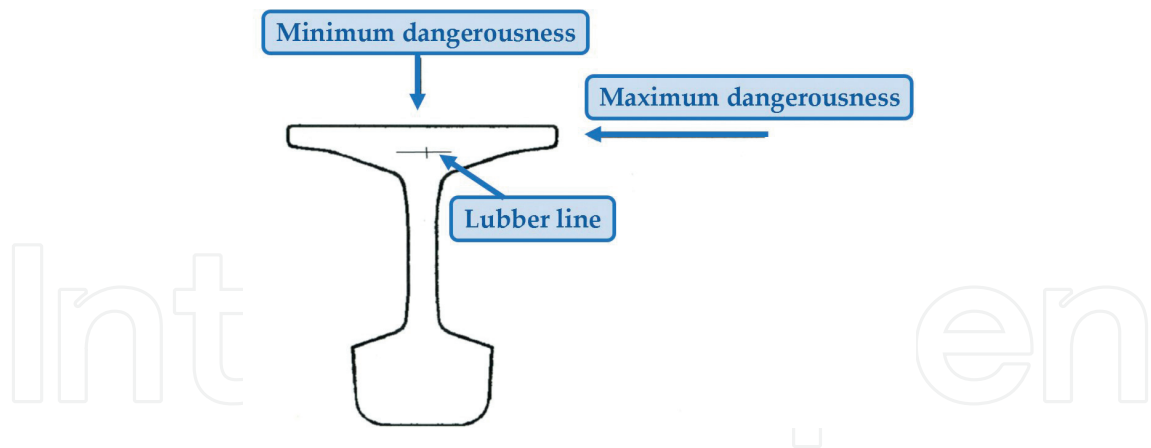
Figure 12. Transverse section of a track curve reference stake and directions of minimum and maximum danger grade in case of impact by a moving body against the track reference stake.

In **Figure 12**, the transverse section of a track curve reference stake is shown illustrating the variation of the degree of danger as a function of the impact direction of a moving body against the track reference stake. In the figure, two possible impact directions are considered: the one of maximum degree of danger, parallel to the lower surface of the rail chunk and the other of minimum degree of danger, perpendicular to the lower surface of the rail chunk. For intermediate impact angles, the danger increases going from a perpendicular impact to a parallel impact with reference to the lower surface of the rail chunk. In the latter case, the extremely high contact forces due to the sharp configuration of the corner of the lower surface of the rail chunk can easily determine the cutting of the sheet metal of the impacting tank shell.

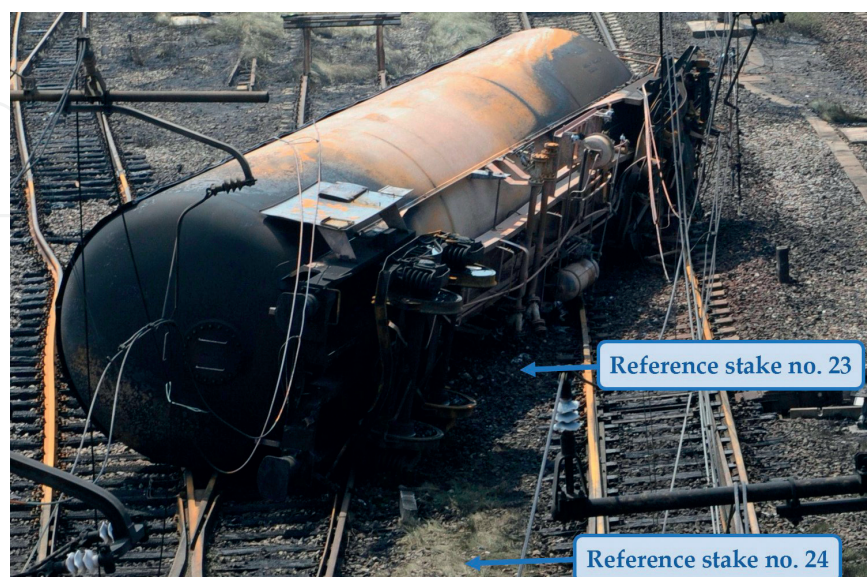
Figure 13. Rear view of carriage no. 1 in the accident scene and positions of track reference stake nos. 23 and 24.

Figure 13 shows the rear view of carriage no. 1 in the accident scene and the positions of track reference stake nos. 23 and 24; the two track reference stakes are 10 m apart, as set by the technical regulations of the Italian railways.

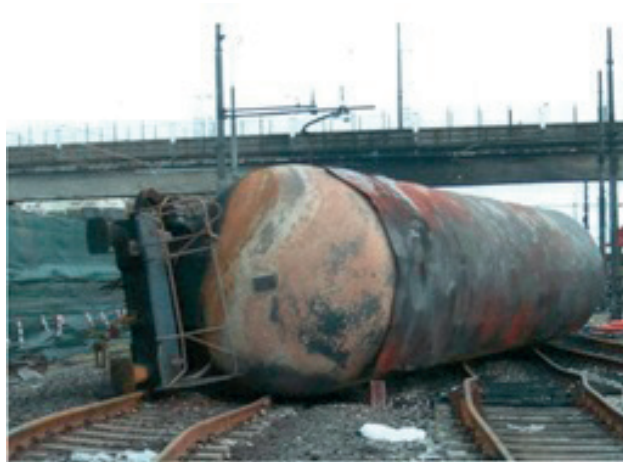
Figure 14 shows the front view of carriage no. 1 where it can be seen that the front bumper lies on the right rail in the train motion direction of track no. 4.

Figure 14. Front view of carriage no. 1 in the accident scene and position of its front bumper.

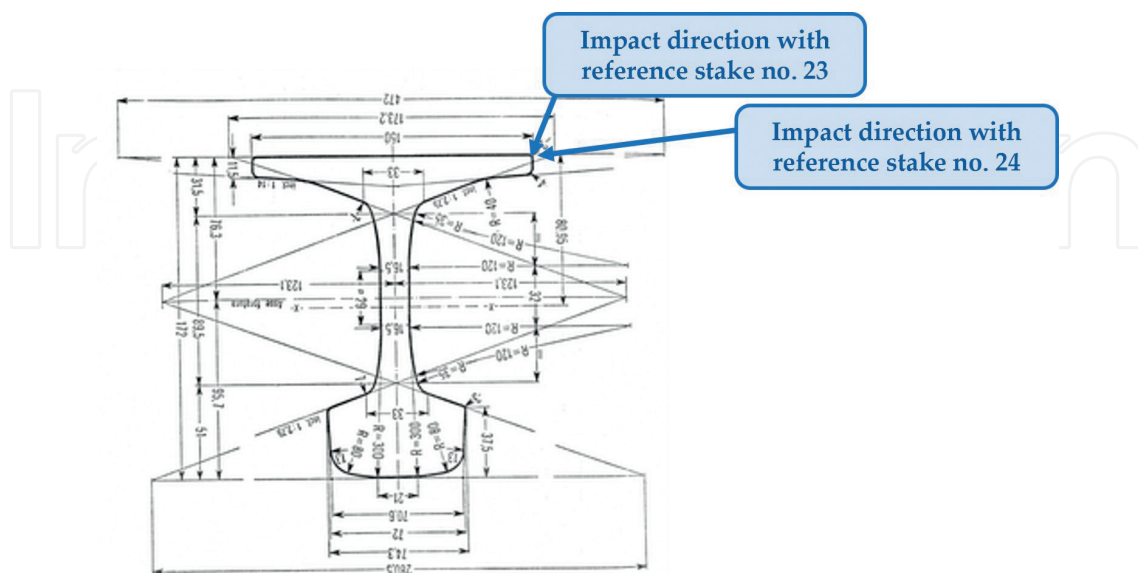
In **Figure 22**, the directions of the impact between the tank of carriage no. 1 and track reference stake nos. 23 and 24 are evidenced. It is worth recalling that the tank first hit the track reference stake no. 24 and afterward the track reference stake no. 23.

During the interaction with track reference stake no. 24, which was hit first, the tank, under the action of the applied forces, initiated a rotational motion around a vertical axis, as endorsed by the arched shape of the cut on the tank shell.

Figure 22. Direction of the impact between the tank of carriage no. 1 and track reference stake nos. 23 and 24.

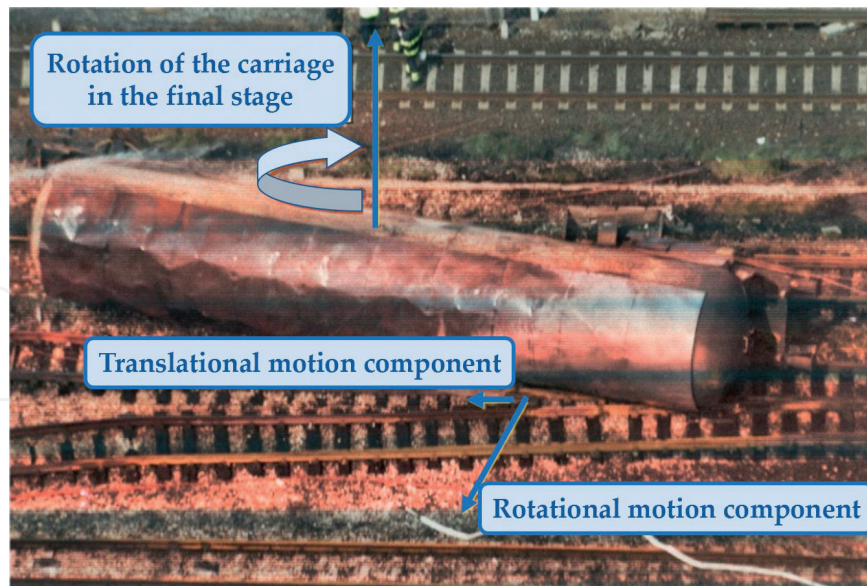
Figure 23 illustrates the motion of tank carriage no. 1 when, after hitting track reference stake no. 24, it proceeded to hitting track reference stake no. 23. The rotation of the carriage around the vertical axis was about 5° clockwise for an observer looking at the scene from above.

Figure 23. Rotational motion of tank carriage no. 1 around a vertical axis.

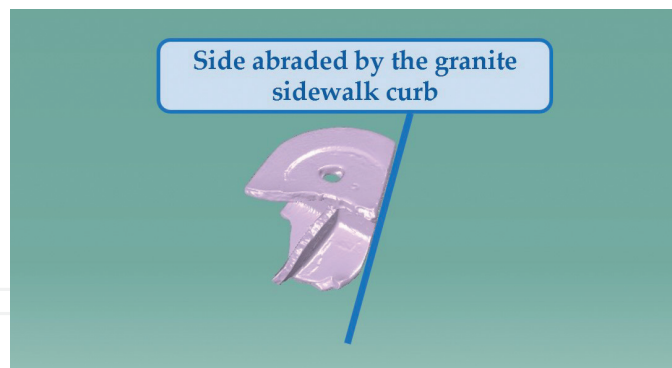
Figure 27. Digital twin of the chunk of the right axle box of the first wheel set of the front bogie of carriage no. 1 obtained by reverse engineering reconstruction based on geometry acquisition with a structured light optical sensor.

The front part of the right axle box—right side in the train motion direction—of the front wheel set was greatly abraded by the granite of the sidewalk curb that acted on the right front axle box just like a grinding wheel on the workpiece in a grinding process (**Figures 26b and 27**).

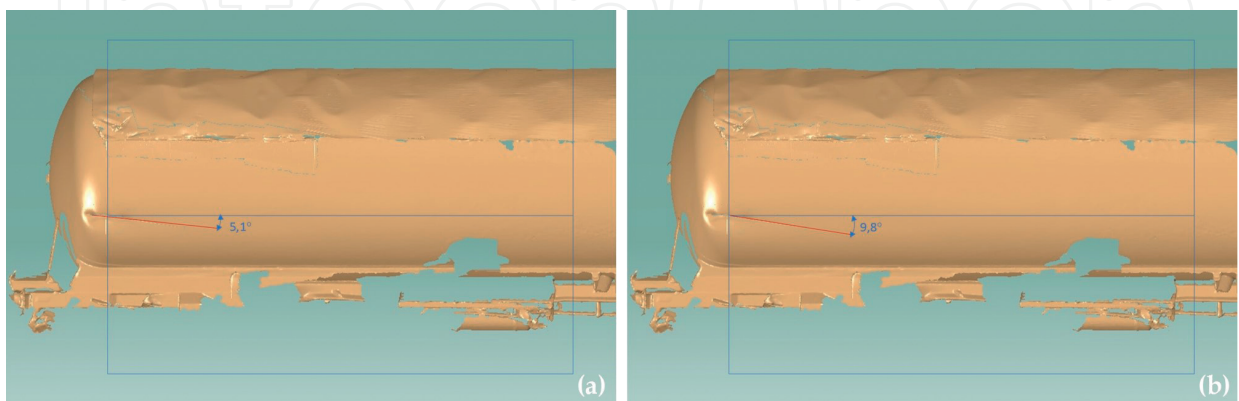
Figure 29 shows the digital model of the tank of carriage no. 1, obtained by reverse engineering reconstruction based on geometry acquisition with a time-of-flight laser sensor. The digital model highlights the incidence angle of the cut that varies during progressing of the cutting process. The incidence angle is the angle between the generatrix of the cylindrical body of the tank and the straight-line tangent to the outline of the cut at the point of intersection between generatrix and cut.

By examining the digital models of **Figures 29 and 30b**, it can be noted that the cut starts with an incidence angle of 5.1° and ends with an incidence angle of 9.8° . Accordingly, the rotation of the tank around a vertical axis, as illustrated in **Figure 12**, was about 5° .

Figure 29. Digital twin of the tank of carriage no. 1. Obtained by reverse engineering reconstruction based on geometry acquisition with a time-of-flight laser sensor, with indication of the incidence angle of (a) beginning of the cut and (b) end of the cut.

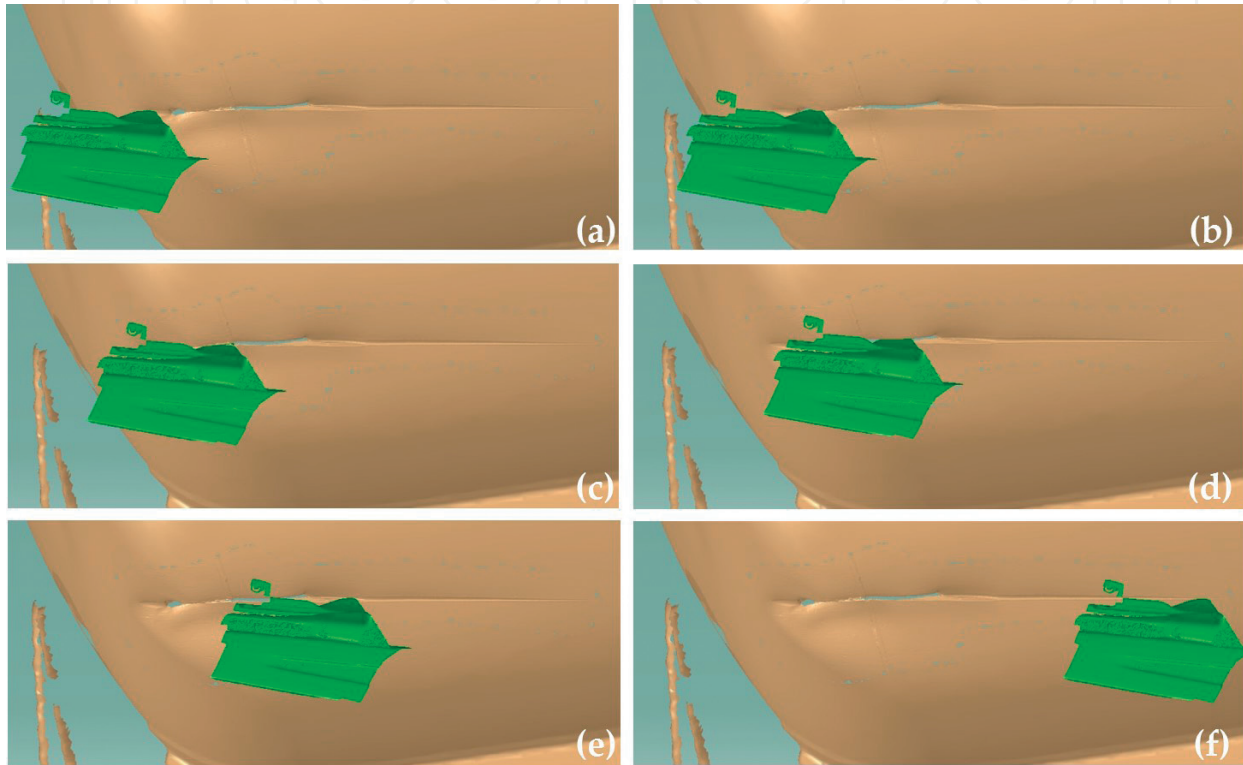
Figure 32 illustrates the simulation of the interaction between wing rail (the digital model of which was considered fixed with respect to the ground) and the deformed area of the tank

Figure 32. Simulation of the interaction between wing rail and tank shell of carriage no. 1: (a) contact, (b) penetration, (c) cutting, (d) exit, (e) start of sliding, and (f) end of sliding.

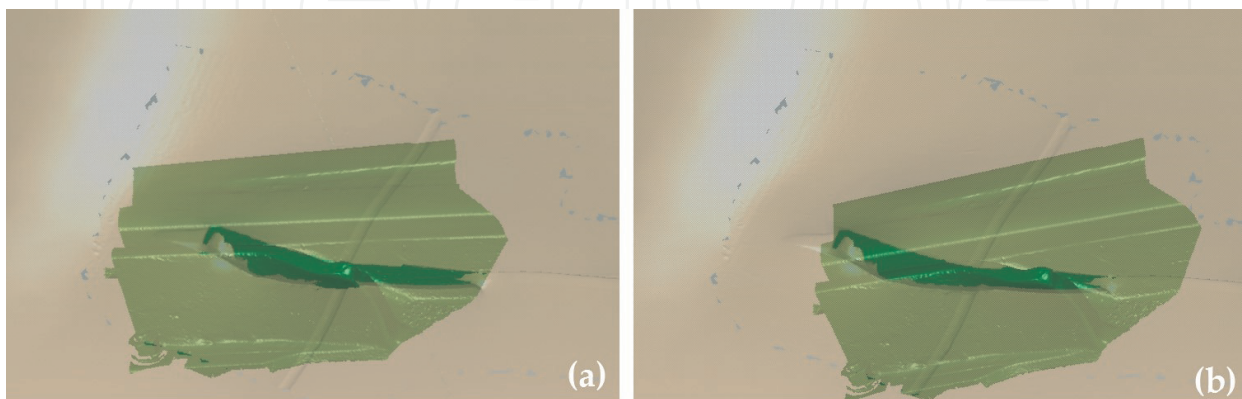
Figure 33a and **b** shows the details of the cutting phases corresponding to the positions of **Figure 32c** and **d**, respectively.

Figure 33. Details of the phases of the cutting action by the wing rail corresponding to: (a) the position of **Figure 32c** and (b) the position of **Figure 32d**.

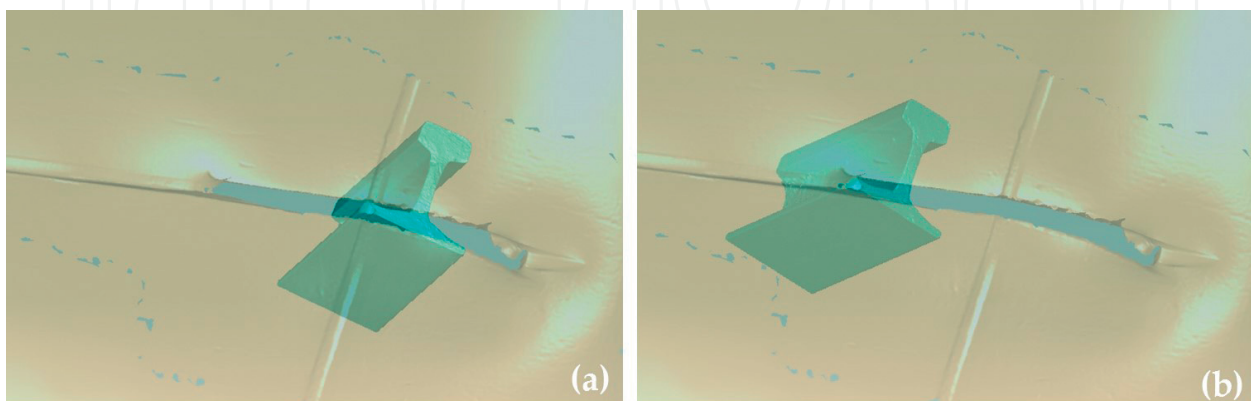
Figure 36a and b shows the details of the phases of the cutting action by track reference stake no. 24 corresponding to the positions of **Figure 35c and d**, respectively.

Figure 36. Details of the phases of the cutting action by track reference stake no. 24 corresponding to the position of (a) **Figure 35c** and (b) **Figure 35d**.

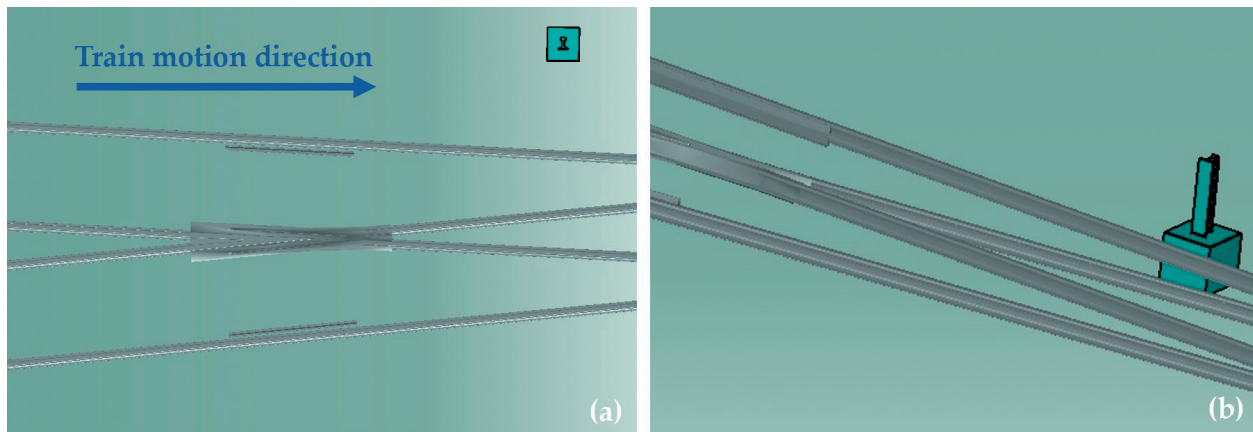
The positions assumed by tank carriage no. 1 during its impact against the elements possibly responsible for the cut were analyzed in the framework of the railway infrastructure with particular reference to the wing rail and track reference stake no. 24 (**Figure 38a and b**).

Figure 38. Digital model reconstruction of the railway infrastructure based on the planimetric measurements of the accident scene: (a) position of the wing rail and (b) lateral view of the position of track reference stake no. 24.

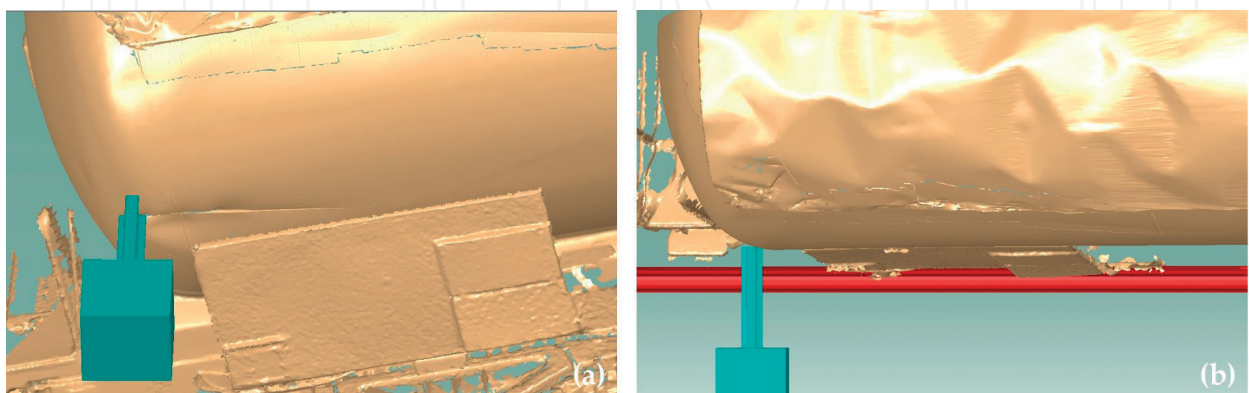
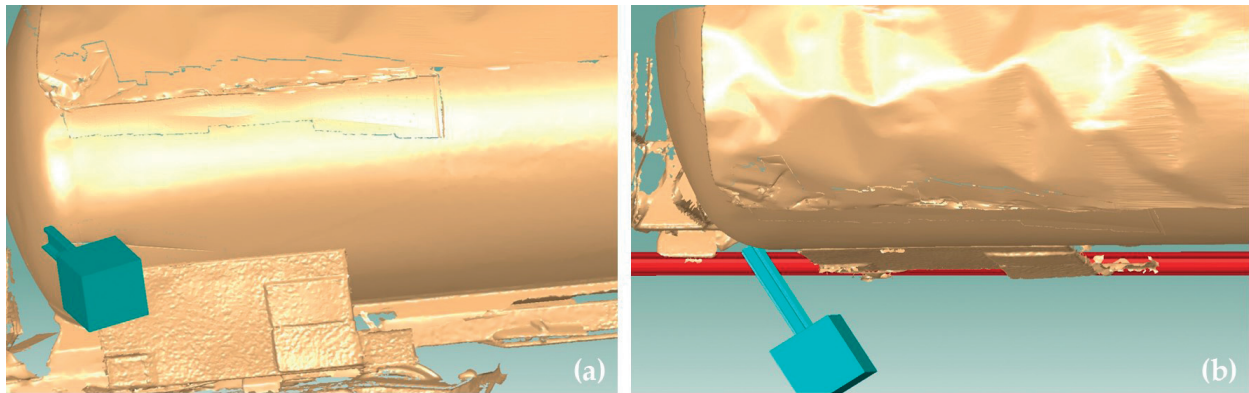
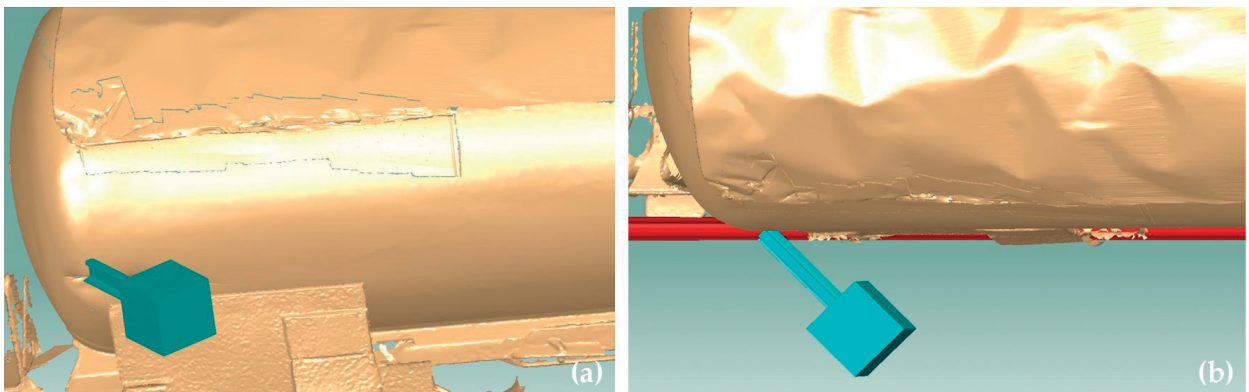
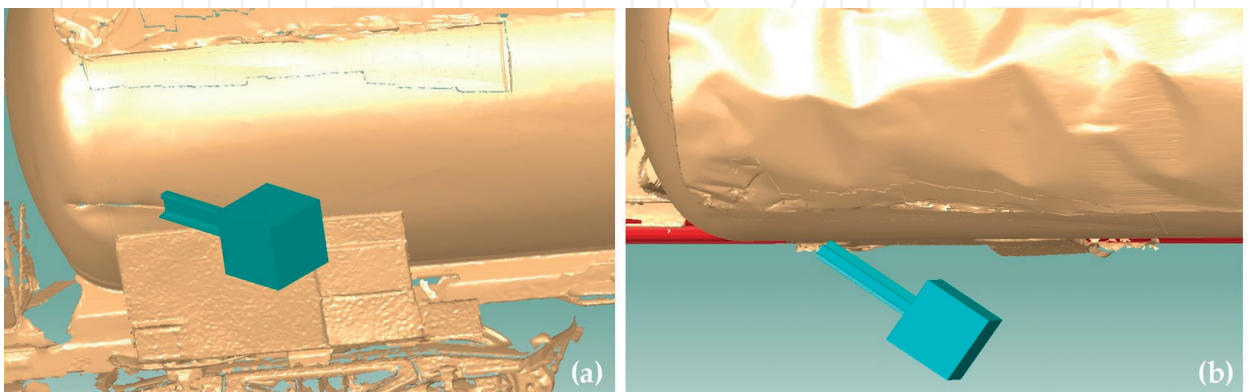
Figures 41-44 show the positions assumed by tank carriage no. 1 under the hypothesis of impact against track reference stake no. 24. In particular, the results refer to the following phases of the cutting process: initial contact (**Figures 35a** and **41**), penetration (**Figures 35b** and **42**), cutting (**Figures 35c** and **43**), and sliding (**Figures 35d** and **44**). The simulations took into account the yielding of track reference stake no. 24, which under the impact action by the tank vessel, was tilted till it knocked down sideways (**Figure 35**).

The simulation results show that, under the hypothesis of tank shell cutting by track reference stake no. 24, no interference is evidenced between tank carriage no. 1 and the railway infrastructure during the tank shell cutting process.

Accordingly, the tank of carriage no. 1, already overturned on its left side, impacted with its front part against track reference stake no. 24, which started the cutting action by penetrating for a certain depth inside the tank shell and continued to cut the sheet metal of the tank shell till it exited from the cut opening after its knocking upon yielding of the ballast where it was grounded.

Figure 41. Position assumed by tank carriage no. 1 in the framework of the railway infrastructure under the hypothesis of tank shell cutting by track reference stake no. 24: initial contact phase (**Figure 35a**).

Figure 42. Position assumed by tank carriage no. 1 in the framework of the railway infrastructure under the hypothesis of tank shell cutting by track reference stake no. 24: penetration phase (**Figure 35b**).

Figure 43. Position assumed by tank carriage no. 1 in the framework of the railway infrastructure under the hypothesis of tank shell cutting by track reference stake no. 24: cutting phase (**Figure 35c**).

Figure 44. Position assumed by tank carriage no. 1 in the framework of the railway infrastructure under the hypothesis of tank shell cutting by track reference stake no. 24: sliding phase (**Figure 35d**).
