# **Degradation Monitoring of Photovoltaic Plants: Advanced GIS Applications**

Miguel de Simón-Martín, Ana-María Díez-Suárez,  
Laura-Álvarez de Prado, Alberto González-Martínez,  
Álvaro de la Puente-Gil and Jorge Blanes-Peiró

<http://dx.doi.org/10.5772/intechopen.75650>

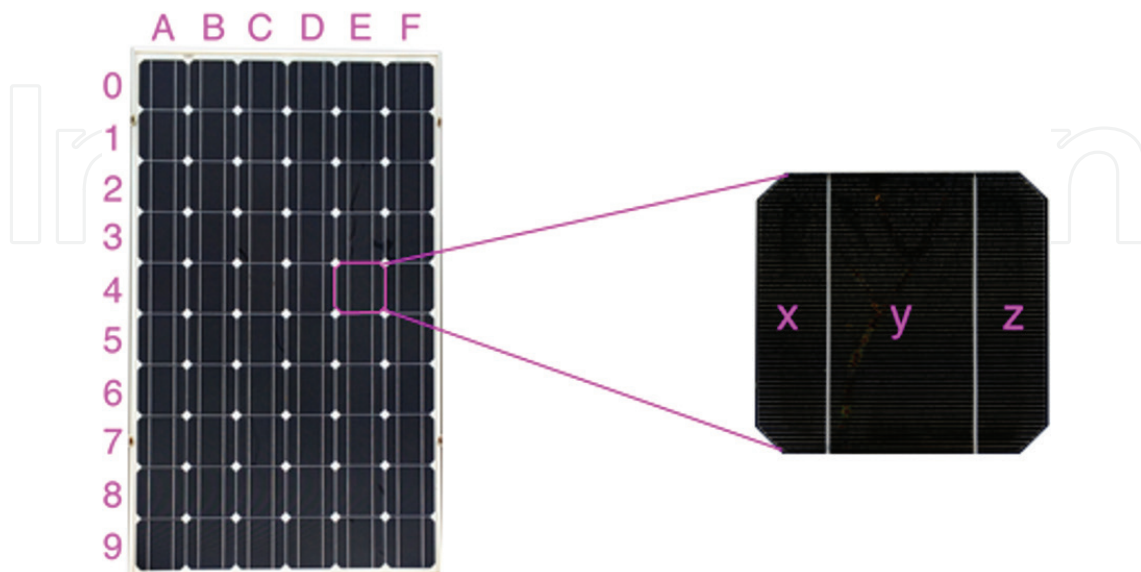
A systematic procedure needs to be set up to identify the geographical position of a defect within a panel. A photovoltaic module is made up of 180 thirds of cells so the following nomenclature is suggested. Each cell in the panel can be split into 6 columns (A–F) and 10 rows (0–9). Each cell is, in turn, split into three thirds (X, Y, or Z). In this way, the position of a defect can be indicated in the third of the cell where it is located by an alphanumerical code (e.g., 4EY). **Figure 5** shows such an identifying code applied to a panel.

**Figure 5.** Adopted nomenclature for PV defect identification.

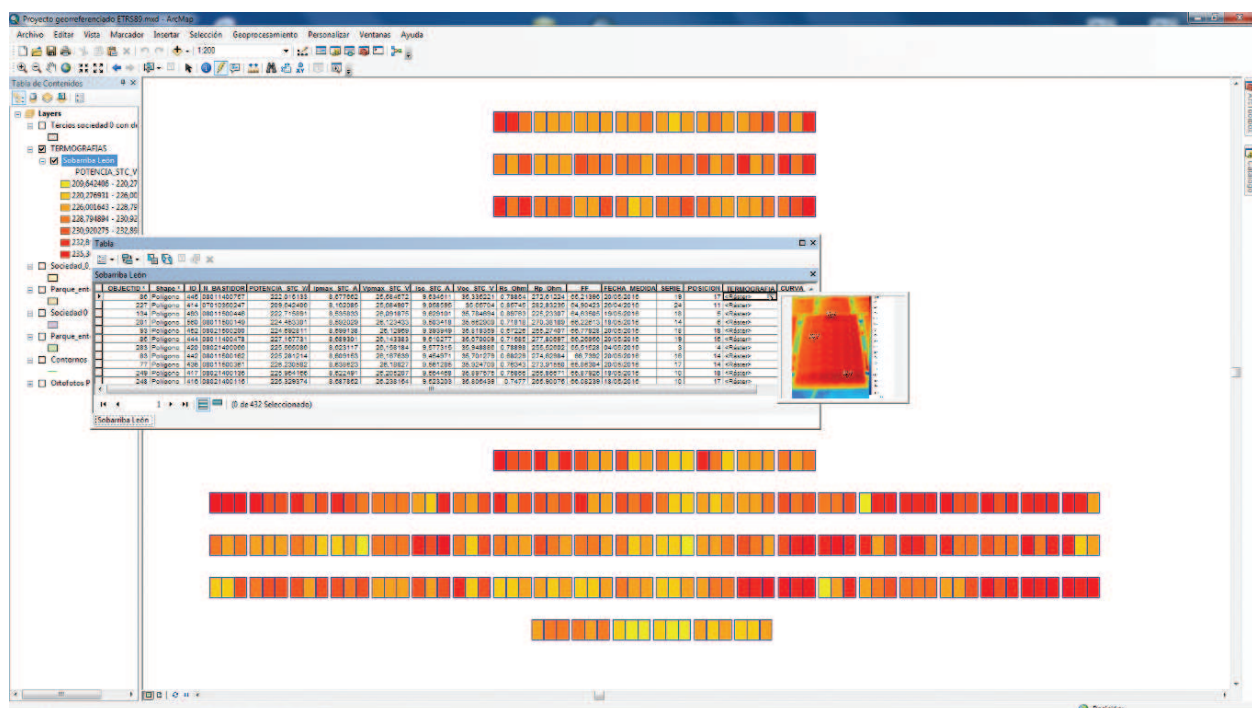
As shown in **Figure 7**, pictures, thermographs, and I-V curves are spatially referenced and associated with each module. This is extremely useful as it means graphic information can be spatially related to the measured attributes in each panel. Furthermore, all graphic information is available both from the geo-database and through the GIS map.

**Figure 7.** Instantaneous access to a PV module frontal thermography.
