Windstorm Resilient Rural Housing: Lessons learned in Temerloh, Malaysia

Foong Sin Lam¹, Jer Vui Lee², Yeok Meng Ngeow³

In 2019 alone, Temerloh district located in central Peninsular Malaysia has been hit by unpredictable wind storms in localised areas which damaged more than 185 rural homes. This research set out to assess the structural vulnerabilities of damaged rural houses to severe winds in Temerloh and lessons learned from windstorm damage through field surveys of damaged homes between March 2019-August 2019 and supplemented by district-level post-windstorm reconnaissance reports prepared by Malaysia Civil Defense Force (APM) and other information gathered from local government. Results indicate poor performance of structural and non-structural building components in resisting high wind loads due to inadequate design, under-strength of failed building materials and defective construction details. The results of this study could have important implications for government agencies, NGOs, builders, and engineers in assisting rural communities in reconstructing windproof resistant homes and planning for future windstorm risk management efforts specially catered to homeowners i

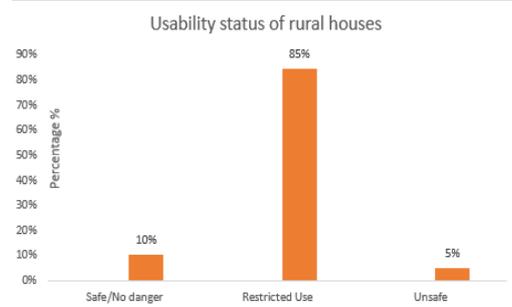
Fig. 2. Usability status of rural houses

We present the results of the status of usability of the buildings using rapid evaluations as shown in Figure 2. According to Figure 2, 10% of the inspected buildings were safe for occupancy. Approximately 85% of the houses that requires restrictions placed on areas of the buildings that were not usable. 5% of the houses were unsafe, and the residents seek shelter temporarily at their neighbours and relatives homes. There was no major collapse. Based on the district-level post-windstorm incident reports and damage pictures, the primary identified causes of damage throughout the community were wind effect. A small percentage of the reported buildings suffered damage due to flying debris from neighbouring roof materials and toppled trees.

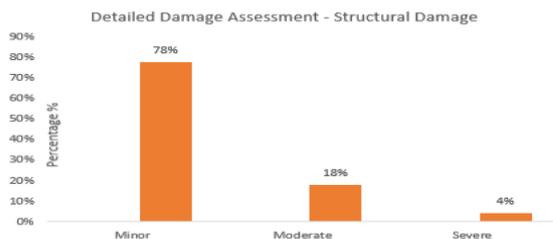
We summarised the results of the detailed evaluation in Table 2. Figure 5 and 6 show the results of the detailed evaluation of statistical patterns in percentage values in terms of the severity of structural and non-structural damages. Damage to structural parts includes column vertical and lateral load-bearing components such as columns, beams, load-bearing walls, roof and floor framing and their connections. Non-structural components consist of ceilings, roof sheathings/shingles and connections, fallen/leaning trees, walls and window. Figure 7 illustrates that 78% of the houses experienced minor structural damage, whereas 18% experienced moderate and 4% severe structural damage. We found that most minor structural damages occurred in the roof system and connections where homeowners need to replace several timber roof beams and purlins. Figure 8 showed that 27% of the houses experienced minor non-structural damage, 62% experienced moderate non-structural damage, and 11% experienced severe non-structural damage.

Fig. 5. Detailed assessment and statistical patterns in terms of severity of structural damage

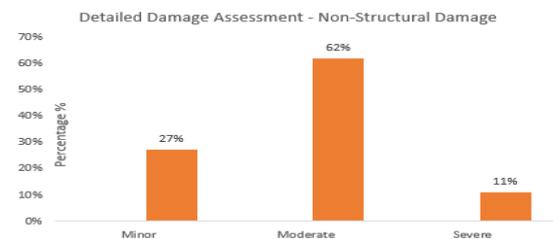
Fig. 6. Detailed assessment and statistical patterns in terms of severity of non-structural damage
