## **Development Of A Procedure For The Detection Of Subsurface Defects In Bridge Deck Joint Armor Using Ground Penetrating Radar And Seismic Properties Analysis**

Larry Lance Rickard, Jr.

A thesis submitted to the graduate faculty in  
partial fulfillment of the requirements for the degree of  
MASTER OF SCIENCE

North Carolina A&T State University  
Greensboro, North Carolina  
2011

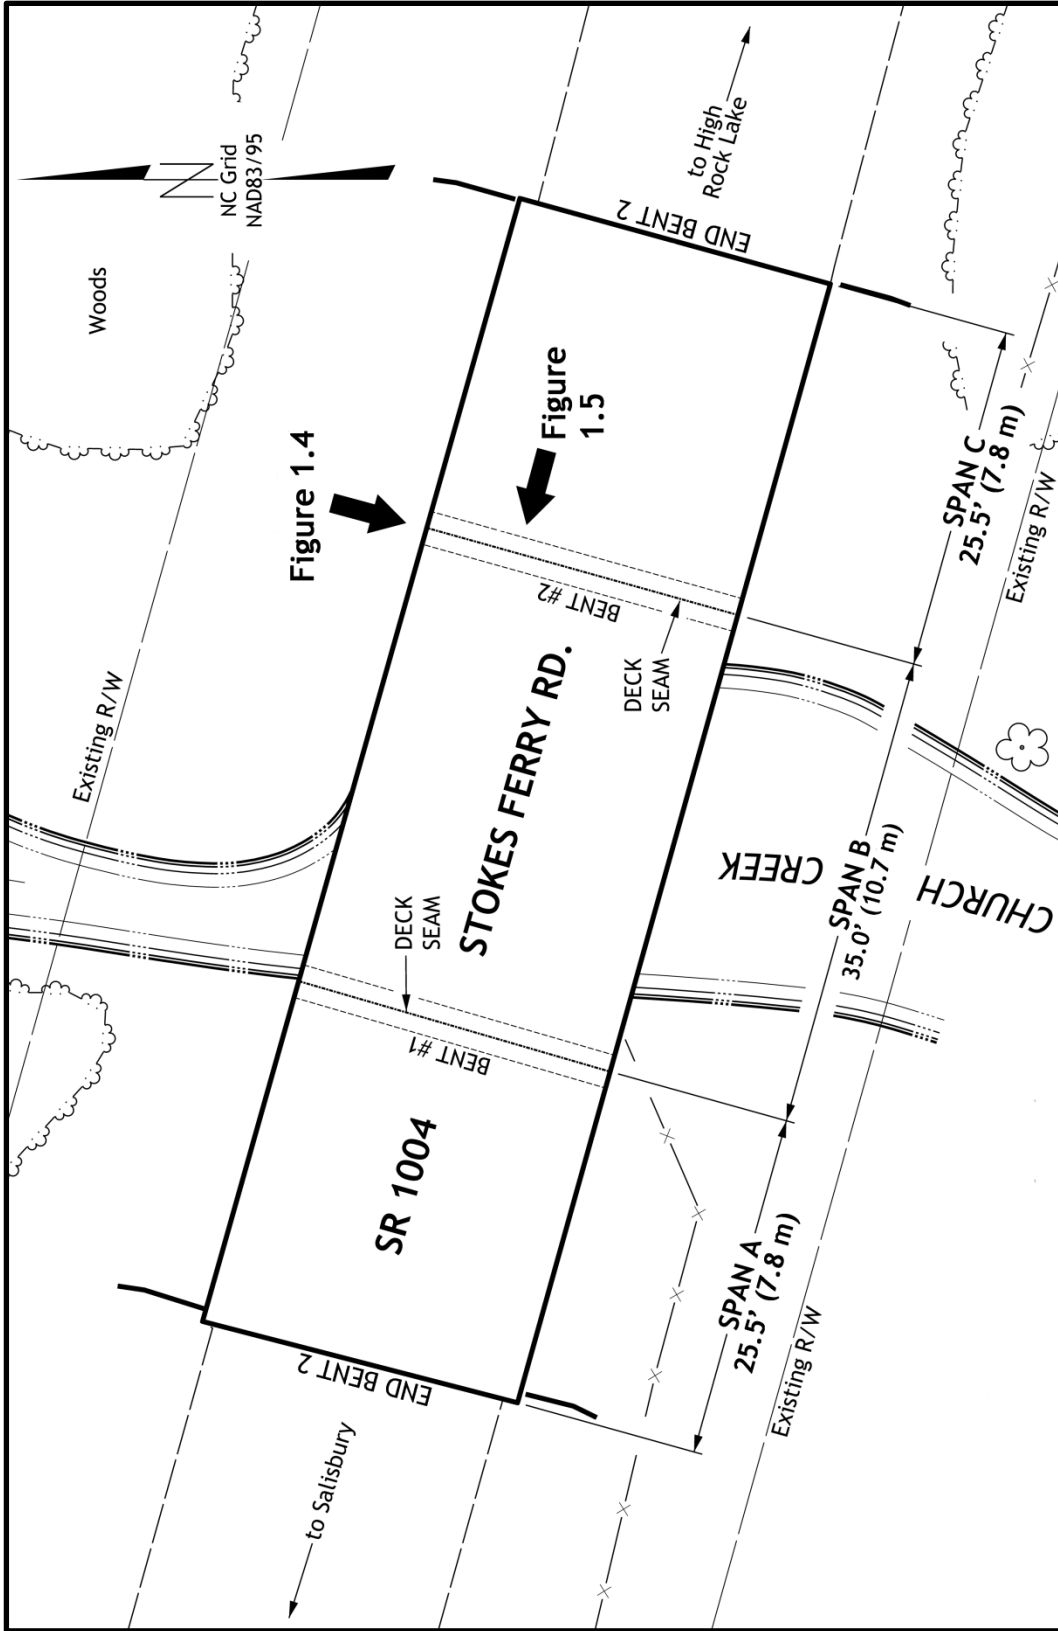
Figure 1.3. General arrangement of Church Creek Bridge. Figure not to scale.

Its superstructure was comprised of a series of three simply-supported spans; two approach spans of 25 ft. 6 in. (7.8 m) each and one 35 ft. 0 in. (10.7 m) center span, for a total length of 86 ft. (26.2 m) (Figure 1.3). Each span consisted of a reinforced concrete deck supported by four steel girders, the ends of which rested on simple steel bearing

plates. On either side of the deck protrusions known as parapets were cast at regular intervals. Reinforced concrete guardrails - known as parapet rails – were cast atop these. The end bents were reinforced concrete caps poured in place over steel piles and the two interior bents were of reinforced concrete post-and-beam construction. Over the previous decades the original concrete wearing surface had been overlaid with hot-mix asphalt concrete (also known as “bituminous surface treatment” by NCDOT). The construction details of the deck joints were unknown, but were assumed to be a type of sealed butt joint.

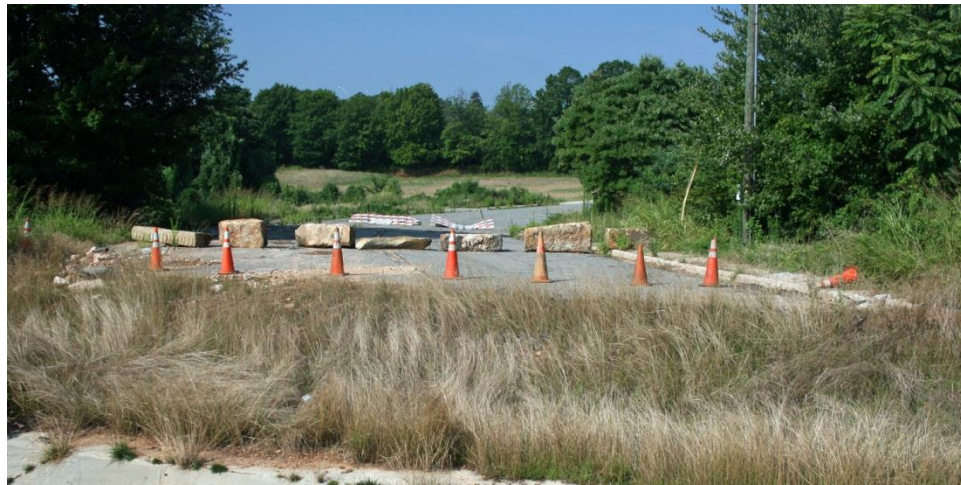
**Figure 4.3. Greyhound Court Bridge, southwest approach.** View from end of span B.

The removal of span A and the placement of physical barriers meant that traffic would pose essentially no danger to those performing the field tests, but it also brought with it several trade-offs. First, the missing span created a situation whereby all reasonable access to the deck was restricted to the bridge's northeast approach (Figure 4.3). This created a dead-end condition that made escape difficult for anyone confronted with a dangerous situation (the residential area to the east was considered high-crime and the areas between the girders at the end bents of many bridges are commonly inhabited by the homeless). This concern was addressed by performing all testing as early in the day as possible and by having more than one person present during testing.

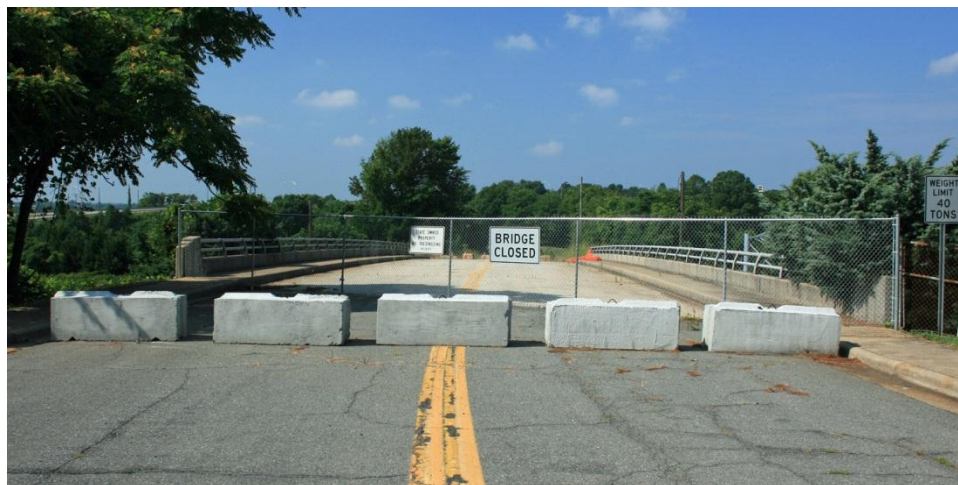
**Figure 4.4. Greyhound Court Bridge, northeast approach.**

The chain-link fence and concrete barriers erected across the northeastern approach (Figure 4.4) presented another minor difficulty in accessing the bridge. The concern here was the deployment of test equipment, all of which would have to be lifted over the guardrail behind the fence. Because of the guardrail's height, anyone involved with the field testing could suffer lifting-related injuries. The SPA in its case, for example, weighs approximately 37 pounds (16.8 kg). Damage to the equipment could also occur if it were inadvertently dropped. Both of these possibilities could be mitigated by having two team members involved with the transfer of all equipment, with one person handing items to the other. This was one more argument in favor of additional manpower.

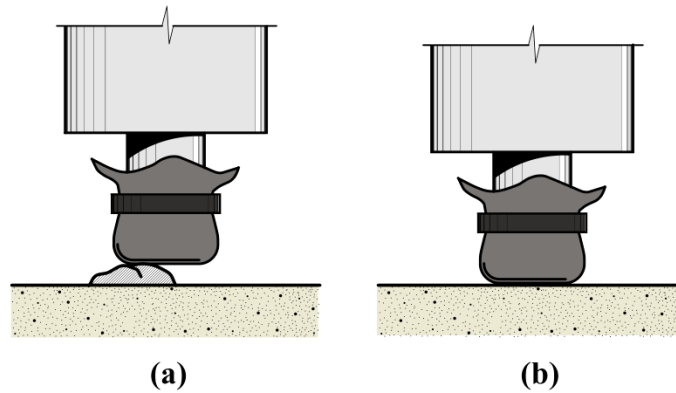
**Figure 5.3. Effects of surface on the proper coupling of SPA feet.**

The weathered deck surface also presented challenges. The exposure of relatively large pieces of aggregate created extremely localized "bumps" in the surface that could prevent proper coupling of the emitter and receivers (Figure 5.3). As with the infinite surface problem, there was little that could be done. Effects of improper coupling could be minimized, however, by (1) following the procedure for placement in the provided

The first involved the coupling issue described in Chapter 5 and illustrated in Figure 5.3. The extremely weathered condition of the deck surface made it very difficult

documentation, (2) ensuring that each foot rested upon a reasonably level surface and (3) taking repeated measurements at each test point.

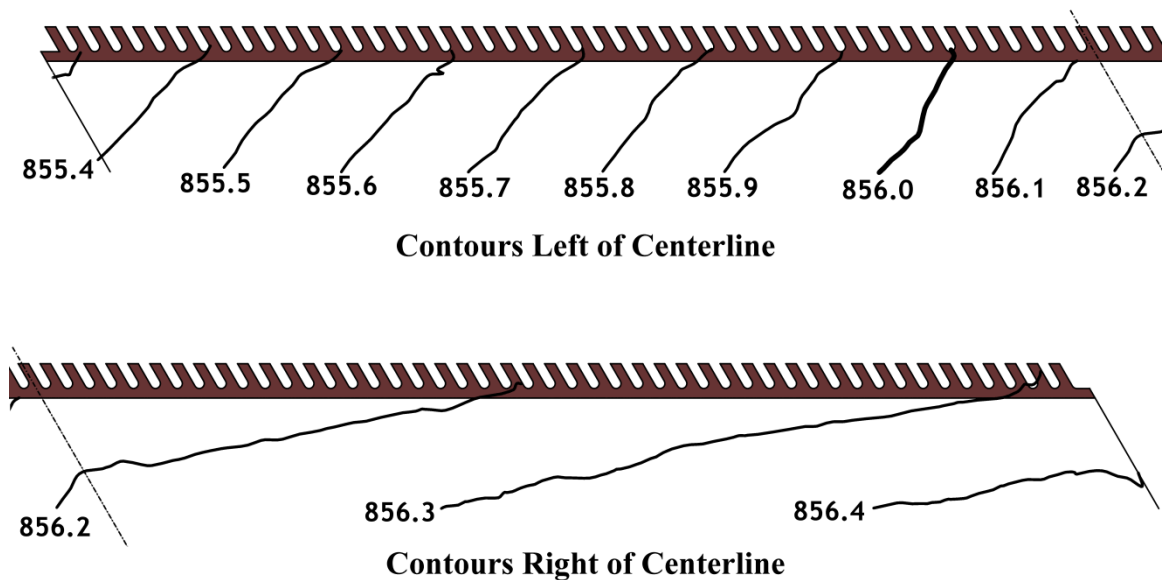
**Figure 6.1. HDS-generated deck contours.** Elevations are in US feet.

The contours also showed little or no evidence of rutting due to traffic or other such wear. These would have appeared as curves in the contours that bowed away from the joint and would have been located in the general vicinity of the wheel paths. Only the two contours at 855.9 ft. and 856.0 ft. display this effect; however, their positions are outside the areas where any wheel wear would be expected to occur.

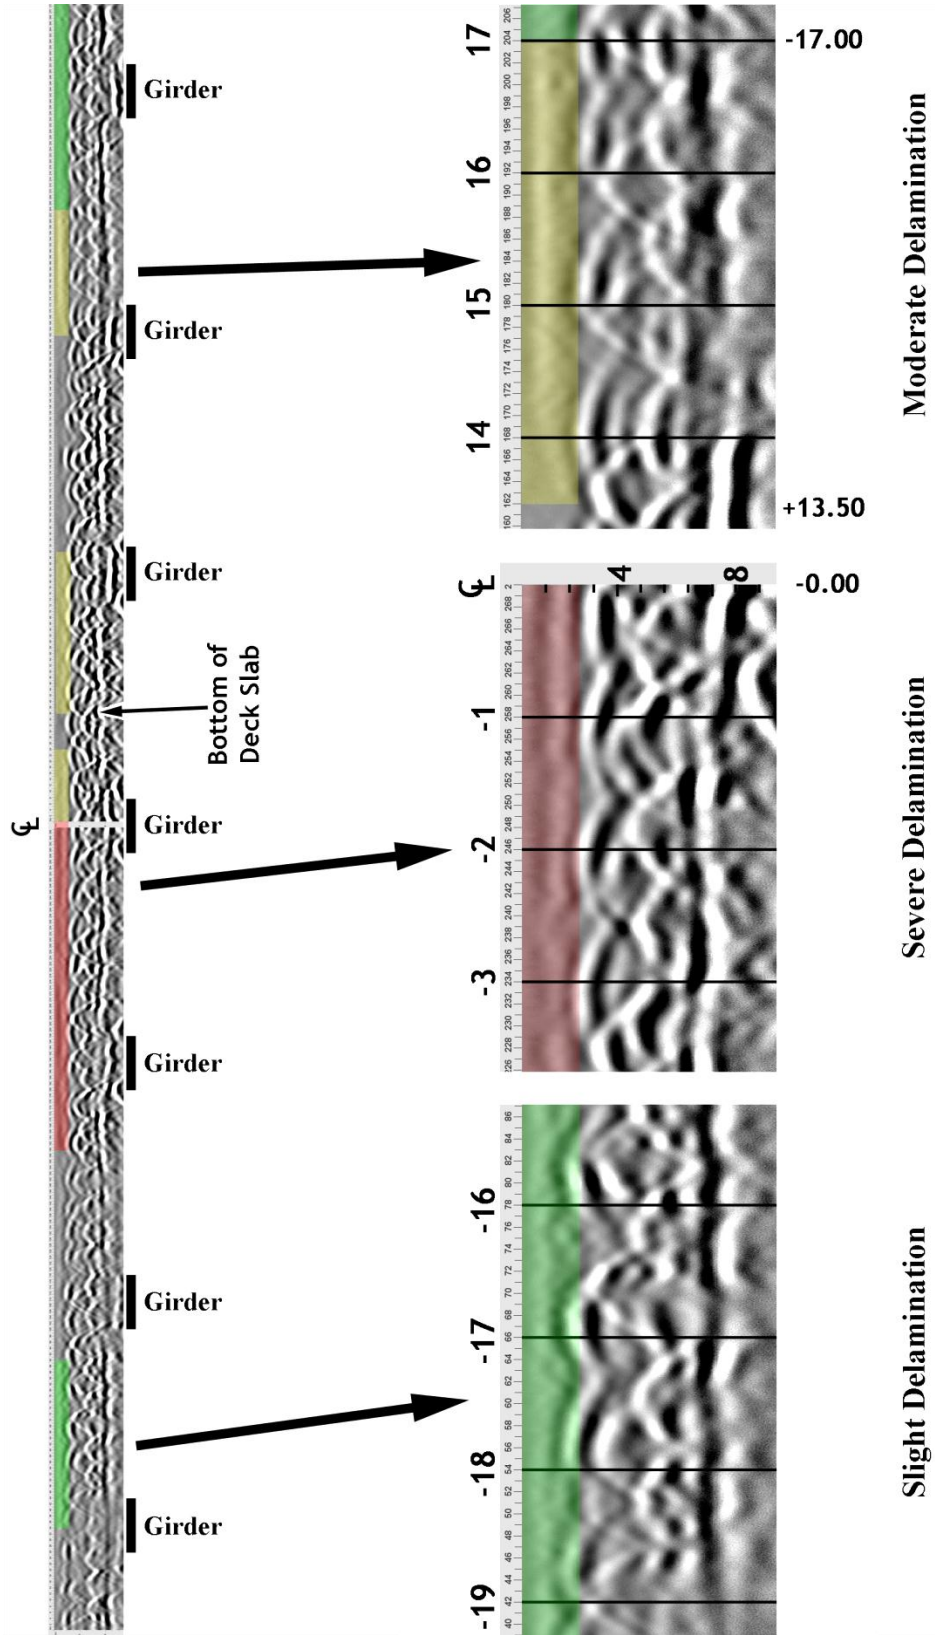
Figure 6.3. Typical GPR scan (Station 21 shown).

A preliminary look at the scans revealed much about the bridge's structure (Figure 6.3). Scans closest to the joint under study revealed the relatively complex structure of the reinforcing steel in that area (see Appendix A, Stations 1 and 5). Echo signatures from the bottom of the slab were notably absent, possibly because of 1) interference from the reinforcing steel, 2) increased slab depth, and/or 3) the fact that the scan depth of the SSM was limited to 8 in. (203 mm). Images further from the joint

interface exhibited echo signatures from the bottom of the deck as well as the girder locations (see Appendix A, Stations 9, 13, 17, 21 and 25). This was considered as evidence of the SSM's ability to detect discernible patterns beneath the layers of reinforcing steel. These echo signatures were later used as the primary means of determining the maximum coring depth.

Of particular interest was the existence of several discolored or "ghosted" areas in the images. These were located primarily between the surface of the concrete and the upper layer of reinforcing steel. These apparent anomalies varied considerably in their intensity and were considered as possible evidence of delamination or other defects; many of these areas tended to sound hollow when struck with a hammer.

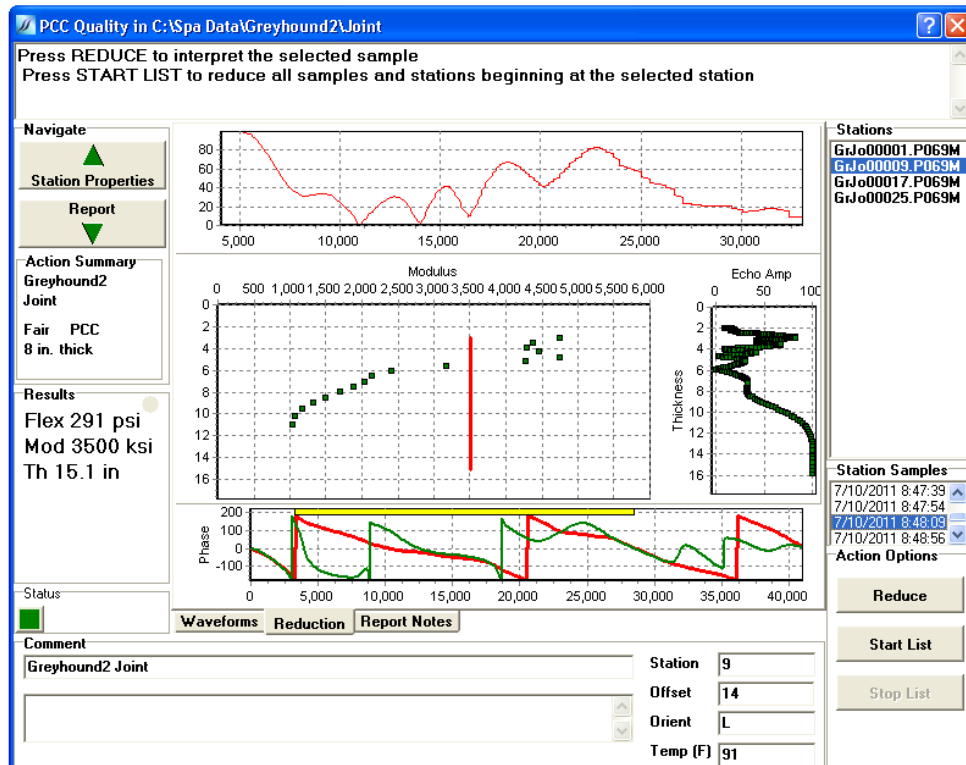
Figure 6.5. Screen capture of a typical SPA data reduction (Station 9, 14 ft, Right). IE plot is at the middle right.

Initial review of the IE data verified that the deck was in poor overall condition. The IE signature for the majority of the test points displayed numerous high-amplitude echoes at varying depths, evidence of significant deterioration (Figure 6.5). This phenomenon was observed with reasonable consistency throughout the test area. An attempt was made to quantify and map this data, but no reasonable means to do so could be formulated. Therefore, the IE signature for each test point was reviewed individually and compared to the frequency and modulus plots.

Another observed phenomenon was the apparent 2 in. (51 mm) offset in the thickness of the concrete. This offset must be subtracted from any reading on the scale in order to determine the correct depth of a given defect. The bottom “knee” of the IE graph indicates a depth of 8 in. (203 mm); subtracting 2 in. (51 mm) from this reading yields a total depth of 6 in. (0.15 m) in this location. This was subsequently verified during the process of collecting core samples.

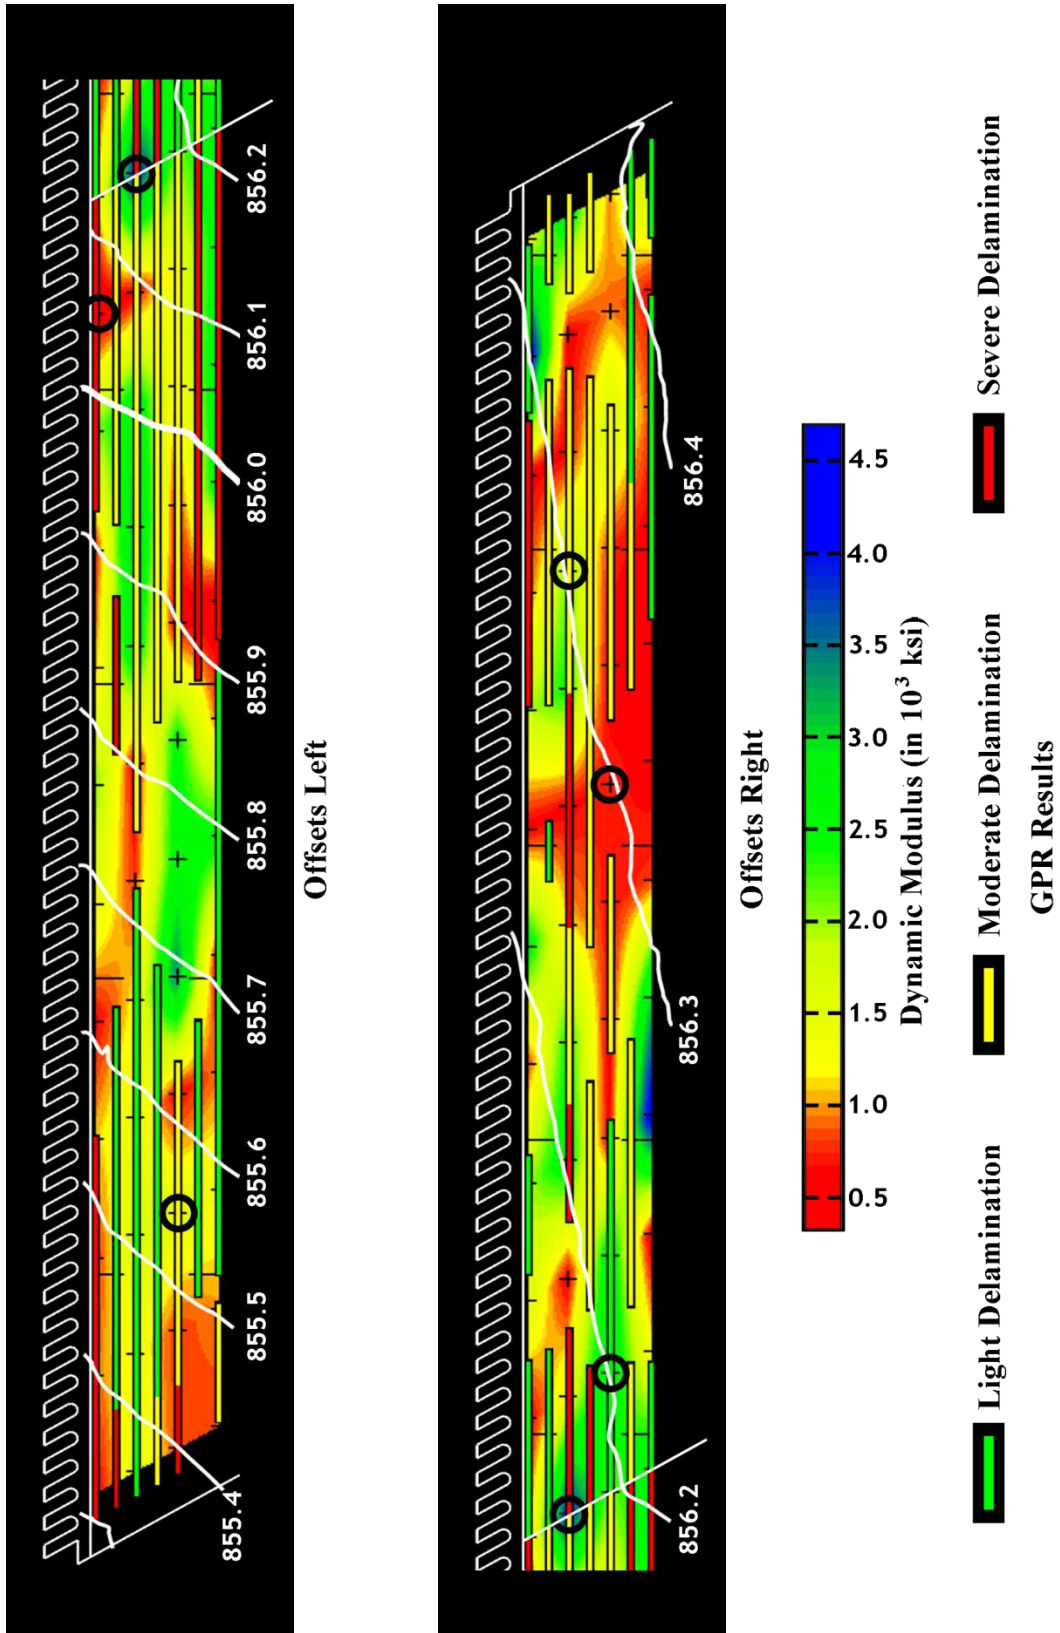
Figure 6.8. Locations of core samples taken for this study. Core locations are indicated by black circles.

In order to verify the GPR and SPA results, six 4 in. (102 mm) diameter core samples were taken at random within the test area. Because of the bridge's location over live traffic, the core drill depth was limited to 5 in. (127 mm) to prevent penetration of the deck. One exception was at Station 1, 2 ft. Left, where the core depth was limited to 3 in. (76 mm). A summary of the coring results is given in Table 6.2, the location of each sample is shown in Figure 6.8 and a photograph of each core is shown in Figure 6.9. The particular details of each core specimen are described in the following sections.
