Citation: Nezhad, H. Y. ORCID: 0000-0003-0832-3579, Egan, B., Merwick, F. and McCarthy, C. T. (2017). Bearing damage characteristics of fibre-reinforced countersunk composite bolted joints subjected to quasi-static shear loading. *Composite Structures*, 166, pp. 184-192. doi: 10.1016/j.compstruct.2017.01.029

Bearing Damage Characteristics of Fibre-reinforced Countersunk Composite Bolted Joints Subjected to Quasi-static Shear Loading

Hamed Yazdani Nezhad, Brian Egan, Fiachra Merwick, Conor T. McCarthy

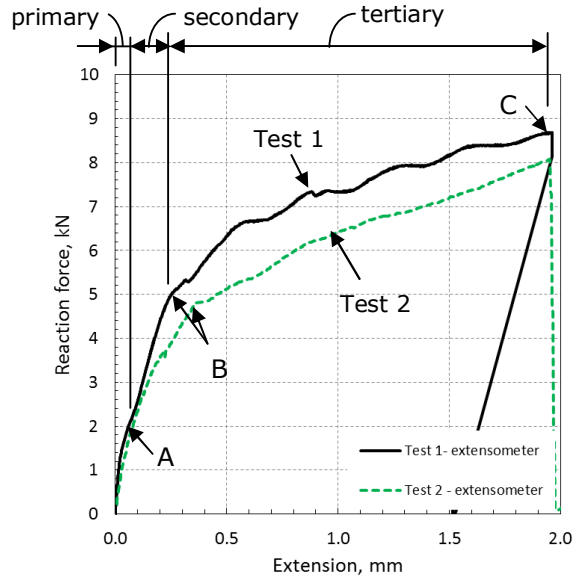
Load-extension curves obtained from tensile bearing testing of two single-bolt CBJs are shown in Figure 3. Two joints showed similar trends. The main features are identified as primary, secondary and tertiary stiffness (all labelled in Figure 3). Test data obtained from the points and the slopes in the primary, secondary and tertiary regions are summarised in Table 1. The primary stiffness is due to sticking caused by friction between the laminates. The curves in Figure 3 present identical primary stiffness. Point A in Figure 3 is denoted at the end of this region, at which the primary stiffness drops to secondary stiffness. This drop is attributed to the sticking-to-slipping mechanism, and subsequent matrix damage. The value of the secondary stiffness shown in Table 1 has been obtained from the average of the two slopes between points A and B. After point B, a bound of $\sim 1\text{kN}$ difference is observed between tests 1 and 2 at an equal extension. This

difference can be due to inherent differences occurring in assembly of the joint such as fastening pre-load. The pre-load has direct effect on friction coefficient between the CSK-L and NCSK-L surfaces in contact, and thus has a direct effect on the shear load. Tertiary stiffness is then obtained from the average of the two slopes between point B and the ultimate failure point 'C'.

Figure 3: Load-extension behaviour of the single-bolt joints in single-lap CBJs

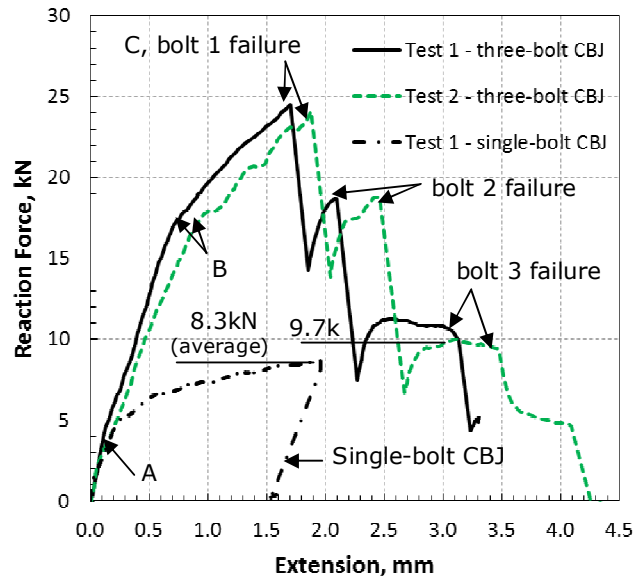
Figure 7 presents the load-extension response of the three-bolt CBJ. One curve from the single-bolt CBJ was also included in the figure for comparison. The dominant *final* failure in three-bolt CBJs was bolt failure promoting fastener pull-through. Bolt failure in multi-bolts is attributed to high shear load transfer [2]. Two tests show consistent peak load and equal drop in load level when bolts 1, 2 and 3 failed one after another. As seen in Figure 7, load carrying capacity of the last unfailed bolt (i.e. bolt 3) drops to 9.7kN, close to and slightly higher than that for the single-bolt CBJ which failed at 8.3kN. Thus, the three-bolt CBJ with its last bolt performs approximately the same as the single-bolt CBJ.

Figure 7: Load-extension behaviour of three-bolted joints extensometer data

Surprisingly for the three-bolt CBJs examined in this work, the ultimate loads corresponding to fastener failure are 24.3kN, 18.7kN and 9.7kN, respectively for bolt 1, 2 and 3 failure. The peak load for the single-bolt CBJ was 8.3kN. Thus, the ratios of three-bolt ultimate failure loads to the single-bolt one are 2.9, 2.3 and 1.2 respectively. These values are not far from 3, 2 and 1, meaning that the ultimate loads increase proportionally with the increasing number of bolts.

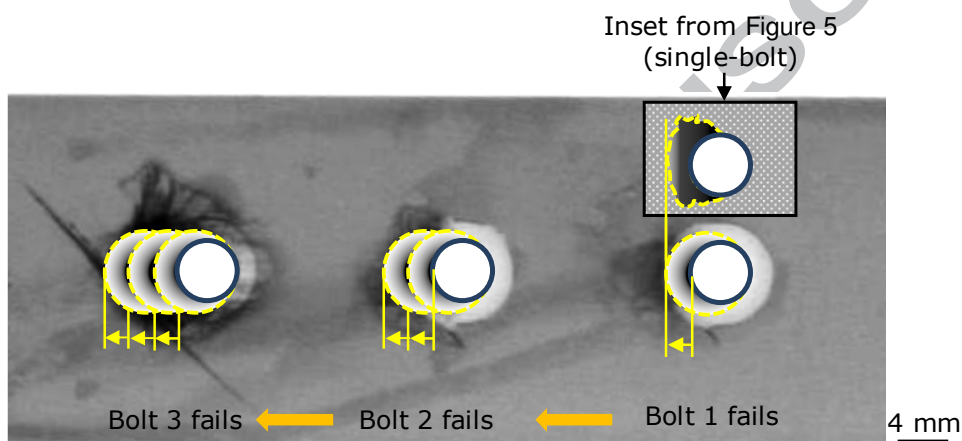
Consider the damage development outlined in Figure 10 in conjunction with the joint load displacement curve in Figure 7. As the joint loads up to the first significant failure event at 24kN we hypothesise that each bolt hole in the CSK joint sustains approximately equal amounts of bearing damage area, indicated by the first dashed circles around the bolt holes in Figure 10. Then, Bolt 1 fails suddenly and the joint load drops to 14kN. The joint then behaves as a two bolt joint (as Bolts 2 and 3 are still intact) and further progressive damage occurs as the joint reloads to approximately 19kN. During this reloading the damage area increases at Holes 2 and 3 to the second dashed circular area indicated. Bolt 2 then fails suddenly, the joint load drops to approximately 8kN, and Bolt 3 then sustains all the remaining joint load and acts as a single bolt joint. The

joint again reloads to 12kN causing further bearing damage progression at Hole 3, until Bolt 3 fails and catastrophic joint failure occurs. The damage area from the single-bolt joint test in Figure 5 is shown insert in Figure 10, and as can be seen the damage area at Hole 1 when Bolt 1 fails in the three-bolt joint is almost identical to that of the single bolt joint case at failure. Furthermore, the damage at Hole 2 is approximately twice, while at Hole 3 is approximately three times, that of the single bolt damage area. In addition, it should be noted that this first significant failure load in the three bolt joint of 24kN is approximately three times that of the average single bolt failure load of approximately 8.3kN. This simple linear superposition of failure load and damage area suggests that single-bolt joint tests results can be used to predict the response of three-bolt joints with reasonable accuracy. However, much further experimental testing is required to further validate this hypothesis; especially for larger joint assemblies with many more fasteners in two-dimensional straight and staggered arrays and under load (rather than displacement) controlled scenarios.

Figure 10: Schematic illustration of damage development in three-bolt countersunk CBJ

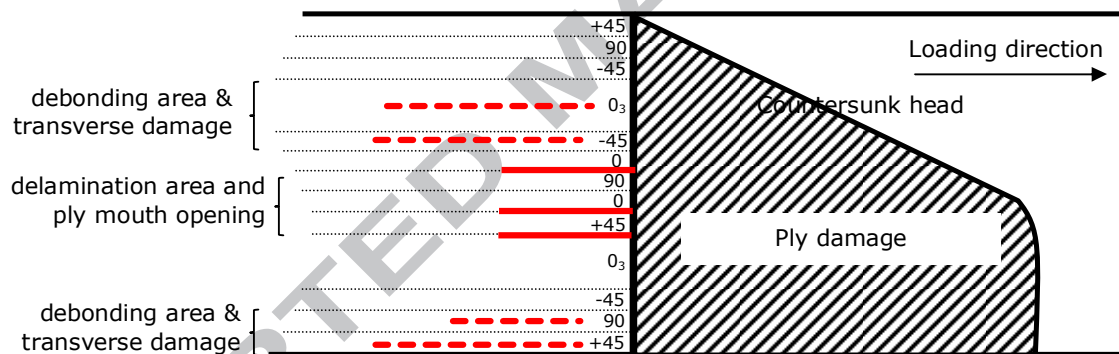
X-ray properly captured bearing damage at holes with a combination of in-plane and intra-laminar delamination damage. Slight inter-laminar delamination and fibre-matrix debonding damage were found the mechanisms occurring away from the holes. Figure 11 schematically shows the mechanism and extension of damage. Summarising from the single- and three-bolt CBJ optical and X-ray images, the most possible failure modes occur as follows: Ply damage occurs underneath the countersunk head due to the compressive stress, properly captured by X-ray. The ply damage extends to the opposite direction of the loading direction, and through-the-thickness. Slight inter-laminar delamination occurs beyond this region, mostly occurring between the middle plies. Slight transverse damage follows the delamination, kinking through the 45° plies. Fibre-matrix debonding is relatively extensive. While delamination dissipates energy in the middle plies, debonding mostly occurs at the bottom.

Figure 11: Schematic illustration of dominant failure modes and their locations in CSK part of CBJs; solid and dashed lines represent delamination and debonding/transverse dominant area respectively, with the length representing their schematic extension
