Željko Domazet<sup>1</sup>, Francisko Lukša<sup>1</sup>, Lovre Krstulović-Opara<sup>1</sup>

# Failure analysis of the rolls with grooves

<sup>1</sup>Faculty of Electrical Engineering, Mechanical Engineering and Naval Architecture; University of Split; Split, Croatia

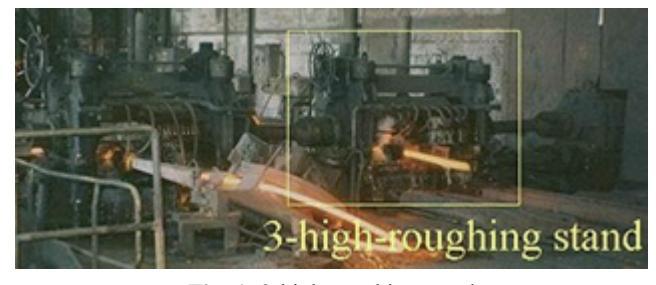
Fig. 1. 3-high-roughing stand

In "Steelworks Split" failures of the rolls with grooves on the 1<sup>st</sup> stand of the 3-high-roughing mill stand (Fig.1) occurred four times. The 3-high-roughing mill stand was suitable for the hot rolling of the billets with an initial cross-section of 100 mm square and 3 m initial length in 8 passes. The mass of one billet was 230 kg.

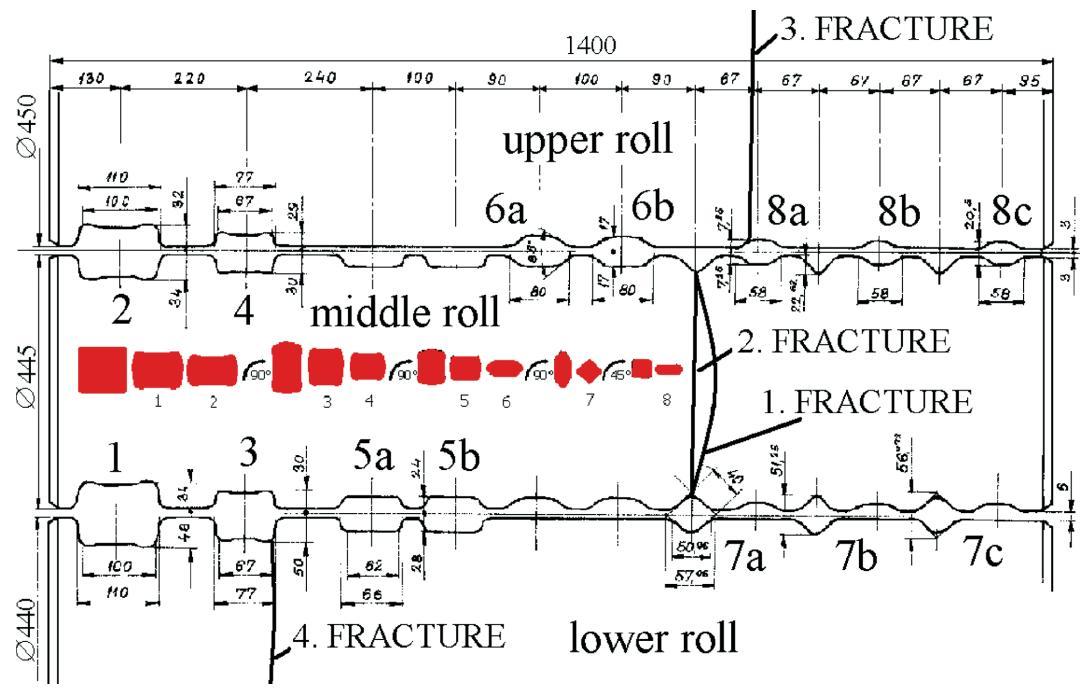
Fig. 2. Roll design and groove distributions

The pass schedule and corresponding dimensions are given in Table 1. Figure 2 shows the roll design and groove distributions with positions of the failures.

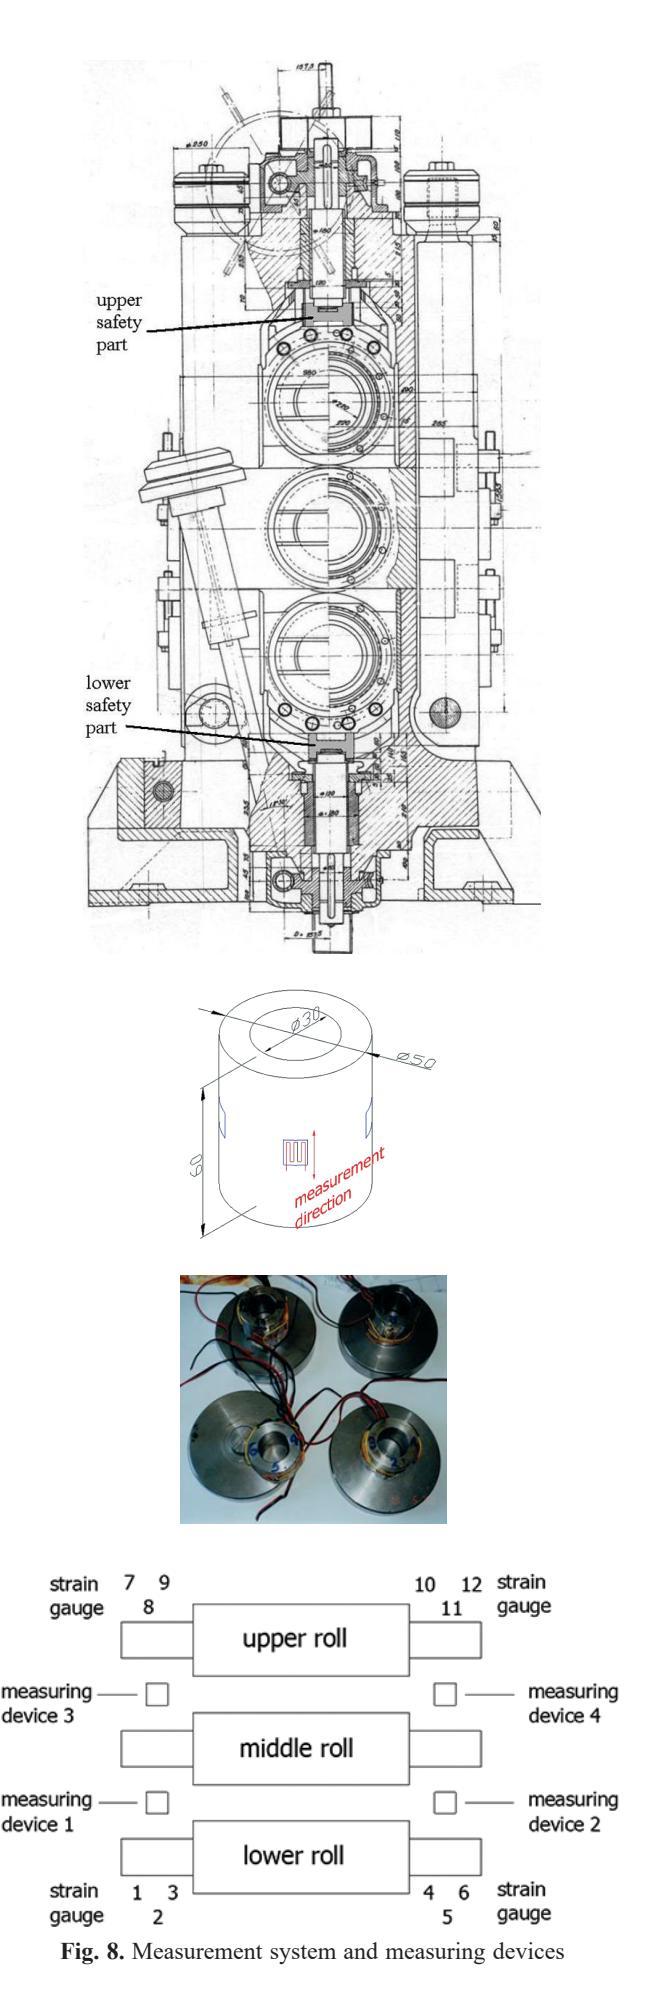
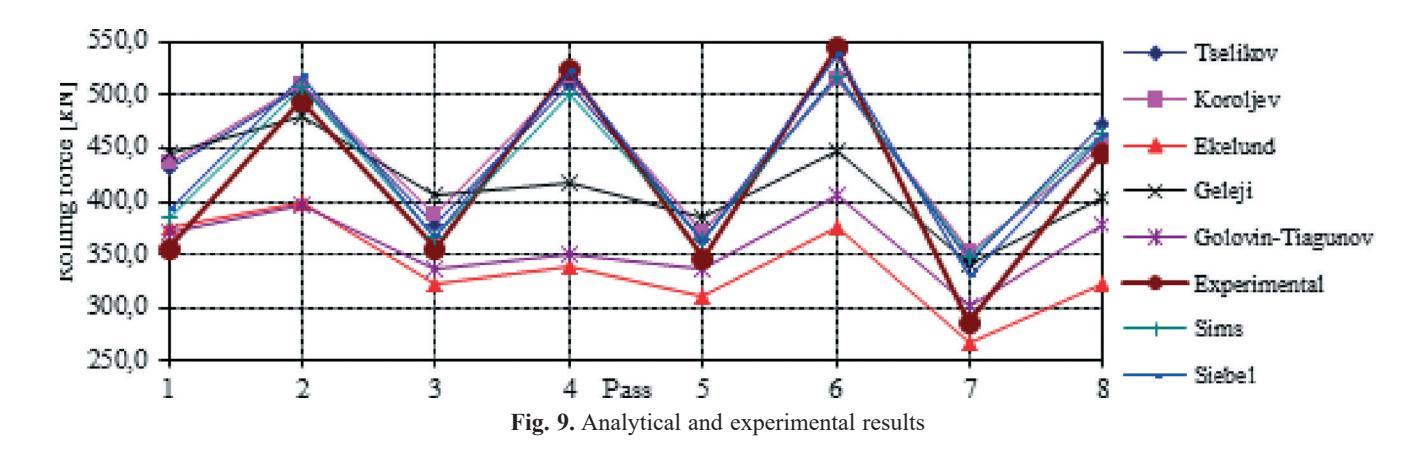
In accordance with results from analytical methods for determining the rolling force, four measuring devices with three strain gauges on each, were designed for the experimental determination of rolling force (Fig. 8). The

measuring devices were mounted on both sides of the stand, instead of safety parts against the breakage of rolls (Fig. 8).

The rolls are protected from bending overload with the safety parts (Fig. 8). In case of the bending overload, one (or both) safety part has to fail before the failure of the roll. The material used for safety parts was flake graphite iron GG20 according to DIN. Figure 15 shows the safety parts design.

In all cases of the roll failures, the failure of safety parts did not occur.

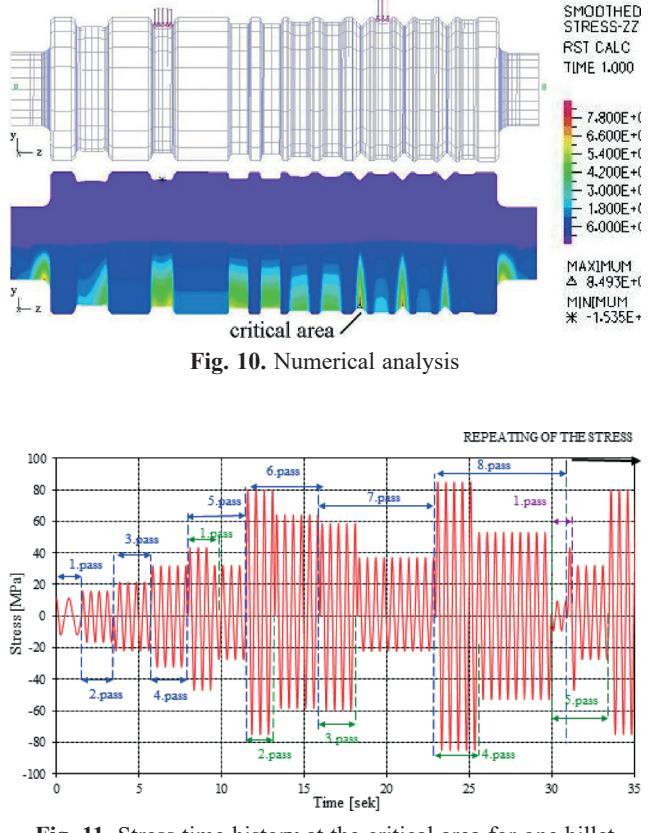
Fig. 11. Stress time history at the critical area for one billet

Stress time history of the individual local stress and stress spectrum are obtained from numerical analysis and pass schedule. Figure 11 shows stress time history of the local stress in the 7.a pass for only one billet.

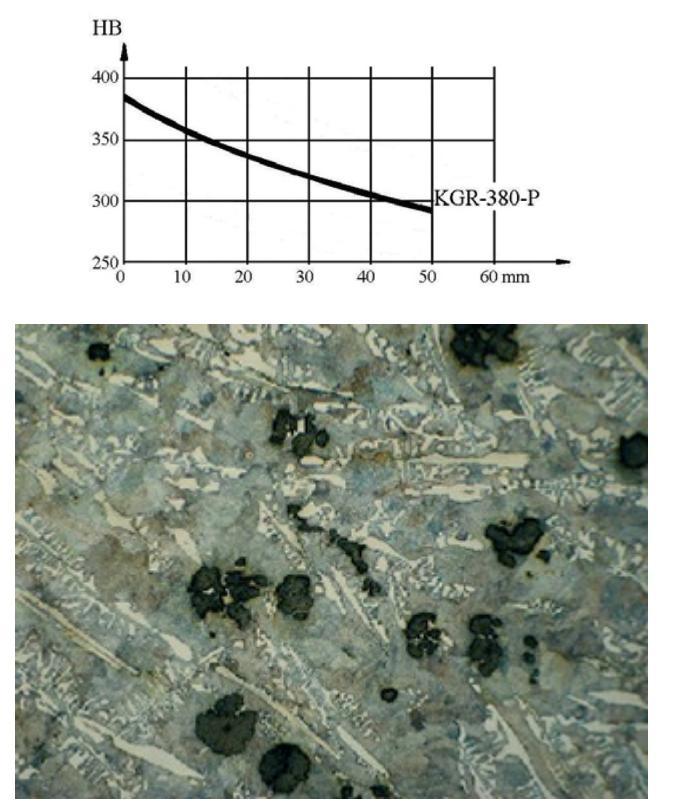
Fig. 12. Hardness drop and metallographic structure (500x)

The material used for rolls is spheroidal graphite iron with the pearlitic base. Chemical composition of the roll material is  $3.4\div3.6$  % C,  $1.8\div2.2$  % Si,  $0.5\div1$  % Mn, < 0.05% P, < 0.05% S, < 0.5% Cr,  $1.5\div3\%$  Ni and <0.2% Mo. Hardness on the roll surface is 380 HB. Fig. 12 shows hardness drop of KGR 380 rolls and metallographic structure of the roll material.

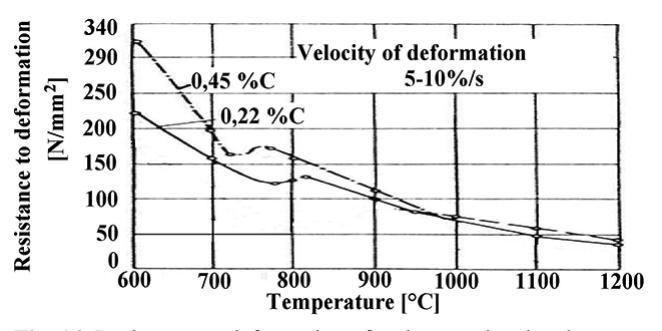
Fig. 14. Resistance to deformation of carbon steels related to temperature

The temperature of the rolling material has a great influence on the rolling forces. When the rolling process is carried out at a decreased temperature, the rolling forces are higher and bending stresses can be two or three times higher than usually (Fig. 14).

During the rolling process some of the rolling stocks stayed on the rollers outside of the furnace due to technological stops. The temperatures of these stocks decreased due to cooling by ambient air. No sensors of the temperature of a rolling stock between the furnace and 3-high-roughing mill stand were anticipated and there was no control of decreasing rolling temperature between the furnace and 3-high-roughing mill stand. Because of this fact the rolls were occasionally subjected to higher rolling forces and bending overloads as the result of technological stops.
