Failure of two overhead crane shafts

Faculty of Electrical Engineering, Mechanical Engineering and Naval Architecture; University of Split; Split, Croatia

Abstract

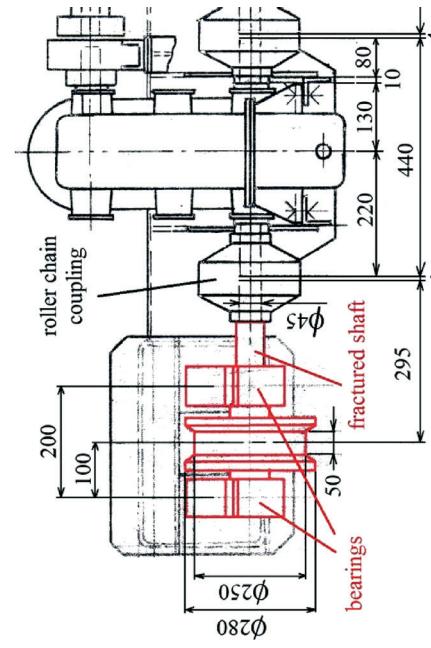
Fig. 2. Overhead crane trolley [2]

The shaft was connected with the gearbox by a roller chain coupling, supported by two roller bearings and connected with the wheel by a key, Figure 2.

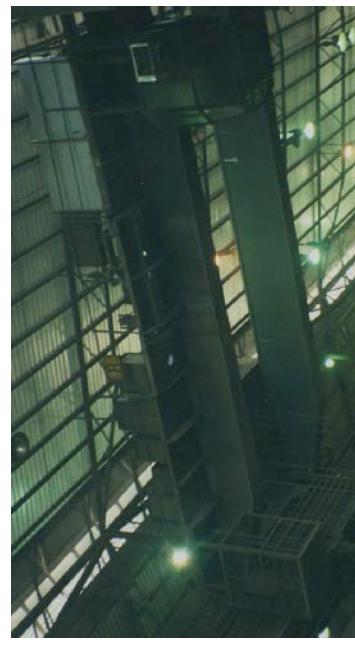
Fig. 11. Overhead crane for transport of ladle with liquid steel

An electric overhead crane, Fig. 11, was suitable for the transport of a ladle with liquid steel from the ladle furnace to the continuous casting machine. The crane was rated at 50 tons with a span of 18.4 m and handled about 20 lifts and transports per day, each lift averaging 43 tons. The stepped drive shaft used in an overhead crane trolley gearbox, Figure 12, broke after 36 months of service.
