**EVALUATION OF CONSERVATION PROBLEMS  
OF DEĞİRMENDAĞI DISTRICT  
IN İZMİR**

**A Thesis Submitted to  
the Graduate School of Engineering and Science of  
İzmir Institute of Technology  
in Partial Fullfilment of the Requirements for the Degree of**

**in Architectural Restoration**

**by  
Özge AKBULUT**

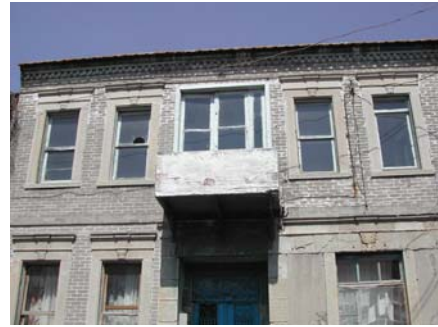
Figure 3.8. 384th Street No. 65

functions as a common area while the rooms on the upper floor are used as bedrooms. In some two-storey buildings, a cumba is observed in the rooms on the upper floor. On the other hand, in some of the buildings, the cumbas have been eliminated or turned into a balcony (Figures 3.7 and 3.8).

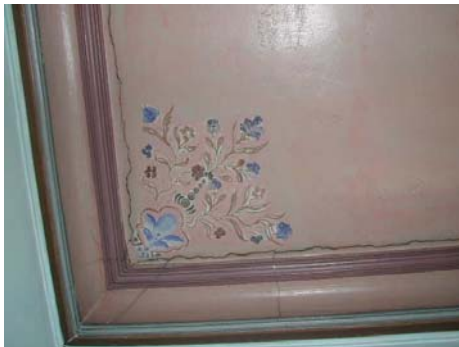
Figure 3.9. Second floor, the ceiling of the living room (391st Street No. 16)

The ceilings of some rooms on the second floor are decorated either with plaster works or chisel works (Figures 3.9 and 3.10).

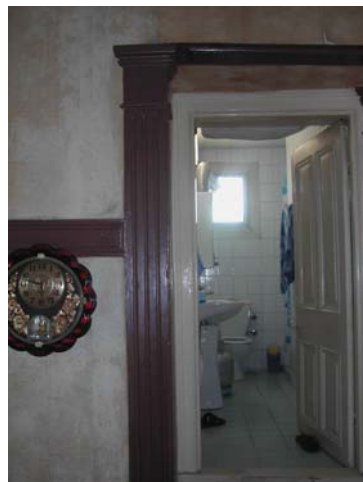
These spaces are generally either renewed in most of the buildings or added to the building later on. In some cases, the wet closets are standing alone while in some of the buildings those wet closets are combined with the bathroom space. In two storey buildings, such spaces are not observed on the upper floors. Those spaces are generally positioned on the ground floor either inside the building or in the courtyard (Figure 3.19).

Figure 3.19. Wet space on the first floor inside the building, (Halil Rıfat Paşa Street, No. 74)

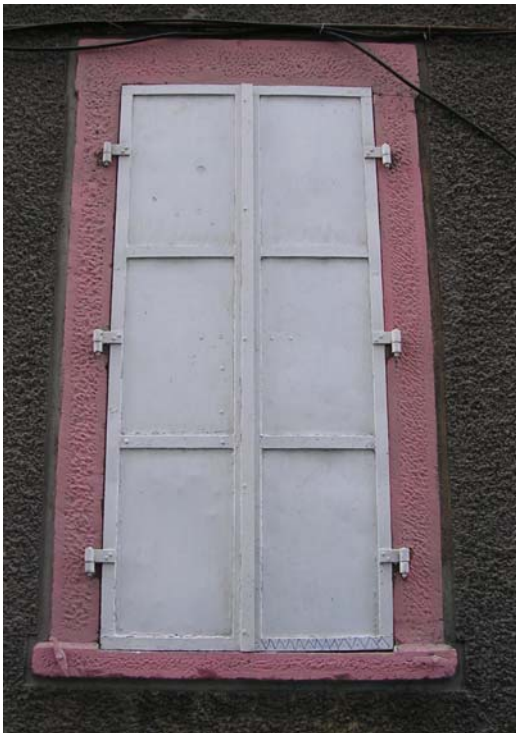
Figure 3.37. Although it is an upper floor window, an iron shutter is used. (S2 zone)

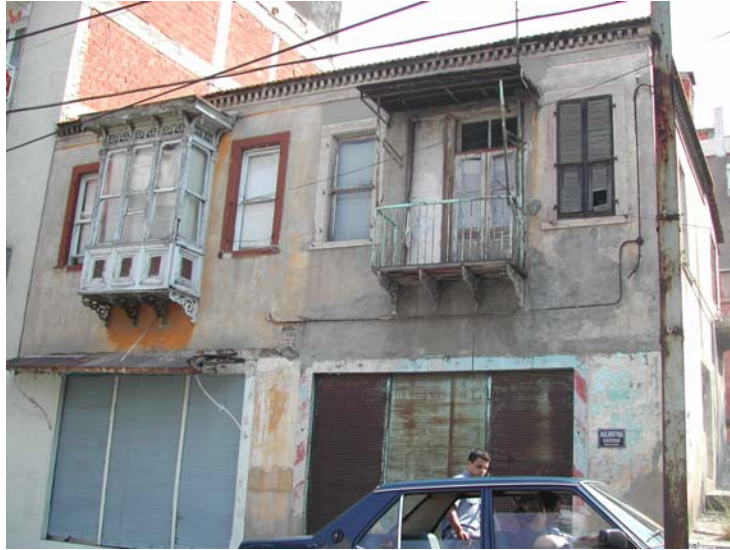
In the S3 zone, it has been determined that one building was reconstructed. There are also material alterations in doors and windows while a cumba was converted into balcony.

Figure 3.65. Cumba converted into balcony (Halil Rifat Paşa Street No. 60-62)

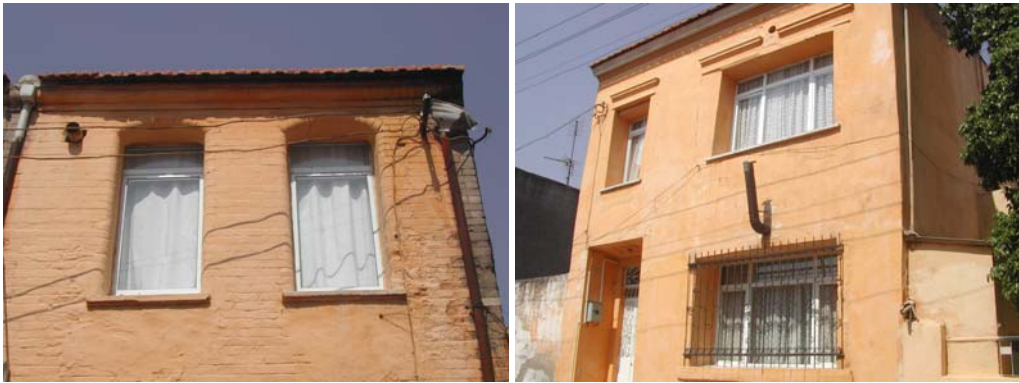
It is determined in the S2 zone that 3 buildings are reconstructed. In this zone and especially in the buildings on 404th Street, doors and window jambs were altered and houses were renovated. Cumbas are converted into balconies in a building on 400th Street in the S2 zone, in two buildings in the S1 zone, and in one building in the S3 zone. Balconies have the same ratio with cumbas and similarly, there are iron cantilevers below each balcony.

Figure 3.66. Alterations in window dimensions and materials

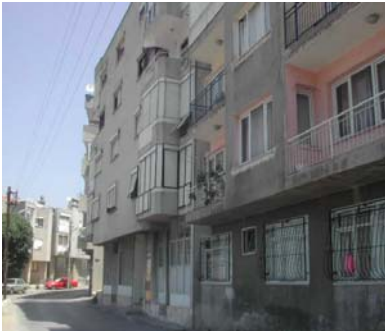
New multi-storey buildings are being built on Halil Rıfat Paşa Street constituting a threat for the inner segments of the district. As a matter of fact, it is determined that old houses are being destroyed and instead, new buildings are being built (Figures 4.1 and 4.2).

Figure 4.1. Multi-storey buildings on Halil Rıfat Paşa Street

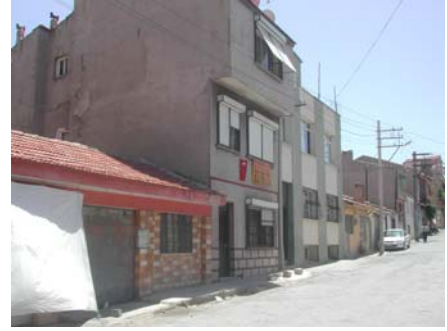
Figure 4.2. New buildings on 384 Street

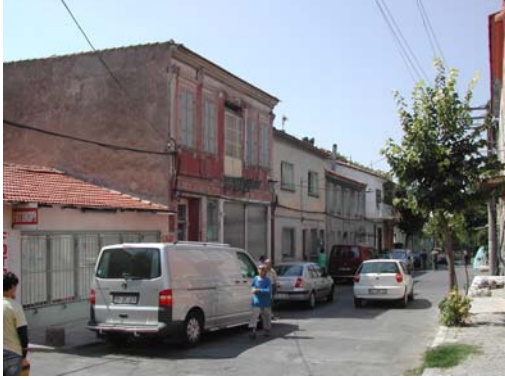
The problems concerning the transportation are narrow streets, lack of adequate place for parking lots, and lack of public transportation through inner parts (Figures 4.3 and 4.4).

Figure 4.3 Traffic on 384 Street

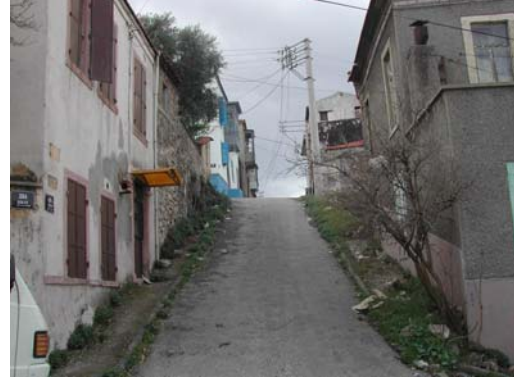
Figure 4.4 Narrow and inclined streets, 403 Street

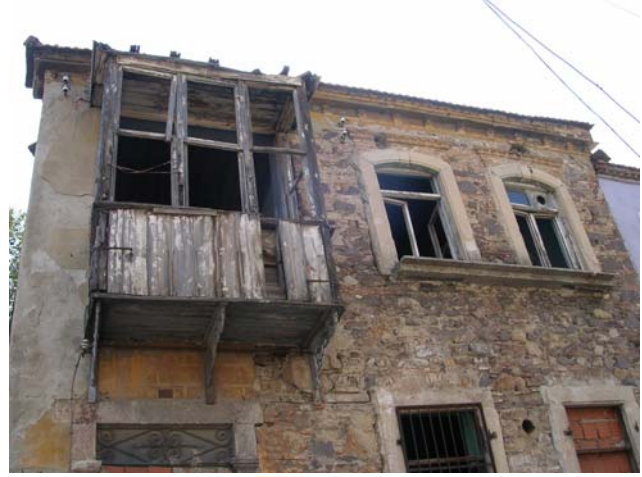
Since their structural conditions are derelict and they are about to lose all their characteristics, the registered buildings located at 403 Street No. 28 and No. 22 should immediately be taken up (Figure 4.7) and the registered wall of Selimiye Mosque facing 404 Street should immediately be taken under conservation (Figure 4.8). The buildings which do not require any handling depending on their good structural conditions and that they have preserved their characteristics, are the buildings located on 404 Street Nos. 9/A, 19, 21, 23, 25, 27, and the building located at 403 Street No. 30. The buildings which need major repair are the registered buildings located at 403 Street No. 22, No. 28, and No. 13 because they are about to lose all their characteristics since the buildings have been handled improperly. The other buildings in the S2 zone only require some minor repairs and basic façade arrangements.

Figure 4.9 Ruined building on 403 Street No. 28

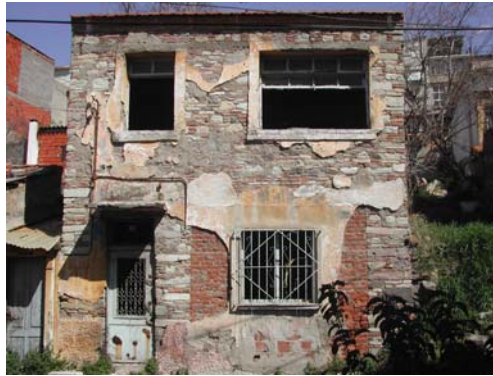
Since their structural conditions are derelict and they are about to lose all their characteristics, the building at Halil Rıfat Paşa Street No. 81 (Figure 4.10) and the twin buildings located at Halil Rıfat Paşa Street Nos. 54 and 56 should immediately be taken up as they are about to collapse (Figure 4.9). The buildings which do not require any handling depending on their good structural conditions and in that they preserve their characteristics; there is no building other than Nur Kamer Mosque which does not require any handling. There are two buildings at Halil Rıfat Paşa Street which are about to collapse. The registered building at Halil Rıfat Paşa Street No. 76 is dilapidated so it should be reconstructed in accordance with its previous pictures.

Figure 4.11 Ruined building at Halil Rıfat Paşa Street No. 81

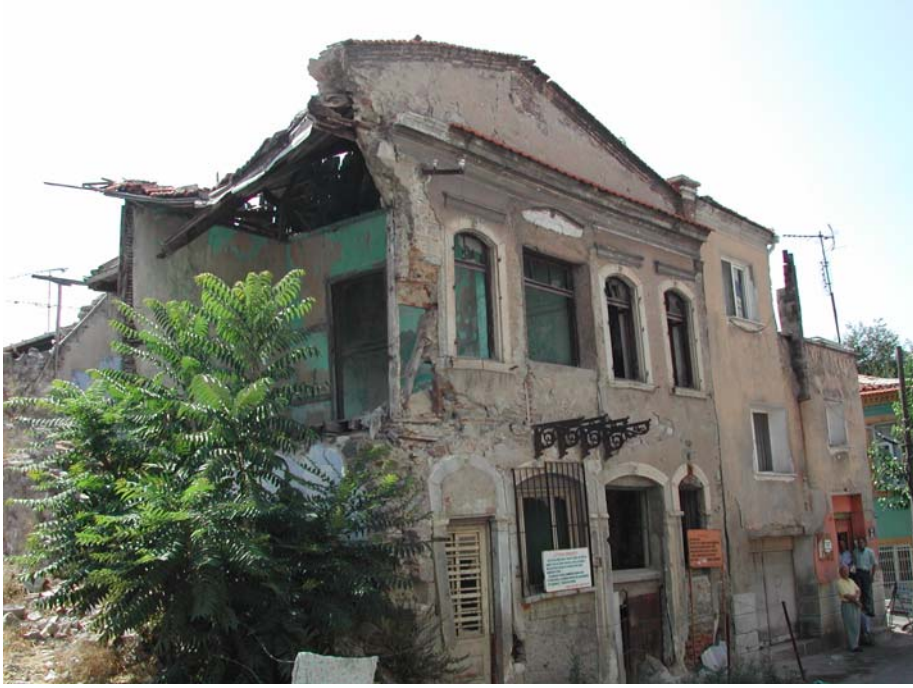
**1.** The building at 384 Street No. 22 (Figure 4.11)

Figure 4.12 Ruined building at 384th Street No. 22

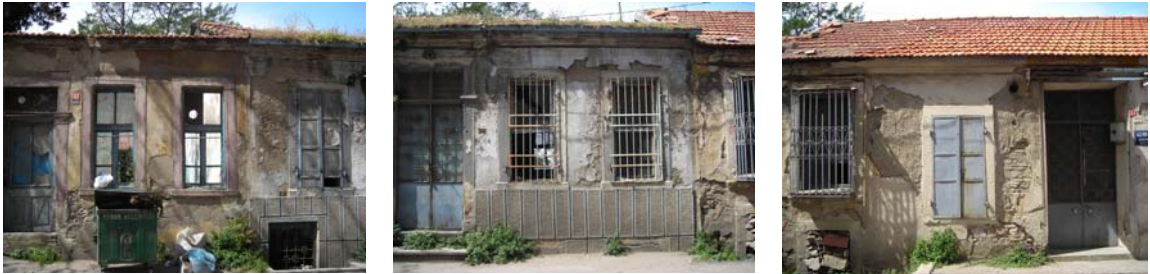
2. The buildings at Halil Rifat Paşa Street Nos. 44 - 46 and 48 (Figure 4.12)

Figure 4.13 Ruined buildings at Halil Rifat Paşa Street Nos. 44 – 46 – 48

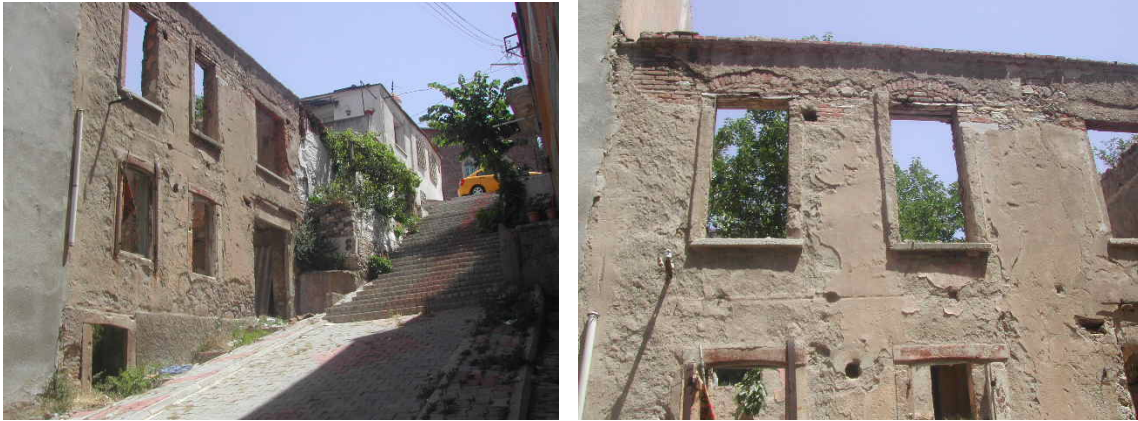
### 3. The ruin on 403 Street No. 7 (Figure 4.13)

Figure 4.15 The ruin at 403 Street No. 7

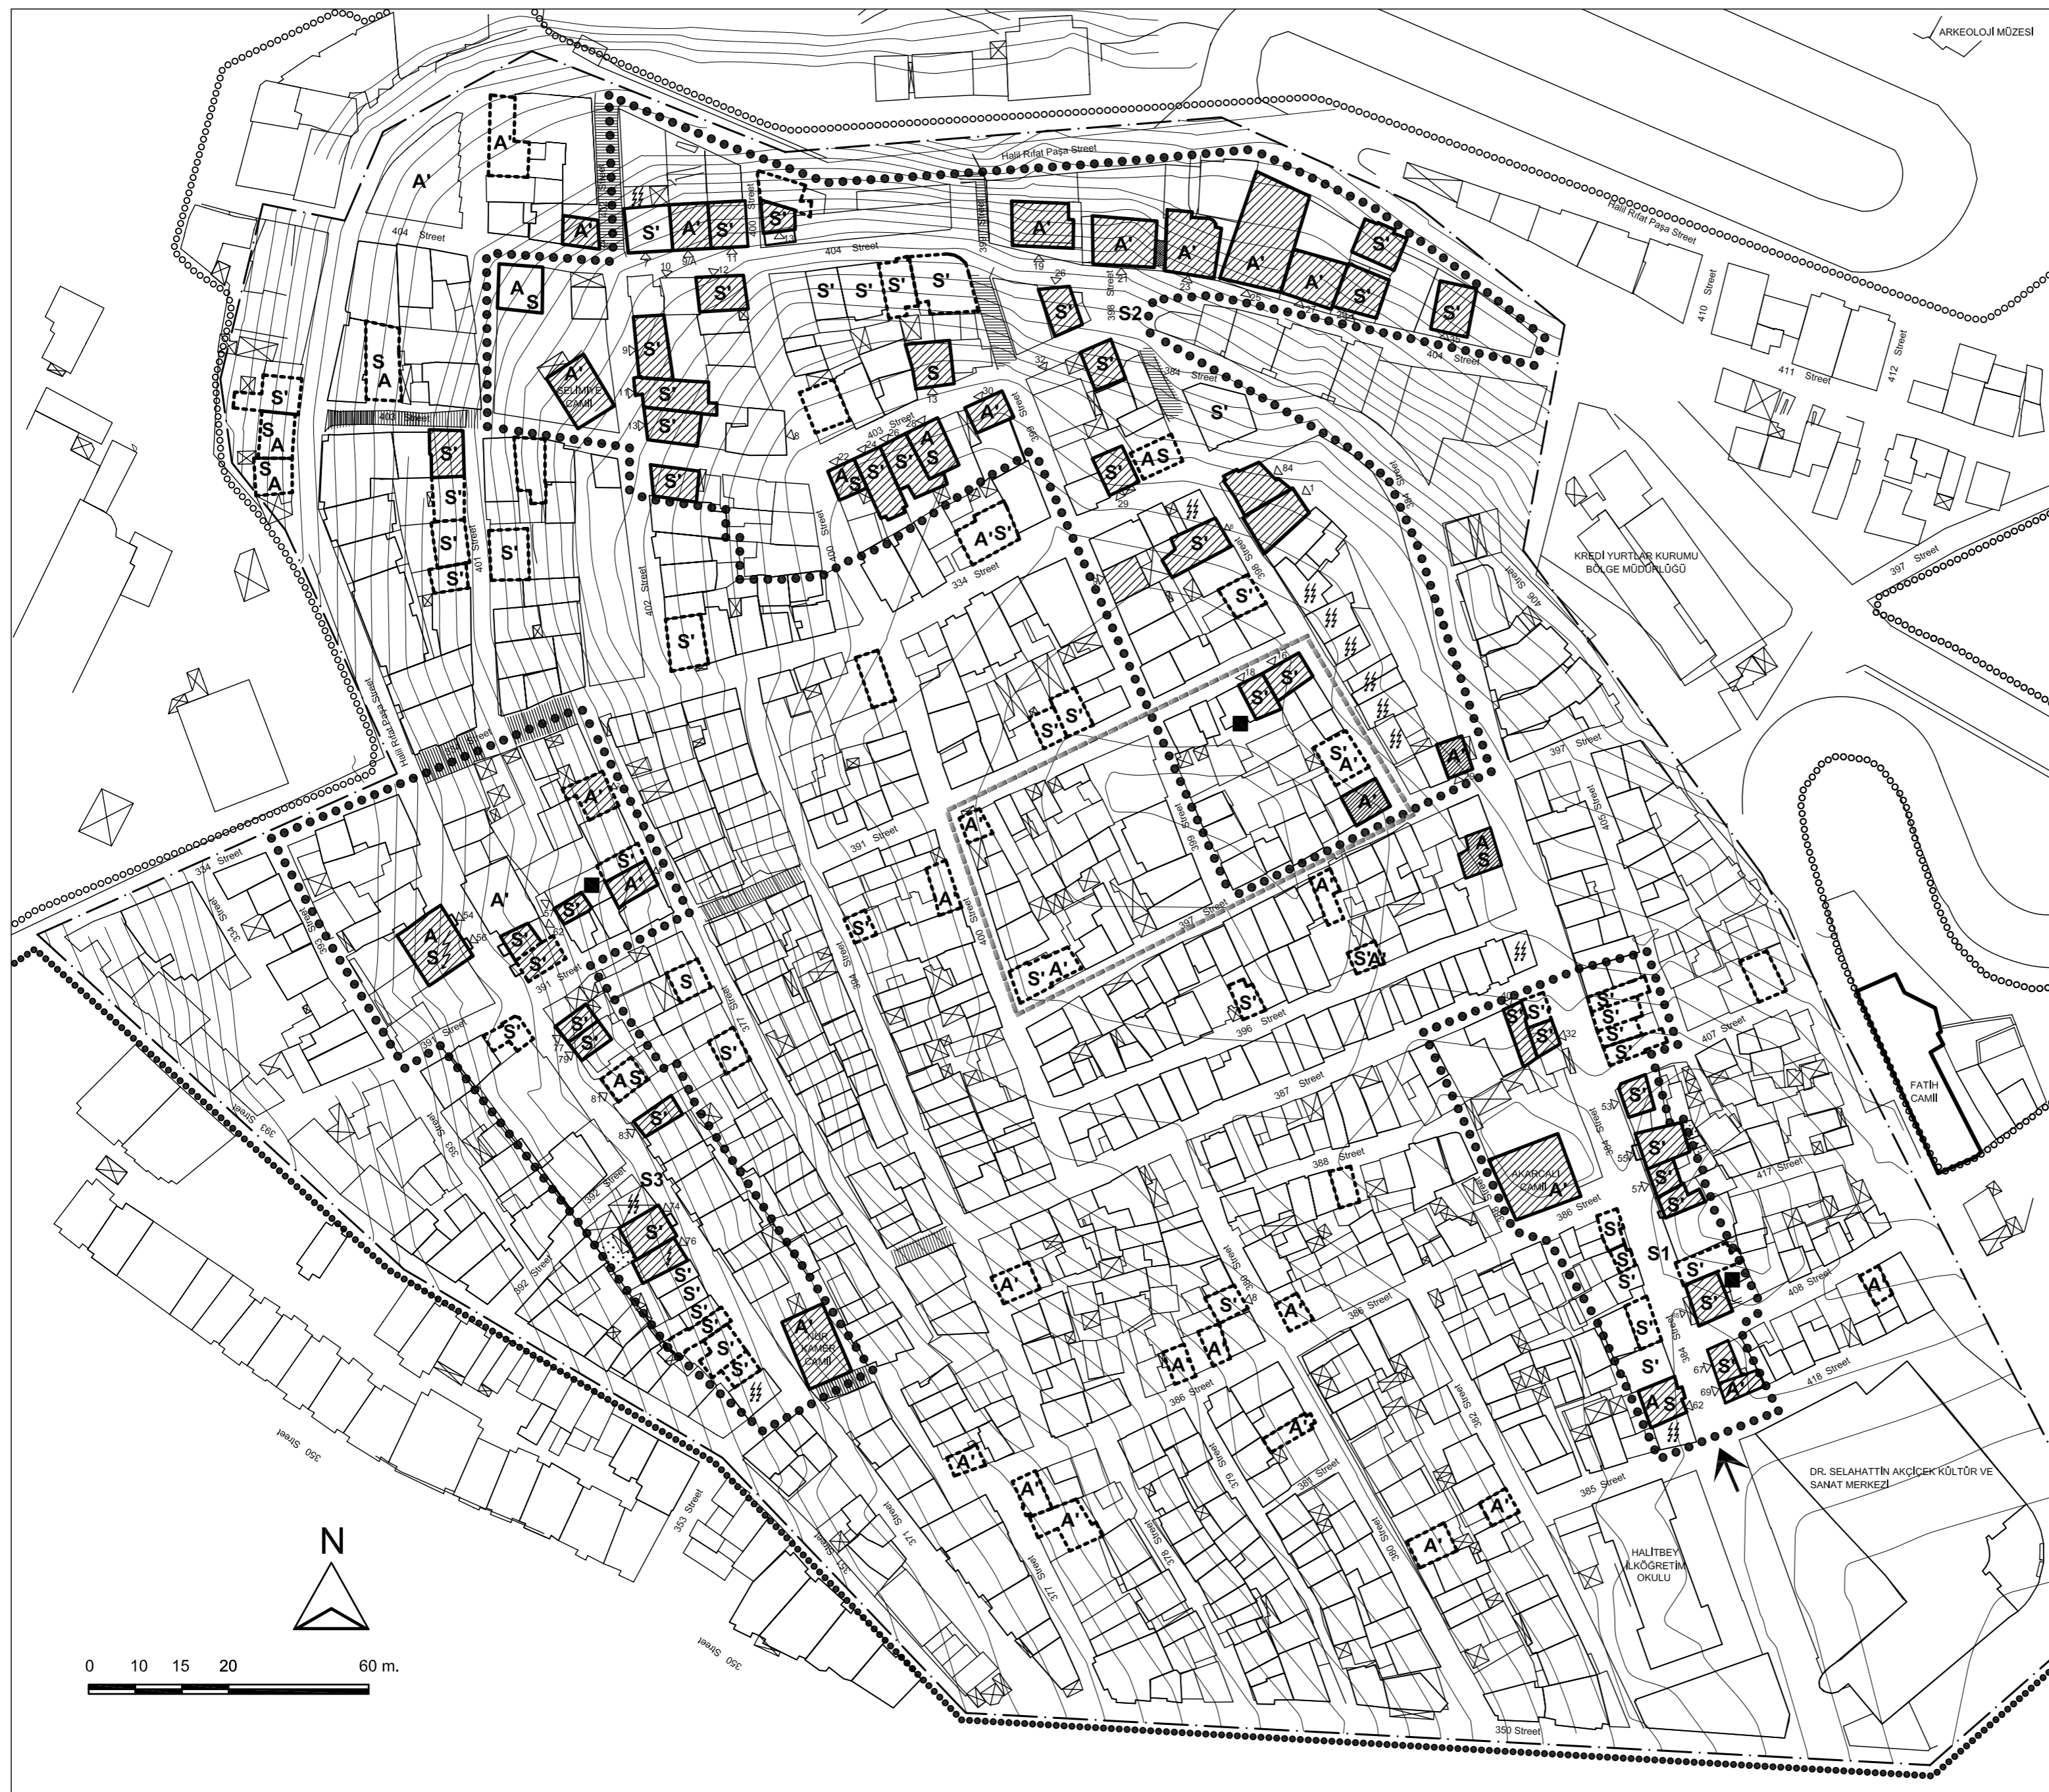
Figure 4.14. Evaluation

Suggested to Registration
- A** Buildings which primarily need intervention
- A'** Buildings which do not necessiate any intervention
- S** Major Structural Repair
- S'** Minor Structural Repair
-

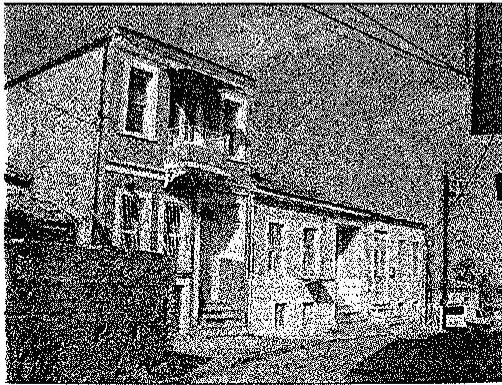
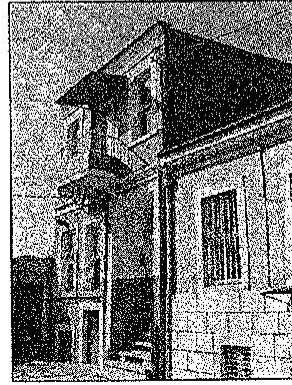
Figure A.9 Inventory card

Top kat sıması ve çatı silmesi var.  
Çatı silmesinde boya işçiliği var.

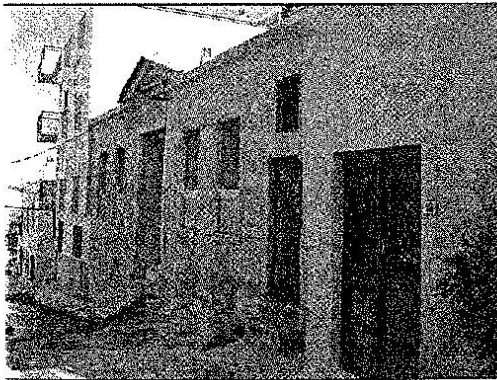
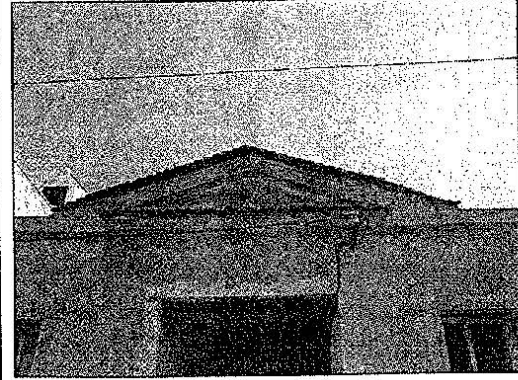
Figure A.15 Inventory card

Yapı yenileme aşamasında ve diğer malzemeler tamamen kaldırılmış.  
Pencere araları değiştirilmiş.

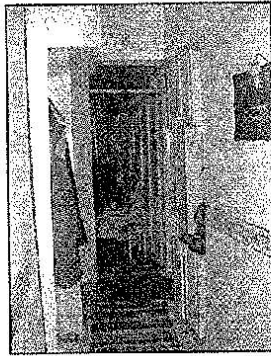
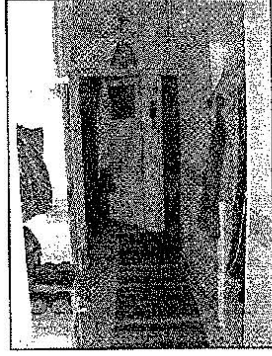
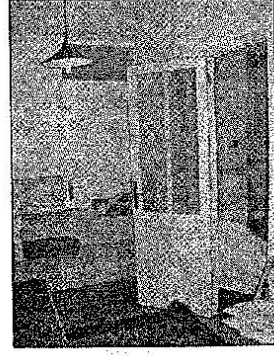
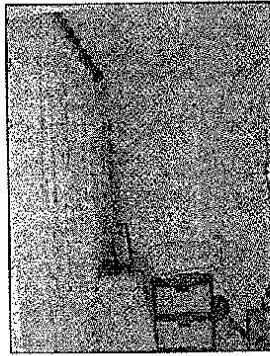
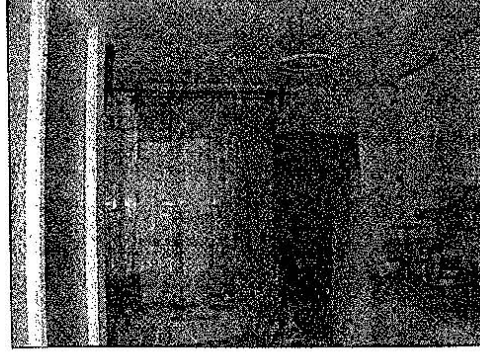
Figure A.20 Inventory card

DOLAP:		DOLAP:		DOLAP:		DOLAP:	
YUKLUC:		YUKLUC:		YUKLUC:		YUKLUC:	
KÖRKULUC:		KÖRKULUC:		KÖRKULUC:		KÖRKULUC:	
				NOTLAR			
				Ev tamamen yenilenmiş. Orjinal malzeme karedeyse yok.

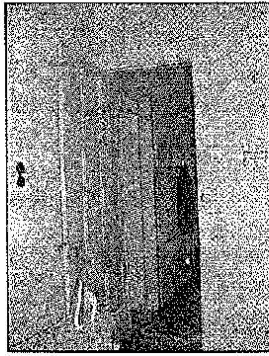
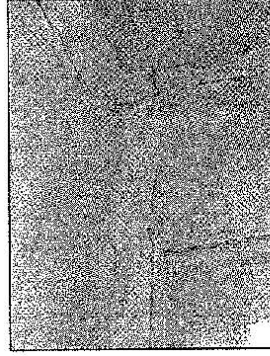
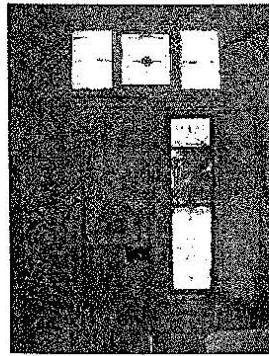
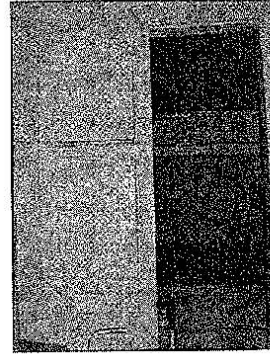
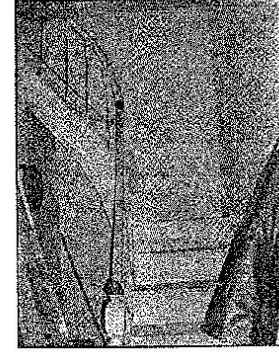
Figure A.52 Inventory card

- BODRUM KATA GİRİLMEMİŞ.
- 1. KAT HOLLİNDE AHDAP ADEKLİKLERİ VAR.
- 1. KAT DUVACILARINDA YERİN ÇATLAKLAR GÖZLENMEKTE

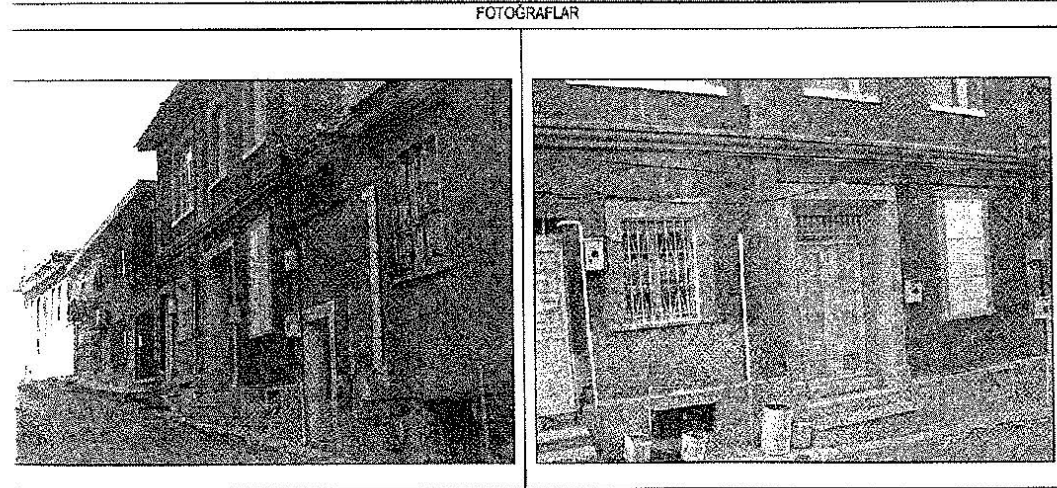
Figure A.54 Inventory card

- EV, ŞU AN 1.KAT, ZEMİN KAT VE BODURUM KAT OLMAK ÜZERE ÜÇ AYRI KULLANICI TARAFINDAN KULLANILMAKTA.
- (27-A-1.KAT, 27-C-BODURUM KAT)
- CEPHE AĞIRLIKLARININ BİR KİMLİNİN ORANLARI DEĞİŞTİRİLMİŞTİR.
