Qualitative and Comparative Analysis of Stormwater management in the Tan Brook Watershed

Qualitative and Comparative Analysis of Stormwater Management in the Tan Brook Watershed

Natalia von Hausen

Landscape Architecture and Regional Planning Department

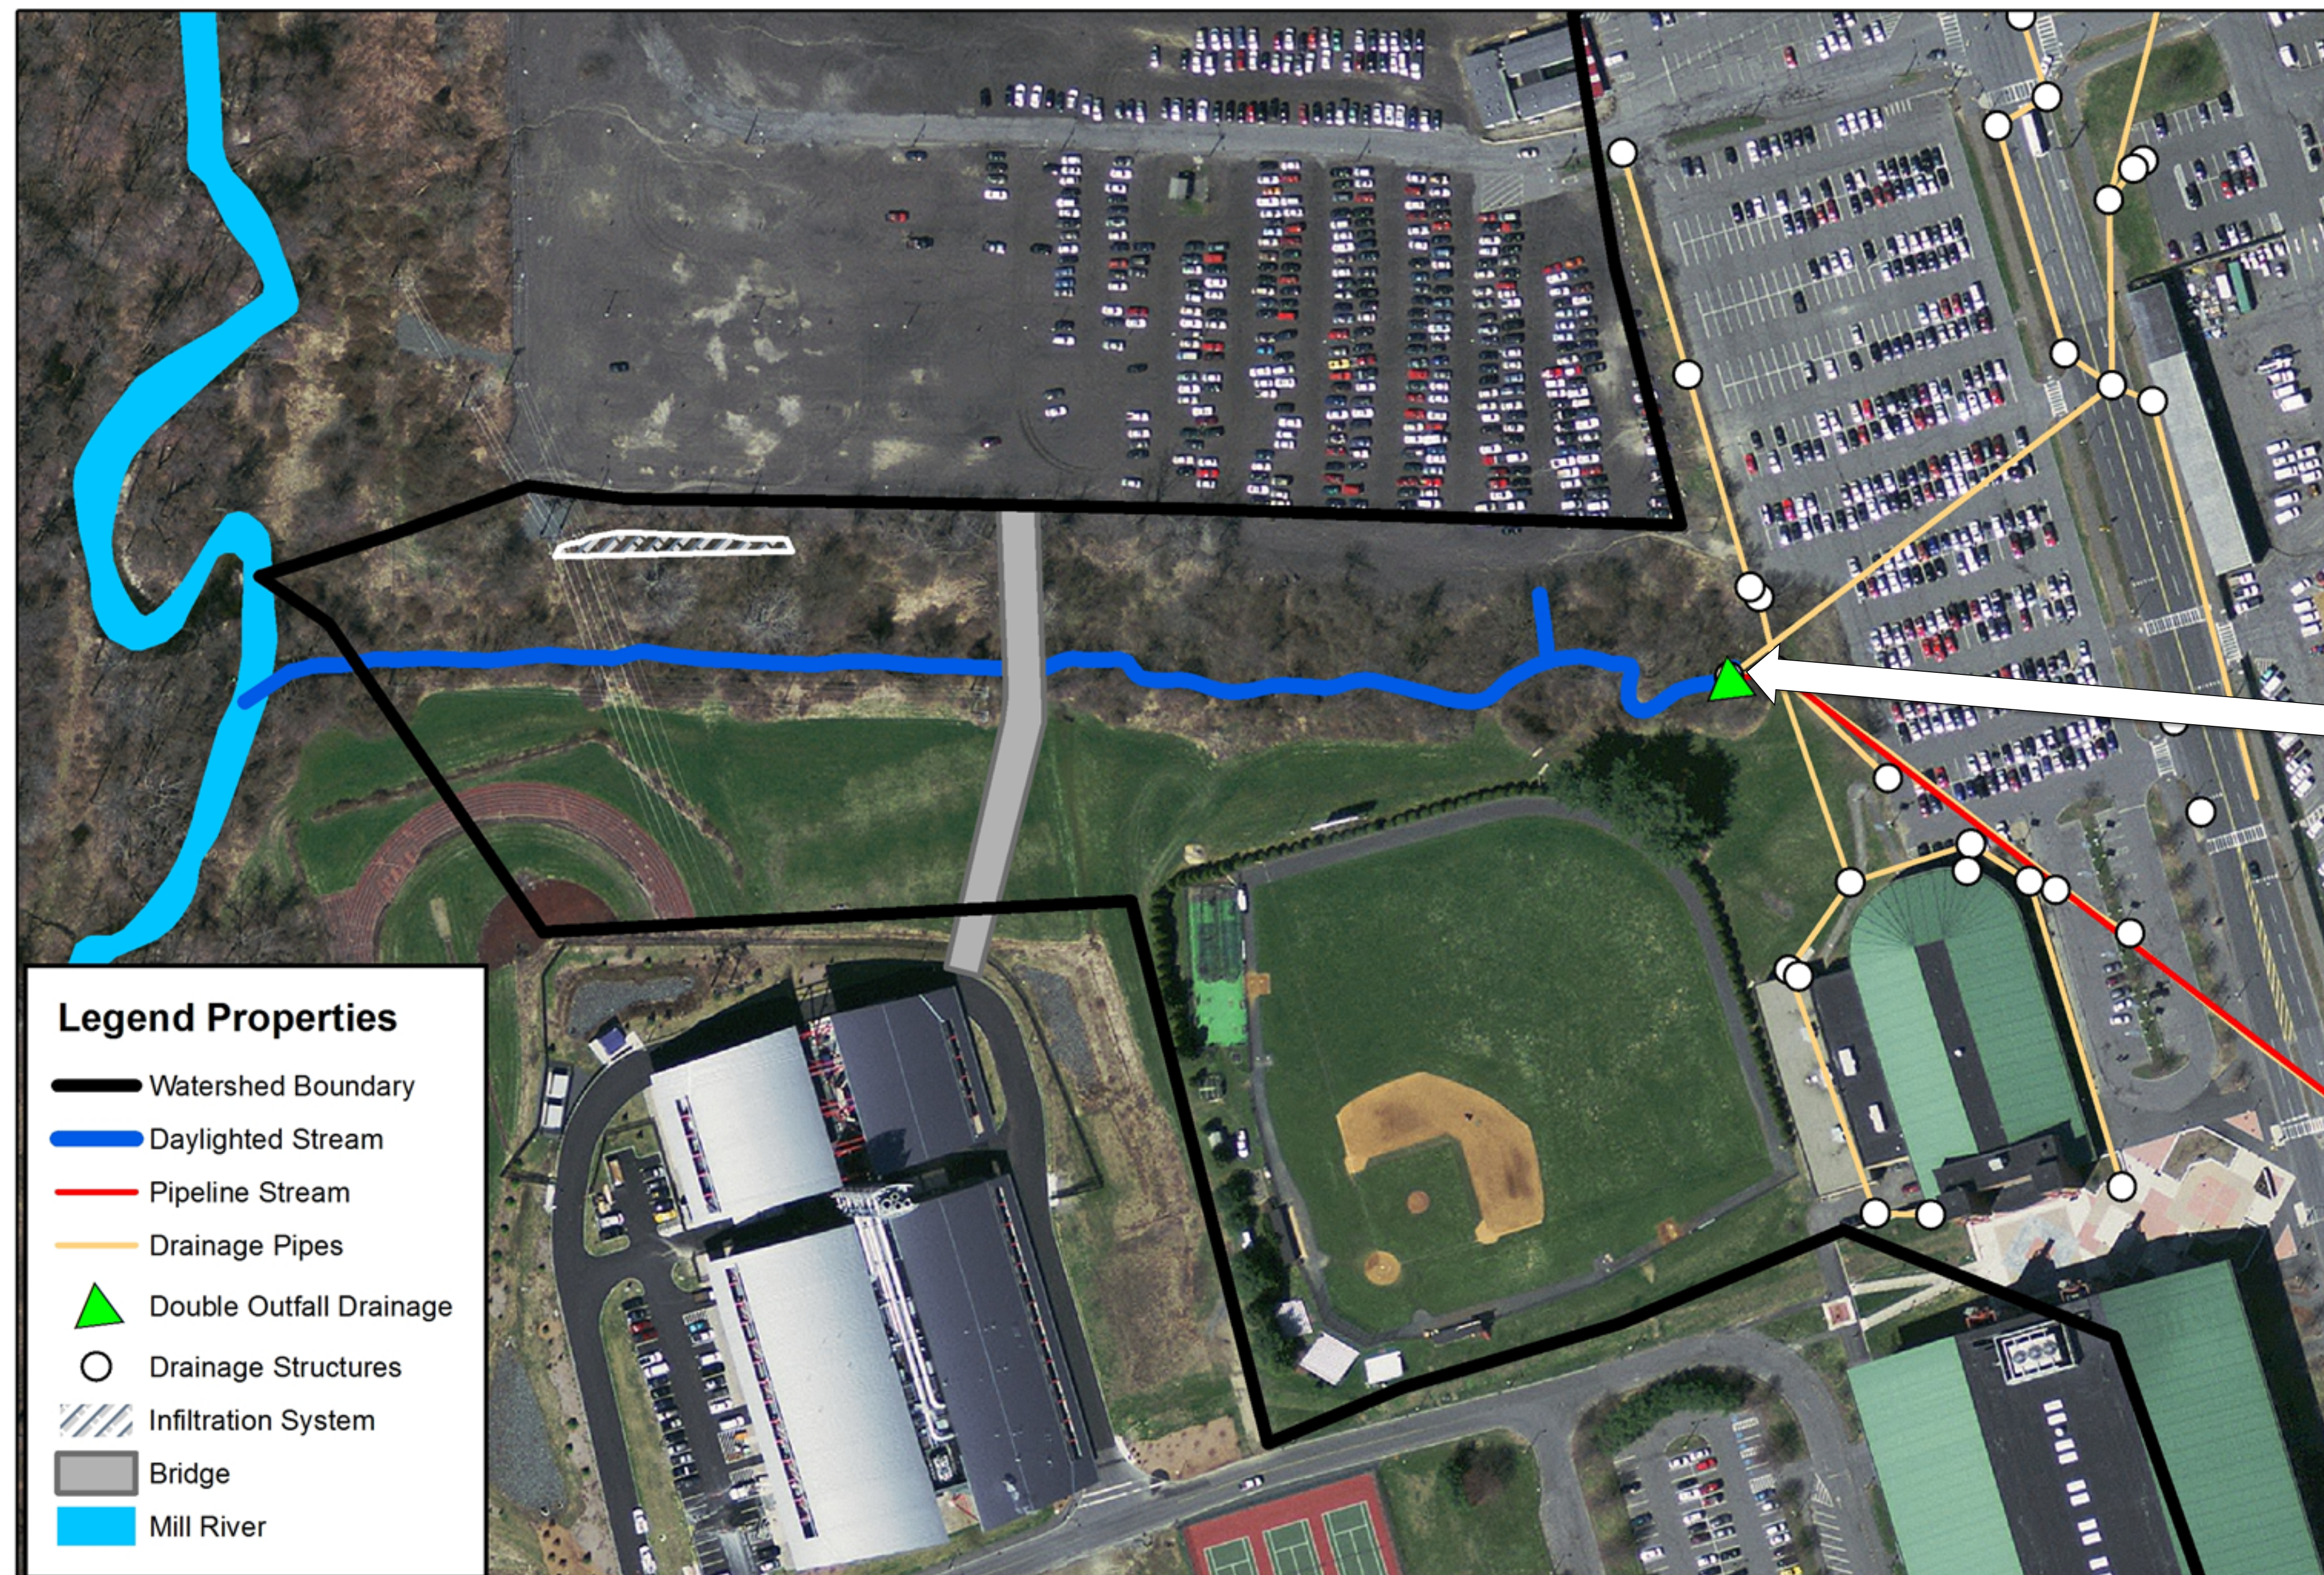
Institutional Site: University of Massachusetts Amherst

- Various manhole drainage systems collect water run-off from surrounding campus area
- Pipelined stream (Red Line) runs underneath front parking lot of the Mullins Center.
- Two outfall drainage systems bring the two stream courses together
- The stream that comes from the surrounding run-off was a bright orange color
- Rock trench infiltration system
- Flow coming from the outfall is high in velocity but slows down when filtering through the rocks

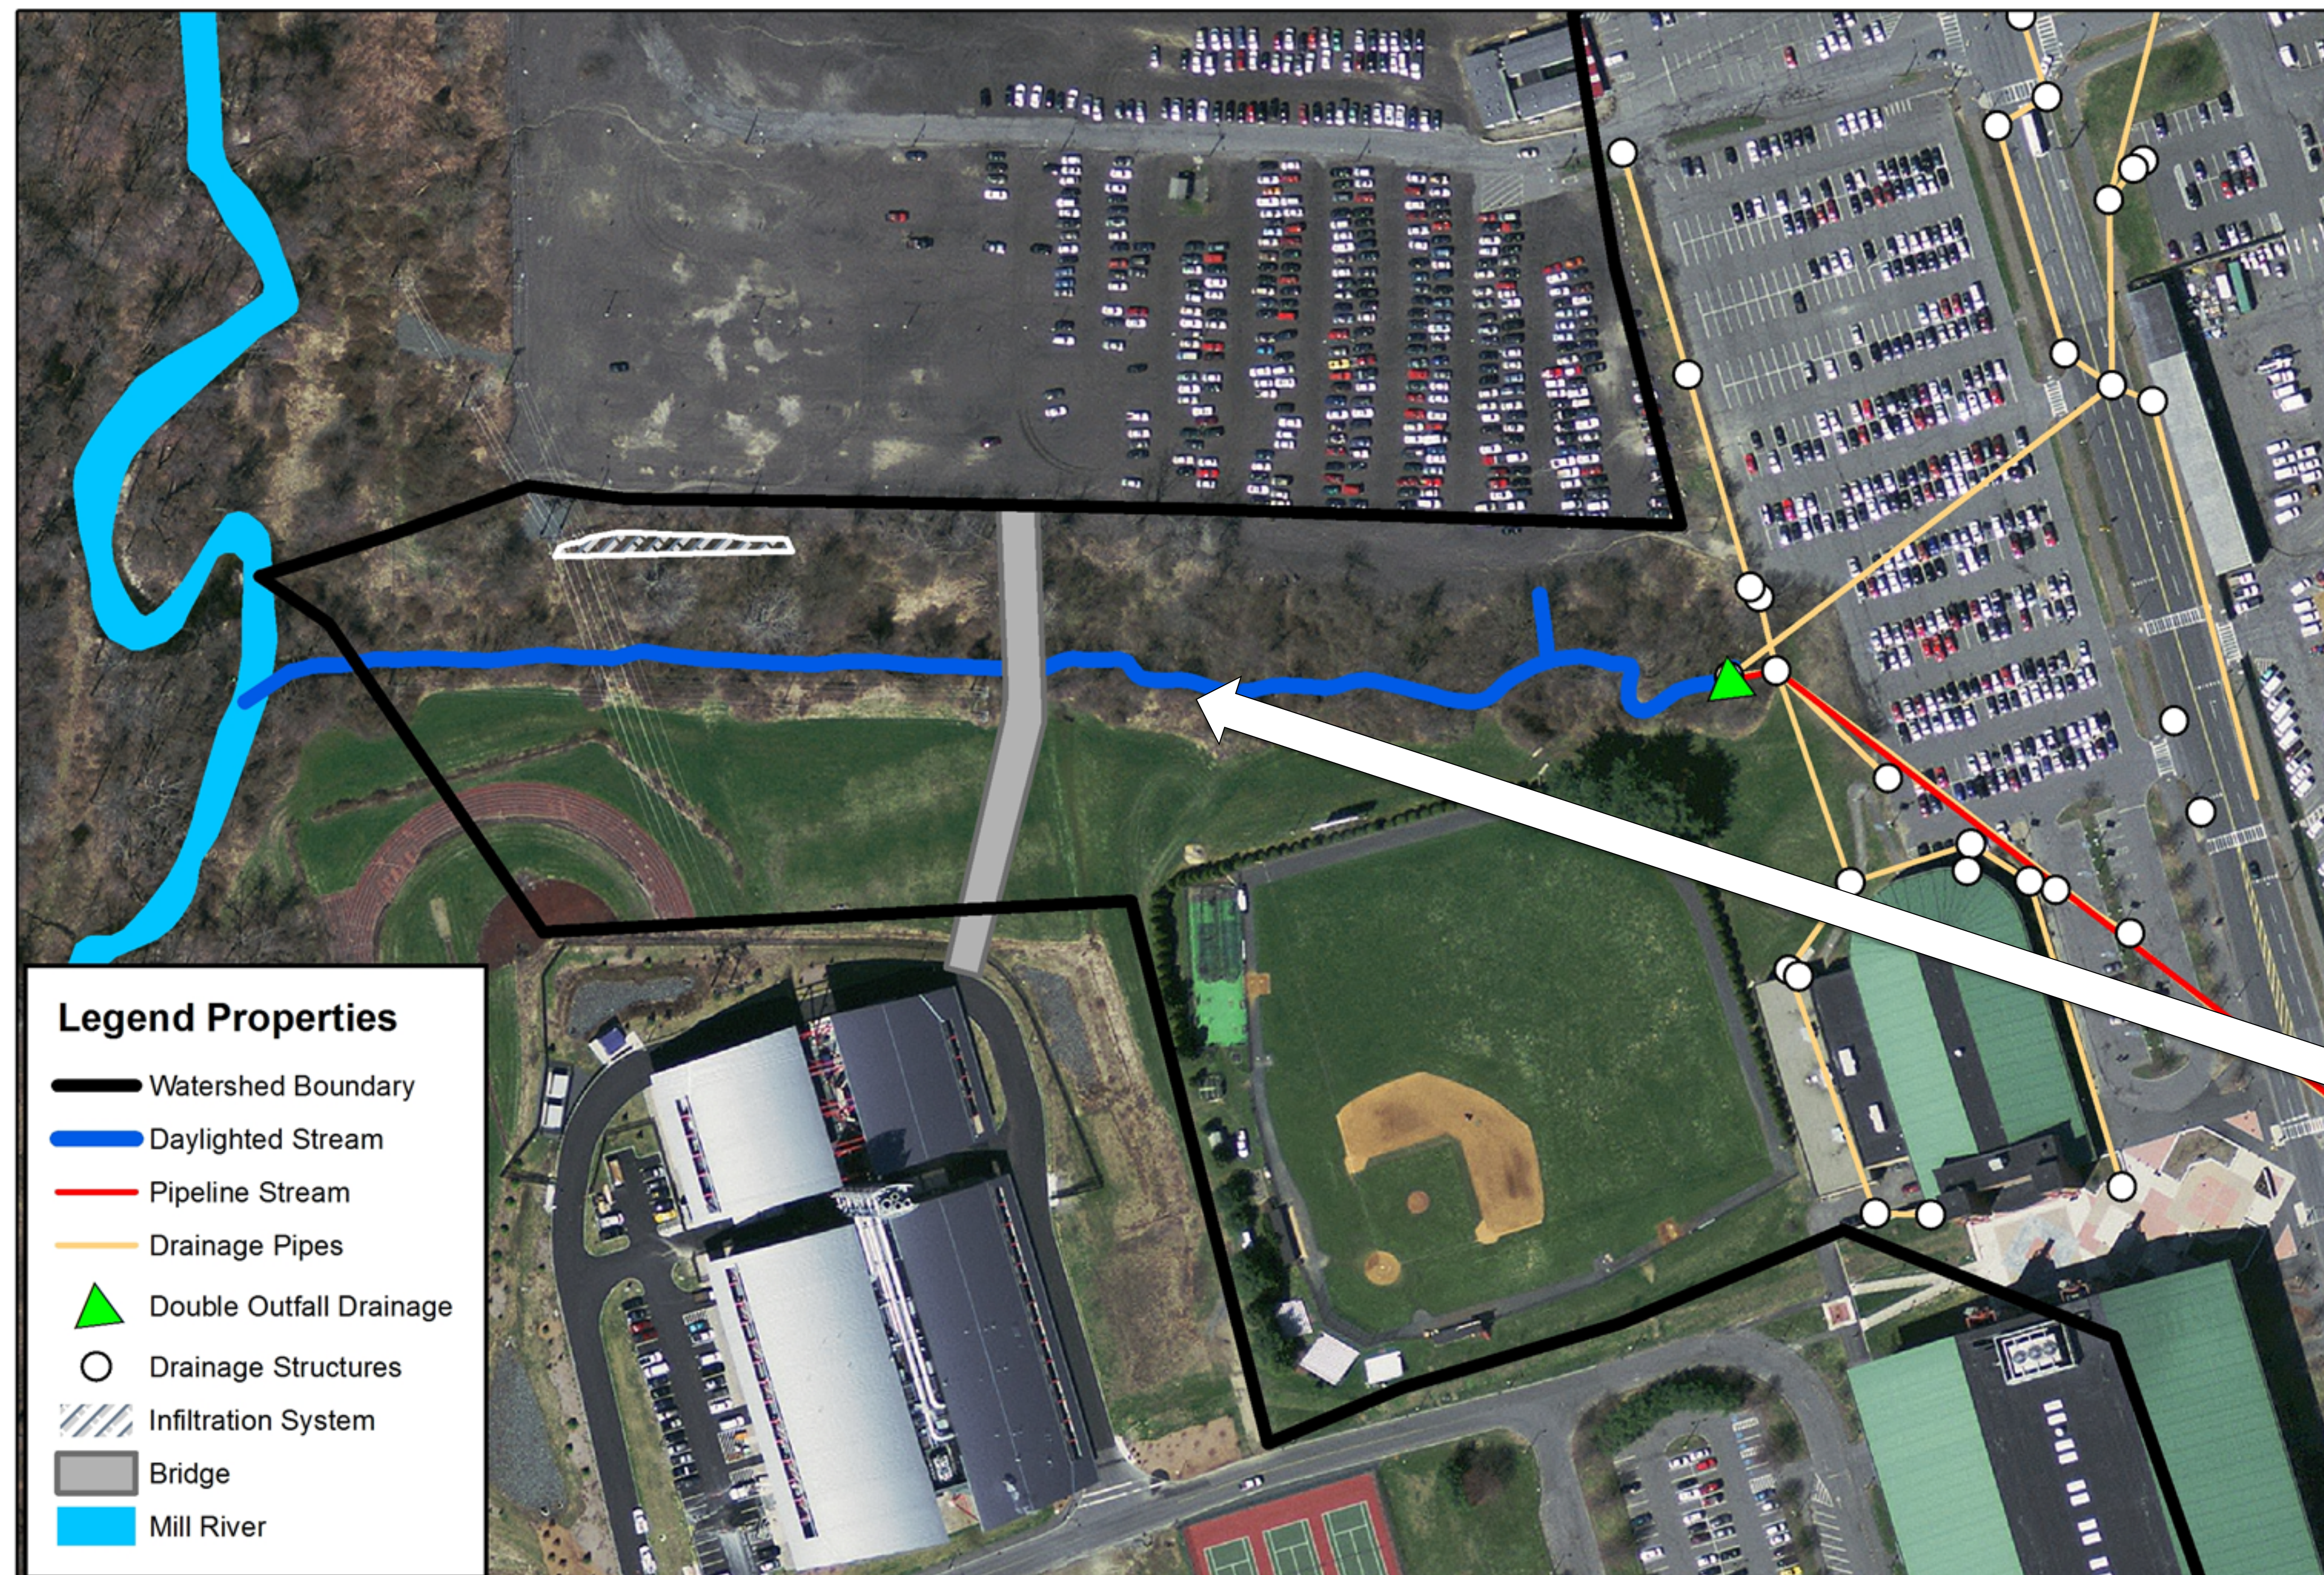
Institutional Site: University of Massachusetts Amherst

- Slabs of concrete framed either the edges of the stream or were just placed throughout the stream
- Concrete helps erosion control
- Stream was cloudy and had a lower velocity and volume, before and after snowmelt

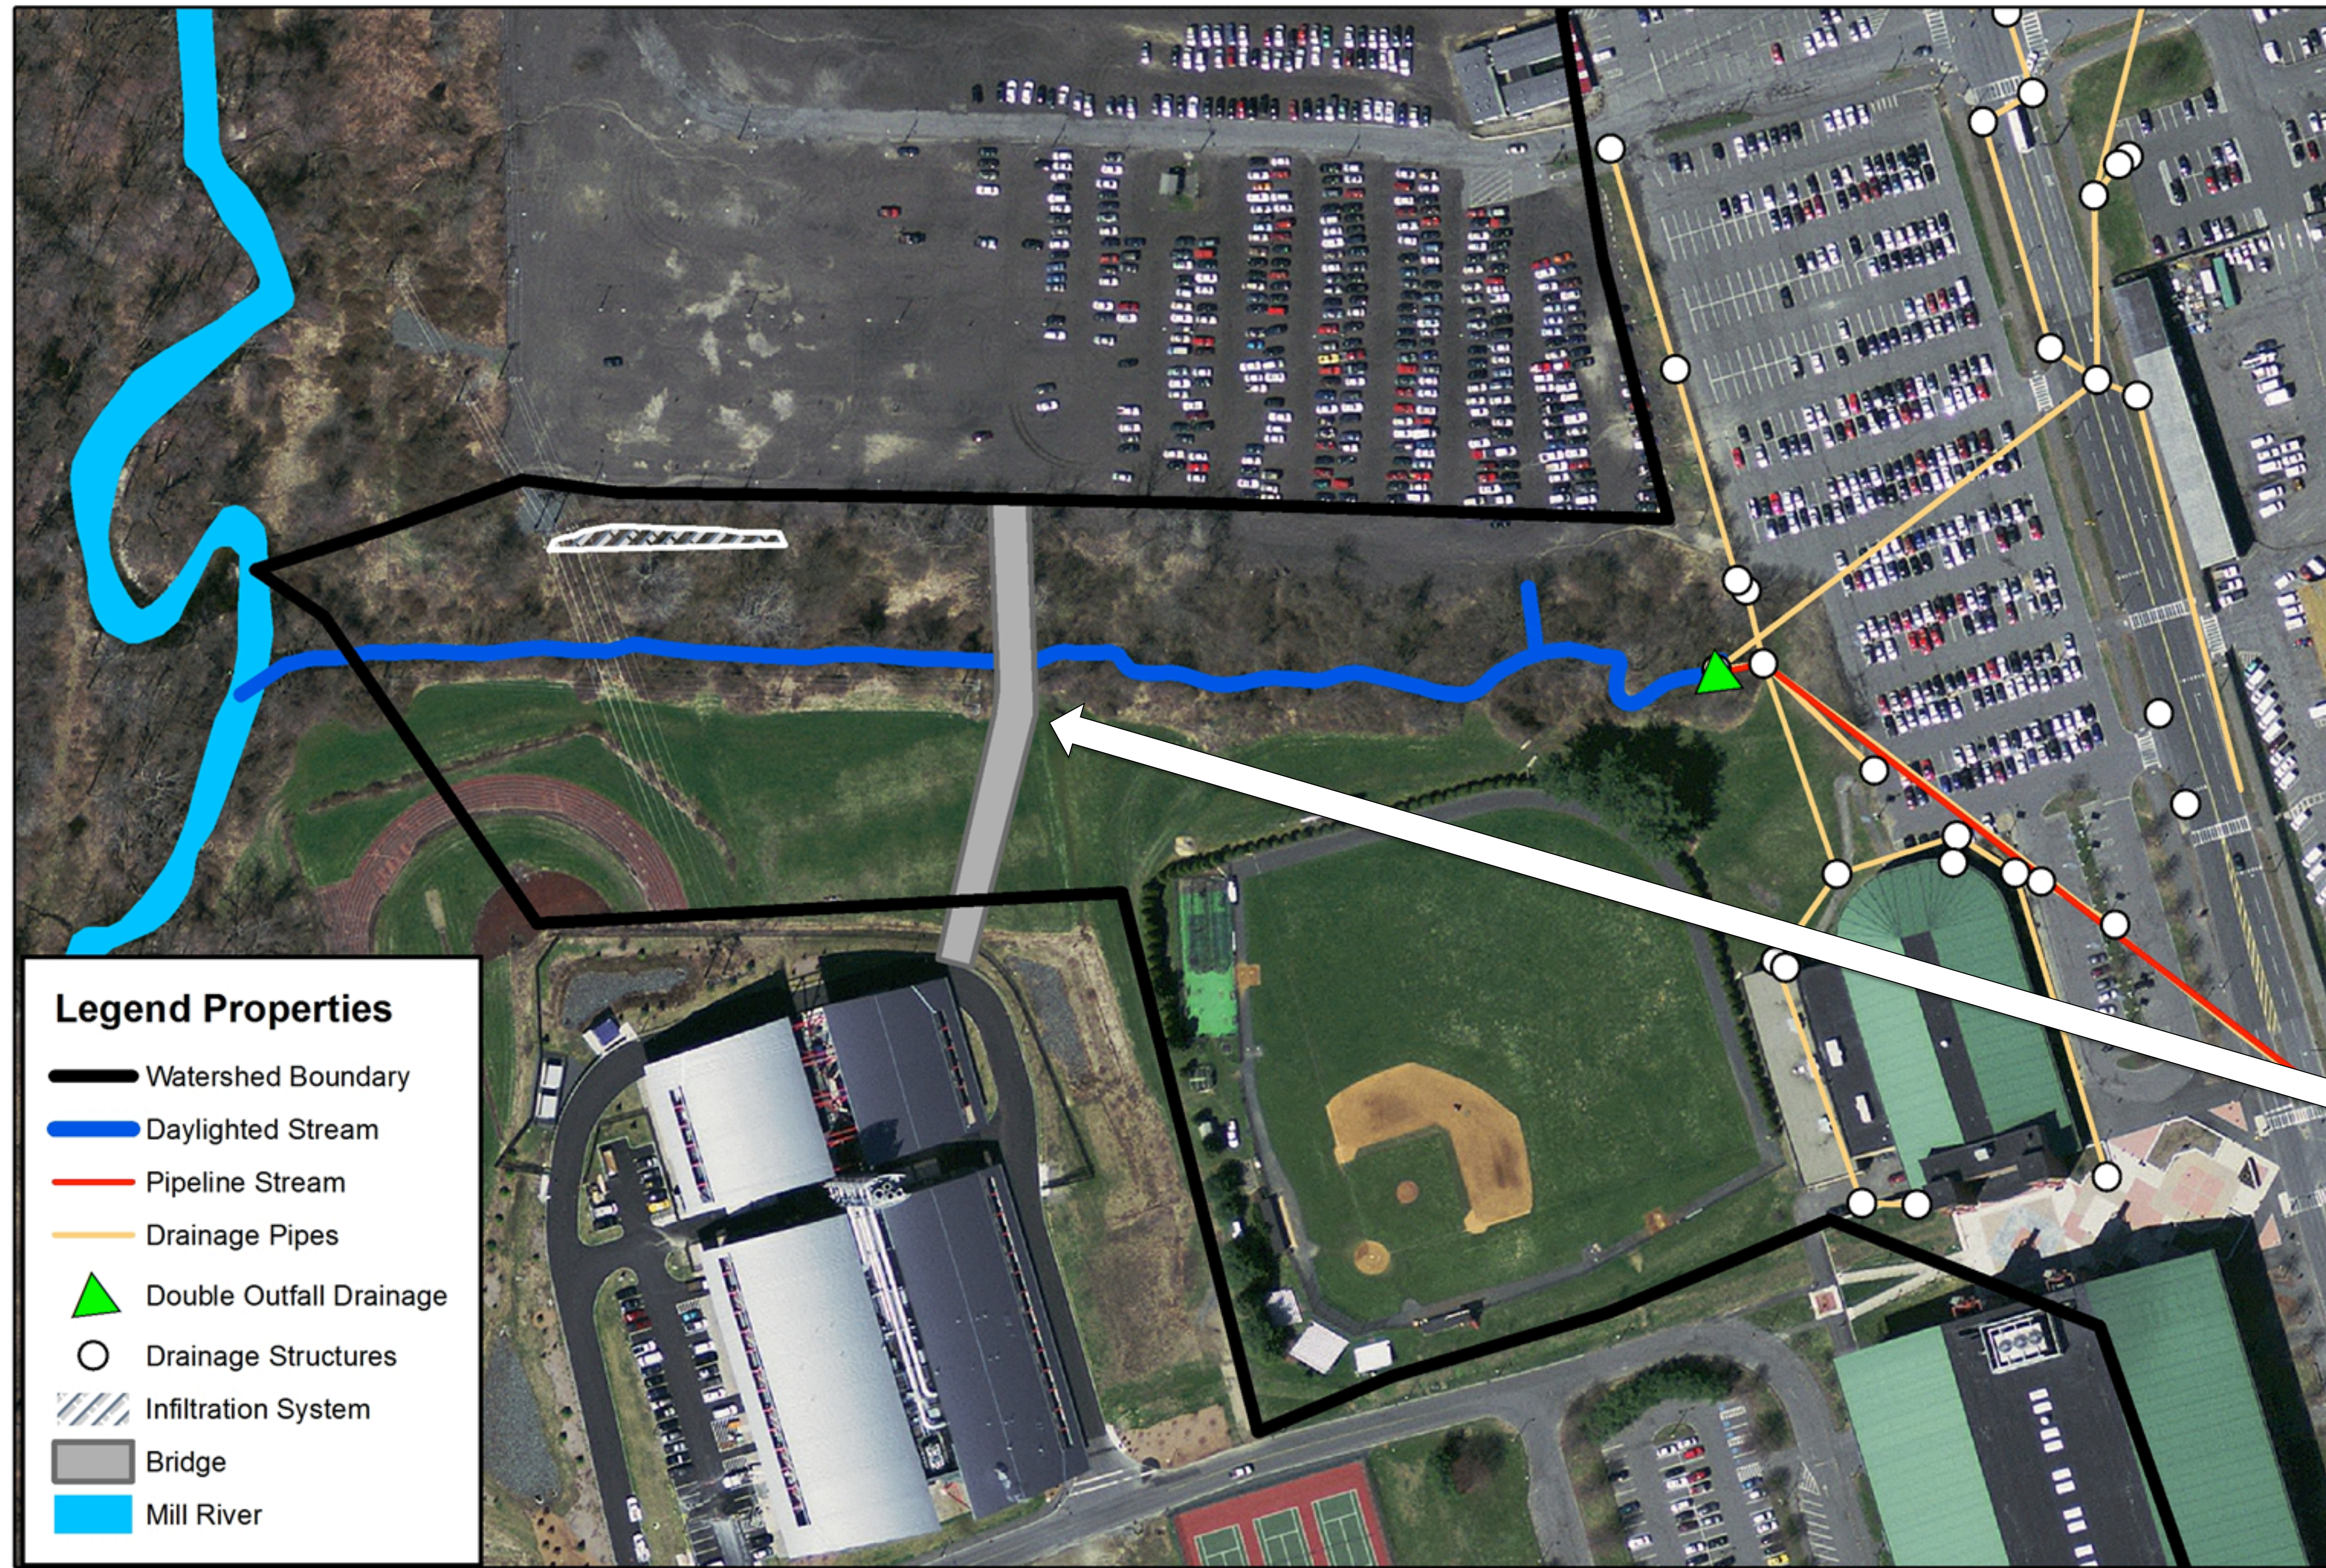
Institutional Site: University of Massachusetts Amherst

- Addition of bridge connection Power Plant to back parking lot of the Mullin's Center in 2010.
- Direct run off from parking lot (shown in picture)
- Infiltration system established on the border of the parking lot and the buffer zone of the stream

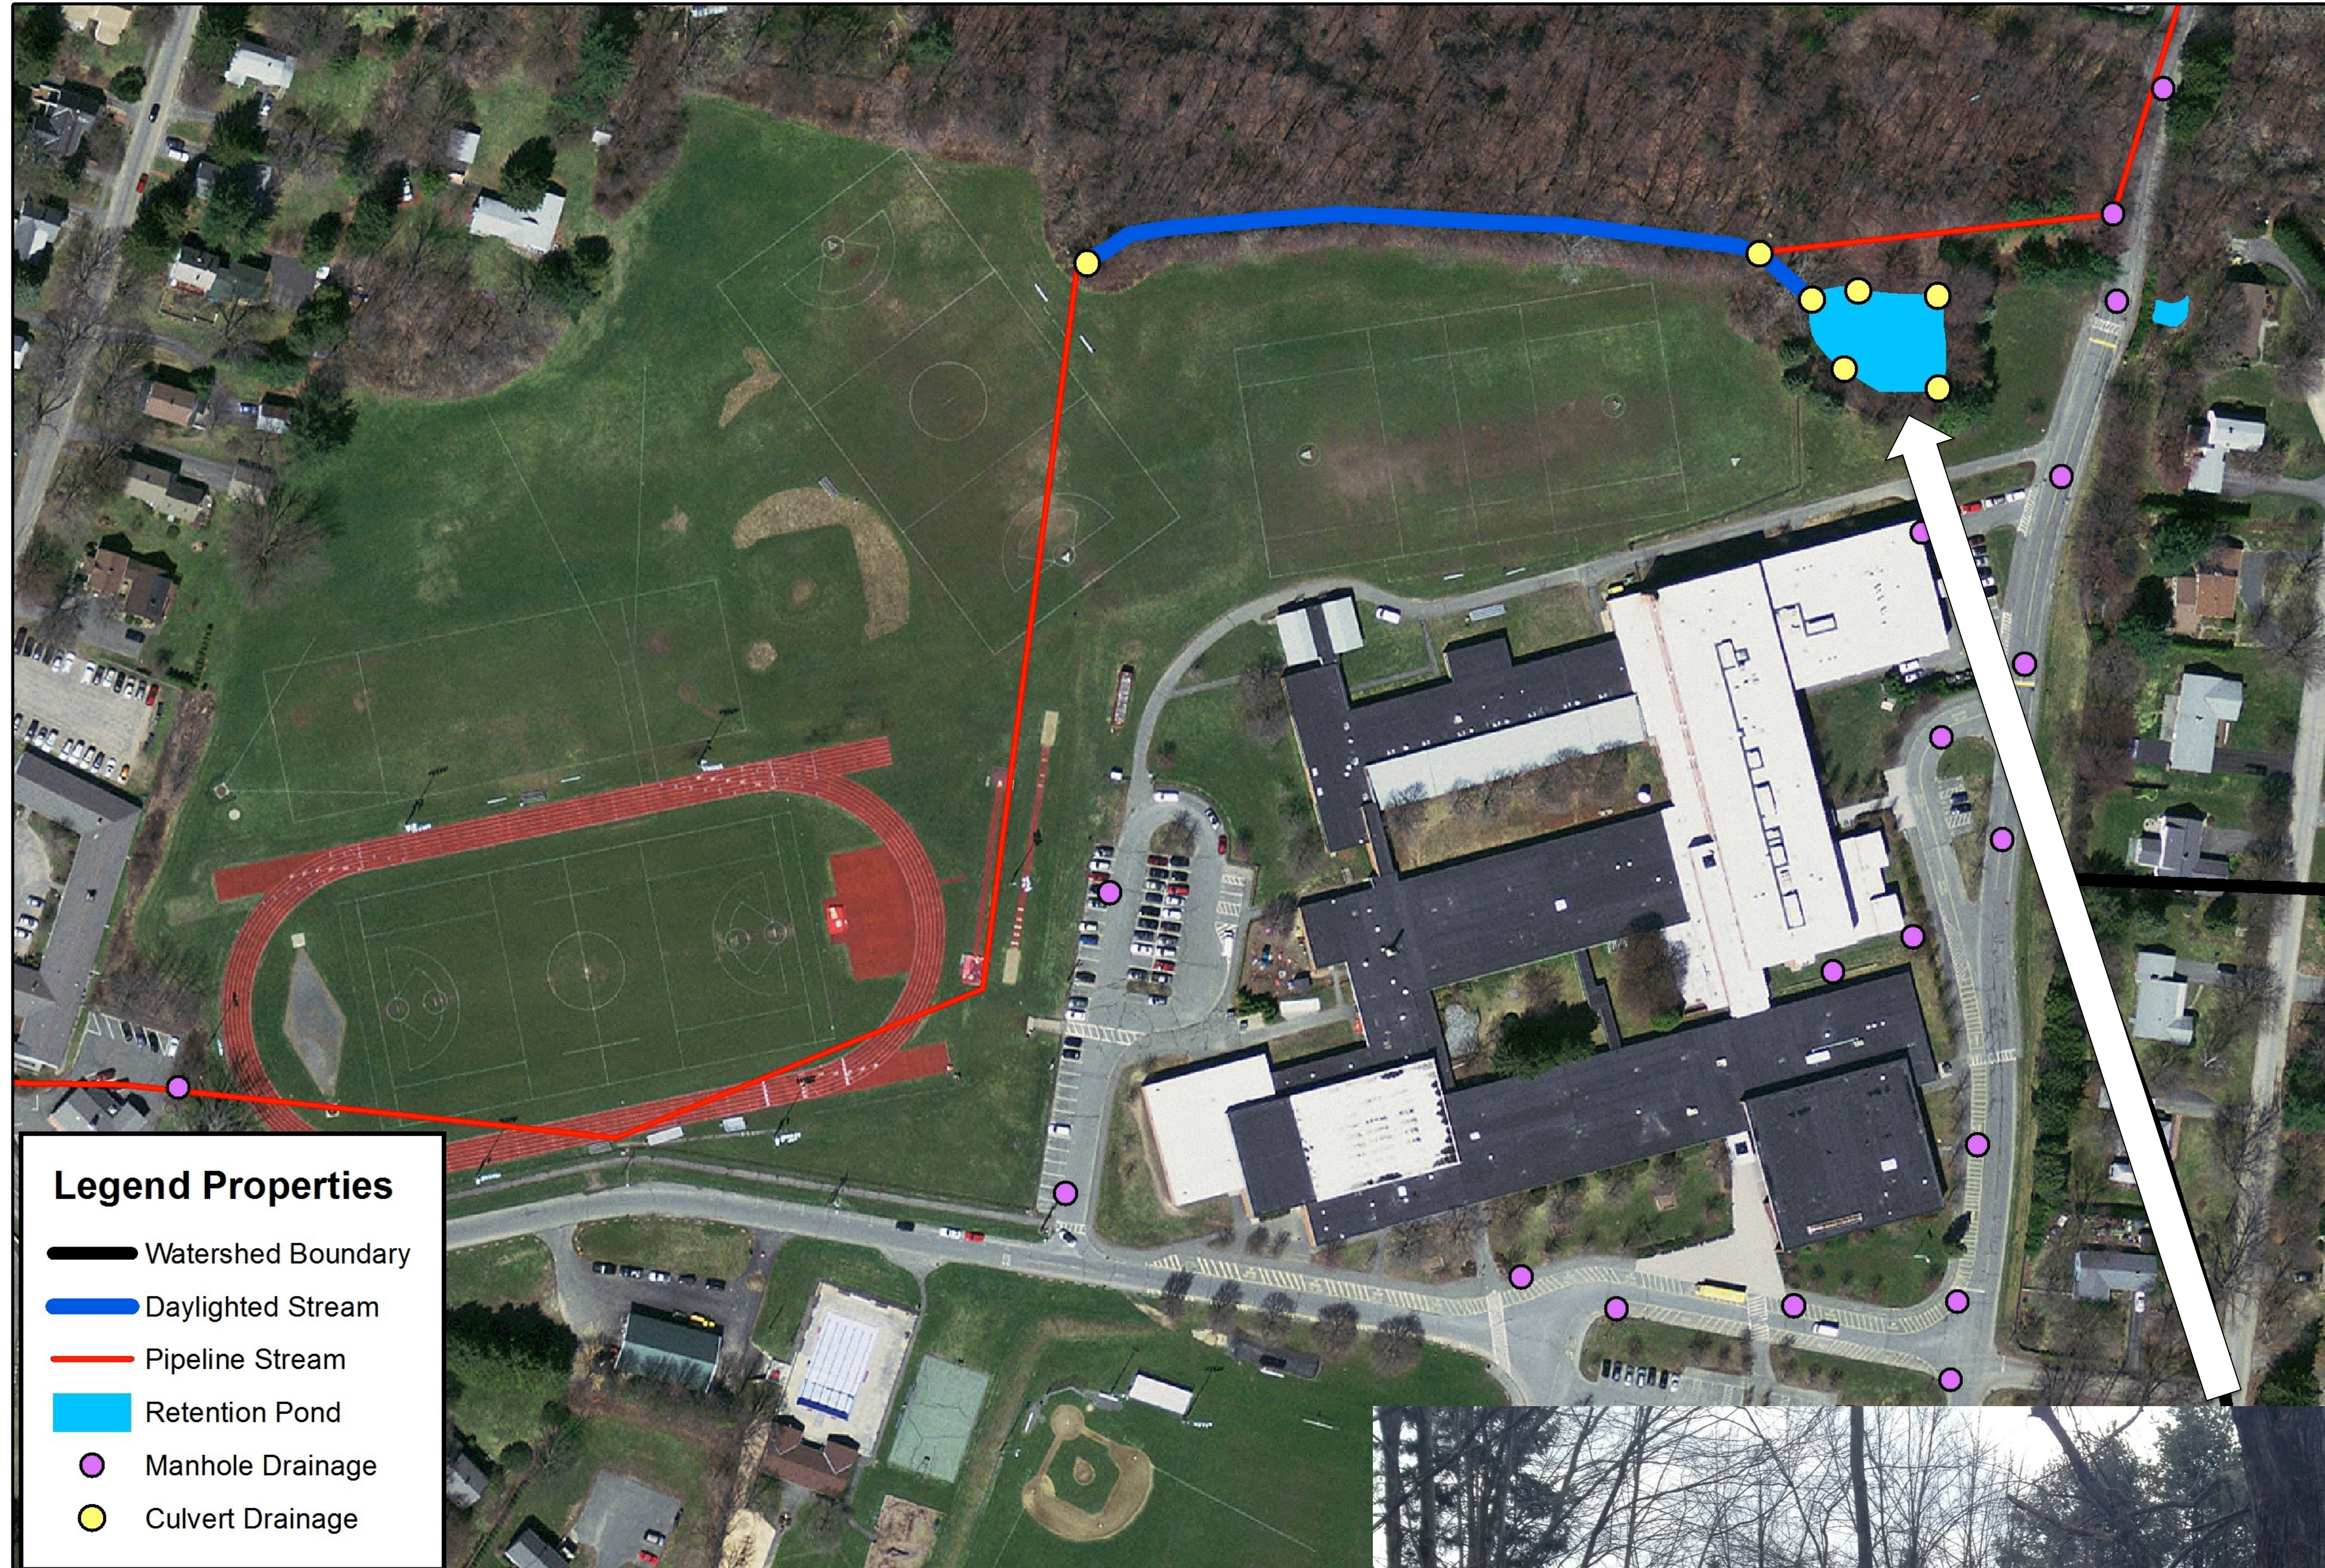
Recreational Site: Amherst Regional High School

- Retention pond (pictured below) fenced off, with 4+ culvert drainage pipes that introduce runoff from surrounding streets, vehicles, buildings, homes, etc.
- Pollution amount is very high
- Frozen over at the time of picture, but after snowmelt was overflowing which resulted in the bordering area to be over flooding
- Affected greatly by the changes in weather
- Fields adjacent were also flooded and muddy

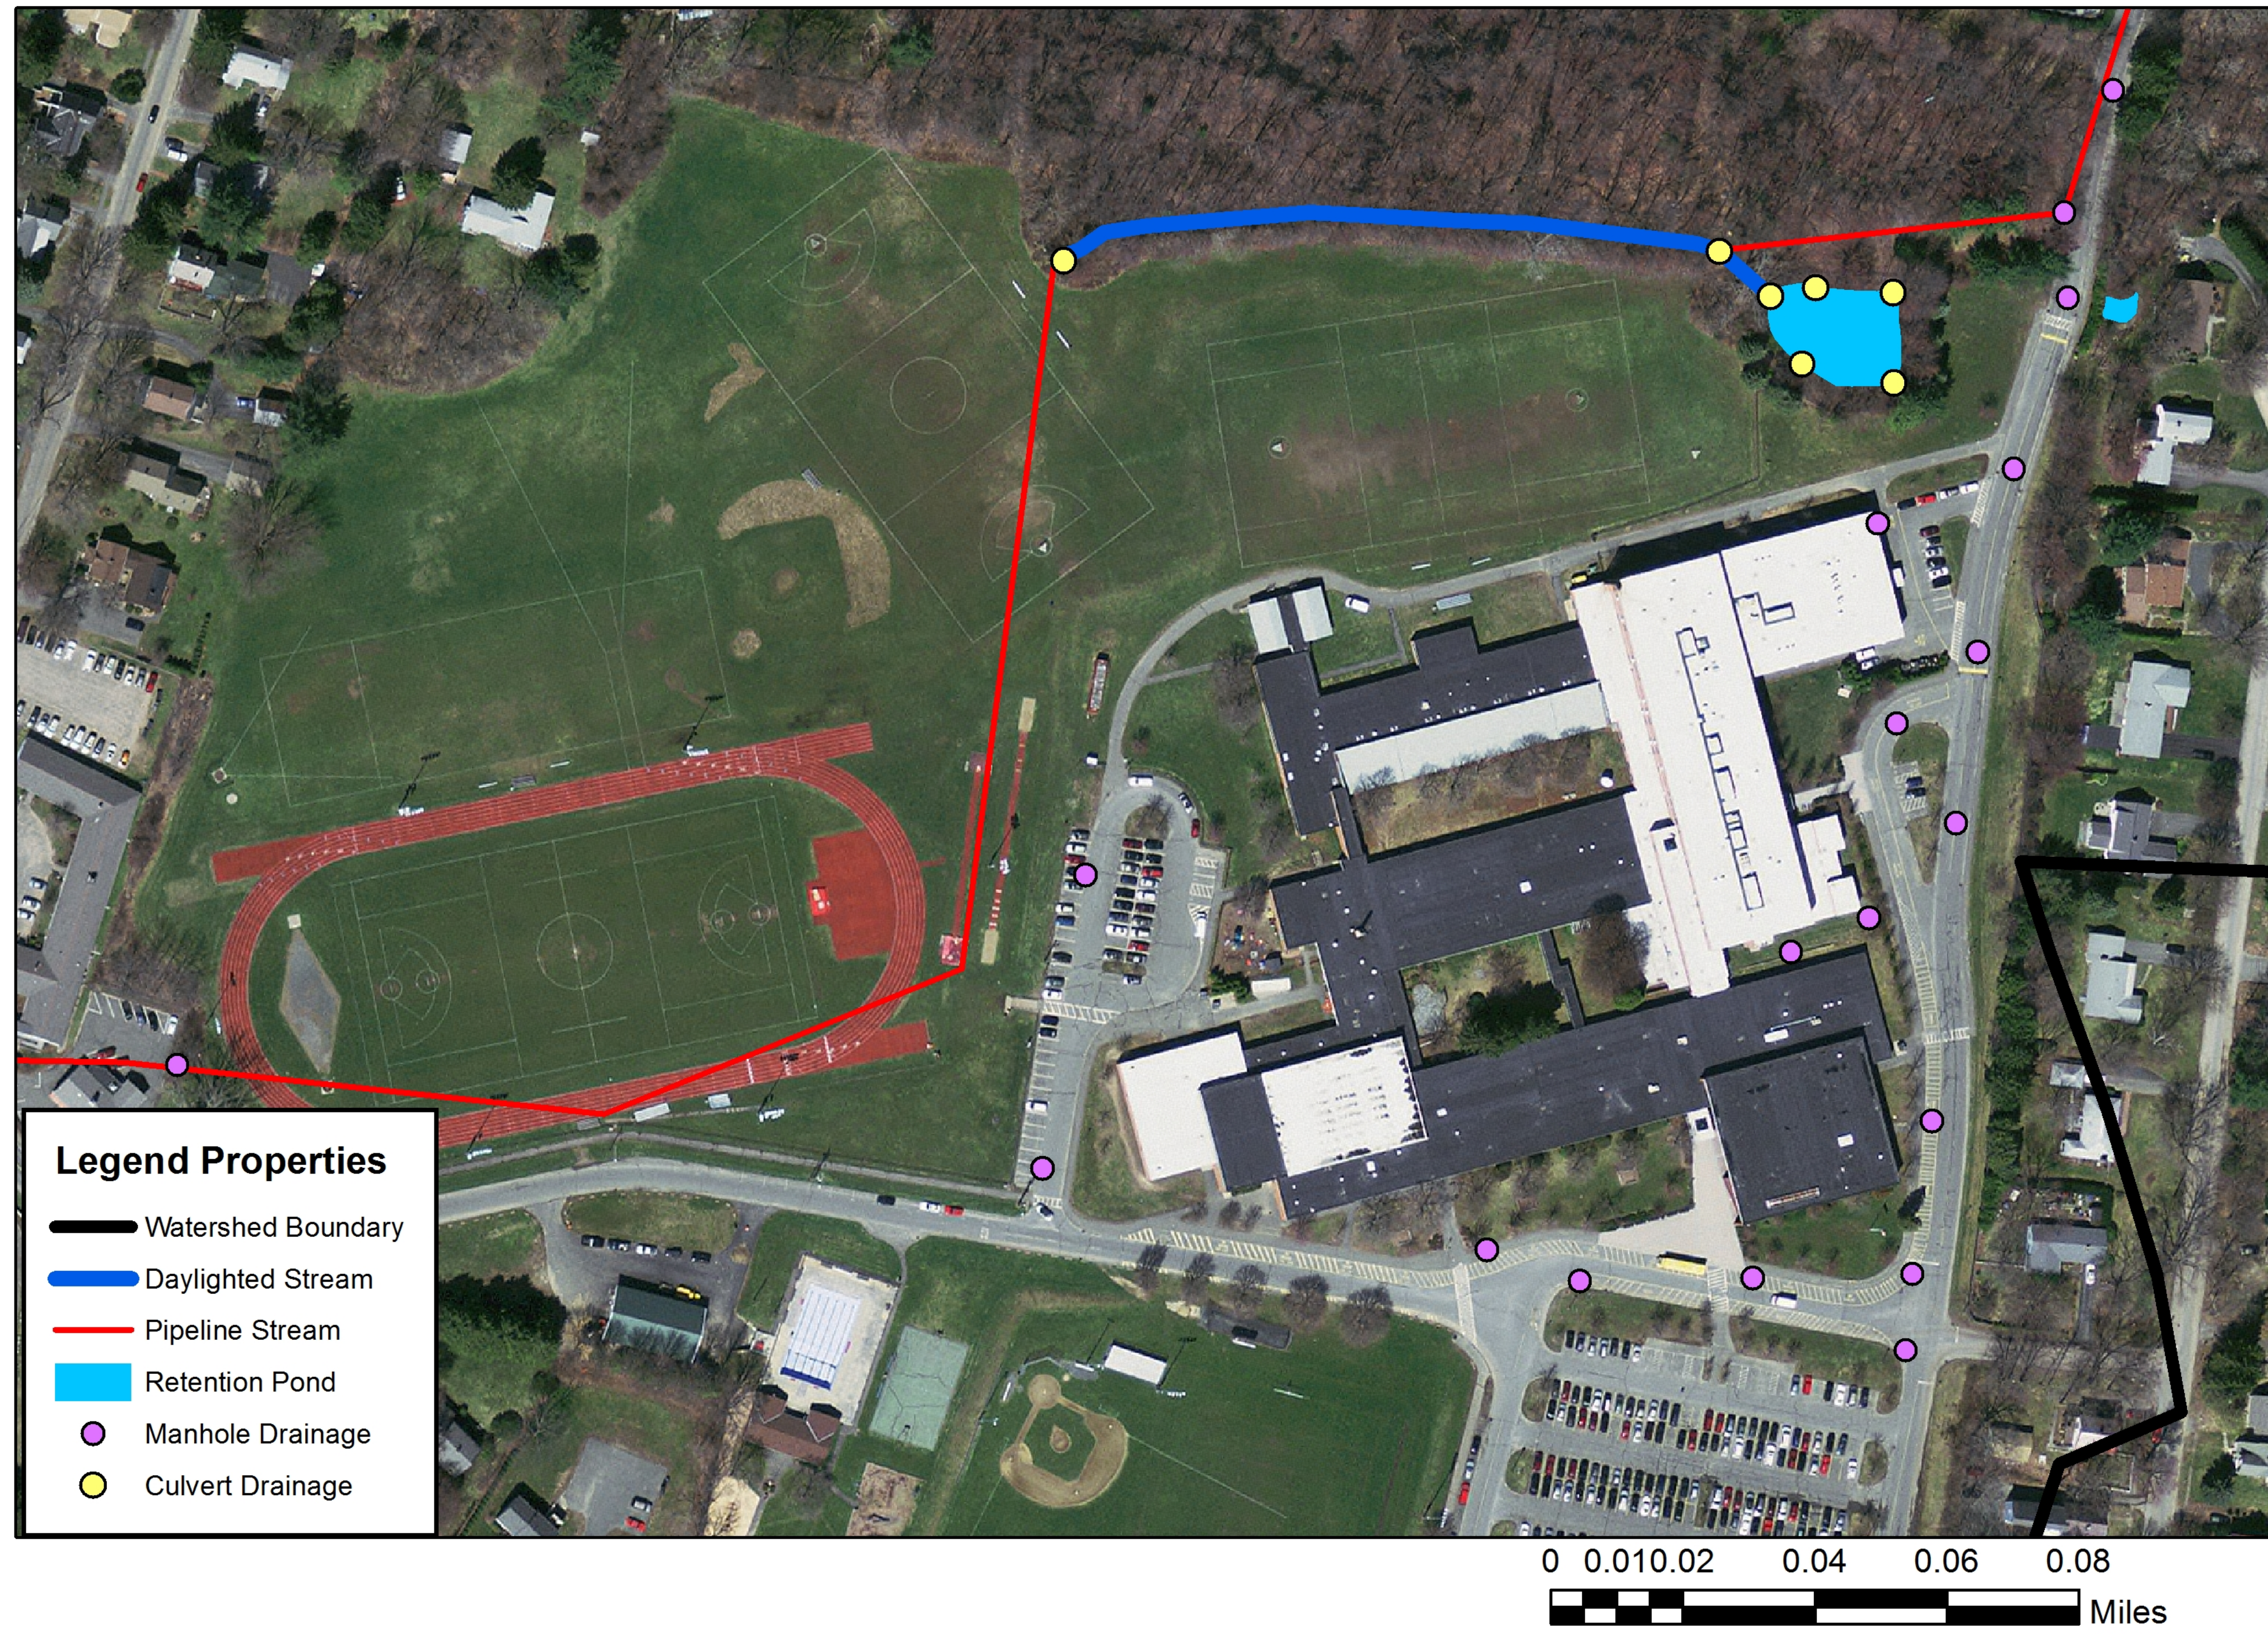
Recreational Site: Amherst Regional High School

- Wetland habitat is prominent (skunk cabbage and moss)
- Pollution is extremely high, most like because of its use by high school/middle school students
- Riffle-pool effect filters stream
- Stream is very low in both velocity and volume
- No observable aquatic wildlife
- Snowmelt resulted in flooding of surrounding area, meandering underground floor up to 30 ft+ from stream

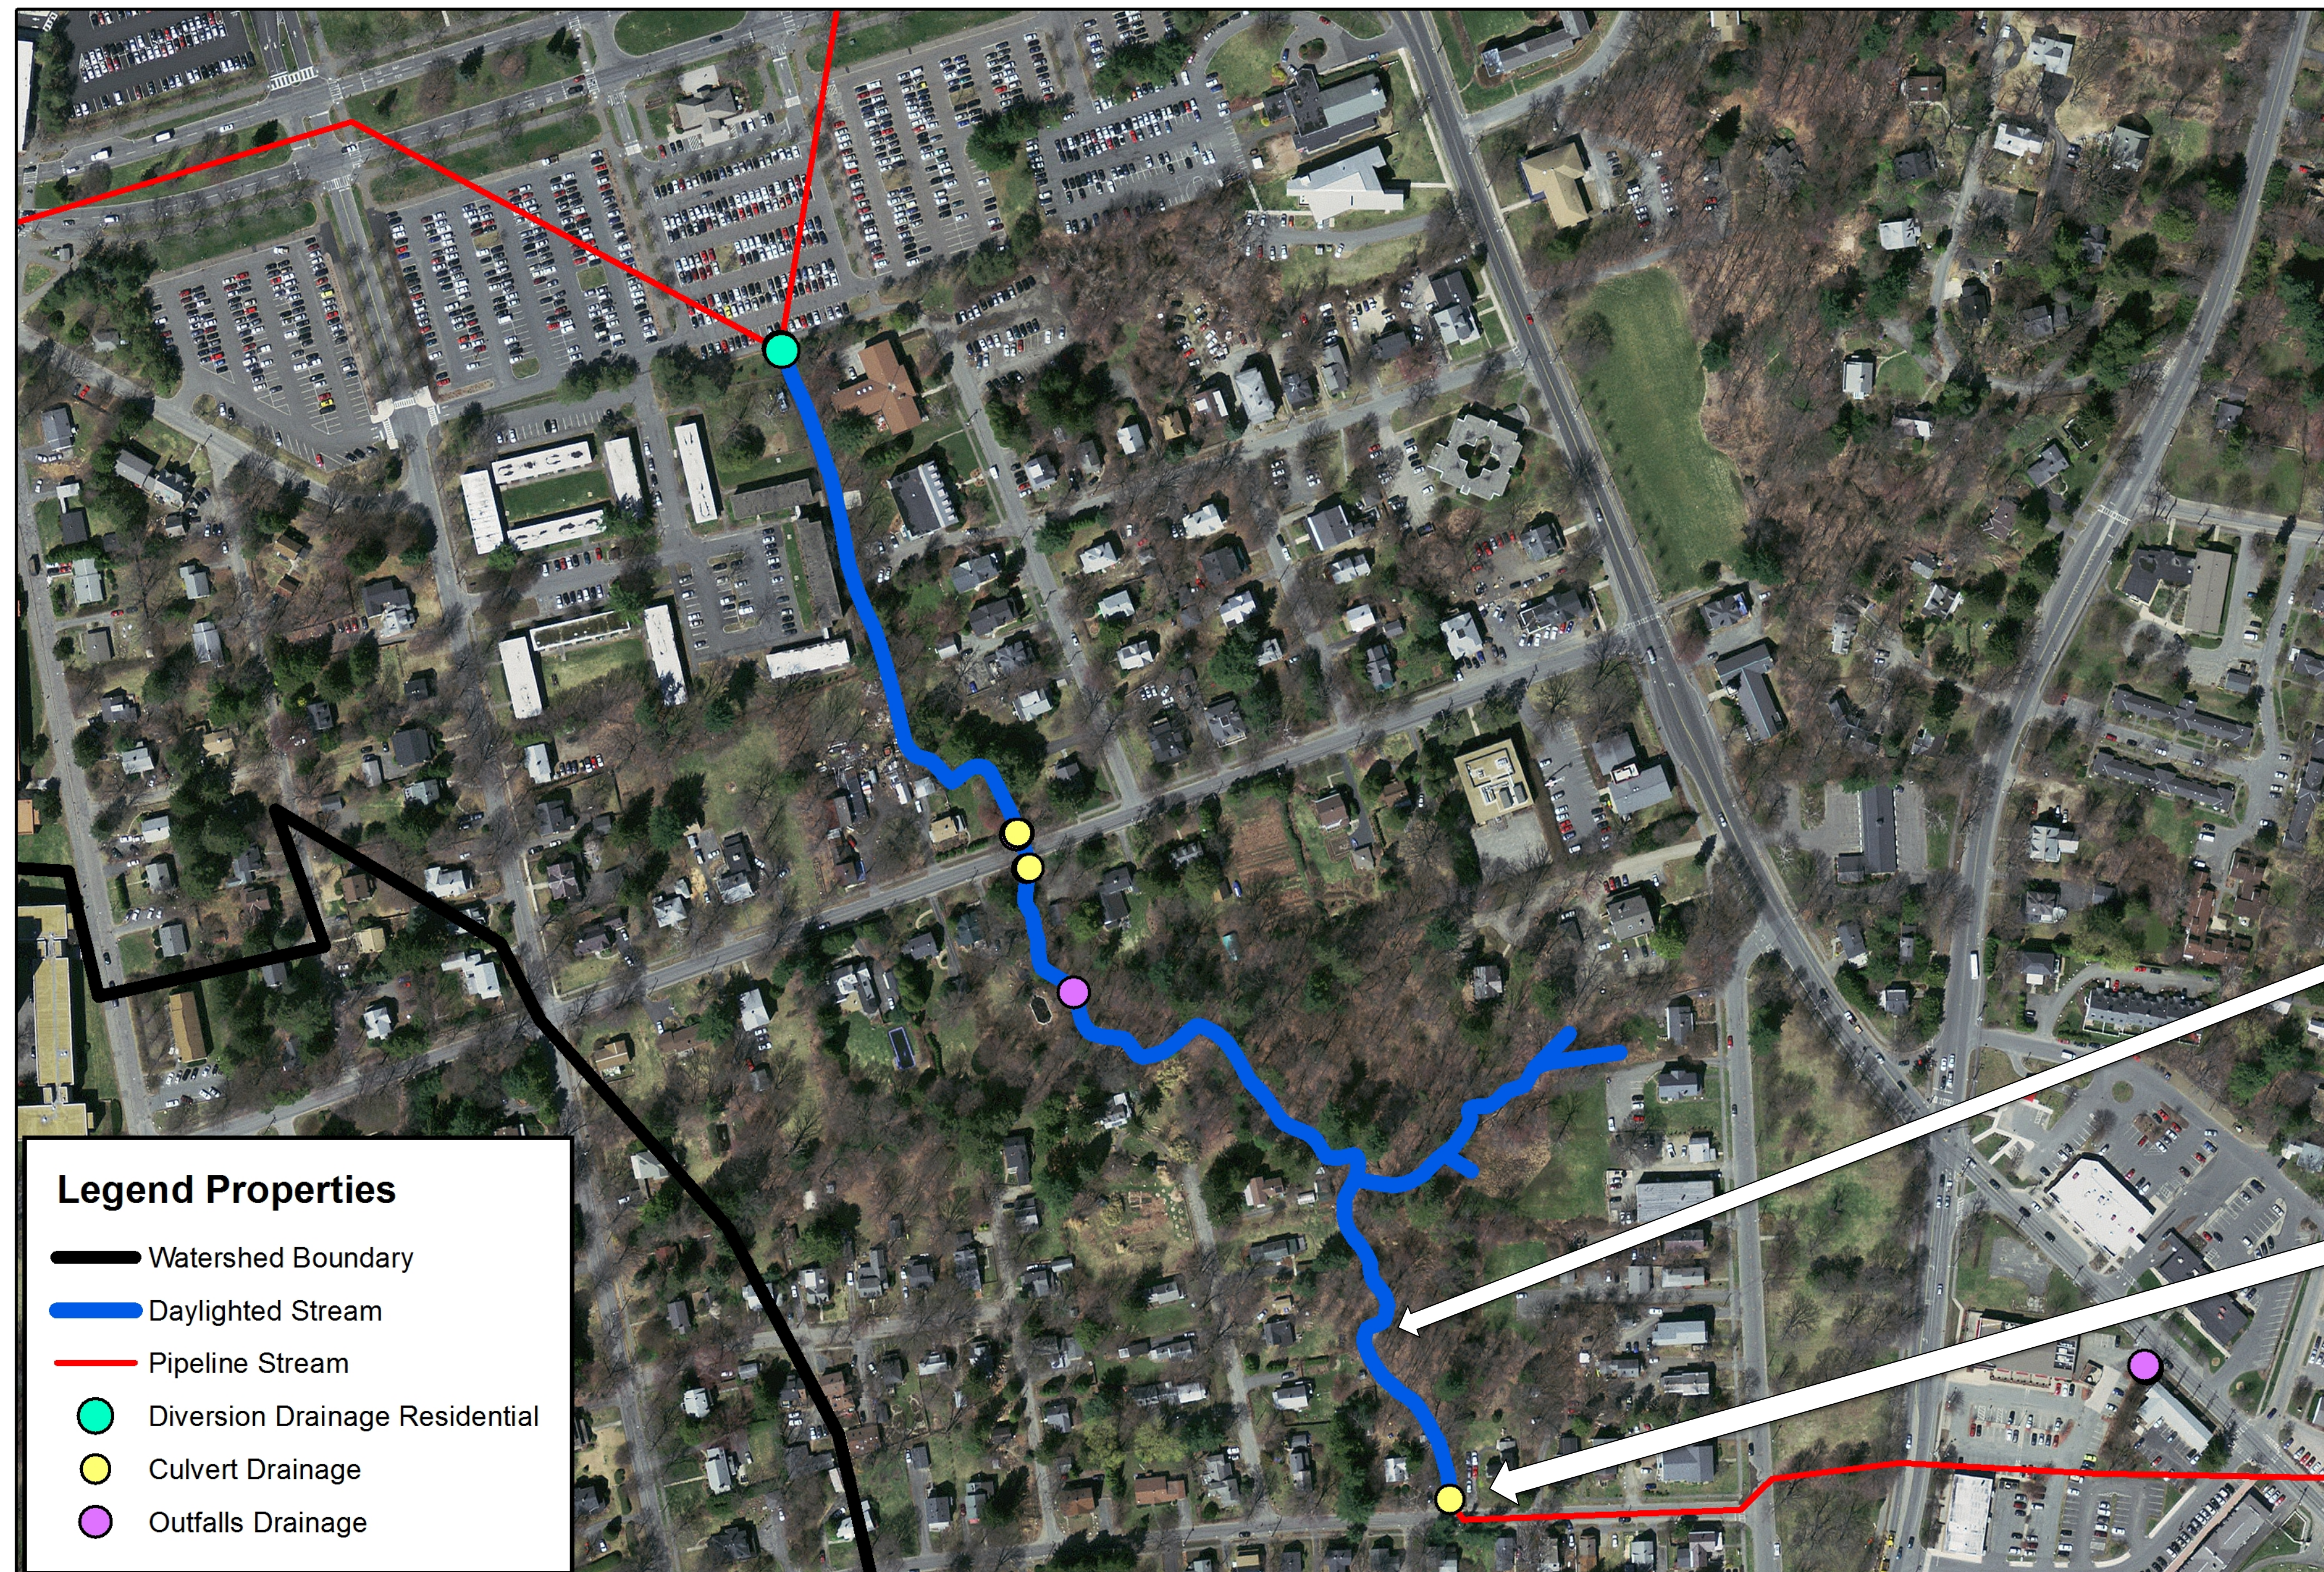
Residential Site: McClellan Street, Amherst MA

- Culvert outfall added in 1978
- Direct run-off from road into stream
- Rock trench infiltration system
- Riffle-pool effect throughout stream
- Velocity was fastest at this site
- Volume was largest
- Erosion was extremely prominent, having 10+ almost on the verge of falling
- Substantial amount of pollution
- Adjacent residential homes were less than 10 feet from direct stream
