Qualitative and Comparative Analysis of Stormwater management in the Tan Brook Watershed

Qualitative and Comparative Analysis of Stormwater Management in the Tan Brook Watershed

Natalia von Hausen

Landscape Architecture and Regional Planning Department

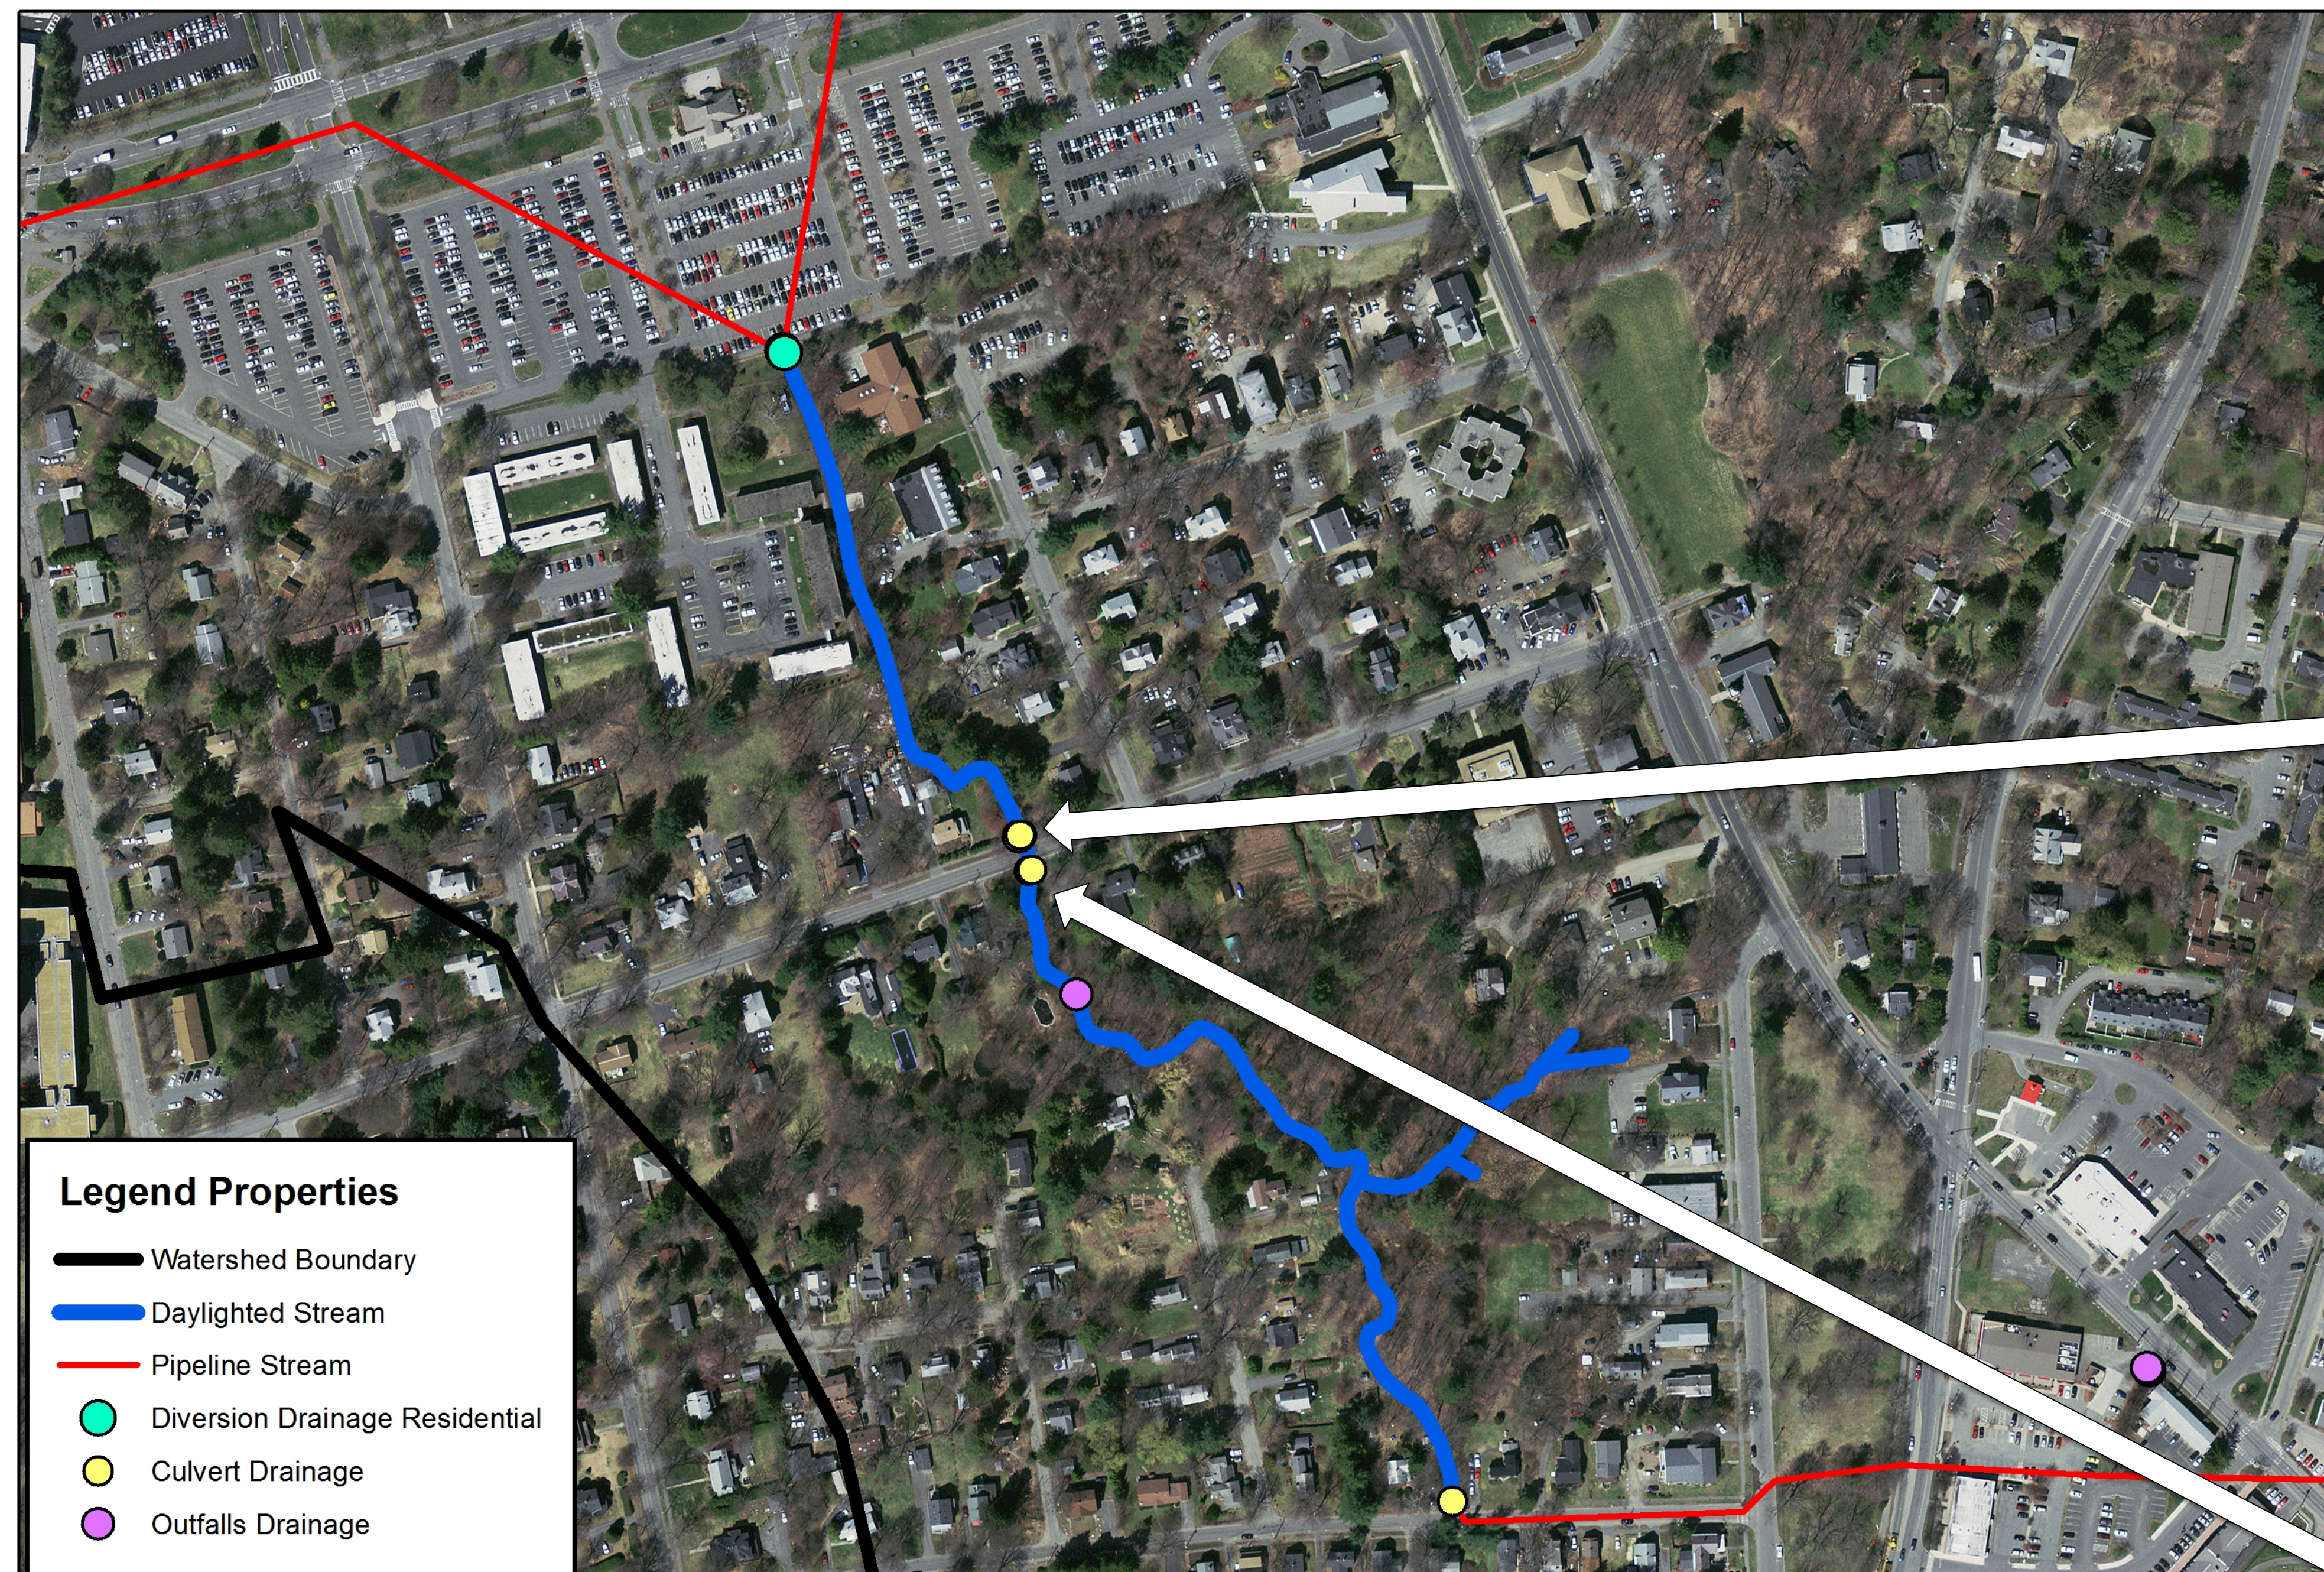
Residential Site: Fearing Street, Amherst MA

- Snowmelt uncovered high amount of litter and pollution
- Two culvert outfall drainage systems run the stream underneath the road
- Absolutely no infiltration or drainage system on south side of street (Image to the right) run-off from street was directly flowing into stream
- Wetland wildlife framed the area around the site
- Turns into a stream with two different piped streams (parking lot the stream diverges)
- Rocks border the stream and yards for slight erosion control
