Gens, A. & Alonso, E. E. (2006). *Géotechnique* 56, No. 3, 185–201

Aznalcóllar dam failure. Part 2: Stability conditions and failure mechanism

A. GENS* and E. E. ALONSO*

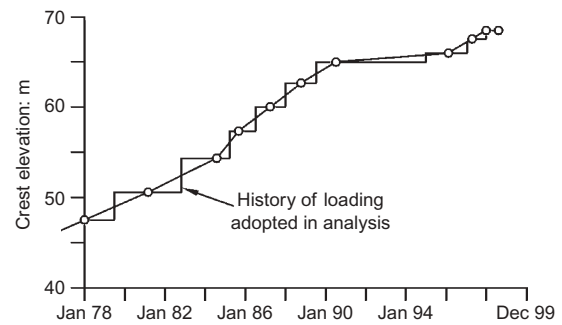
Figure 7 shows the evolution of the embankment at the failed section and the sequence of loading increments adopted in the calculations. The same history of dam elevation applies, with minor variations, to Profile 1, within the unfailed embankment, north of the breach. Data in Figs 3 and 7 define the developing geometry of the embankment from January 1978 to the time of failure, in April 1998. The level of tailings followed the embankment height, the level

Fig. 7. History of dam construction in terms of elevation of crest and incremental sequence used in calculations

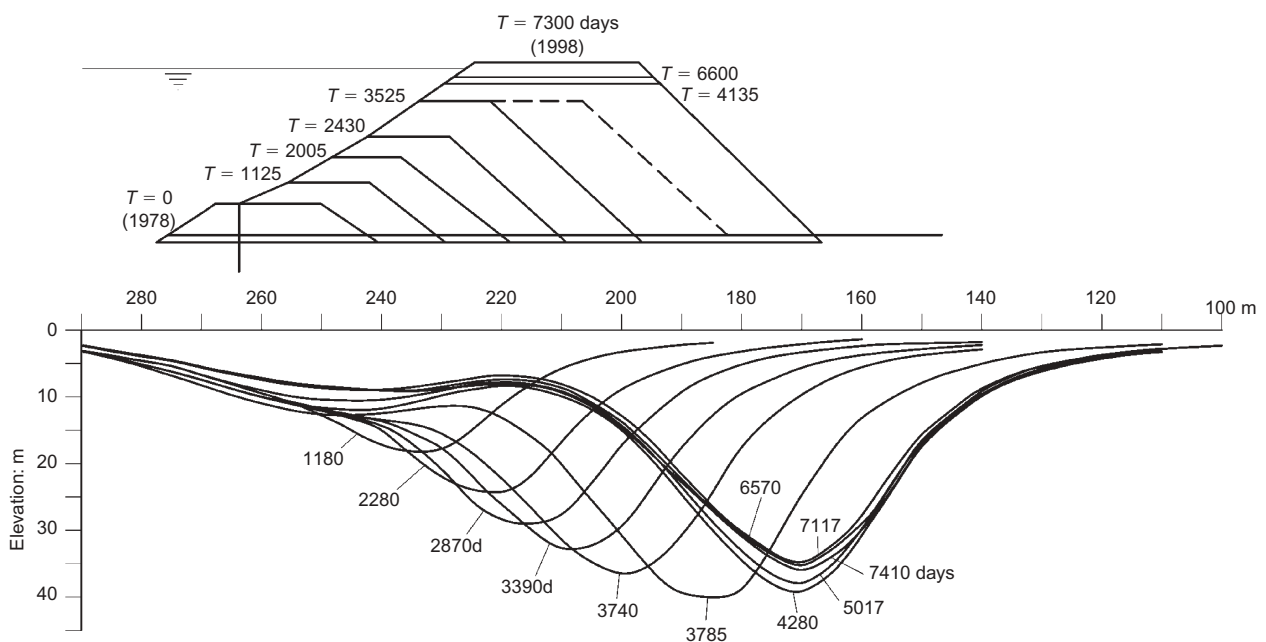
Shear stress τ and effective normal stresses σ'_n were also calculated, on the basis of the elastic stress distributions and the current pore water pressures, on horizontal planes and, in particular, on the position of the future failure plane. The ratio τ/σ'_n has been plotted (as a mobilised friction angle) in Fig. 9 for the points selected for representing pore pressures. Also indicated is the calculated absolute value of τ for a few time values. The mobilised friction angle increases rapidly as the downstream toe of the advancing embankment approaches the point under consideration. As the embankment advances further, the mobilised friction angle decreases because of the increasing 'confinement', which implies a decrease in shear stress and a parallel increase in normal stresses. As time elapses, the dissipation of pore pressures also results in an increase of the effective normal stresses. In this way, an advancing peak of mobilised friction follows the forward construction of the embankment. This is clearly shown in Fig. 10, where the successive profiles of mobilised friction angle along a horizontal plane ($z = 14$ m), very close to the position of the failure plane, are plotted.

This was the situation as early as 1980–1981. Additional stressing in the following years could not be resisted in some areas of the clay. The brittle nature of the clay allowed additional straining in the vicinity of the critical points in a typical progressive failure mechanism. The forward construction of the embankment resulted, therefore, in an increasing extension of the area affected by progressive failure. The line plotted in Fig. 11(c) joins the points of maximum stress ratio. It is viewed as a first approximation of the position of the failed surface under the embankment. Its position is quite close to the position of the future failure plane. The inclination of this line has probably helped to concentrate critical conditions on a specific bedding plane. The line thus defined is an approximation to the failed or damaged surface immediately before failure.

These results should be regarded with caution: the actual distribution of mobilised friction angles cannot possibly be the distribution shown in Figs 10 and 11 because, at any point in the clay, the stress ratio is limited first by its peak strength, and then by the reduced friction angles in subse-

Fig. 10. Variation of mobilised friction in a horizontal plane located at depth $z = 14$ m within clay foundation. Numbers indicate time elapsed (days) since start of dam construction (January, 1978)

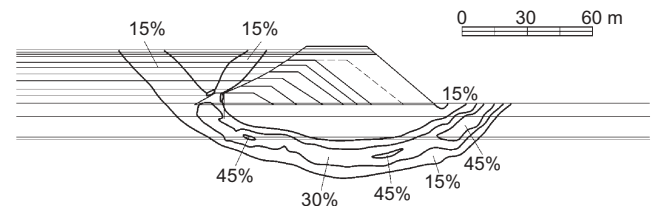
If peak strength parameters are adopted for the clay ($c' = 64$ kPa; $\phi' = 24^\circ$) no plastic points are calculated for the future rupture zone during the whole construction process. It is concluded that, in order to explain the embankment failure, some zones within the clay exhibited reduced strengths. In order to simulate a failure, a progressive reduction of strength parameters is introduced. In this way, the rupture mechanism shown in Fig. 13 is found (contours of equal shear strains are represented). A circular failure is predicted (as in the limit equilibrium type of analysis for homogeneous clay properties).

Fig. 13. Contours of equal shear strain calculated at failure in a 2-D elasto-plastic finite element analysis: homogeneous clay

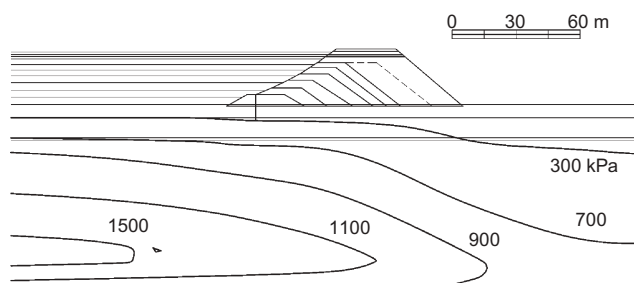
This FE analysis also provided data relating to the evolution of pore water pressures in the foundation. Fig. 14 shows the distribution of pressures at the end of the calculation (just prior to rupture). Note the substantial influence of the heavy tailings and the very limited dissipation of pore pressures. A profile of water pressures along the future failure plane is shown in Fig. 15. The FE prediction is compared with the result of the elastic-consolidation analysis reported before. The correspondence is very good.

Fig. 14. Distribution of pore water pressures in last stage of FE calculations, immediately prior to failure

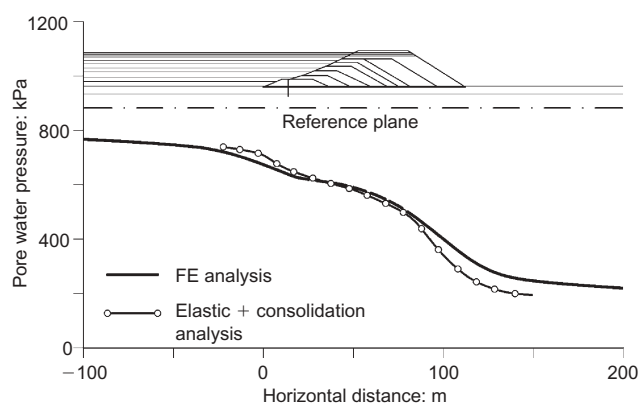
Fig. 15. Distribution of pore water pressures along failure surface (reference plane): comparison of FE and simplified elastic-consolidation analysis

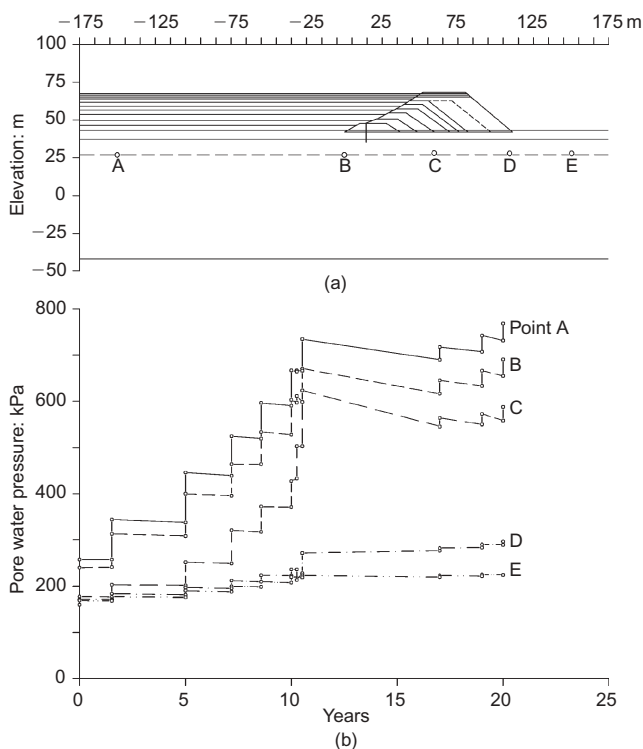
More detailed information on the very limited dissipation of pore water pressures that took place during construction is given in Fig. 16. This shows the calculated evolution of pore water pressures for a few points under the lagoon, under the embankment structure and downstream of the embankment toe. The magnitude of the pore pressure developed is basically controlled by the added weight placed above each of the points considered.

Fig. 16. Calculated development of pore water pressure at points of failure surface: FE analysis
