## **Collapse Scene Investigation (CSI) Carmel River Bridge Failure**

Avila, Catherine M. C. (2008): Collapse Scene Investigation (CSI) Carmel River Bridge Failure. In: Sekiguchi, Hideo (Hg.): Proceedings 4th International Conference on Scour and Erosion (ICSE-4). November 5-7, 2008, Tokyo, Japan. Tokyo: The Japanese Geotechnical Society. S. 707-711.

# Collapse Scene Investigation (CSI) Carmel River Bridge Failure

Catherine M.C. Avila, P.E., D.WRE, MSCE, MBA

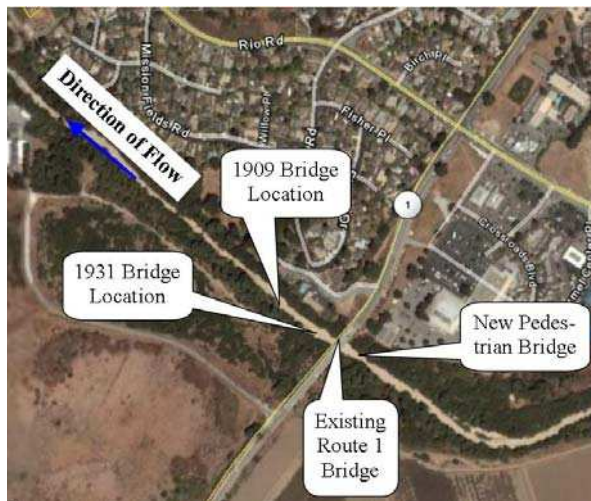
Figure 2: Past, Present and Future Bridges at the Site (basemap from googleearth.com).

As shown in Figure 2, there have been three state highway bridges at the site and a pedestrian bridge is proposed.

The earliest bridge with records available was constructed in 1909. This 1909 timber bridge was replaced in 1934 with a bridge upstream because the timber piles and deck were rotting and the bridge was settling. The 1934 bridge was replaced in 1995 with a

reinforced concrete box girder bridge upstream when three spans of the 1934 bridge washed into the river on March 10, 1995. A pedestrian bridge is currently proposed upstream of the 1995 Route 1 Bridge as part of a pedestrian and bicycle corridor planned by the Transportation Agency of Monterey County (TAMC).
