## **Foreshore erosion and scour induced failures of sea dikes**

Mai, C. V.; Pilarczyk, K. W.; Gelder van, P. H. A. J. M. (2006): Foreshore erosion and scour induced failures of sea dikes. In: Verheij, H.J.; Hoffmans, Gijs J. (Hg.): Proceedings 3rd International Conference on Scour and Erosion (ICSE-3). November 1-3, 2006, Amsterdam, The Netherlands. Gouda (NL): CURNET. S. 424-433.

**Abstract:** This paper aims at investigation of sea dikes failures and its mechanism due to foreshore erosion and scour in front of coastal dikes. The case of Namdinh sea dikes in Vietnam is introduced and selected for analysis. Some methods to estimate scour dimensions will be reviewed and applied for the Namdinh case in determination of suitable dimensions for dike's toe and bed protection. Namdinh coastal zone is a low-lying area which has been protected by sea dikes. In the region typhoons arrive on average four to six times each year at the coastline and the typhoons generate storm surges and waves, both attacking severely the sea dikes along the coast. As the result the sea dike system frequently suffer from damages and failures. One of the main reason for failures of the sea dikes is due to co

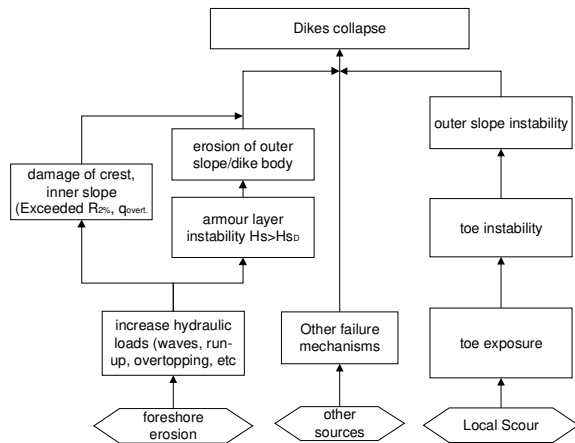
Figure 6. Consecutive failure mechanisms due to foreshore erosion and scour at a sea dikes

In coastal structure design in general and sea dike design in particular it is necessary to know in advance all kind of possible failure modes of such structures and their causes. Obviously, foreshore erosion and scour contribute a considerable effect to the failure by either direct or indirect ways. It is possible to analyze these effects by analytical method or setting up physical and/or numerical models. In term of foreshore erosion and scour induced failures of sea dikes, these consecutive failure mechanisms can be modelled conceptually as in Figure 6.

Foreshore erosion and scour cause direct and indirect effects to the safety of sea dikes and revetment. Failures of the dikes due to these problems are obviously indicated in the case study of sea dikes in Vietnam. Given result shows that when possible scour holes occurs the safety of the dikes decrease considerably. Since the maximum scour depth of 1.2 meters (approximately 50% original depth) presents in front of the dikes, the actual safety of the dikes is decrease by factor of 0.7 in term of wave run up and stability of amour layer, and wave overtopping reduce safety factor by 0.5. The overall safety factor of the toe structure is very low at 0.32. A conceptual model of consecutive failure mechanisms in Figure 6. described these effects to the failure of sea dikes.

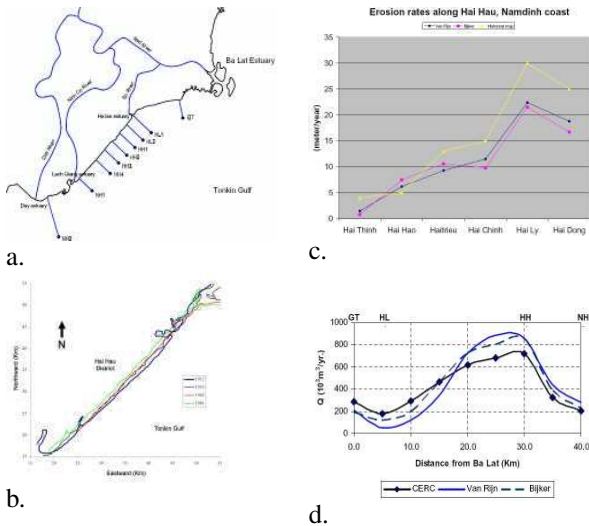
Figure 11. Longshore sediment transport and beach erosion simulation a long Namdinh coast

According to the model output, the net sediment transport direction is from north to south along the coastline. Obviously, the whole project areas are subject to erosion. The maximum erosion rate is at Hai Ly, about 22.4 meters/year (Van Rijn formula) and 21.5 meters/year (Bijker formula) which is situated in the northern part of the project, and then the erosion rate decreases southward. In order to calibrate the coastline model the simulation results are compared with the available collected data, which were deduced from the erosion map in period 1972 - 1996 (see Figure 15 b.). The comparison is shown in the Figure 15c with a acceptable fit. This result gives quite good agreement with the future prediction in the previous section.

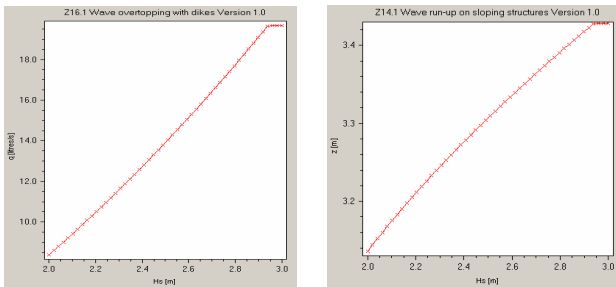
Figure 16. Sensitivity analysis of wave height related criterion

Sensitivity analysis on rock stability of outer slope protection base on Pilarczyk 2<sup>nd</sup> formula for rock armour show that due to 50% water depth increase, the depth limited wave height increase by factor 1.5. As the result the new requirement of rock diameter increase by factor 1.4 or the safety factor decrease by factor 0.7 (see Figure 16. ). Other sensitive impact analysis will be discussed with Namdinh case study at the below section.

Regarding to safety criteria of slope protection, wave run-up and wave overtopping, wave height is a dominant parameter in the equation. With the given increase of wave height,  $\Delta H_s$ , the reduced factor of safety of the above criteria can be estimated by sensitivity analysis (see summary result in Figure 16. and TABLE IV.

Obviously the result shows that due to increase of 1.2 meters water depth (approximately 50% original depth) in front of the dikes, the actual safety of the dikes is decrease by factor of 0.7 in term of wave run up and stability of armour layer, and wave overtopping reduce safety factor by 0.5. This can be explained for the actual low safety level of Namdinh dikes (extensive analysis see also Mai, C.V. 2004) and what happens there during last ten years.
