## **Fallstudien zur Kolkbildung - Scour Case Studies**

# Fallstudien zur Kolkbildung

## Scour Case Studies

GEORGE W. ANNANDALE, ENGINEERING & HYDROSYSTEMS, HIGHLANDS RANCH, COLORADO, USA

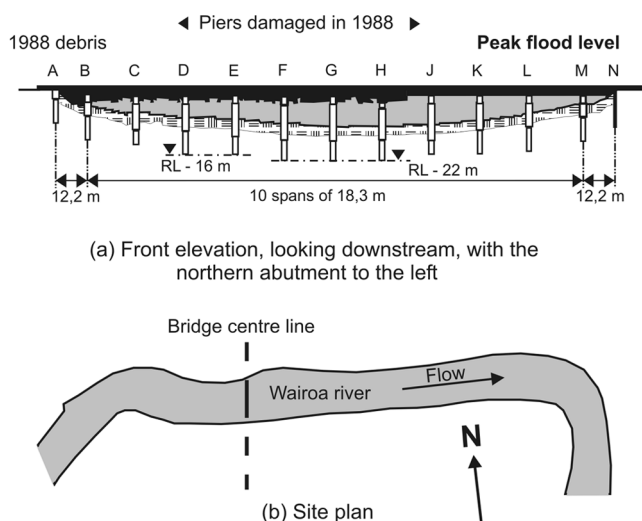
The Wairoa River Road Bridge was situated on the east coast of the North Island, New Zealand. The bridge structure, shown in Figure 5, comprised a reinforced-concrete deck supported by 10 plate-girder spans of 18.3 m with a 12.2 m steel-beam span at each end.

Figure 5: The Wairoa River Road Bridge, after Melville and Coleman (2000)

The bridge was located in a relatively straight reach of the river and downstream from a bend, as shown in Figure 5. The bed sediment at the site is characterised as follows:  $d_{16} = 0.2$  mm, median size  $d_{50} = 0.35$  mm, and  $d_{84} = 0.55$  mm. Bed investigations in 1988 (for the replacement bridge) showed the riverbed to be at about 5 m below MSL, with about 38 m of silty sands and gravels overlying siltstone.
