Conference Paper, Published Version

Scour at a Submerged Rock Dike, Willapa Bay, Washington

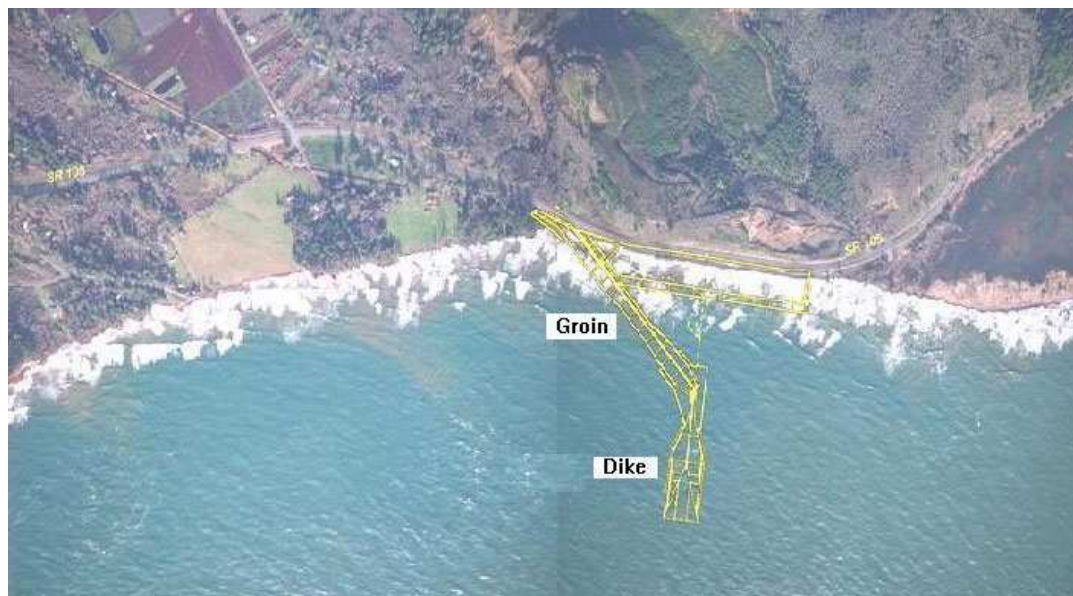
Figure 3. Aerial Photo

The project design consists of a rubble-mound underwater dike, a rubble-mound groin and beach nourishment. The project is shown superimposed on an aerial photo in Figure 3. Figure 4 shows in plan view the project elements. The rock groin structure extends seaward from the shoreline out to the northern edge of the North Channel. The underwater dike extends from the end of the groin across a portion of the North Channel. The beach nourishment is placed behind the dike to protect the shoreline adjacent to the highway. The project was built in the summer of 1998.

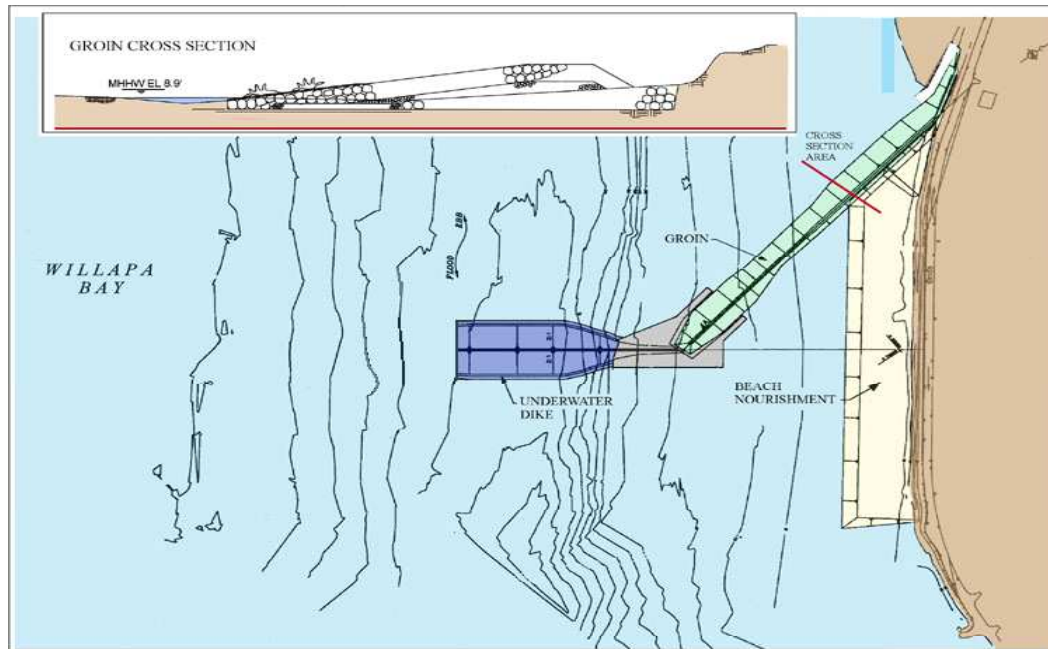
Figure 4. Project Design Features

The rock groin structure extends approximately 1,600 feet from the shoreline. The groin is aligned perpendicular to the predominant wave direction at an angle of 40 degrees to the shoreline. The seaward exposed portion of the groin was designed and built with a 7H:1V slope. The leeward side of the groin was constructed at a 7H:1V slope at locations not covered by beach nourishment material. The outermost 150 feet of the groin has a top elevation of -2.5 feet, Mean Lower Low Water (MLLW) and 3H:1V side slopes. The top of the groin varies from a maximum design elevation of +18 feet, MLLW at the groin's leeward end, to a minimum design elevation of -2.5 feet, MLLW at the offshore end (northern edge of the North Channel). The minimum height of the groin above existing ground is approximately 13.5 feet.

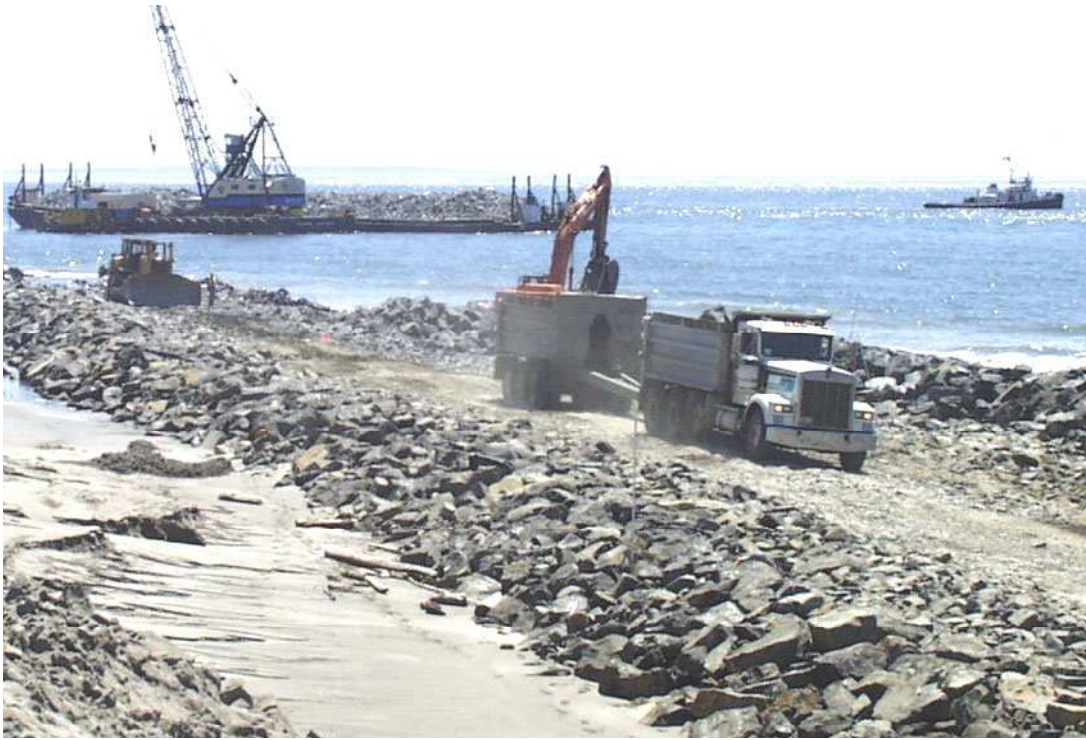
Figure 5. Project During Construction

The project was bid in April 1998 as two separate contracts, a first contract for the beach nourishment and groin/breakwater features and a second contract for the underwater dike feature. Two contracts were let to ensure the project was completed prior to the 1998 winter season and completion within the in-water work windows specified by natural resource agency permits. In May 1998, a unit price contract was awarded to Quigg Brothers Construction Inc. of Aberdeen, Washington for a low total bid of \$8,260,000. Miller Contracting of Vancouver, British Columbia provided the rock source, transport barges and ocean tugs as a subcontractor. Figure 5 shows rock placement during project construction.

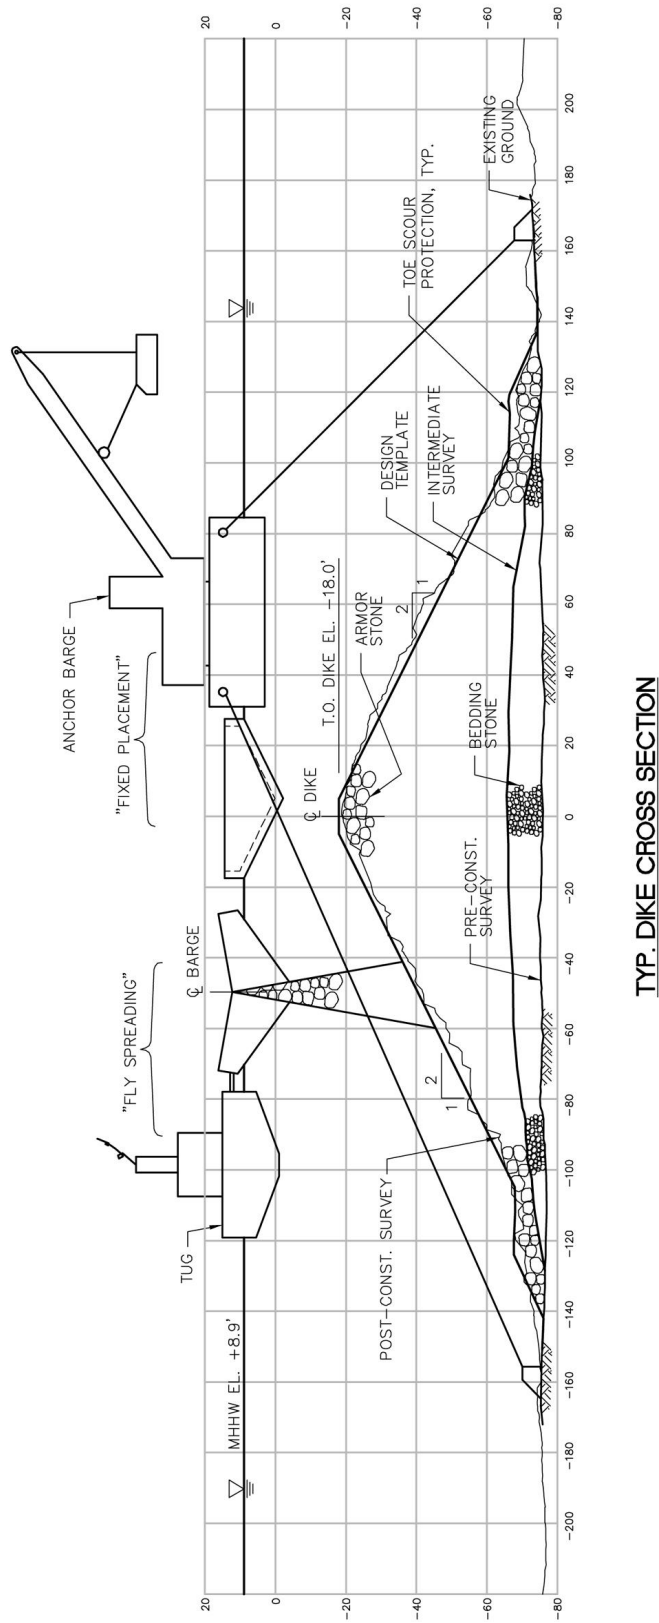
Figure 6. Underwater Dike Rock Placement

Three methods of rock installation were used to construct the dike, and are illustrated in Figure 6:

The third method of placement used split hull barges to “fly” spread rock at specific dike locations. This method was primarily used for installing armor stone in the interior and at the top of the dike and for installing bedding stone. Using GPS, the incoming loads of rock were positioned over the desired placement cell, either unassisted or adjacent to the crane barge. The split hull barge was then opened at a slow rate and moved over the placement cells to spread the rock over a large area rather than an entire load dropped instantly at one location. This method was used to minimize trimming work by spreading each barge load over a greater area rather than installing large individual piles. Current velocity magnitude and direction was measured to predict the trajectory of the rock being spread. Rock was placed at slack high tide in order to work around the extremely high velocities encountered at the site during mid ebb and flood tides. The floating crane was positioned with GPS and securely anchored for use as a tie-up barge for each incoming bottom dump barge load of rock.

For both the “fly” spreading and moored barge placement methods, the initial barge dumps onto existing sand resulted in the material fanning out along the footprint to a 4H:1V to 5H:1V side slope. Once a foundation of rock existed, the dike began to rise up a 1.5H:1V to 1.25H:1V side slope; slightly steeper than the 2H:1V specified slope. Rock continued to be placed with split hull barges up to the specified side slope and top elevation tolerances.
