Conference Paper, Published Version

Scour effects on Coastal Defense Structures Examples from the Portuguese West Coast

F. Taveira-Pinto*, F. Veloso-Gomes* and P. Rosa-Santos*

* Faculty of Engineering of the University of Porto – IHRH, Porto, Portugal

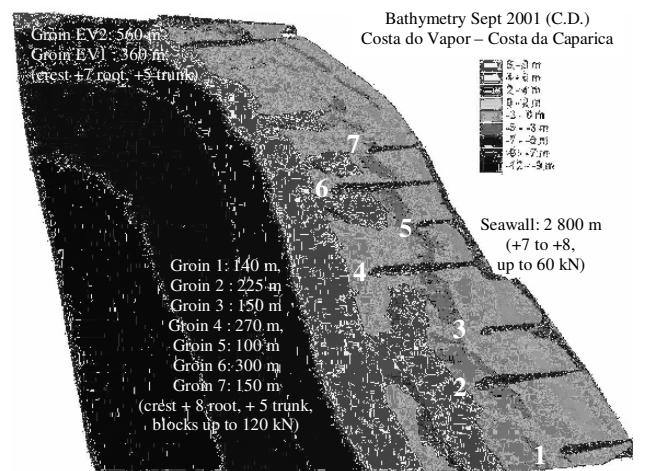
Figure 4. Costa da Caparica groin field after reconstruction (2006) and before the artificial sand nourishment [4].

Some of these structures can reach more than 500m of length, having dimensions and structural components similar to harbor breakwaters. Fig.4 presents the dimensions of the Costa da Caparica groin field after the 2005/2006 repair program, as well as the bathymetry in the vicinity of these structures.

The highly energetic wave climate in the Portuguese West coast and the construction of long groin structures, which can easily reach depths of -5m bellow chart datum, Fig.4, expose these coastal structures to significant forcing loads.

The mobile sand foundation of these structures is also an important drawback issue. At the groin's head, bathymetry can change between -1 and -4m, bellow tide datum, during the year, [5].

A scour depth of -11m has been measured in 2005 near the head of groin EV2 at Costa da Caparica. The bathymetric changes in the vicinity of the Costa da Caparica groin field, between September 2001 and September 2005, are presented in Fig.5.
